Tree Inventory Report

**Hope Village Residential Development Project Site,
Los Angeles, California
800 North Main Street – 1081 North Vignes Street
Los Angeles Council District 14**

March 7, 2024

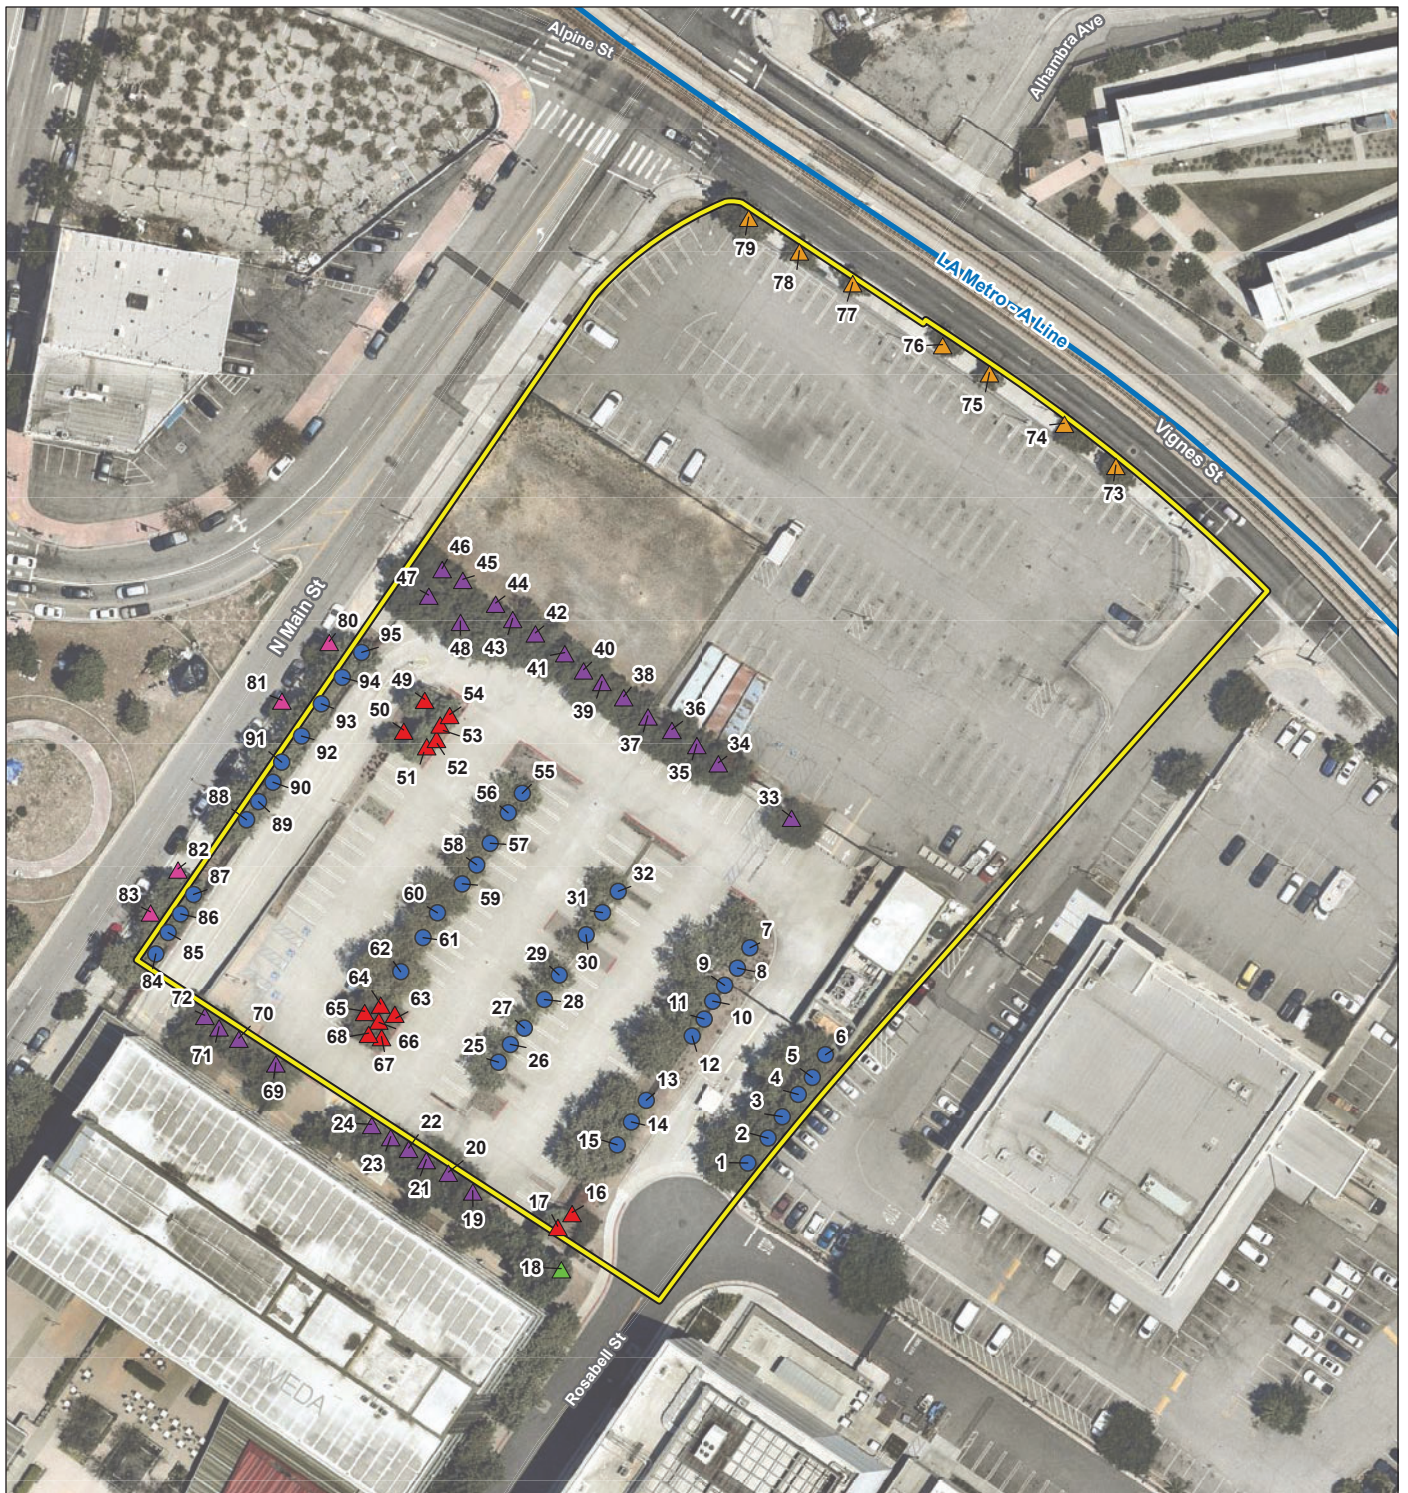
Exhibit 3

A total of 95 trees were documented during the site survey, 84 of which occur within the Project site boundary and 11 other trees that occur within the City right-of-way along North Main Street and Vignes Street. A summary of trees that were encountered during the tree survey are summarized below in Table 2 and their locations are presented in Exhibit 3.

Of the 7 London plane trees along Vignes Street, 6 are more recently planted (measuring between 5 and 7 inches dsh) with good to fair health. The most mature London plane tree is located at the corner of North Main Street and Vignes Street. The four pink trumpet trees located along North Main Street are in fair to poor health as result of ongoing wounding and graffiti located on their trunks and lower branches. The documented street trees have root systems constrained by the surrounding hardscape. No street trees occur nearby along

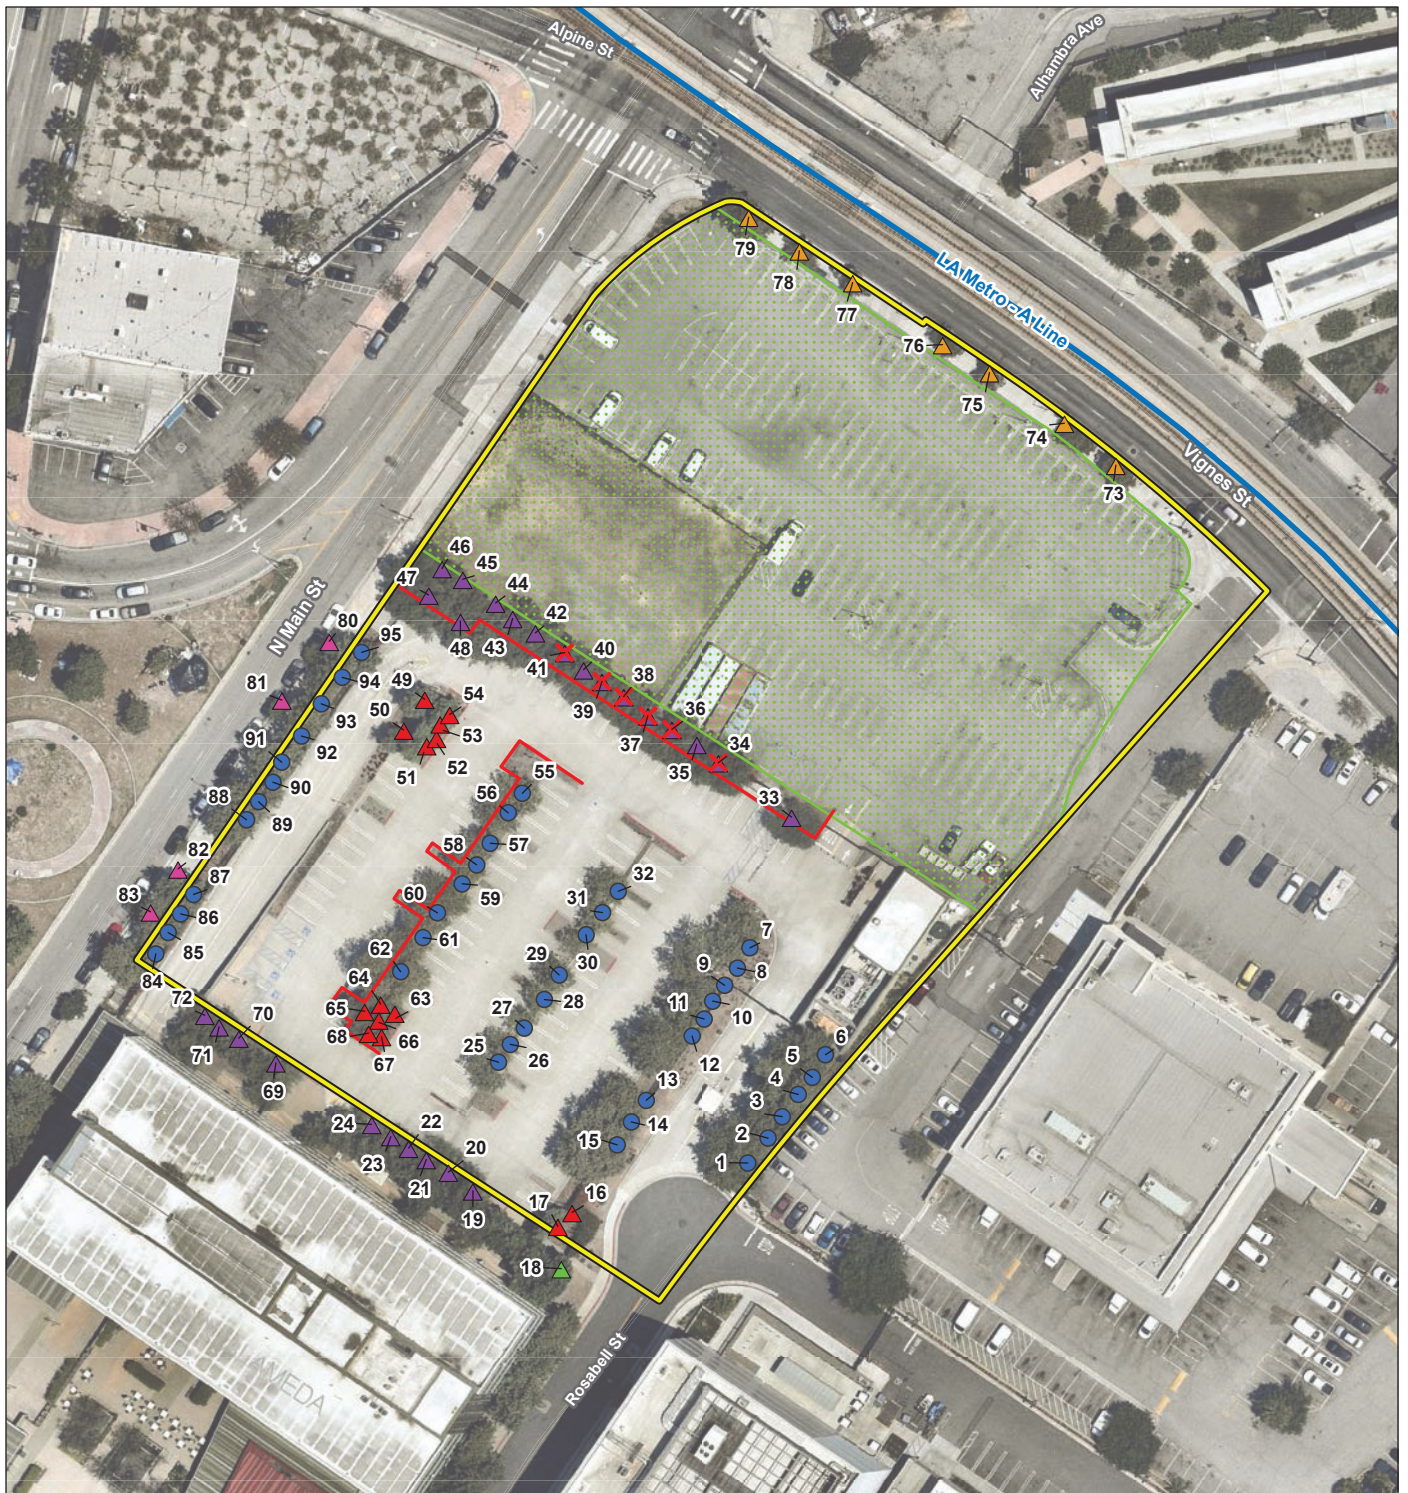
Exhibit 4

Project development activities will be focused in the northern half of the at the Project site and are expected to result in the removal of 6 Peruvian pepper trees. These are tree numbers 34, 36–39, and 41 as indicated on Exhibit 4. Many trees in the survey area are located in tree wells within and along the parking lot areas. In two locations, these curbs are proposed for removal which will occur within the tree protection zones of 14 trees, though little soil disturbance is expected which would affect the health of these trees. No impacts to street trees are proposed; trees along North Main Street and North Vignes Street are planted in tree wells surrounded by sidewalks and their roots do not extend into the Project development area. A site plan is provided in Attachment C that shows the location of on-site trees described herein. Trees that will experience encroachment within their tree protection zones are numbers 33, 35, 40, 42–48, and 55–68.

Table 3 provides a summary of proposed tree impacts associated with the Project following the format of the City's Environmental Assessment Form. Please note that trees listed as "impacted" in Table 3 are those where concrete curbs will be removed within the protection zone of these trees.

To offset the removal of the 6 on-site non-protected trees summarized in Table 3, a total of 53 replacement trees will be installed as part of the overall Project site landscaping. The landscape plan proposes installation of 8 western redbuds (*Cercis occidentalis*), 2 desert willows (*Chilopsis linearis*), 19 western sycamores, 4 coast live oaks (*Quercus agrifolia*), 5 red willows (*Salix laevigata*), 9 Peruvian pepper trees, and 6 bay laurels (*Umbellularia californica*).

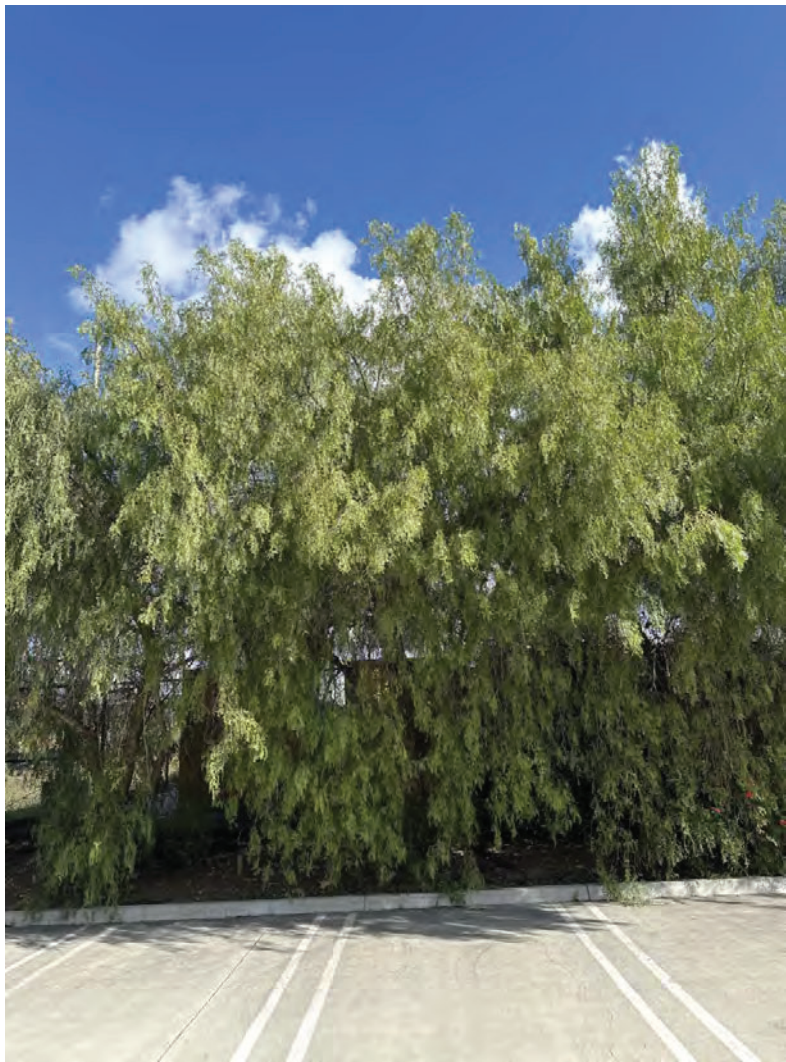
Photo 35. View of Tree 36

36	Peruvian pepper tree <i>Schinus molle</i>	Planted	on-site	Non-Protected	3	13.0	9.0	4.0	-	26.0	25	25	4	3	Removal	New Construction	1:1	TBD	Poor structure, past pruning, in hedgerow
37	Peruvian pepper tree <i>Schinus molle</i>	Planted	on-site	Non-Protected	1	14.0	-	-	-	14.0	25	20	3	3	Removal	New Construction	1:1	TBD	Poor structure, past pruning, in hedgerow
38	Peruvian pepper tree <i>Schinus molle</i>	Planted	on-site	Non-Protected	3	14.0	6.5	2.0	-	22.5	25	25	3	3	Removal	New Construction	1:1	TBD	Poor structure, past pruning, in hedgerow
39	Peruvian pepper tree <i>Schinus molle</i>	Planted	on-site	Non-Protected	3	14.0	4.6	4.5	-	23.1	25	25	3	3	Removal	New Construction	1:1	TBD	Poor structure, past pruning, in hedgerow
40	Peruvian pepper tree <i>Schinus molle</i>	Planted	on-site	Non-Protected	1	16.0	-	-	-	16.0	25	25	3	3	Encroach	Curb removal	N/A	TBD	Poor structure, past pruning, in hedgerow
41	Peruvian pepper tree <i>Schinus molle</i>	Planted	on-site	Non-Protected	1	16.9	-	-	-	16.9	30	25	4	3	Removal	New Construction	1:1	TBD	past pruning, in hedgerow

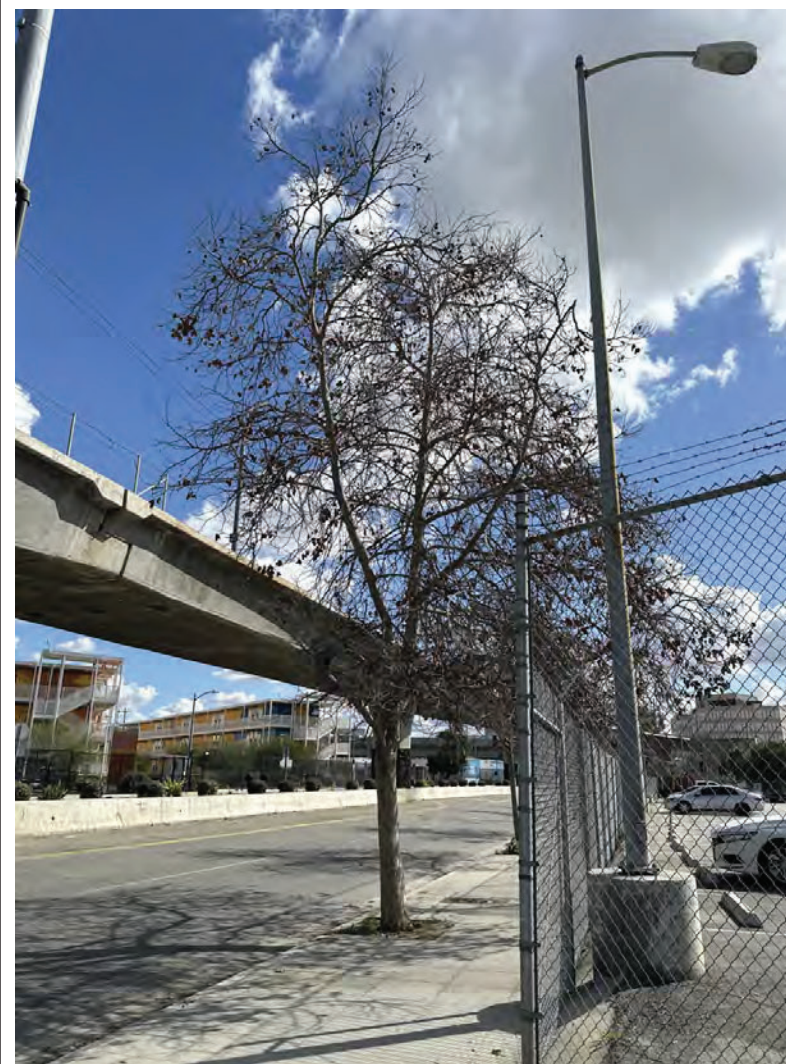
Photo 68. View of Tree 79

79	London plane tree <i>Platanus x hispanica</i>	Planted	street tree	Non-Protected	1	10.9	-	-	-	10.9	35	25	3	3	Preserve	N/A	N/A	N/A	Concrete cutout by street. Graffiti. Trunk wounds. Past pruning.
80	pink trumpet tree <i>Handroanthus heptaphyllus</i>	Planted	street tree	Non-Protected	1	5.6	-	-	-	5.6	10	15	2	2	No Impact	N/A	N/A	N/A	Concrete cutout. Wound damage. Graffiti. Leaf blight.
81	pink trumpet tree <i>Handroanthus heptaphyllus</i>	Planted	street tree	Non-Protected	1	4.5	-	-	-	4.5	10	10	2	2	No Impact	N/A	N/A	N/A	Concrete cutout. Wound damage. Graffiti. Leaf blight.
82	pink trumpet tree <i>Handroanthus heptaphyllus</i>	Planted	street tree	Non-Protected	1	3.9	-	-	-	3.9	10	5	2	2	No Impact	N/A	N/A	N/A	Concrete cutout. Wound damage. Graffiti. Leaf blight.
83	pink trumpet tree <i>Handroanthus heptaphyllus</i>	Planted	street tree	Non-Protected	1	4.2	-	-	-	4.2	12	12	3	3	No Impact	N/A	N/A	N/A	Concrete cutout. Wound damage. Graffiti. Leaf blight.
