**Asbestos Survey Report
For
1433-1493 El Camino Real
Santa Clara, CA 95050**

**Bayview Development Group, Inc.
60 S Market Suite 450
San Jose 95113**

**Environmental Construction Services, Inc.
P.O. Box 5277
Bay Point, CA 94565**

July 31, 2017

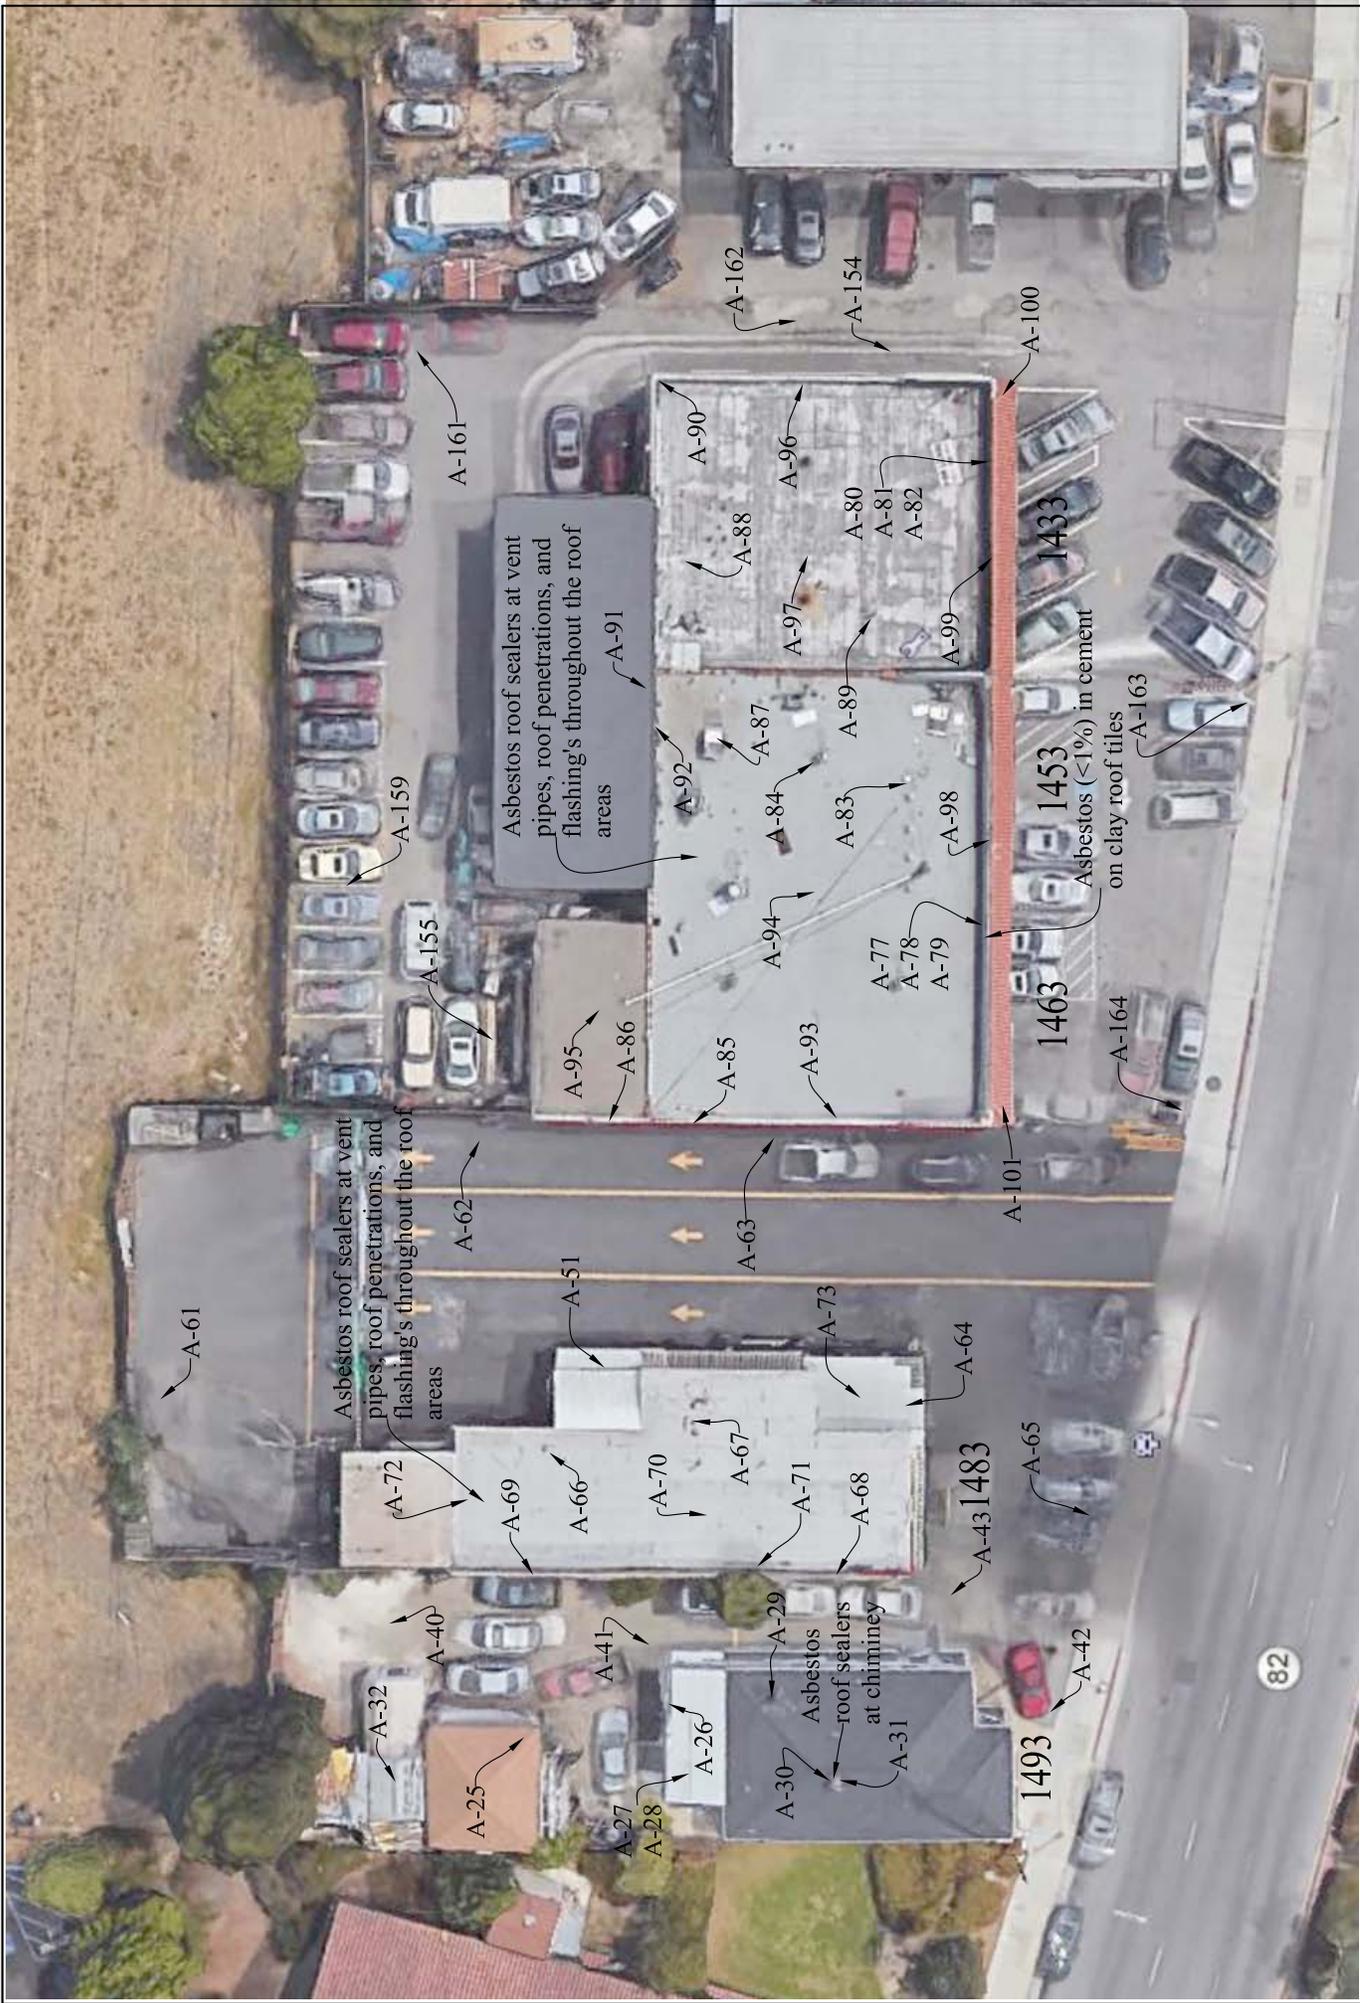
1483 El Camino Real is a 1,850 sq.ft. CMU car wash constructed in approximately 1940. Asbestos was identified in window glazing compounds and roof sealers used at vent pipes, roof penetrations, and flashings throughout the roof areas.

1393 El Camino Real is a 1,260 sq.ft. wood frame home constructed in 1910 with a detached garage. Asbestos was identified in linoleum flooring in the kitchen and laundry room, and roof sealers used at the chimney.

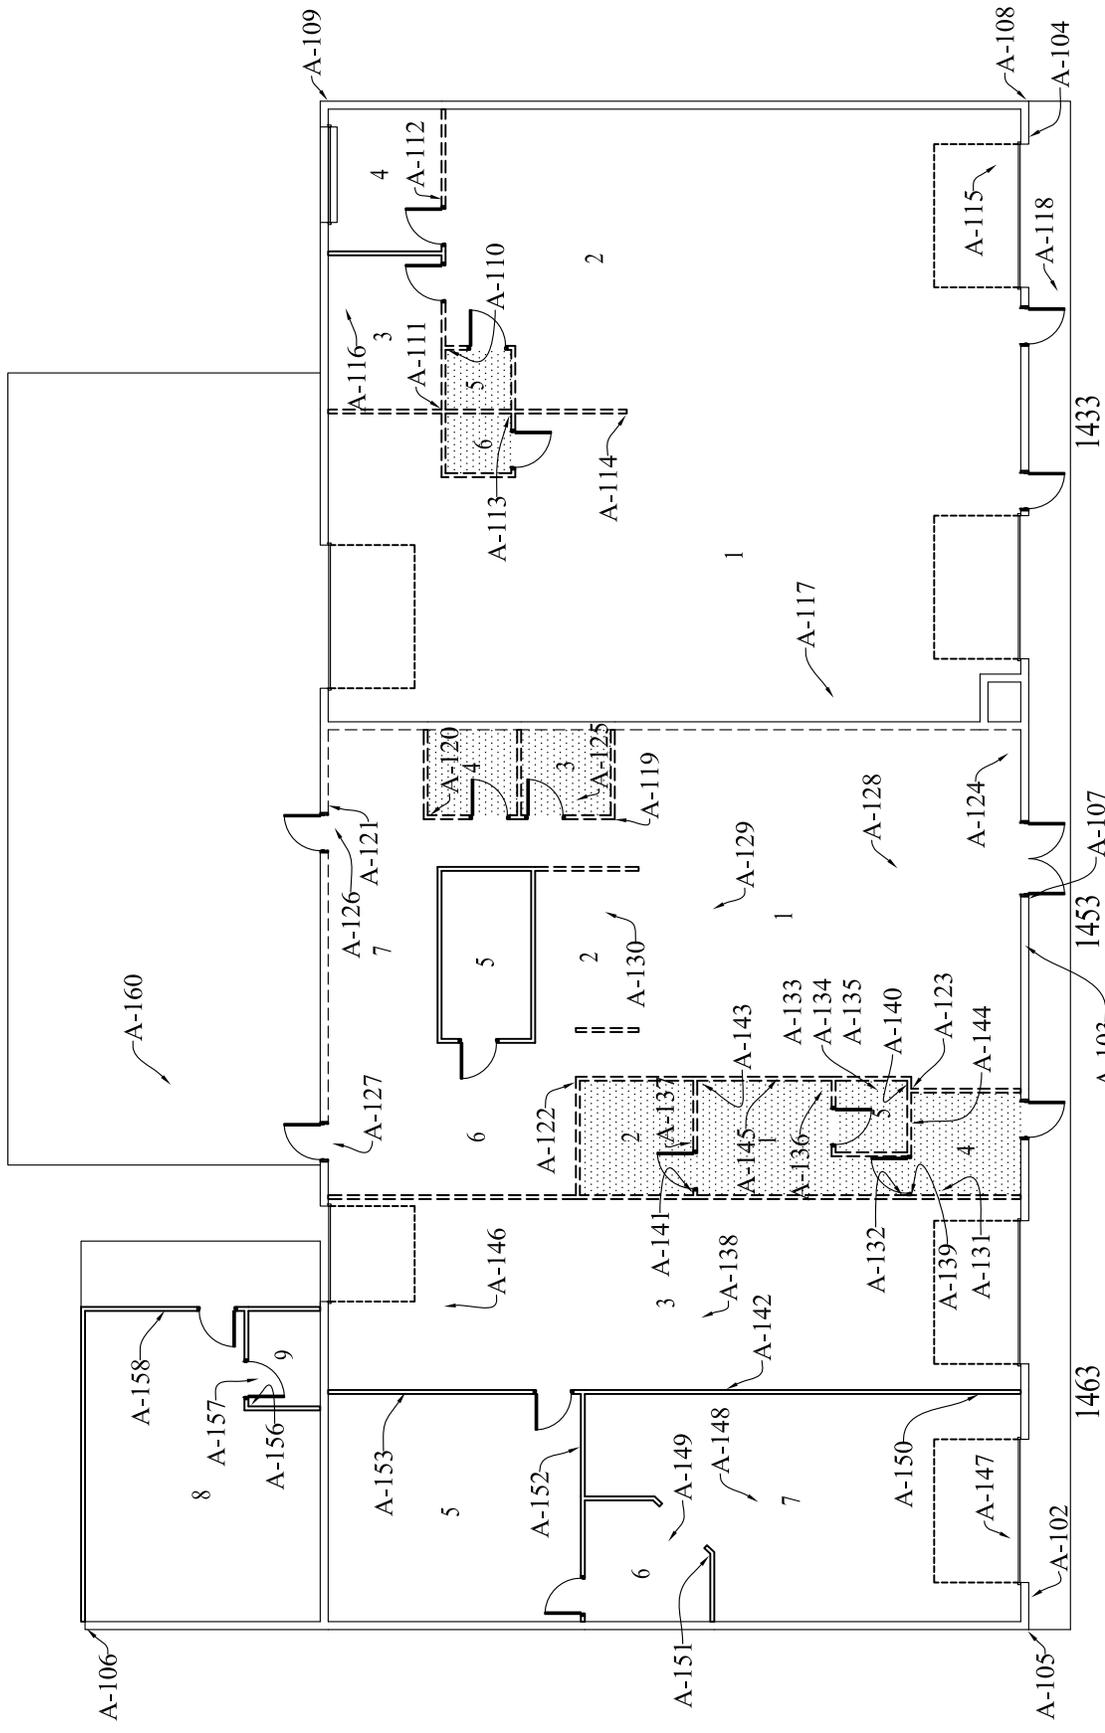
<p>1433-1493 El Camino Real Santa Clara, CA 95050</p>	<p>scale: 1/16"=1'-0" date: July 31, 2017</p>	<p>drawing title: Asbestos Survey 1433-1463 El Camino Real drawing no.: 2 of 3</p>
--	---	---	---	--

Asbestos in joint/texture compounds on drywall ceiling.

----- Asbestos in joint/texture compounds on drywall walls.
