**Jim Borer Certified Arborist #496**  
**Specimen tree preservation, conservation, and analysis**

**March 2, 2021 (revised)**

**Re: On-site Tree Inspection and Inventory Follow-up Report (revised March 2, 2021)**  
**T. Tract 20334**  
**East Avenue, North of Blue Gum**  
**Etiwanda, Ca.**

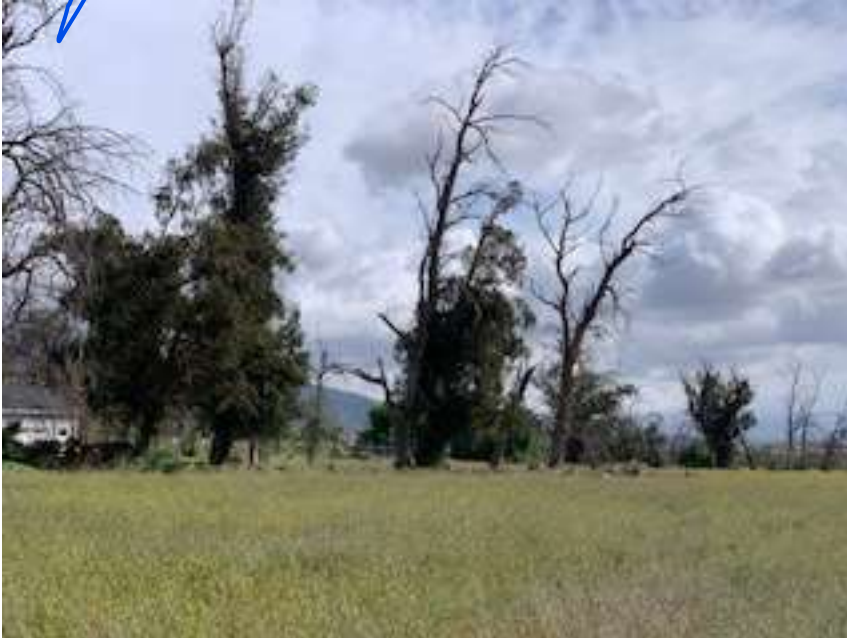
Cross section overview of blue gum Eucalyptus.

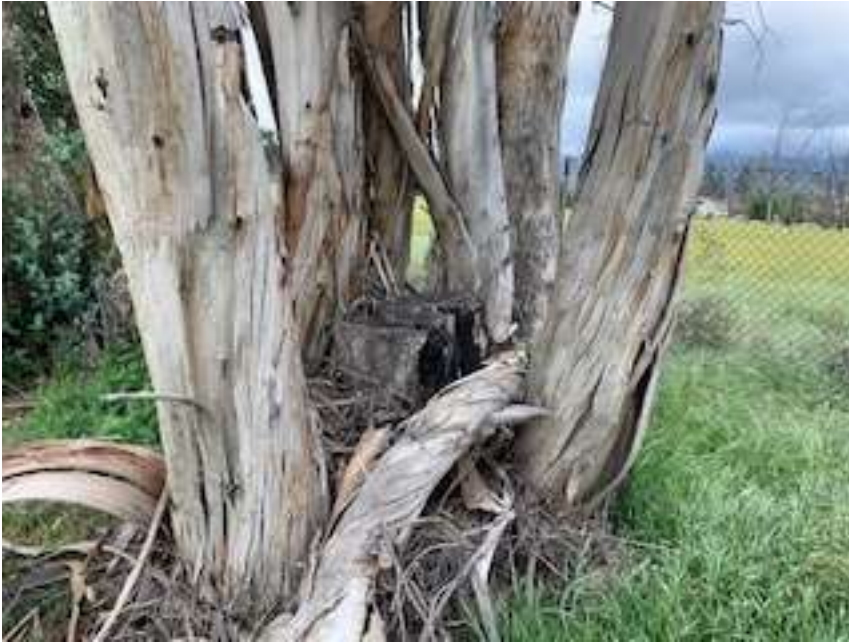
Standing dead tree with typical re-growth of new trunks from distant past removal to ground level.

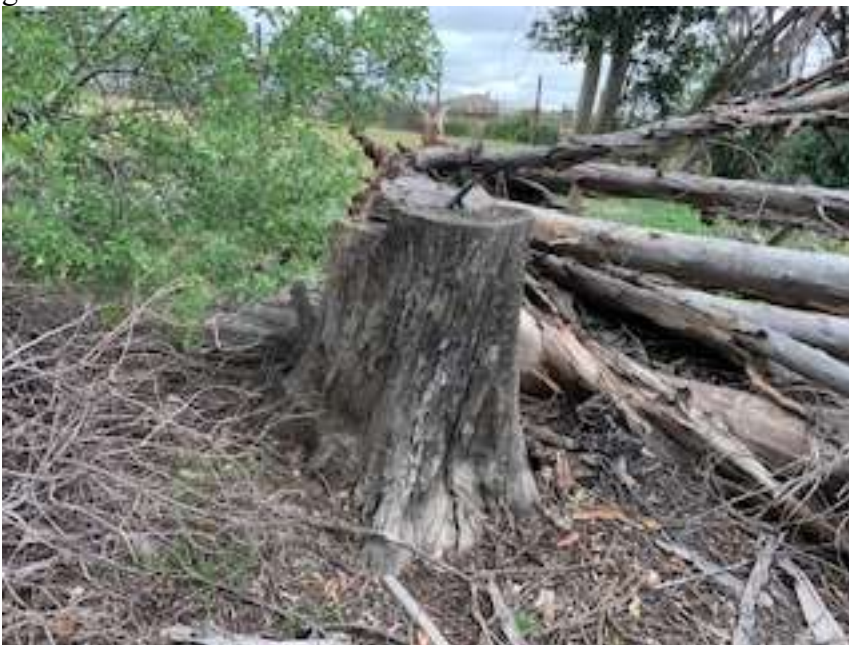
Stump from specimen that was cut down after it had died.

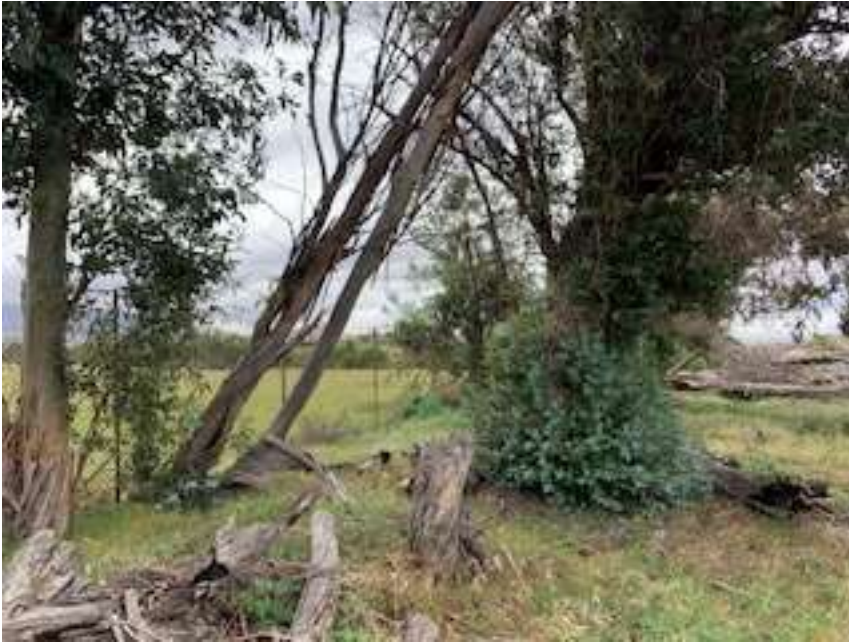
This photograph depicts a mix of live growth, dead standing trunks, and stumps all in one.

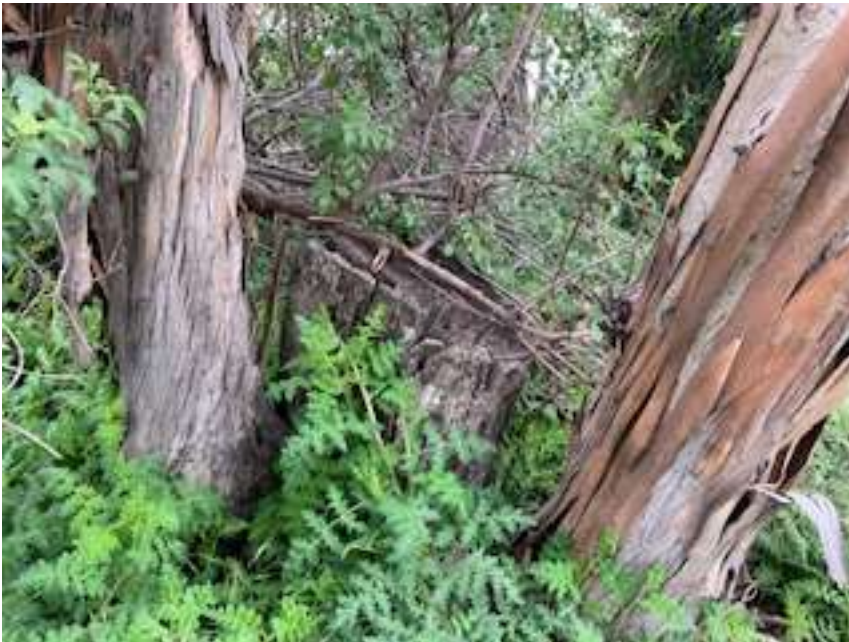
This photograph depicts a stump with a live trunk, right, and a dead trunk, left.

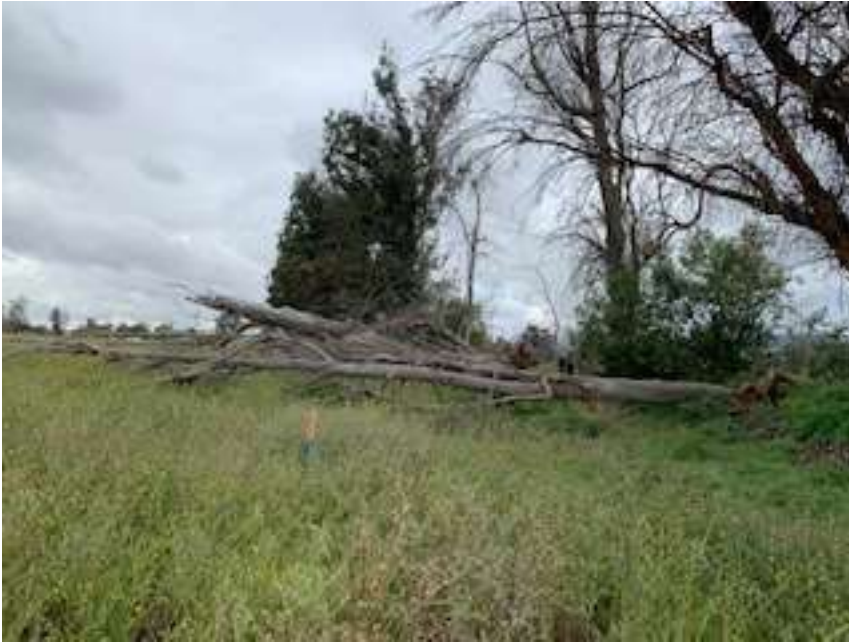
This photograph depicts varying stages of ultimate decline, including live, dead, and leaning dead trees.

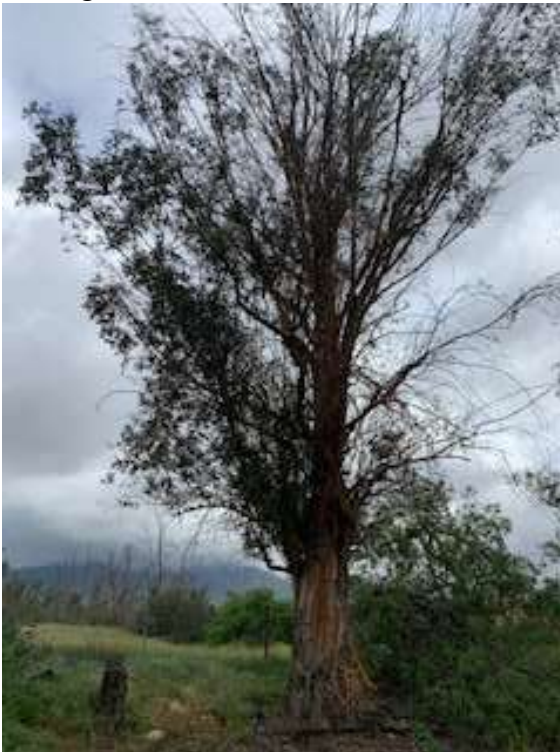
This live specimen exhibits approximately one half of its canopy dead.

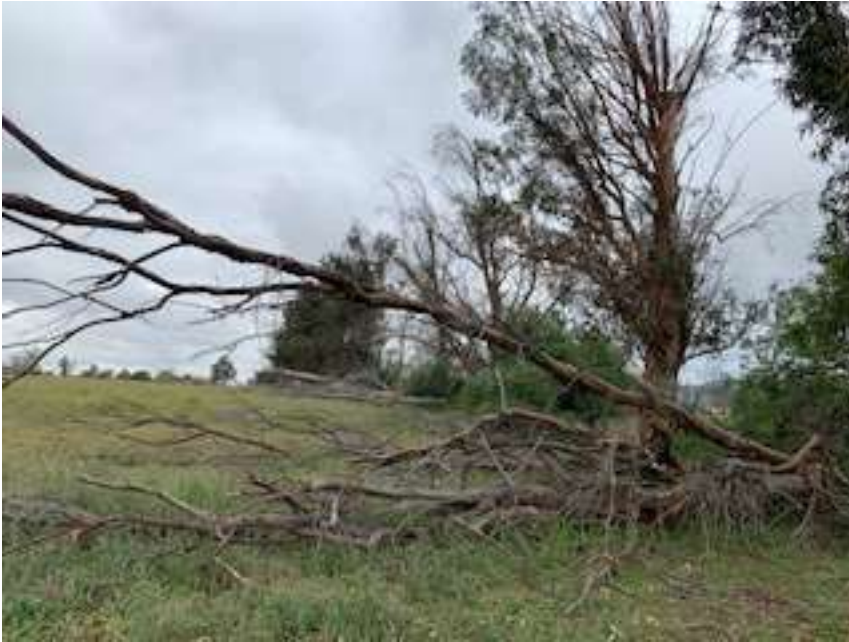
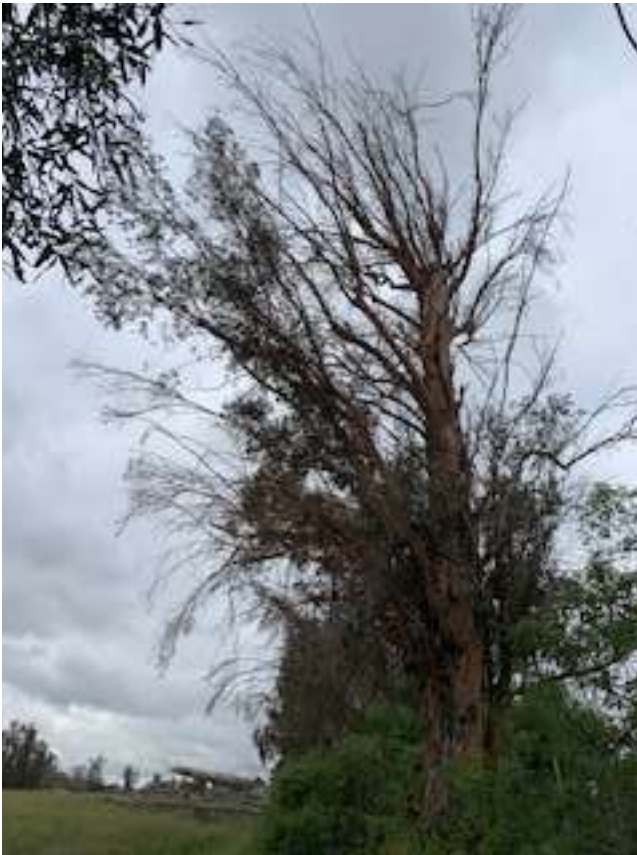
This tree is approximately 90 % dead.

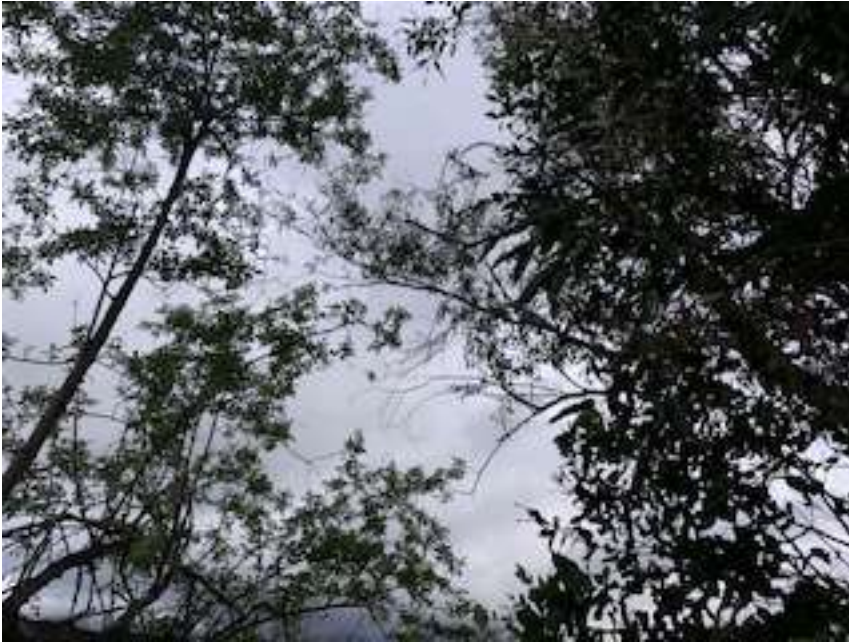
It is my opinion that the relative conditions of the blue gum specimens can be considered by assessing the size of the died-back branches. The larger the size of the die-back branches the longer the decline has been developing and the further along the systemic decline and structural failure potentials are developed. **It is my opinion that the amount of decline that is present in the live blue gum trees disposes them to continuing to experience long-term decline and eventual catastrophic failures if they are conserved in place notwithstanding any amount of heroic or specialized tree care that they may receive. They would be poorly disposed to experiencing any amount of encroachment in the course of engineering the site to construct homes.**

This clump of live tree canopy contains a significant amount of died back branches.

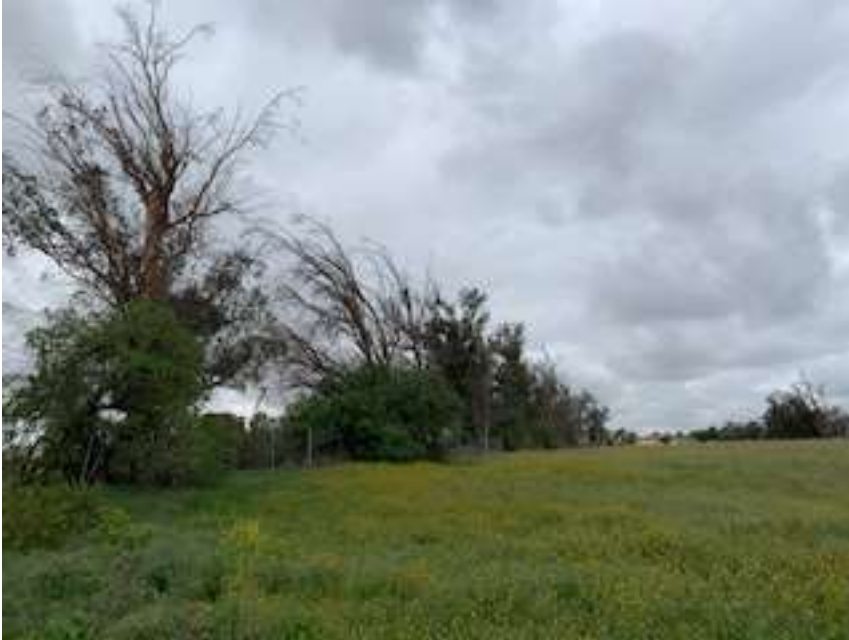
The northern property boundary trees as seen looking east to west on their north side.

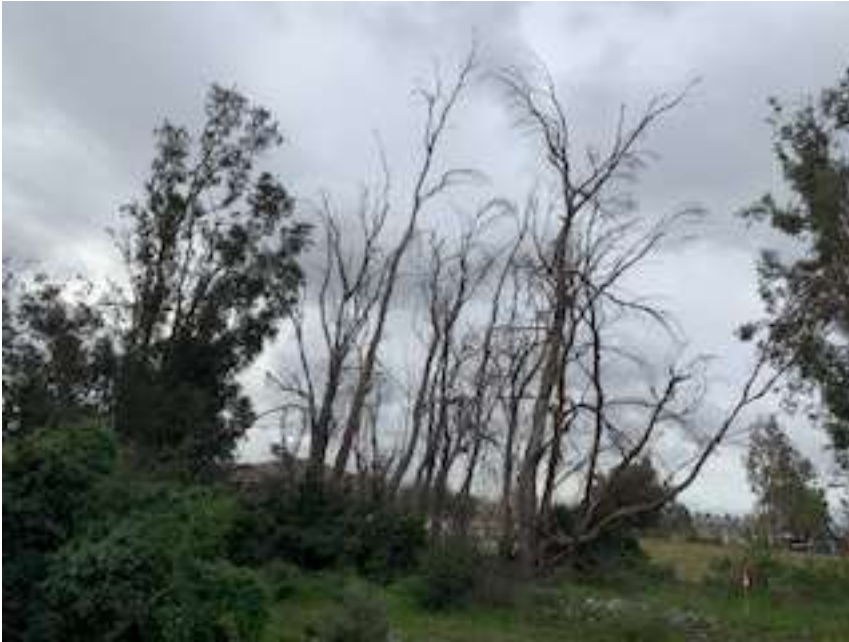
A clump of dead trees in the northern property boundary row.

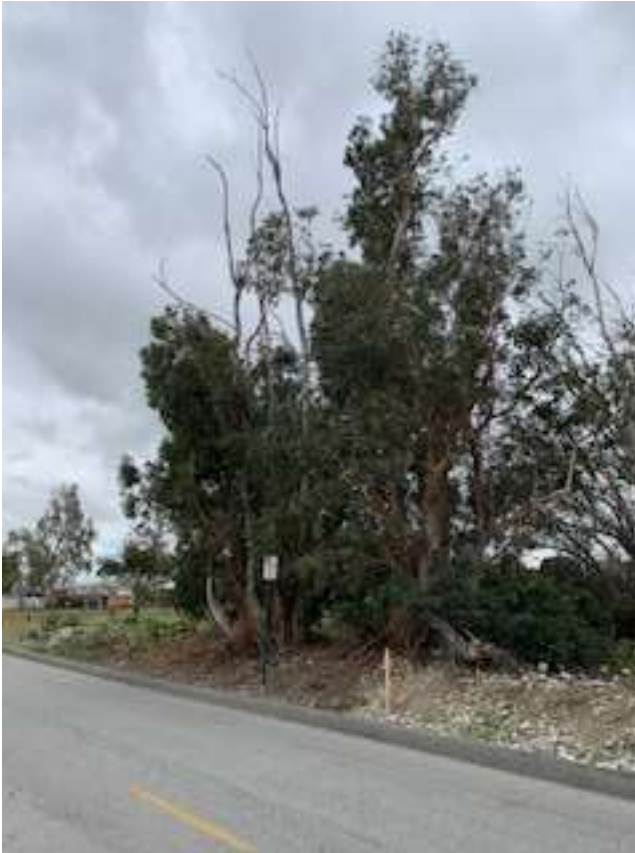
Tree numbers 55-57 are fronting onto Golden Lock.

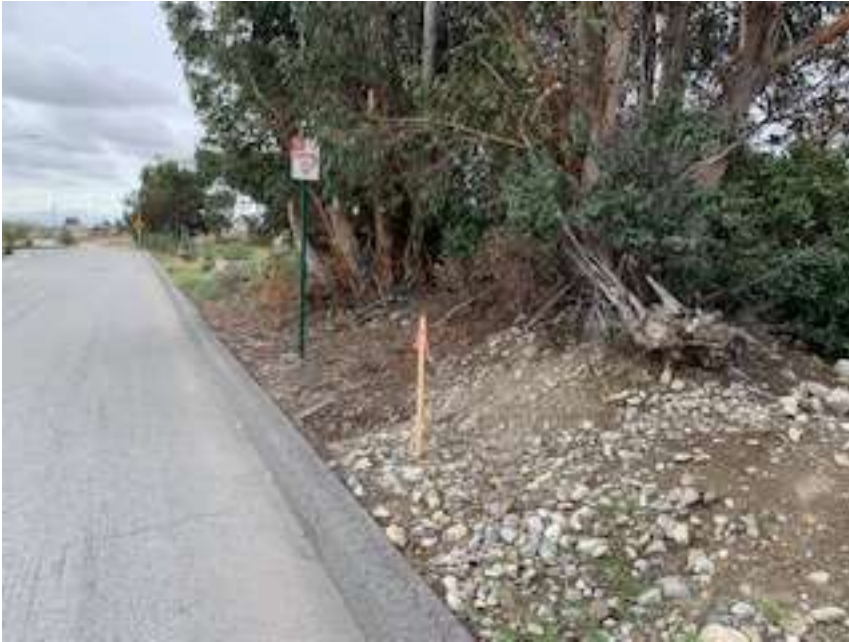
Golden Lock fronting trees as seen from the north.

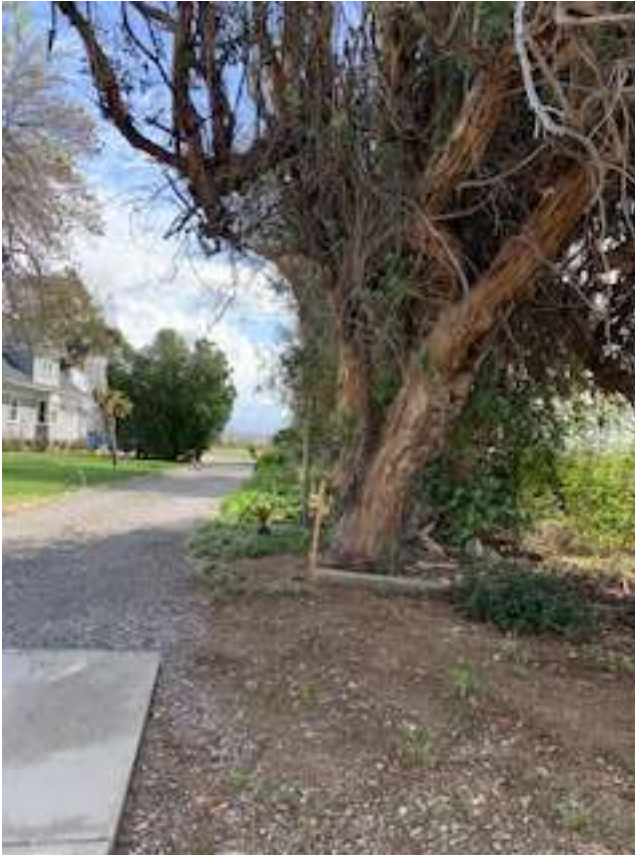
Northern property boundary adjacent to the driveway of the property to the north.

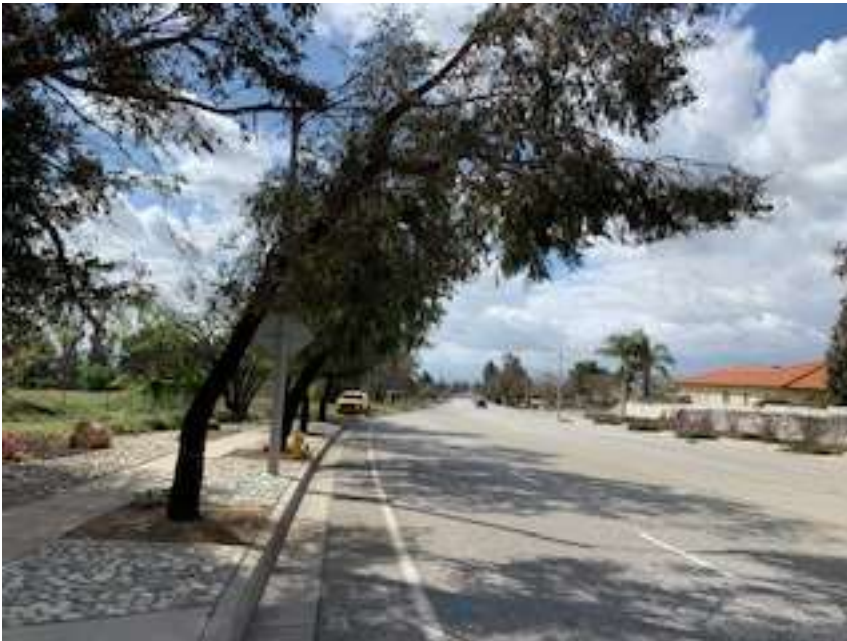
The four street trees, #s 110-113, exhibit vigorous systemic performance. Their canopies exhibit good dispositions for long-term viability. Their branch structures are leaning away from the site's existing trees and into the northbound East Avenue traffic lanes.

Red iron bark Eucalyptus street trees along the East Avenue frontage.

The four street trees are good candidates for long-term conservation in their existing locations given their general systemic vigor and the presence of newly engineered curbs and sidewalks. The red iron bark Eucalyptus would be well-served by more effective traffic lane clearance pruning if they are going to be conserved to full maturity going forward.

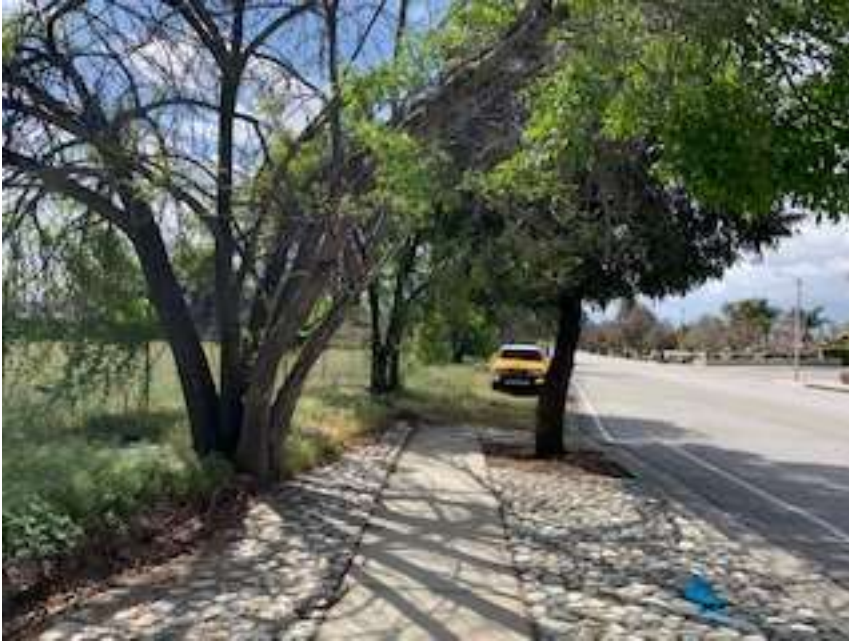
The four live ash trees, #s 114-116 and 118, are generally typical specimens of a water loving tree type that have grown in dryer than ideal conditions. It is likely that they were irrigated more deliberately when they were young or they never would have achieved their current statures. They would be likely to perform poorly and exhibit marginal performance if they were to experience extended drought conditions or any stress in the development of this site.

Tree # 115, ash tree fronting East Avenue sidewalk frontage.

The four live ash trees' conditions are marginal as evident in the one that has died. They would be poor candidates for long-term conservation without their receiving significant

attention to their long-term care. Given their marginal vigor and states of performance they would not be expected to experience encroachment gracefully. Their removal would be a reasonable consideration in the context of the long-term beautification of the site frontage.

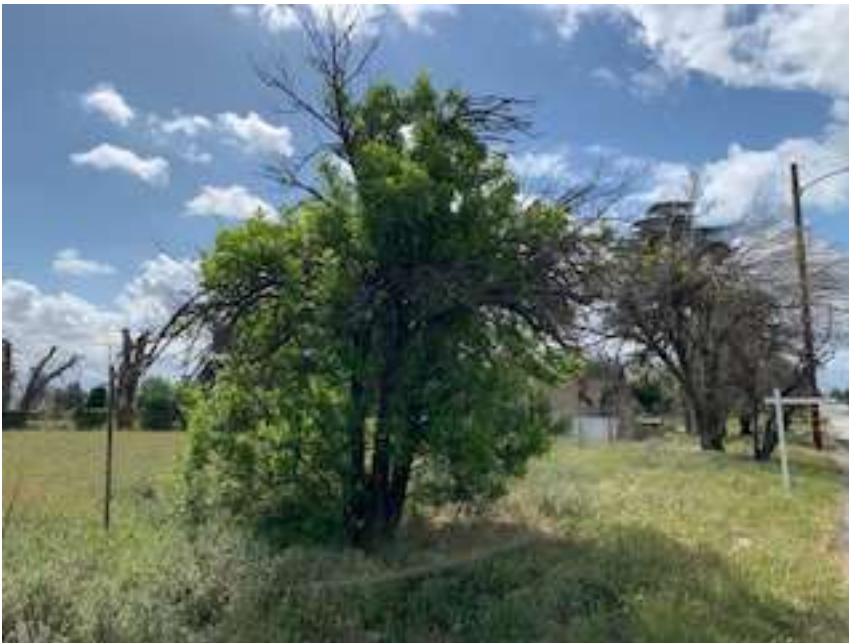
Tree number 117, an ash tree, is dead. Tree number 118 is growing just to the northwest of where Eucalyptus tree number one is located as referenced above.

Ash tree number 116 fronting along East Avenue. Tree numbers 117, dead, and 118 in background to the right.
