## Preliminary Arborist Report

**150 E Santa Clara Street  
San Jose, CA 95113**

**October 21, 2021**

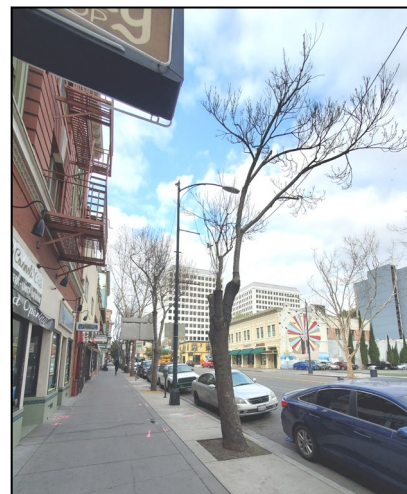
Raywood ash trees #1 and 3 were in fair condition, while tree #2 was poor. The three ashes were planted in 4' by 4' concrete cutouts along E. Santa Clara Street. Trunk diameters were between 11 and 16". All three trees displayed varying levels of mechanical damage on the street-facing side. The root flare on tree #1 was also buried. All three trees had been previously topped with the crown of tree #2 (Photo 1) the most severely affected.

**Photo 1 (right):** Raywood ash #2 had been topped resulting in poor form and structure.

| Tree No. | Species | Trunk Diameter (in.) | Protected Tree? | Condition<br>1=poor<br>5=excellent | Suitability for Preservation | Comments |
|---|---|---|---|---|---|---|
| 2 | Raywood ash | 15 | Yes | 2 | Low | In 4'x4' cutout; codominant branches at 7'; lean to west; topped. |

Based on my observations of the trees and a review of the proposed project plans, I recommend the removal and replacement of all seven street trees surrounding the site.

While the trees are outside the proposed building footprints, they will likely be severely impacted by nearby demolition, site clearing, and construction work. Raywood ashes #1 to 3, additionally, had low suitability for preservation with defects in structure that cannot be corrected. These trees are unlikely to be assets to the new site even if successfully preserved.

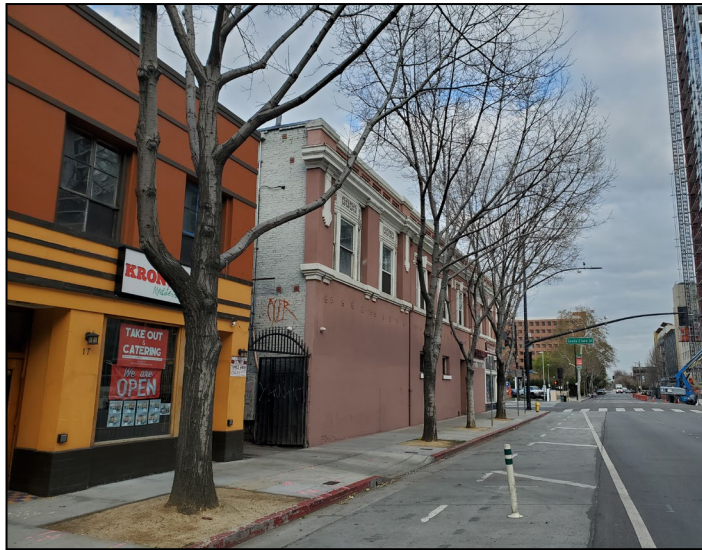
Red oaks #4 to 7 were in fair condition, with trunk diameters between 11 and 17". They were also street trees located in pavement cutouts. Trees #4 - 6 were in 4' by 6' cutouts. Tree #7 was in a 7' by 10' cutout. Trees had upright trunks but crowns were one-sided due to pruning on the building side (Photo 2). Their planting basins were filled with decomposed granite or a similar groundcover. Tree #6 lacked a basal flare.

**Photo 2:** Red oaks #4 – 7 have spreading canopies overhanging S. 4<sup>th</sup> Street.
