## 142-150 EAST SANTA CLARA STREET HISTORIC TREATMENT REPORT

SAN JOSE, CALIFORNIA  
[20053]

PREPARED FOR:  
BAYVIEW DEVELOPMENT GROUP

December 3, 2021

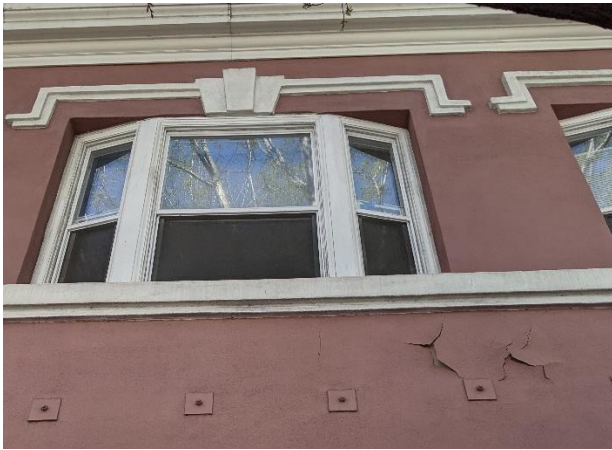
The coated cement plaster finish on the brick masonry walls and columns is in fair condition. There is delamination of the cement plaster at several locations below the stringcourse on the northeast façade (**Figure 5 and Figure 6**). There are bolted metal plates at regular intervals below the stringcourse at the second-floor level approximately on both the northwest and northeast façades; these plates are believed to be the outward termination of wall to floor ties. A vertical crack extends from the bolted metal plates to the wall base towards the south of the northeast façade (**Figure 7**). An embedded metal plate with a coating similar to that on the cement plaster is observed adjacent to the vertical crack (**Figure 8**). At some locations, a color difference in the coating is observed (**Figure 9**). Spalling is observed at a few locations at the wall base along the sidewalk facing South 4<sup>th</sup> Street. Remnants of a historic painted sign is observed above the spalling. (**Figure 10**).

Figure 5. Example of delaminated cement plaster.

As is noted in the conditions assessment section, the cement plaster is in fair condition. The project proposes to remove the existing cement plaster so that the brick masonry walls can be rehabilitated and be exposed. If initial exploratory plaster removal indicates that the underlying brick is not in adequate condition for rehabilitation, the existing plaster system will be retained and repaired as necessary. Existing anchors, installed as part of seismic retrofit work in 1992, will become obsolete with the shotcrete strengthening. These anchors should be removed and patched with mortar to match the composition and color of the existing mortar. After the removal of the cement plaster system, the mortar joints will need to be inspected and if found to be damaged, these mortar joints should be repointed. Any missing bricks should be replaced with brick of a similar size, color, and texture. Typical repairs to rehabilitate the brick masonry and mortar include the following:

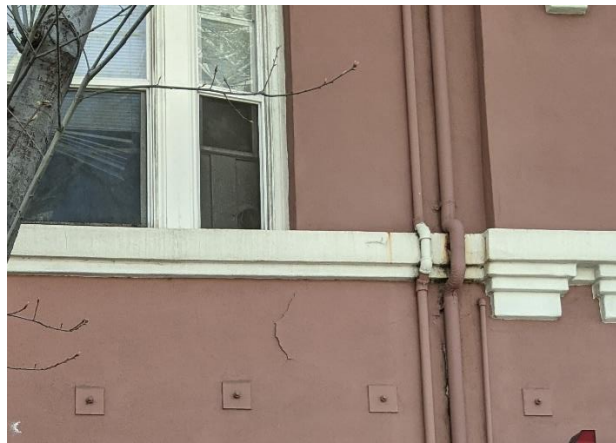
Figure 6. Example of delaminated cement plaster.

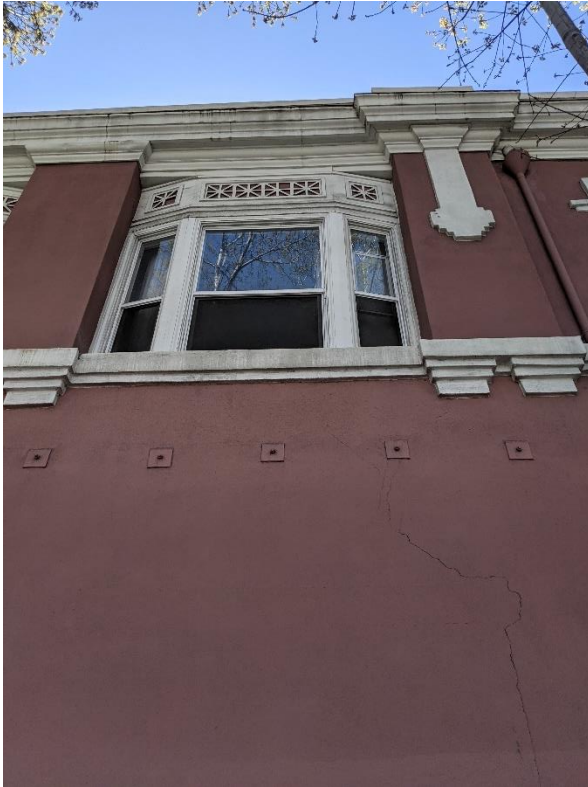
Figure 7. vertical crack at cement plaster extending from the embedded metal.

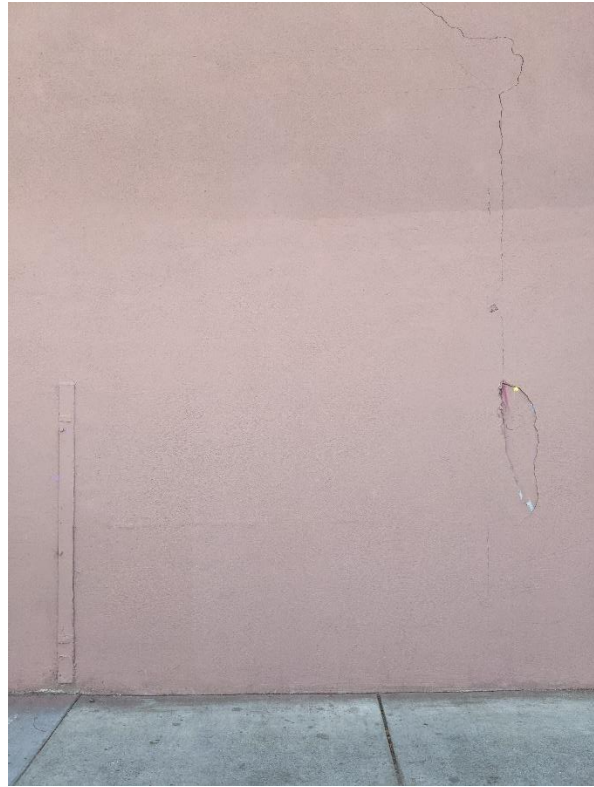
Figure 8. Vertical crack and spall at cement plaster. Coated embedded steel plate at the wall base.

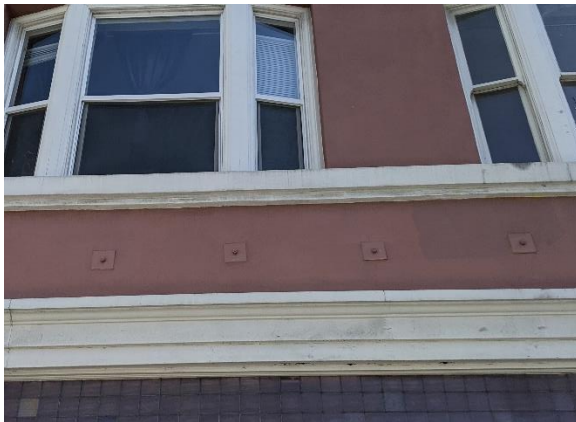
Figure 9. Color variation in cement plaster coating.

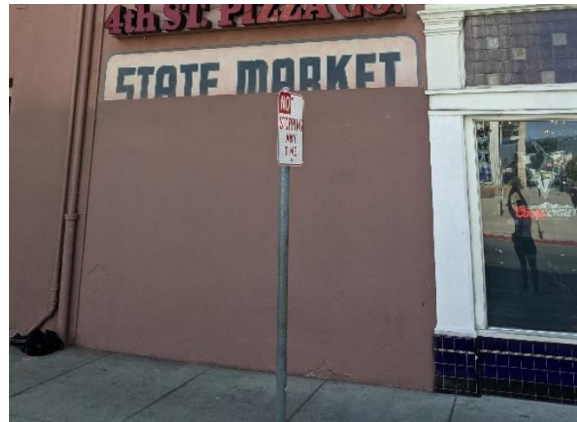
Figure 10. Cement plaster Spalls at wall base with remnants of a historic painted sign above

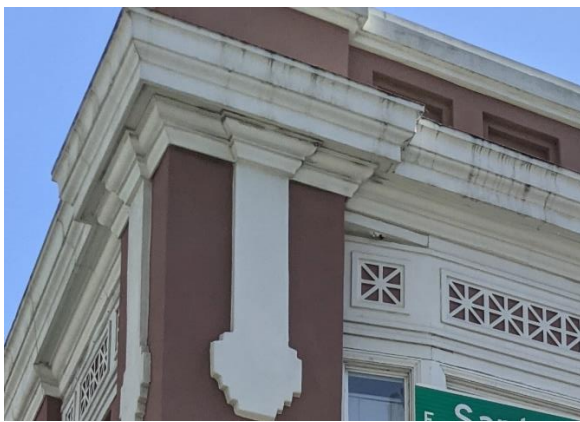
The upper cornice, the storefront cornice, the stringcourse, and decorative features are in fair condition. Peeling coatings are observed at a few locations (**Figure 11**). Parts of the upper cornice have some dents and there is a separation from the pilaster at some locations (**Figure 12**). Parts of the decorated lintel above the bay window is missing at one location. Typically, the seams at the cornice and stringcourse were telegraphing through the coating (**Figure 13**). Staining is observed throughout the upper cornice , and at few locations on the stringcourse and cornice above the storefront (**Figure 14**, **Figure 15**, and **Figure 16**).

Figure 11. Peeling coating at the decorated lintel.

- Clean and coat corroded surfaces to match existing. If any section is significantly damaged replace section of component to match existing profile
- Remove peeling paint and prepare substrate to receive fresh coat of paint that is compatible with the substrate.
- Replace in kind any missing components of the cornice or decorative features.
- Ensure all the cornice and decorative features are fastened and secured.
- As part of the larger project, there should be a metal coping that covers the entirety of the rehabilitated facades to prevent water intrusion from the top of the wall. The coping should be painted to integrate with the color scheme of the rehabilitated façade.

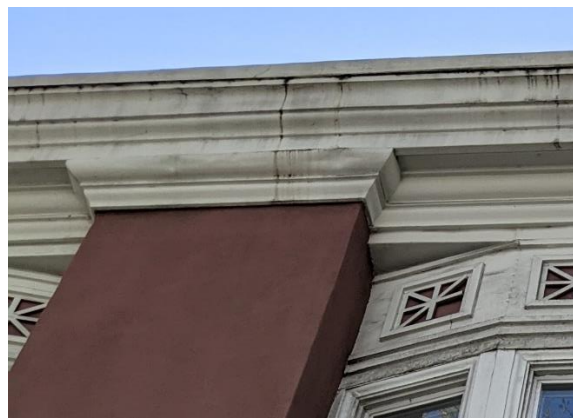
Figure 12. Damaged upper cornice and missing component at decorative lintel. The cornice is separating at the pilaster.

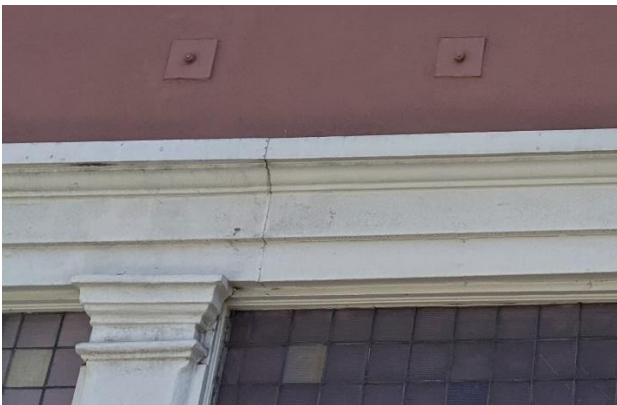
Figure 13. Seams at the store front cornice telegraphing through the coating.

There is significant staining on the upper cornice, which mostly appear to be water drip marks. The telegraphing of metal seams through the coating could also be related to the excessive movement of water or deterioration of paint. Typical repairs to address these conditions include:

- Examine substrate of the cornice and decorative features for corrosion or deteriorated wood.
- Investigate source of staining and water drip marks.

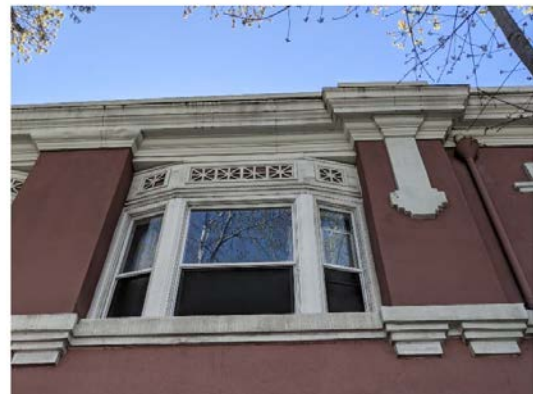
Figure 14. Staining at upper cornice.

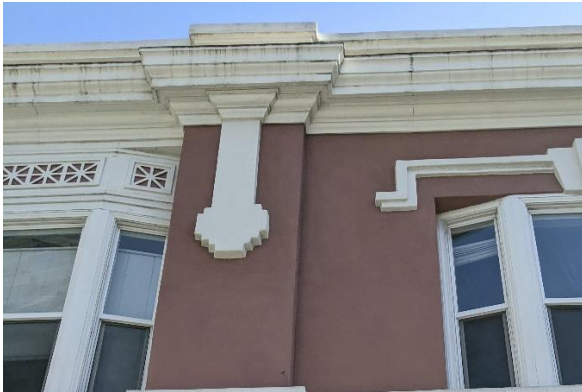
Figure 15. Staining at upper cornice.

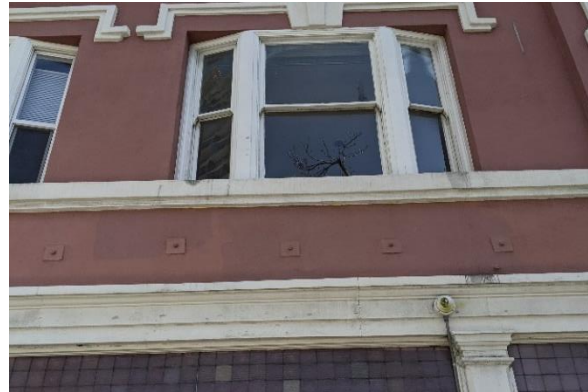
Figure 16. Staining at stringcourse and storefront cornice.

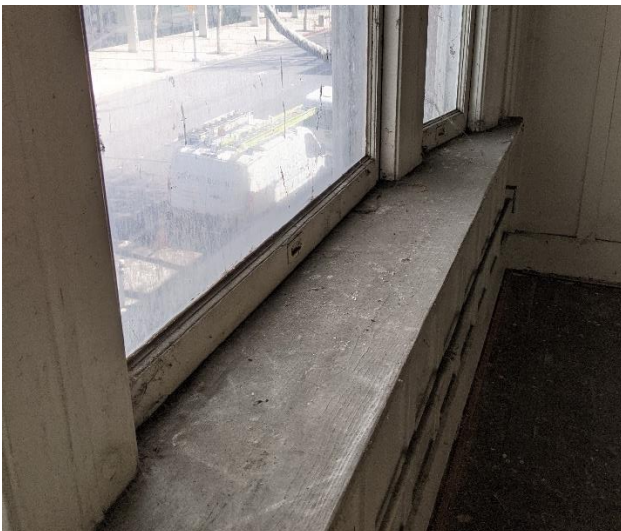
The windows are in fair condition with no broken glass or deteriorated frames. Only the bay window at the south end of the northeast façade and the second bay window from the south on the northwest façade have wood frames and sashes (**Figure 17**). All other windows have vinyl frames and sashes (**Figure 18**). The window casings and trim, and the vertical posts at the bay window outer corners are all wood. The coating is aged typically on the windows with few instances of peeling paint (**Figure 19**). The paint is aged at the louver window frames, and the louvers are deteriorated (**Figure 20**).

Figure 17. Remaining wood windows with aged coating.

- Replace deteriorated wood components in kind, retain and rehabilitate historic trims where in good condition.
- Remove and replace perimeter sealants with new paintable sealants.

- Clean, prepare, and apply new coating on all wood components of window to match existing colour and finish.
- Remove all louvers and infill with new material finished with painted cement plaster. Remove masonry wall and cement plaster for new openings at the northeast façade. Integrate opening waterproofing with existing cement plaster. Patch, repair, and coat cement plaster to match existing.

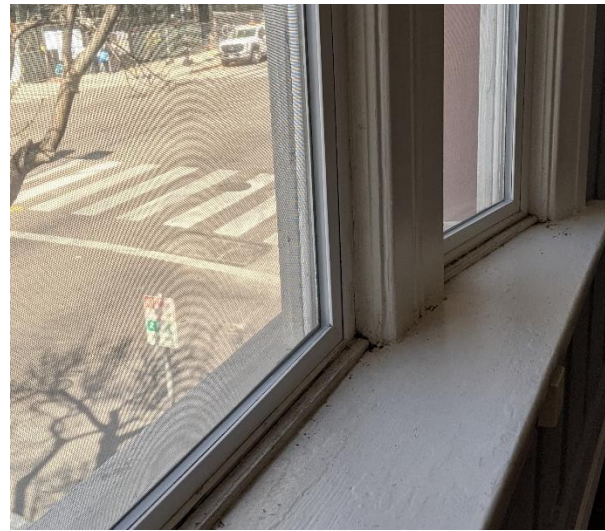
Figure 18. Vinyl windows with wood sill and trim.

Since there are two examples of historic windows remaining the vinyl windows should be replaced with windows matching the existing wood windows in material and profile. Typical repairs to address these conditions include:

- Replace all vinyl windows with painted wood window inserts to match extant wood windows and wood profiles.
- New glazing at the replicated wood windows may be energy efficient double glazing if it can be accommodated within the existing window trim and frame with minimal modification. The selected glazing should be transparent and not reflective.

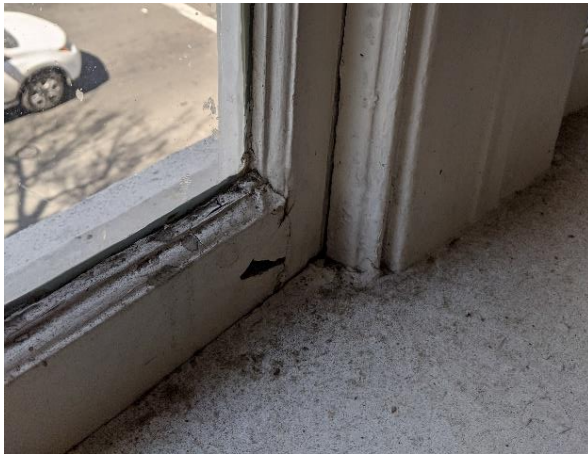
Figure 19. Peeling paint and aged coating at wood windows.

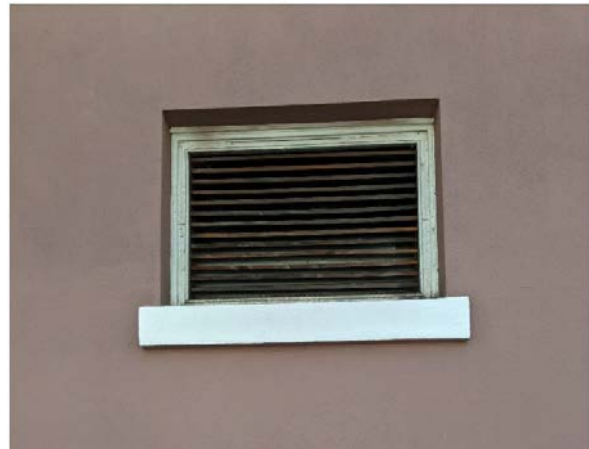
Figure 20. Existing louver windows with aged coating on the frames and deteriorated louvers.

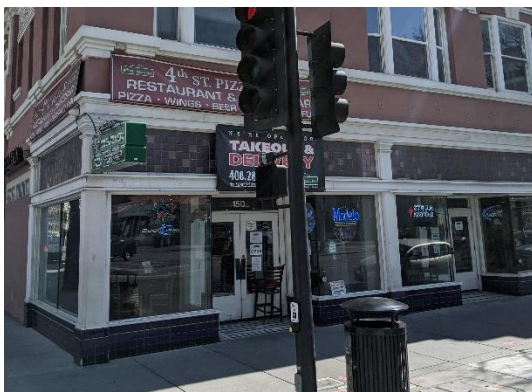
The storefront and doors are in fair condition with only the coating on the frames and lintel being aged (**Figure 21**). Typically peeling paint was observed at the sill frame of the storefront, at the outer edges of the lintel, and at the bottom rail of the door (**Figure 22, Figure 23, and Figure 24**).

Figure 21. Overall view of the storefront.

- Replacement storefront assemblies will be designed to be of a similar design vocabulary and will incorporate similar materials including large, glazed assemblies, painted wood trim, tile base elements, and painted wood door assemblies.
- The new glazing at windows and doors will be dual glazed safety glass to meet current code requirements.
- Clean, prepare, and apply new coating on all wood components of storefronts and doors.

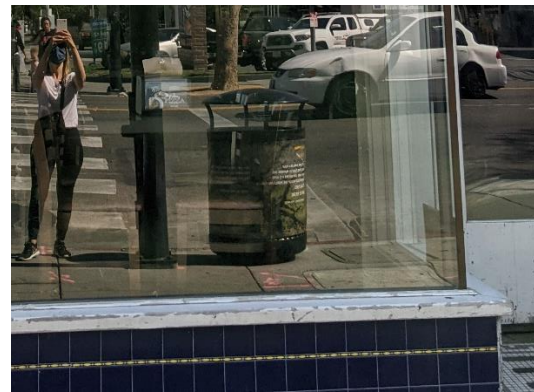
Figure 22. Peeling and aged coating at the storefront sill frames with tiled base below.

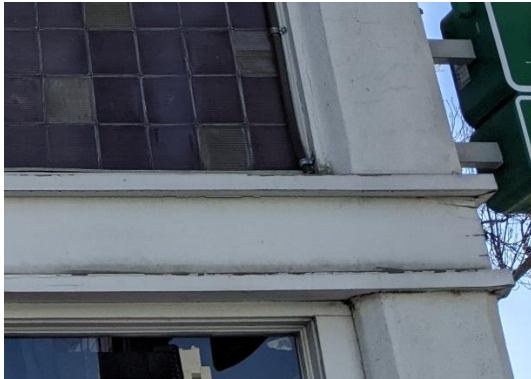
Figure 23. Deteriorated coating at the storefront lintel.

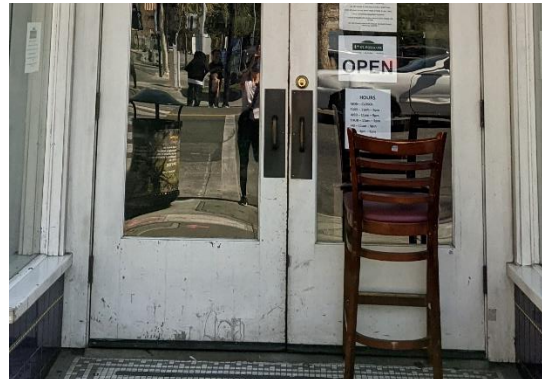
Figure 24. Aged coating at the doors.

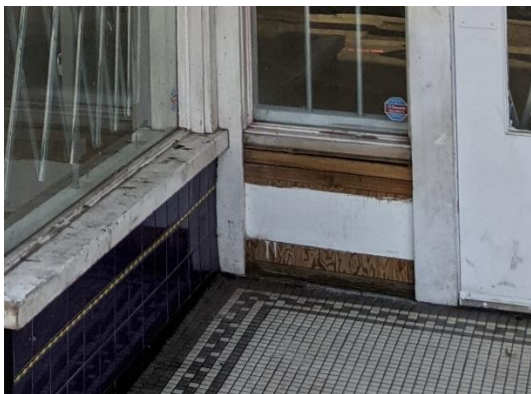
The tiles at the knee wall, and the entryway are mostly in fair condition. There is a missing panel of tiles adjacent to the door towards the corner of the building on the northwest façade (**Figure 25**). The corner trim is missing at the outer corner next to the middle entryway (**Figure 26**). Slip resistant strips installed at the middle entryway have worn off throughout (**Figure 27**). The small black and white floor tiles at the storefront entrances are not historic, and appear to have been installed at the time of the 2005 rehabilitation.

Figure 25. Entire panel of missing knee wall finish tiles adjacent to the door.

- Replace any missing or decolored tile.
- Clean mosaic tile at entryway and install new slip resistive strips.

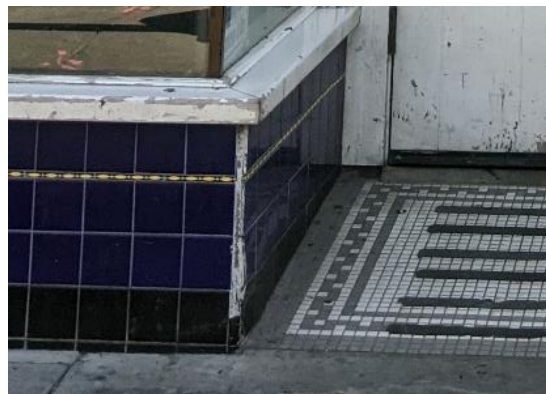
Figure 26. Missing corner trim at knee wall tiles.

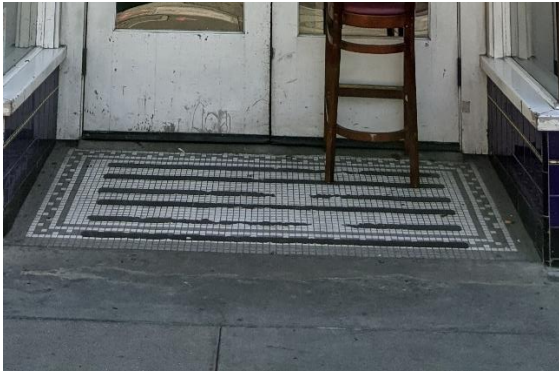
Figure 27. Deteriorated applied slip resistant strips at entryway mosaic tiles.

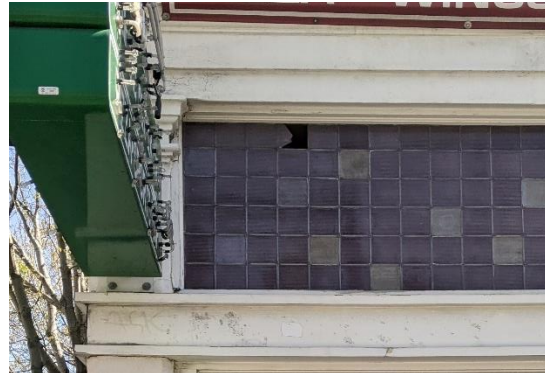
There are infill tiles in the leaded glass transom between the storefront lintel and the cornice, which have color variations, and some broken tiles (**Figure 28**).

Figure 28. Broken and variable color lites in leaded glazed transom.

- Rehabilitate the glazed transom assemblies using glass of a similar appearance and texture to replace broken or missing lites. Where needed to provide improved acoustical or thermal performance, provide secondary glazed assemblies behind the transoms.
