March 8, 2021

Re: Limited Lead based paint and asbestos sampling and analysis
Preparation for Renovation
4110 Alhambra Way, Martinez
SE Project #: 21-389

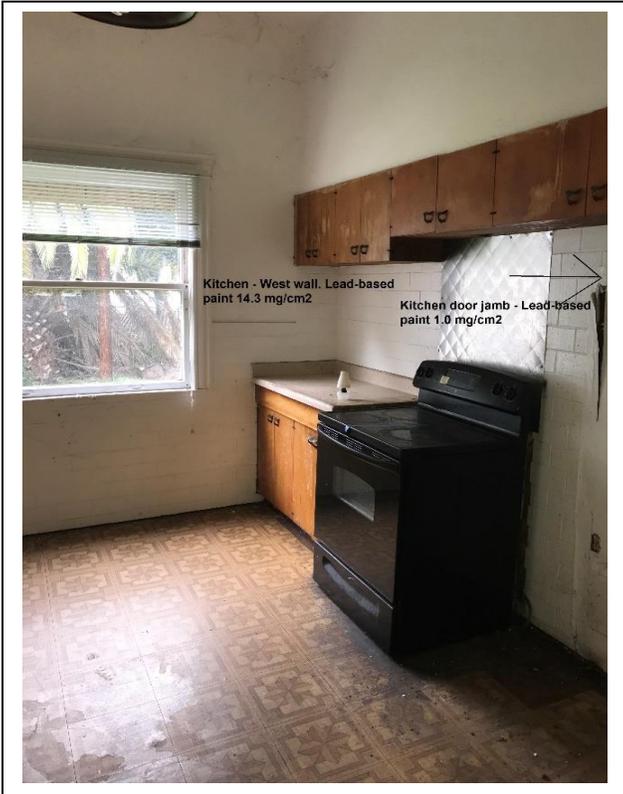
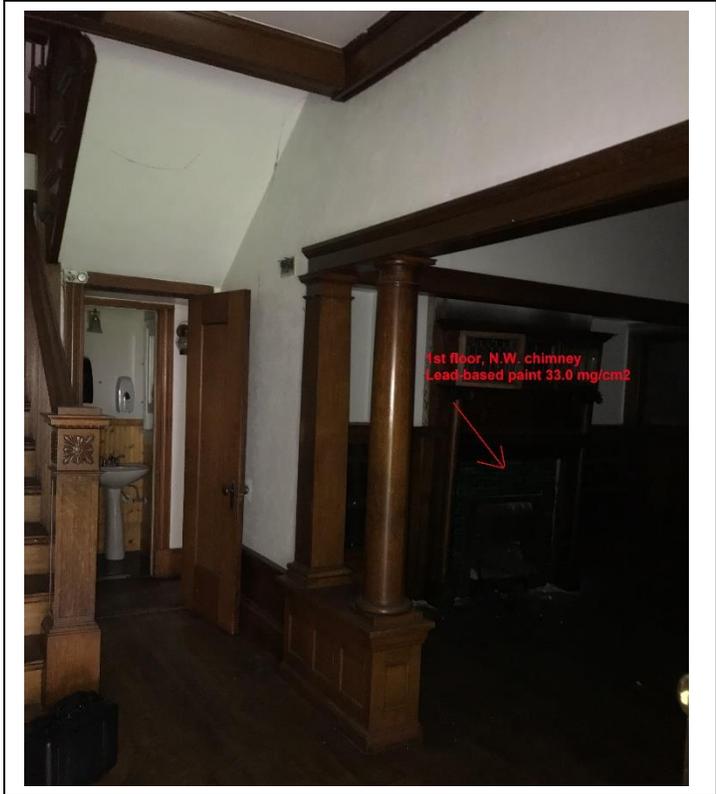
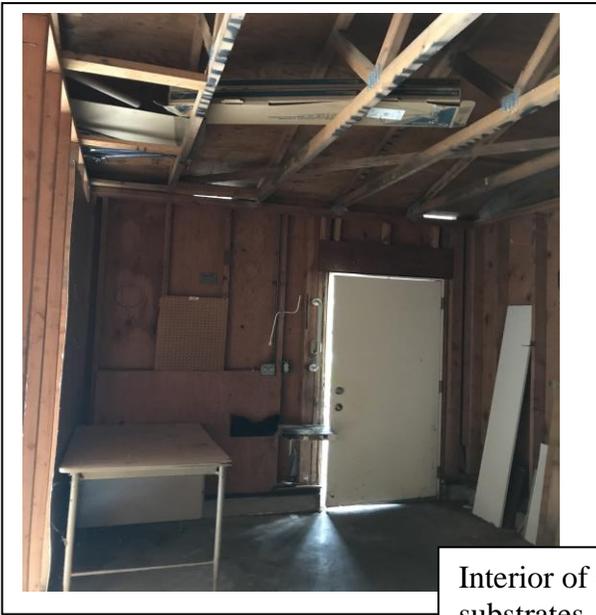
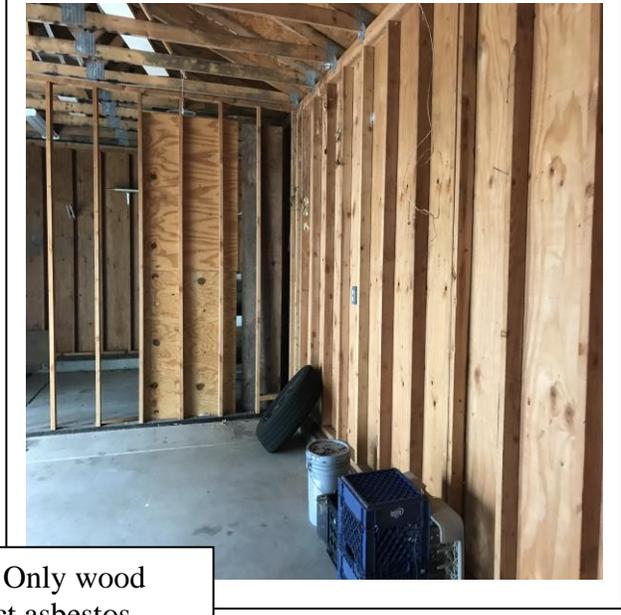
Analysis of painted surfaces within the Hospital did not identify and Lead-Based paint. Three (3) of the results of the lead in paint analysis from the residence yielded levels well above the 1.0 mg/cm2 threshold for lead-based paint as defined by CA/OSHA and the EPA as listed above.

4110 Alhambra Ave – Residential Home Location of Lead-Based Paint/Coatings

SE recommends that all work that will impact the kitchen wall, door jambs, and chimney tiles within the residence with lead-based paint >5000 ppm (1.0 mg/cm2) be performed with the use of lead safe practices and procedures (i.e., separate break and hygiene areas, minimize dust, etc.). All work practices should follow EPA RRP, CDPH Title 17, and DOSH 1532.1 regulatory requirements. Lead safe practices include containment, HEPA vacuums, prompt clean-up, and worker health and safety. EPA RRP requirements include documentation, visual inspection, and dust wipe sampling.

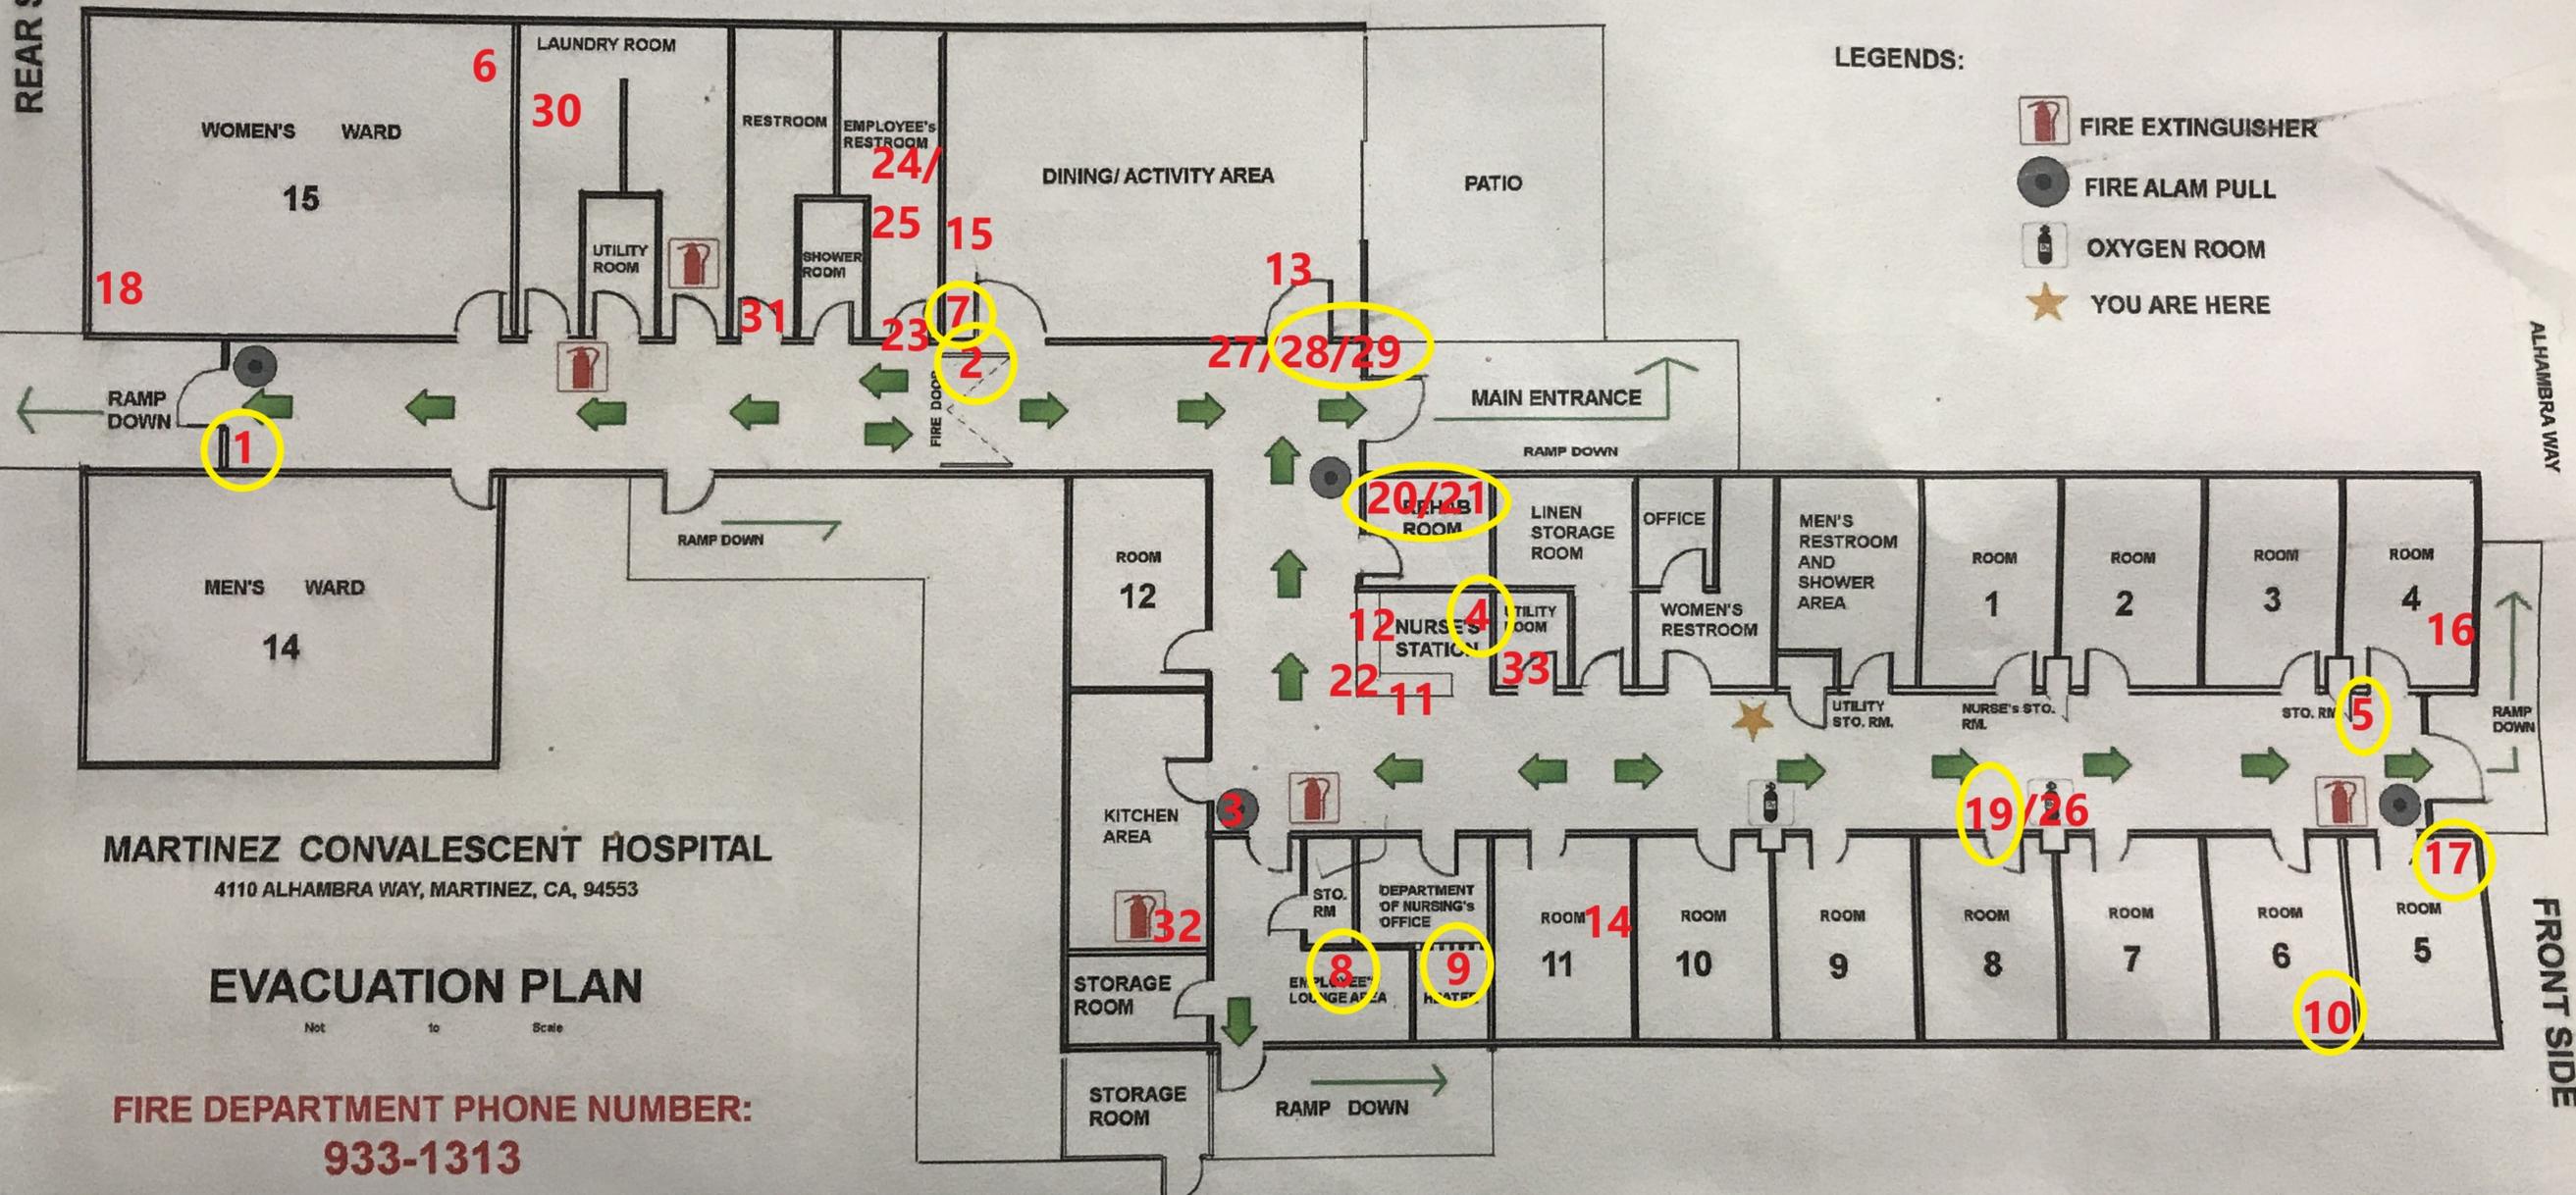
MARTINEZ CONVALESCENT HOSPITAL
4110 ALHAMBRA WAY, MARTINEZ, CA, 94553

- samples that contain asbestos
