# BRIDGE REHABILITATION ASSESSMENT

## DAWSON CANYON ROAD OVER TEMESCAL WASH

Prepared by:  
Kleinfelder, Inc.  
770 First Avenue, Suite 400  
San Diego, CA 92101  
Kleinfelder Job No. 20222889

March 17, 2022

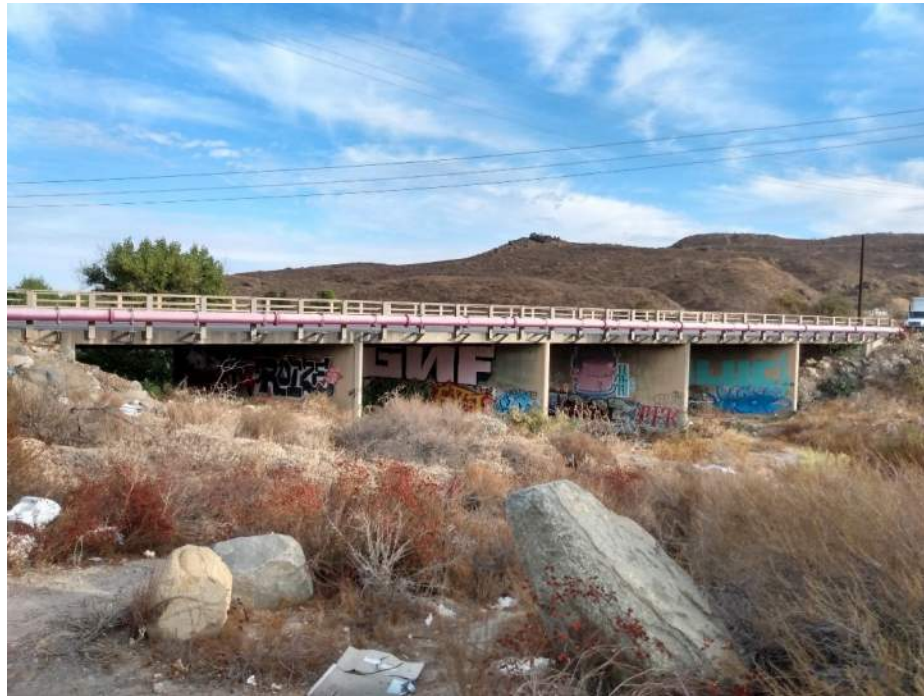
**Photo 1:** Elevation View of Bridge (Looking North)

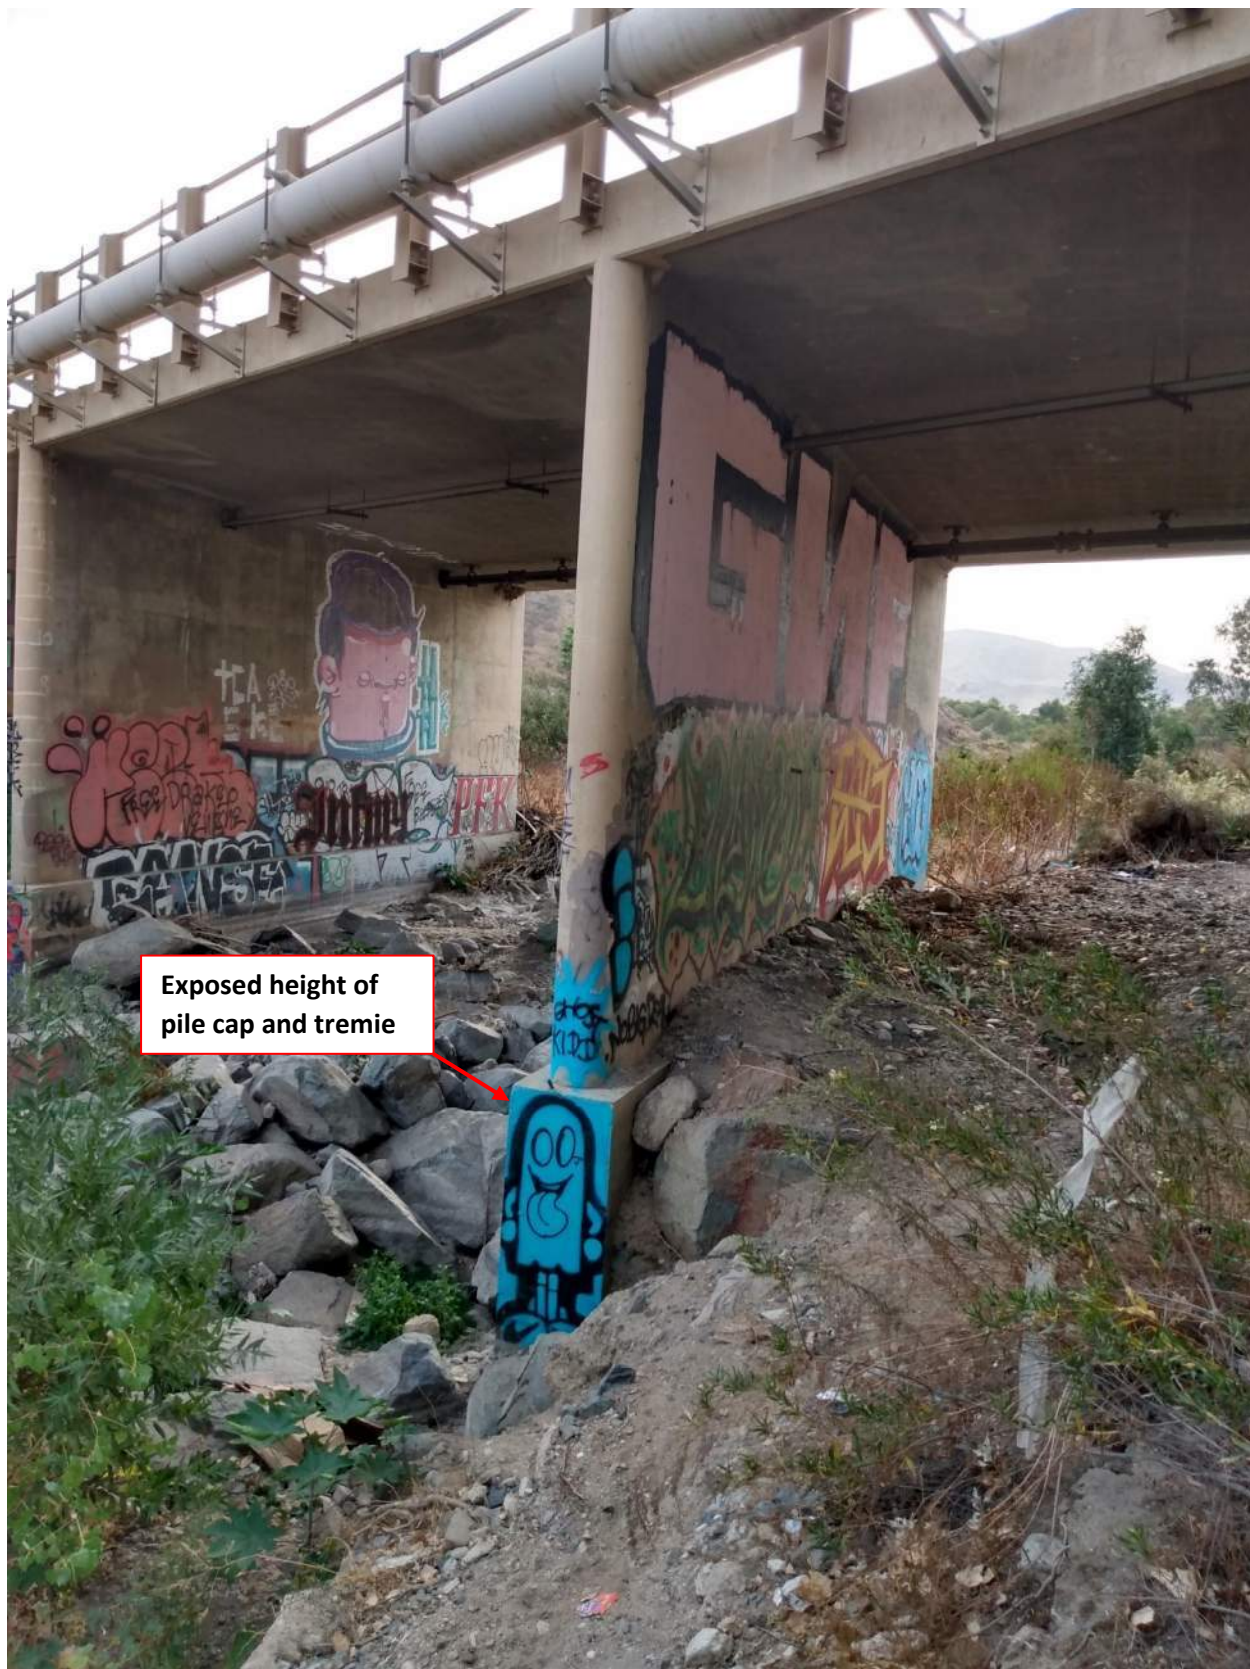
Due to the obstructions caused by the piers in the waterway, local scour is observed at Piers 3 and 4 at the downstream end. The average height difference of soil across the upstream and downstream end of Piers 3 and 4 is about 4'-0". Since Piers 3 through 5 have approximately 3'-6" of exposed height of the pile cap/tremie on the upstream side, contraction scour has occurred all across the stream flow area.

**Photo 6:** Pier 3 photo taken on downstream side of bridge looking south

- Rock riprap at Piers
- Remove debris at Piers

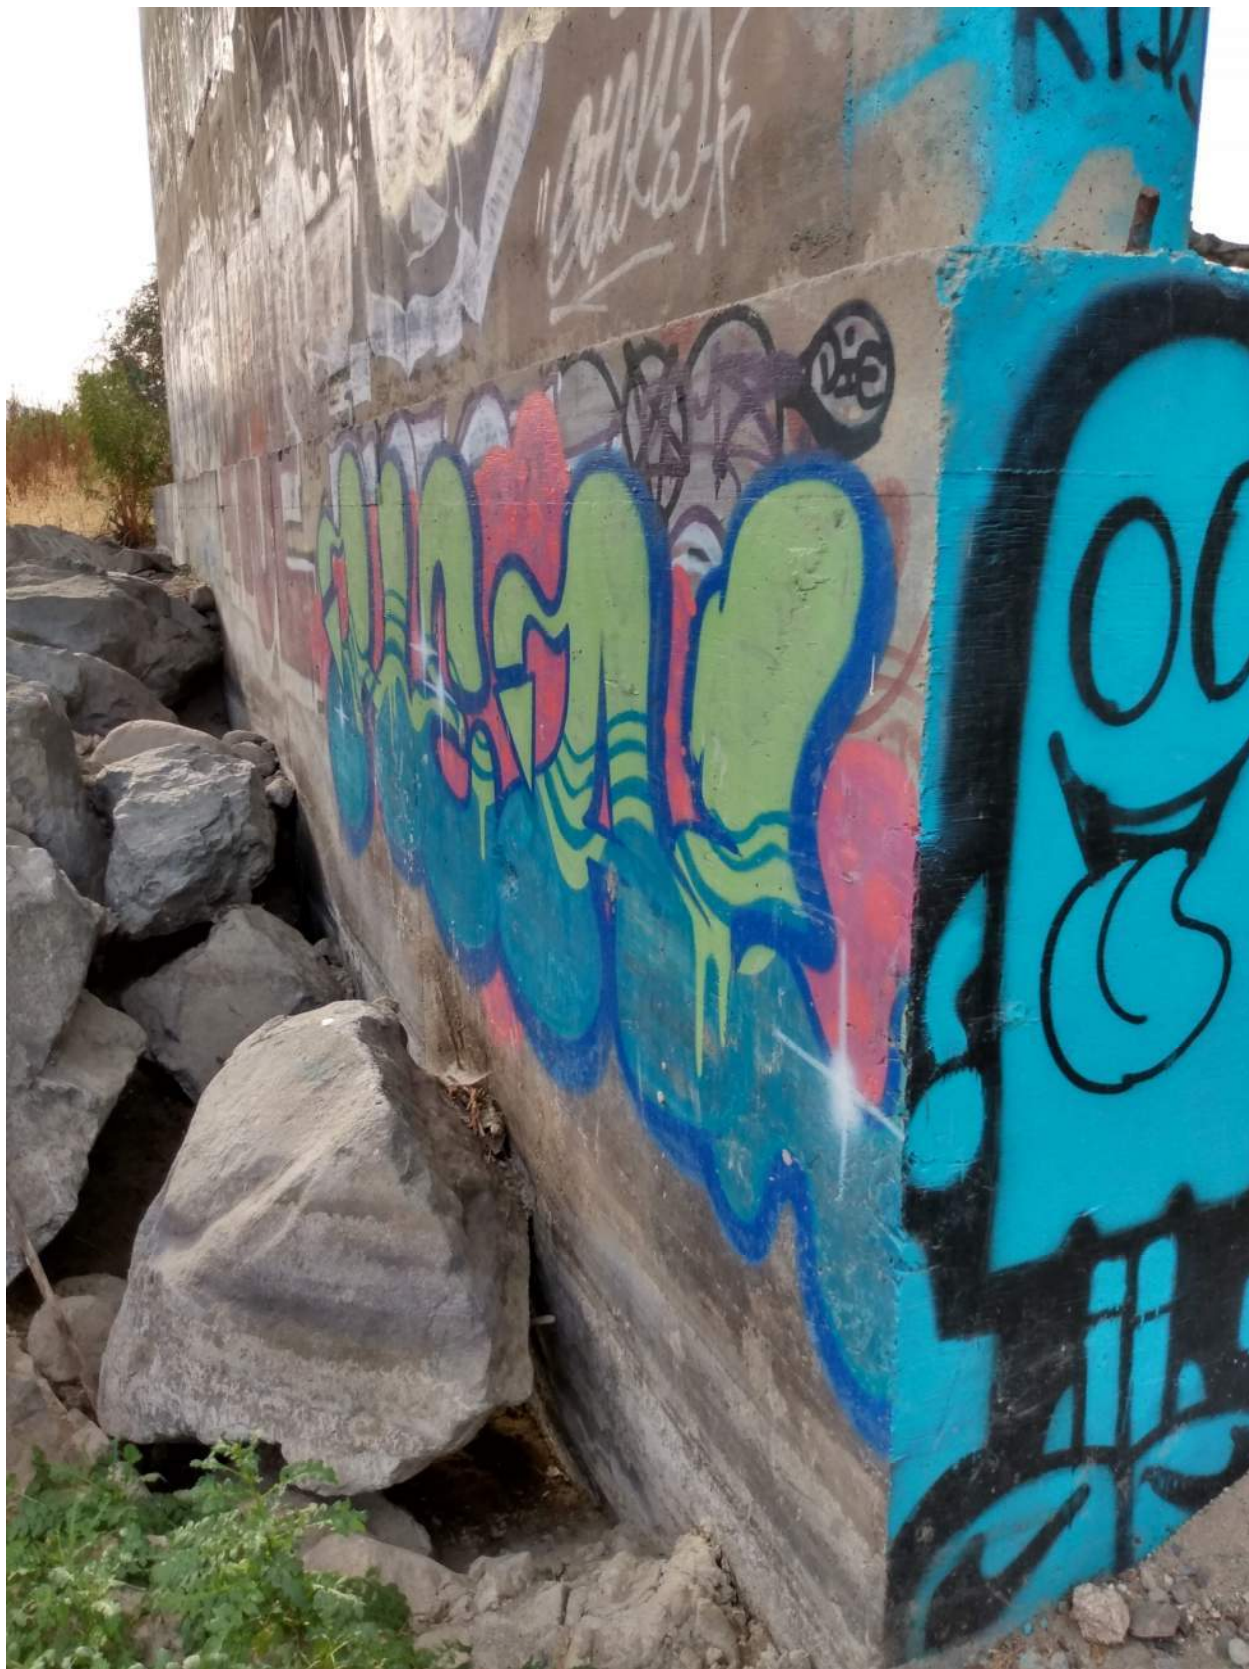
**Photo 7:** Pier 3 photo taken on downstream side of bridge looking south

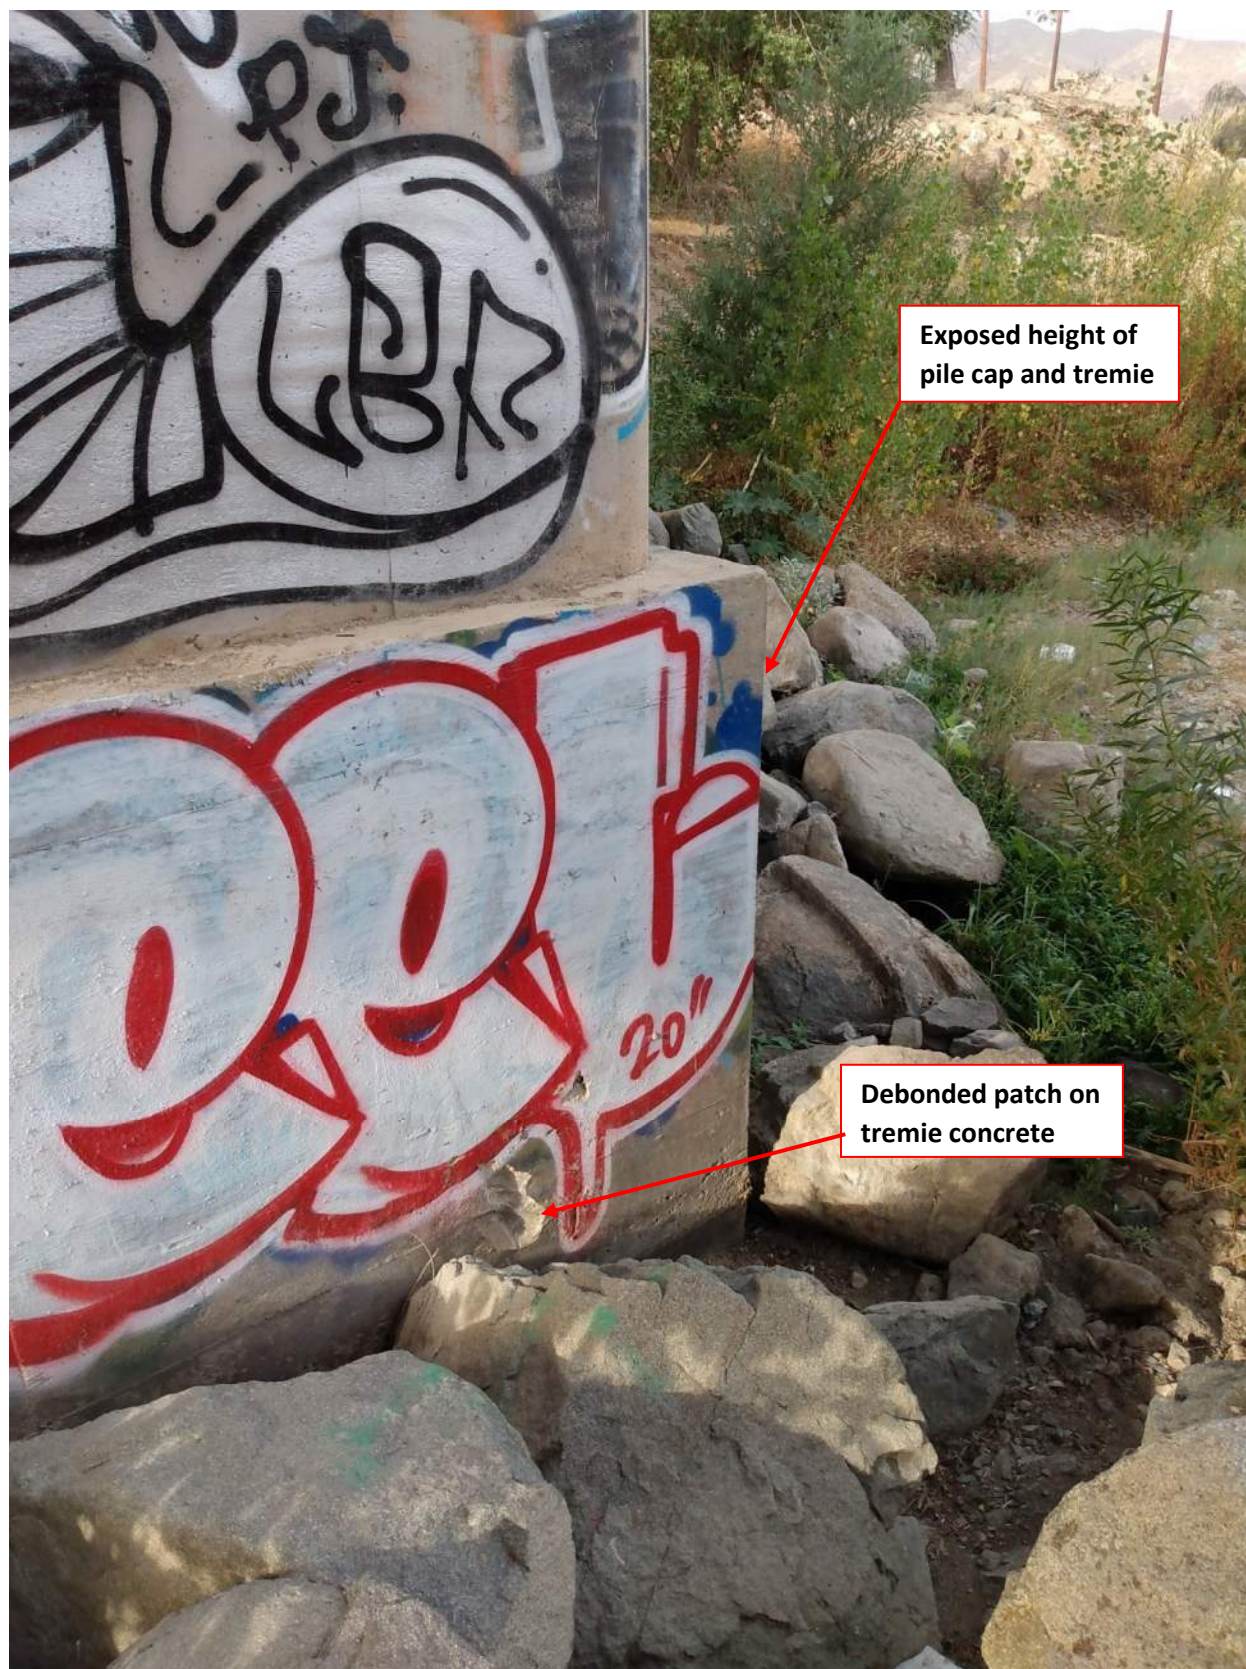
**Photo 11:** Pier 4 photo taken on downstream side of bridge looking west

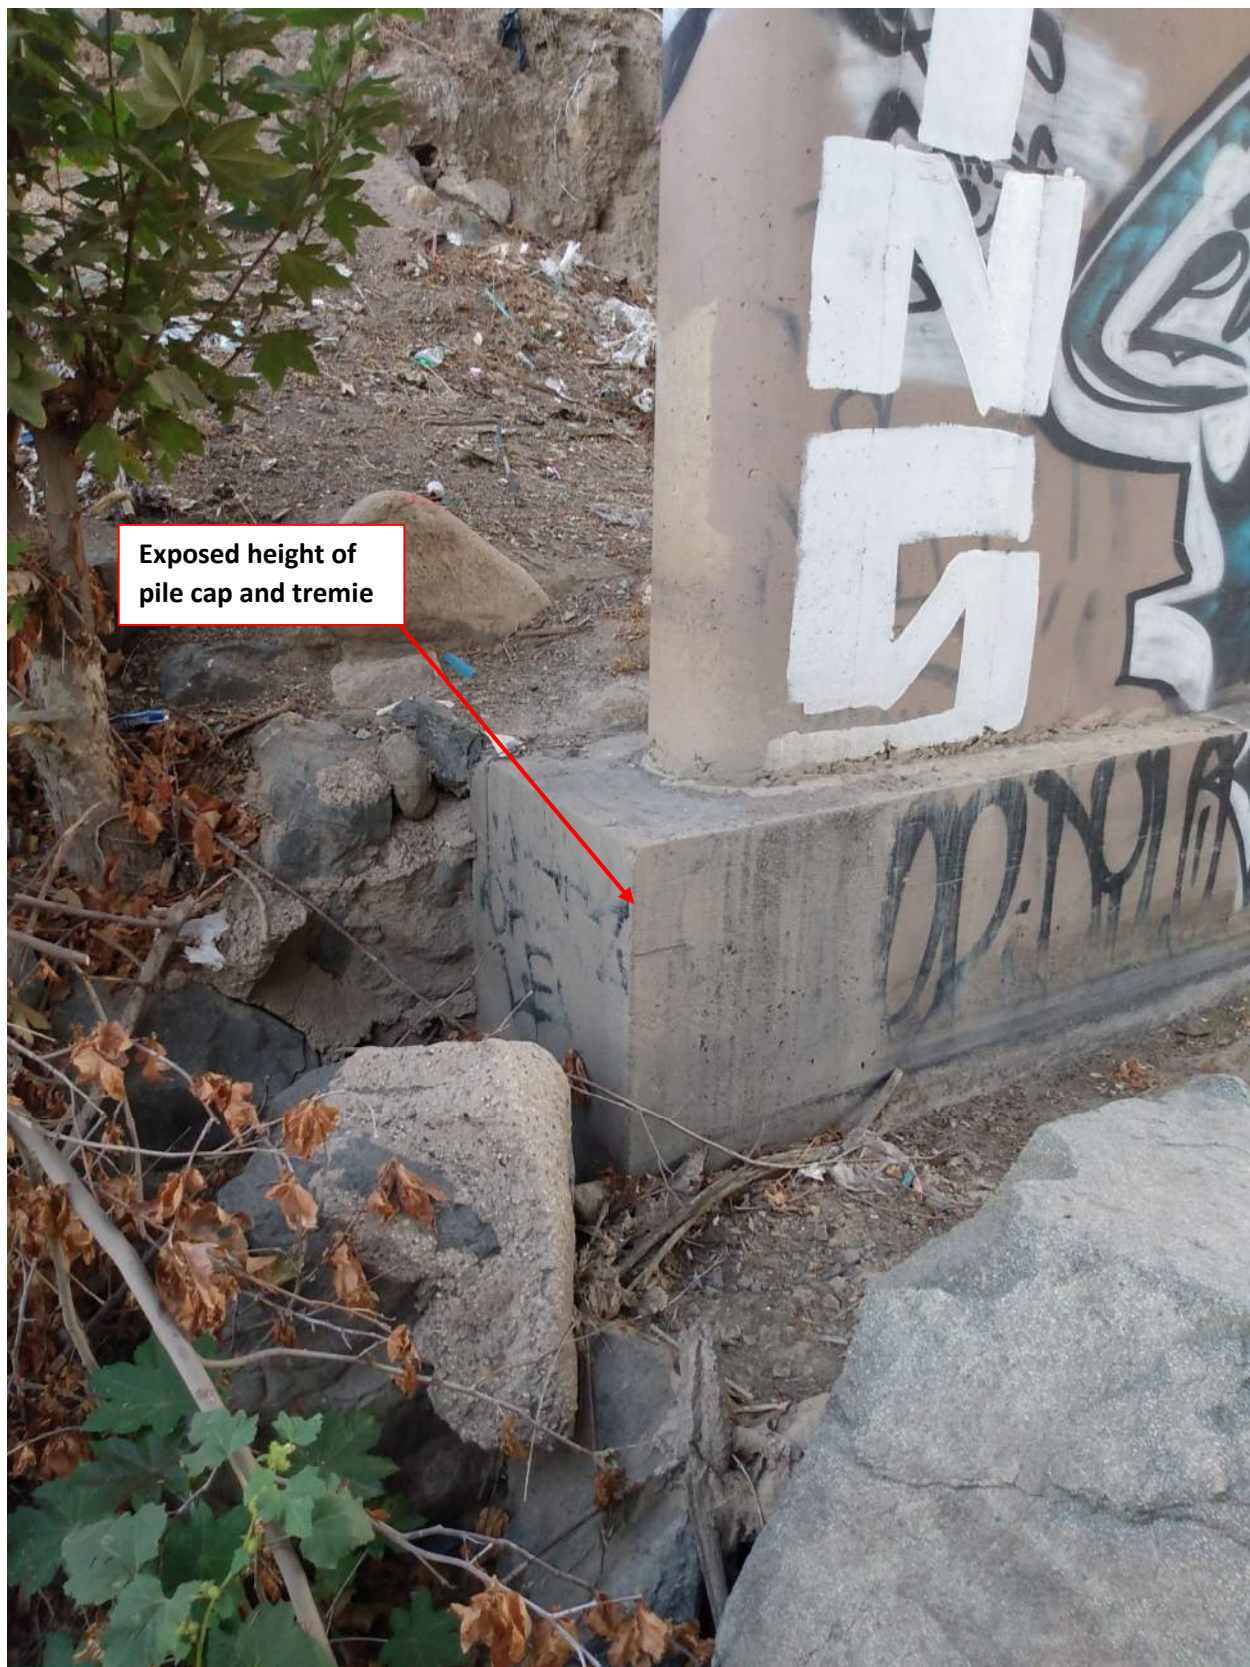
Exposed height of  
pile cap and tremie

**Photo 12:** Pier 5 photo taken on downstream side of bridge looking south

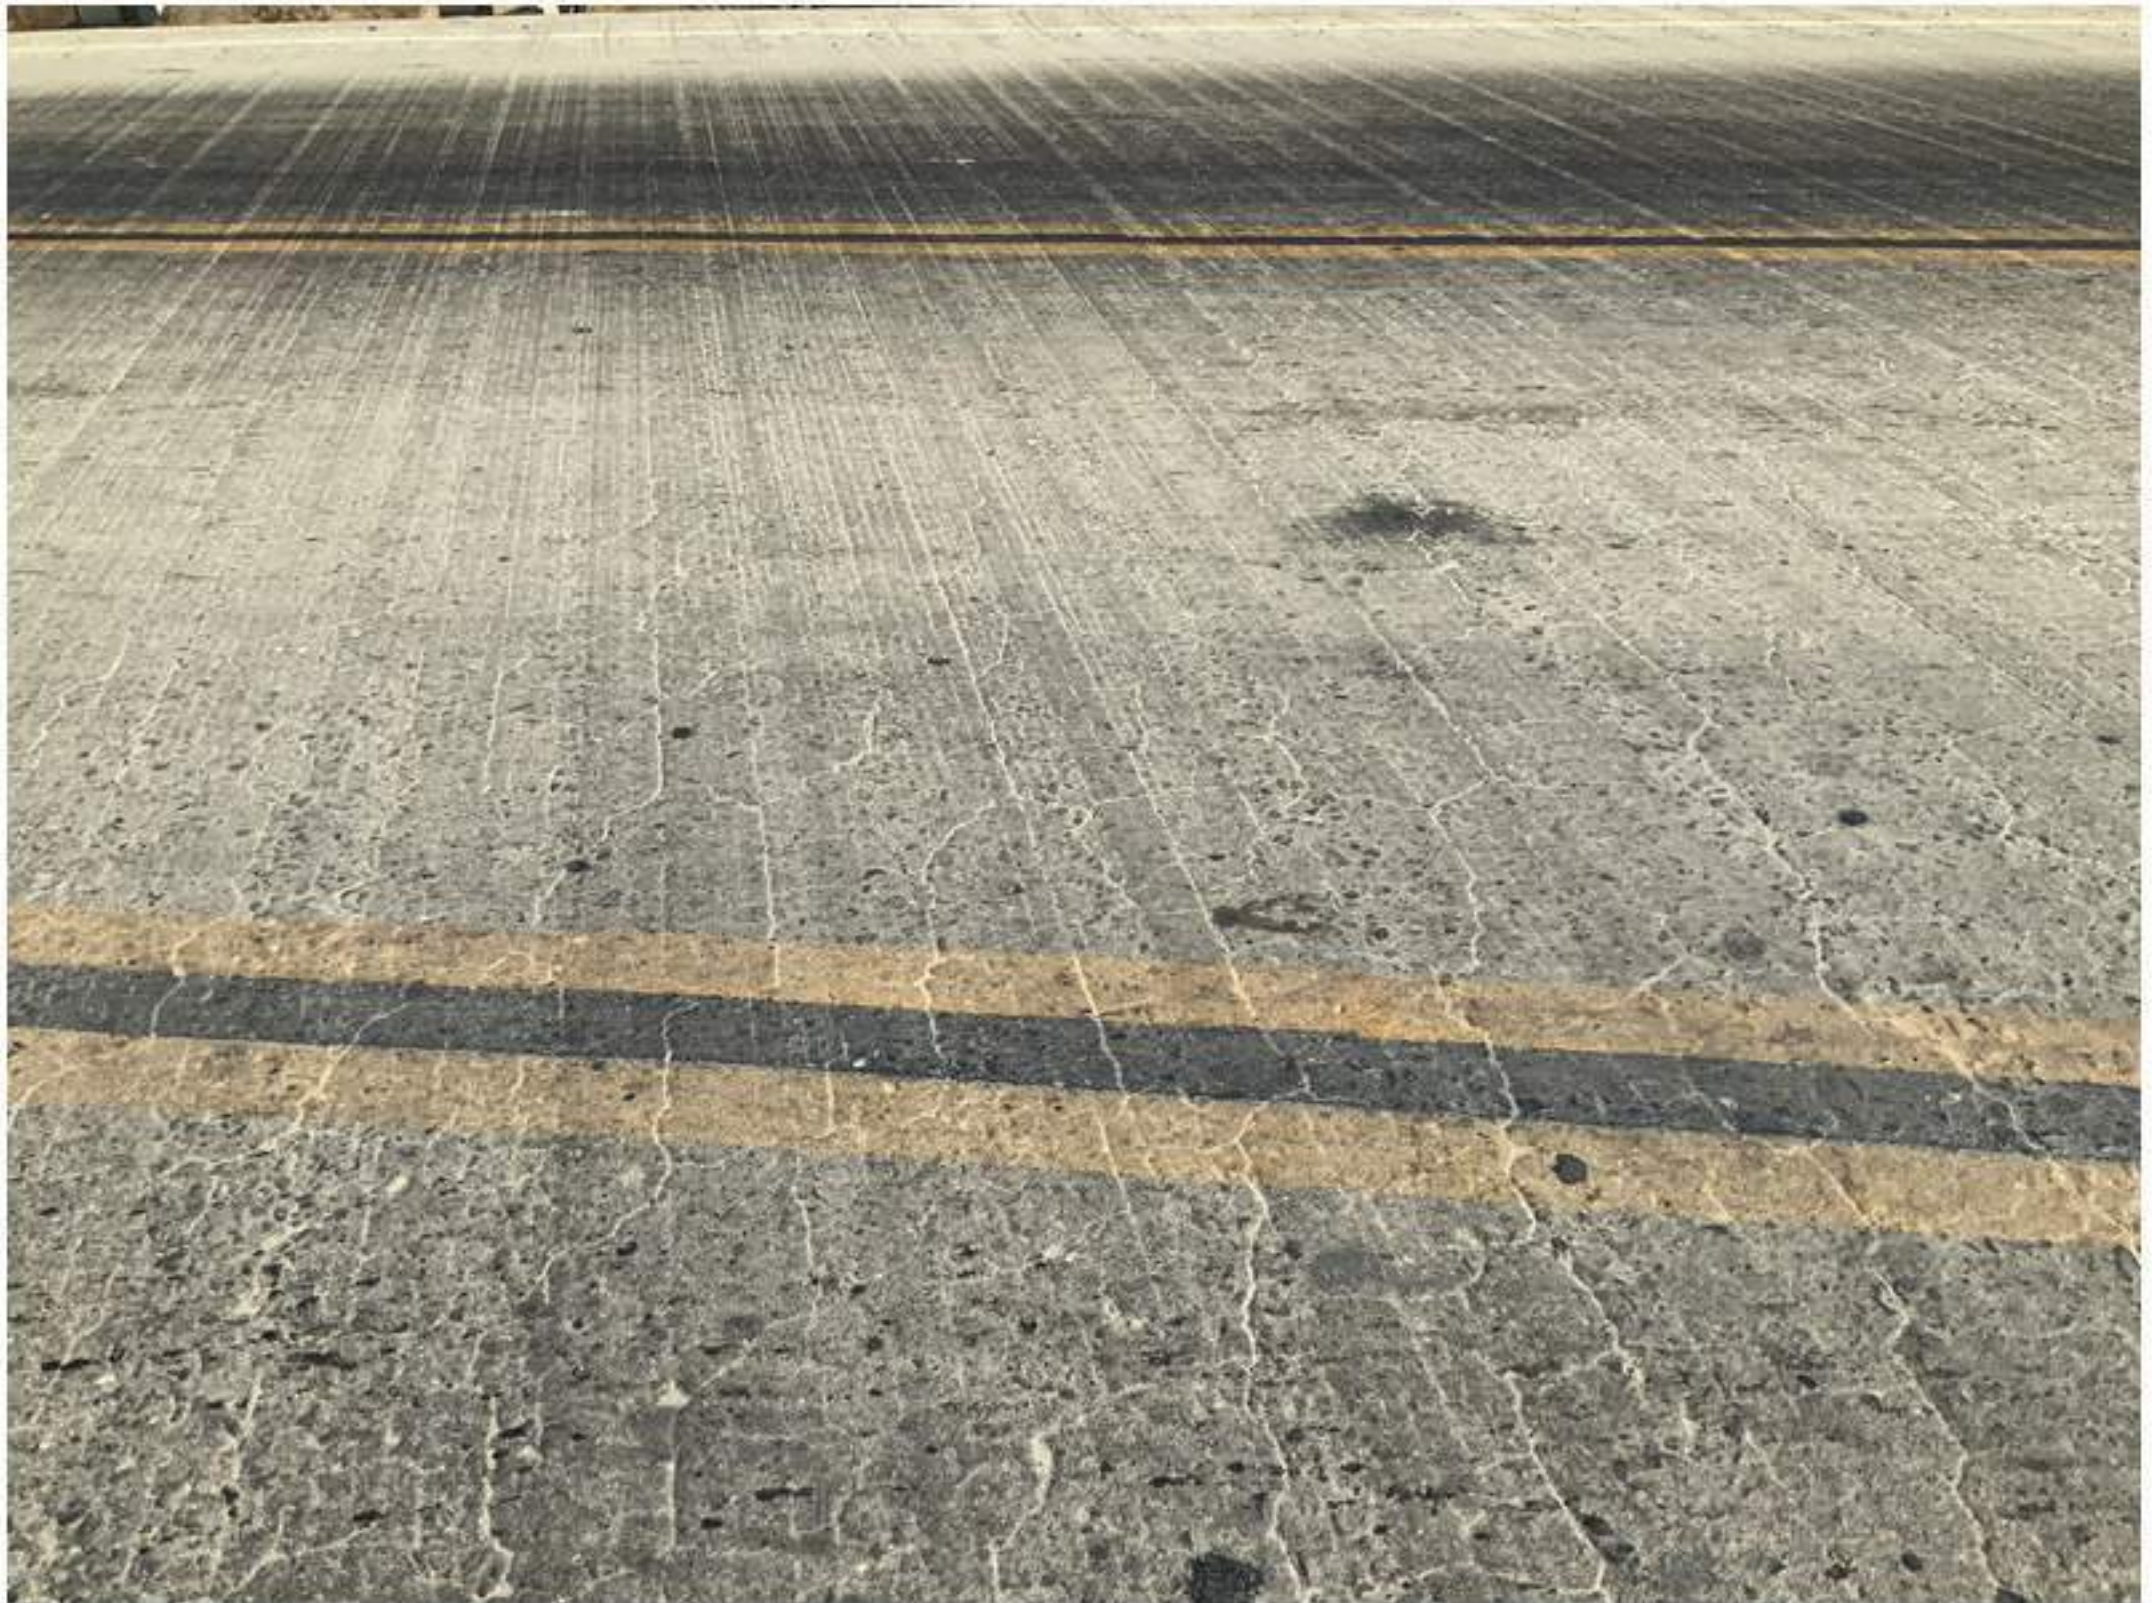
| ELEMENT INSPECTION RATINGS AND COMMENTARY | | | | | | | | | | | |
|---|---|---|---|---|---|---|---|---|---|---|---|
| There are deck map pattern cracks, 0.05 to 0.06 inches wide, spacing 9 to 18 inches. | | | | | | | | | | | |

Photo No. 104  
Typical Deck Cracks

| Action : Deck-Methacrylate | StrTarget: 2 YEARS | cracks by coating the bridge deck with |

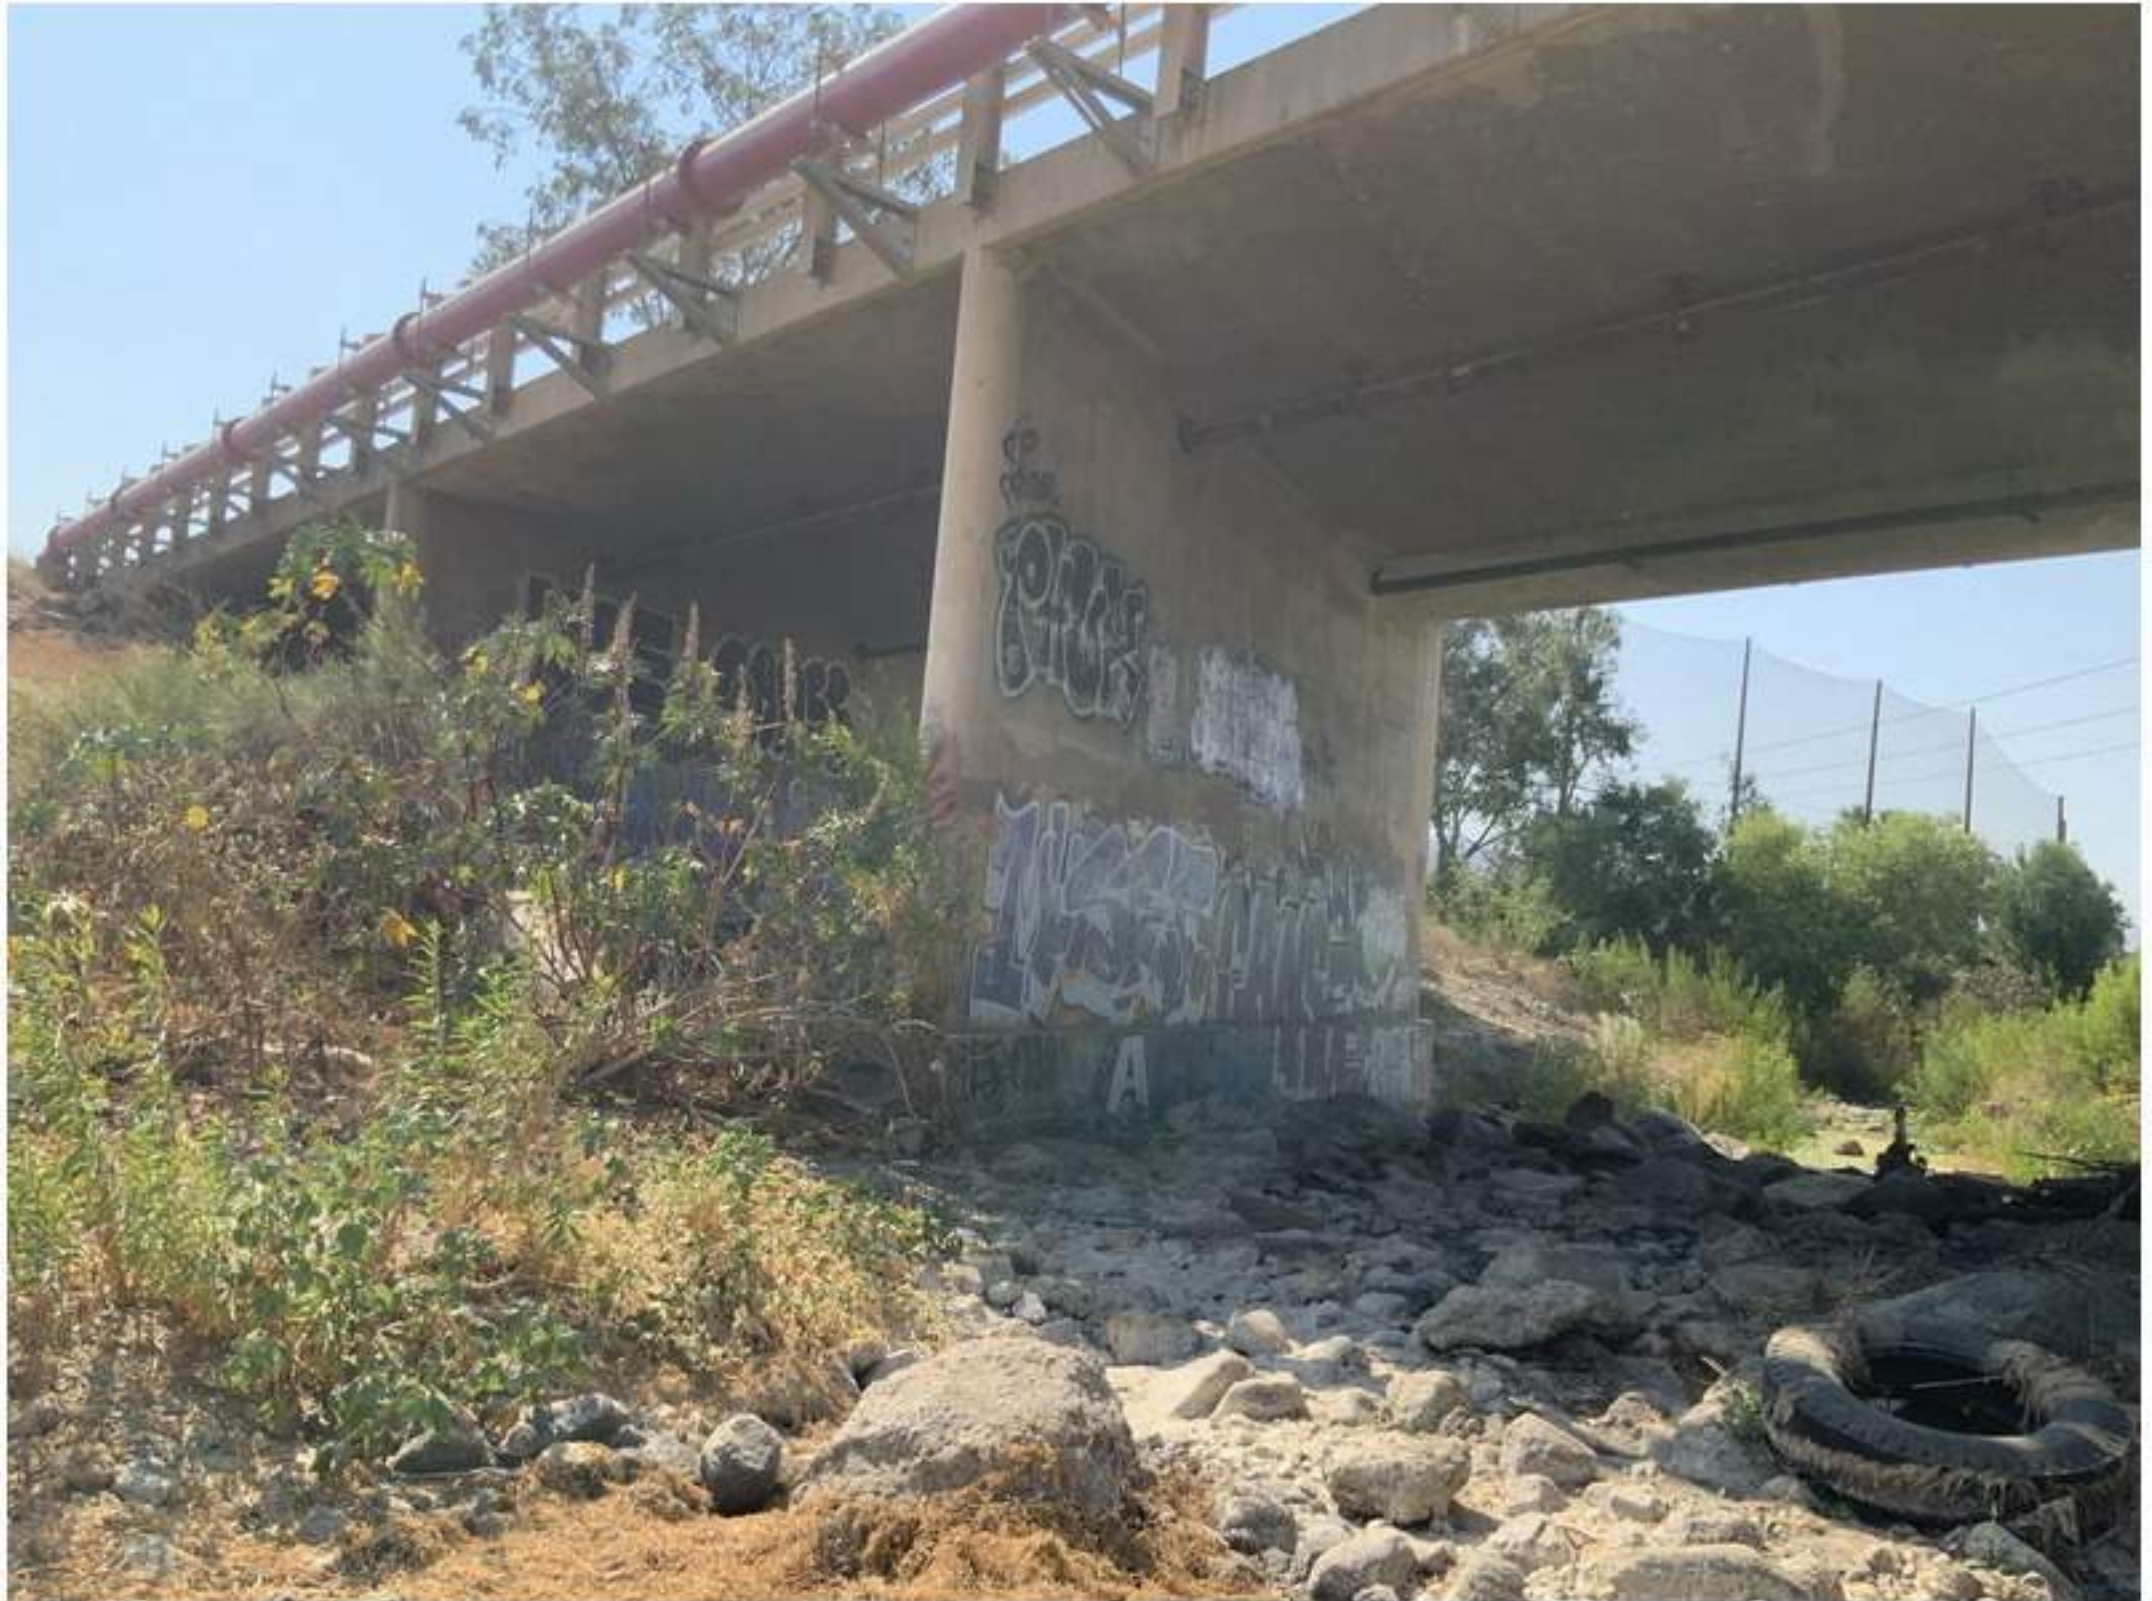
Photo No. 105  
Exposed Pier Wall Footings

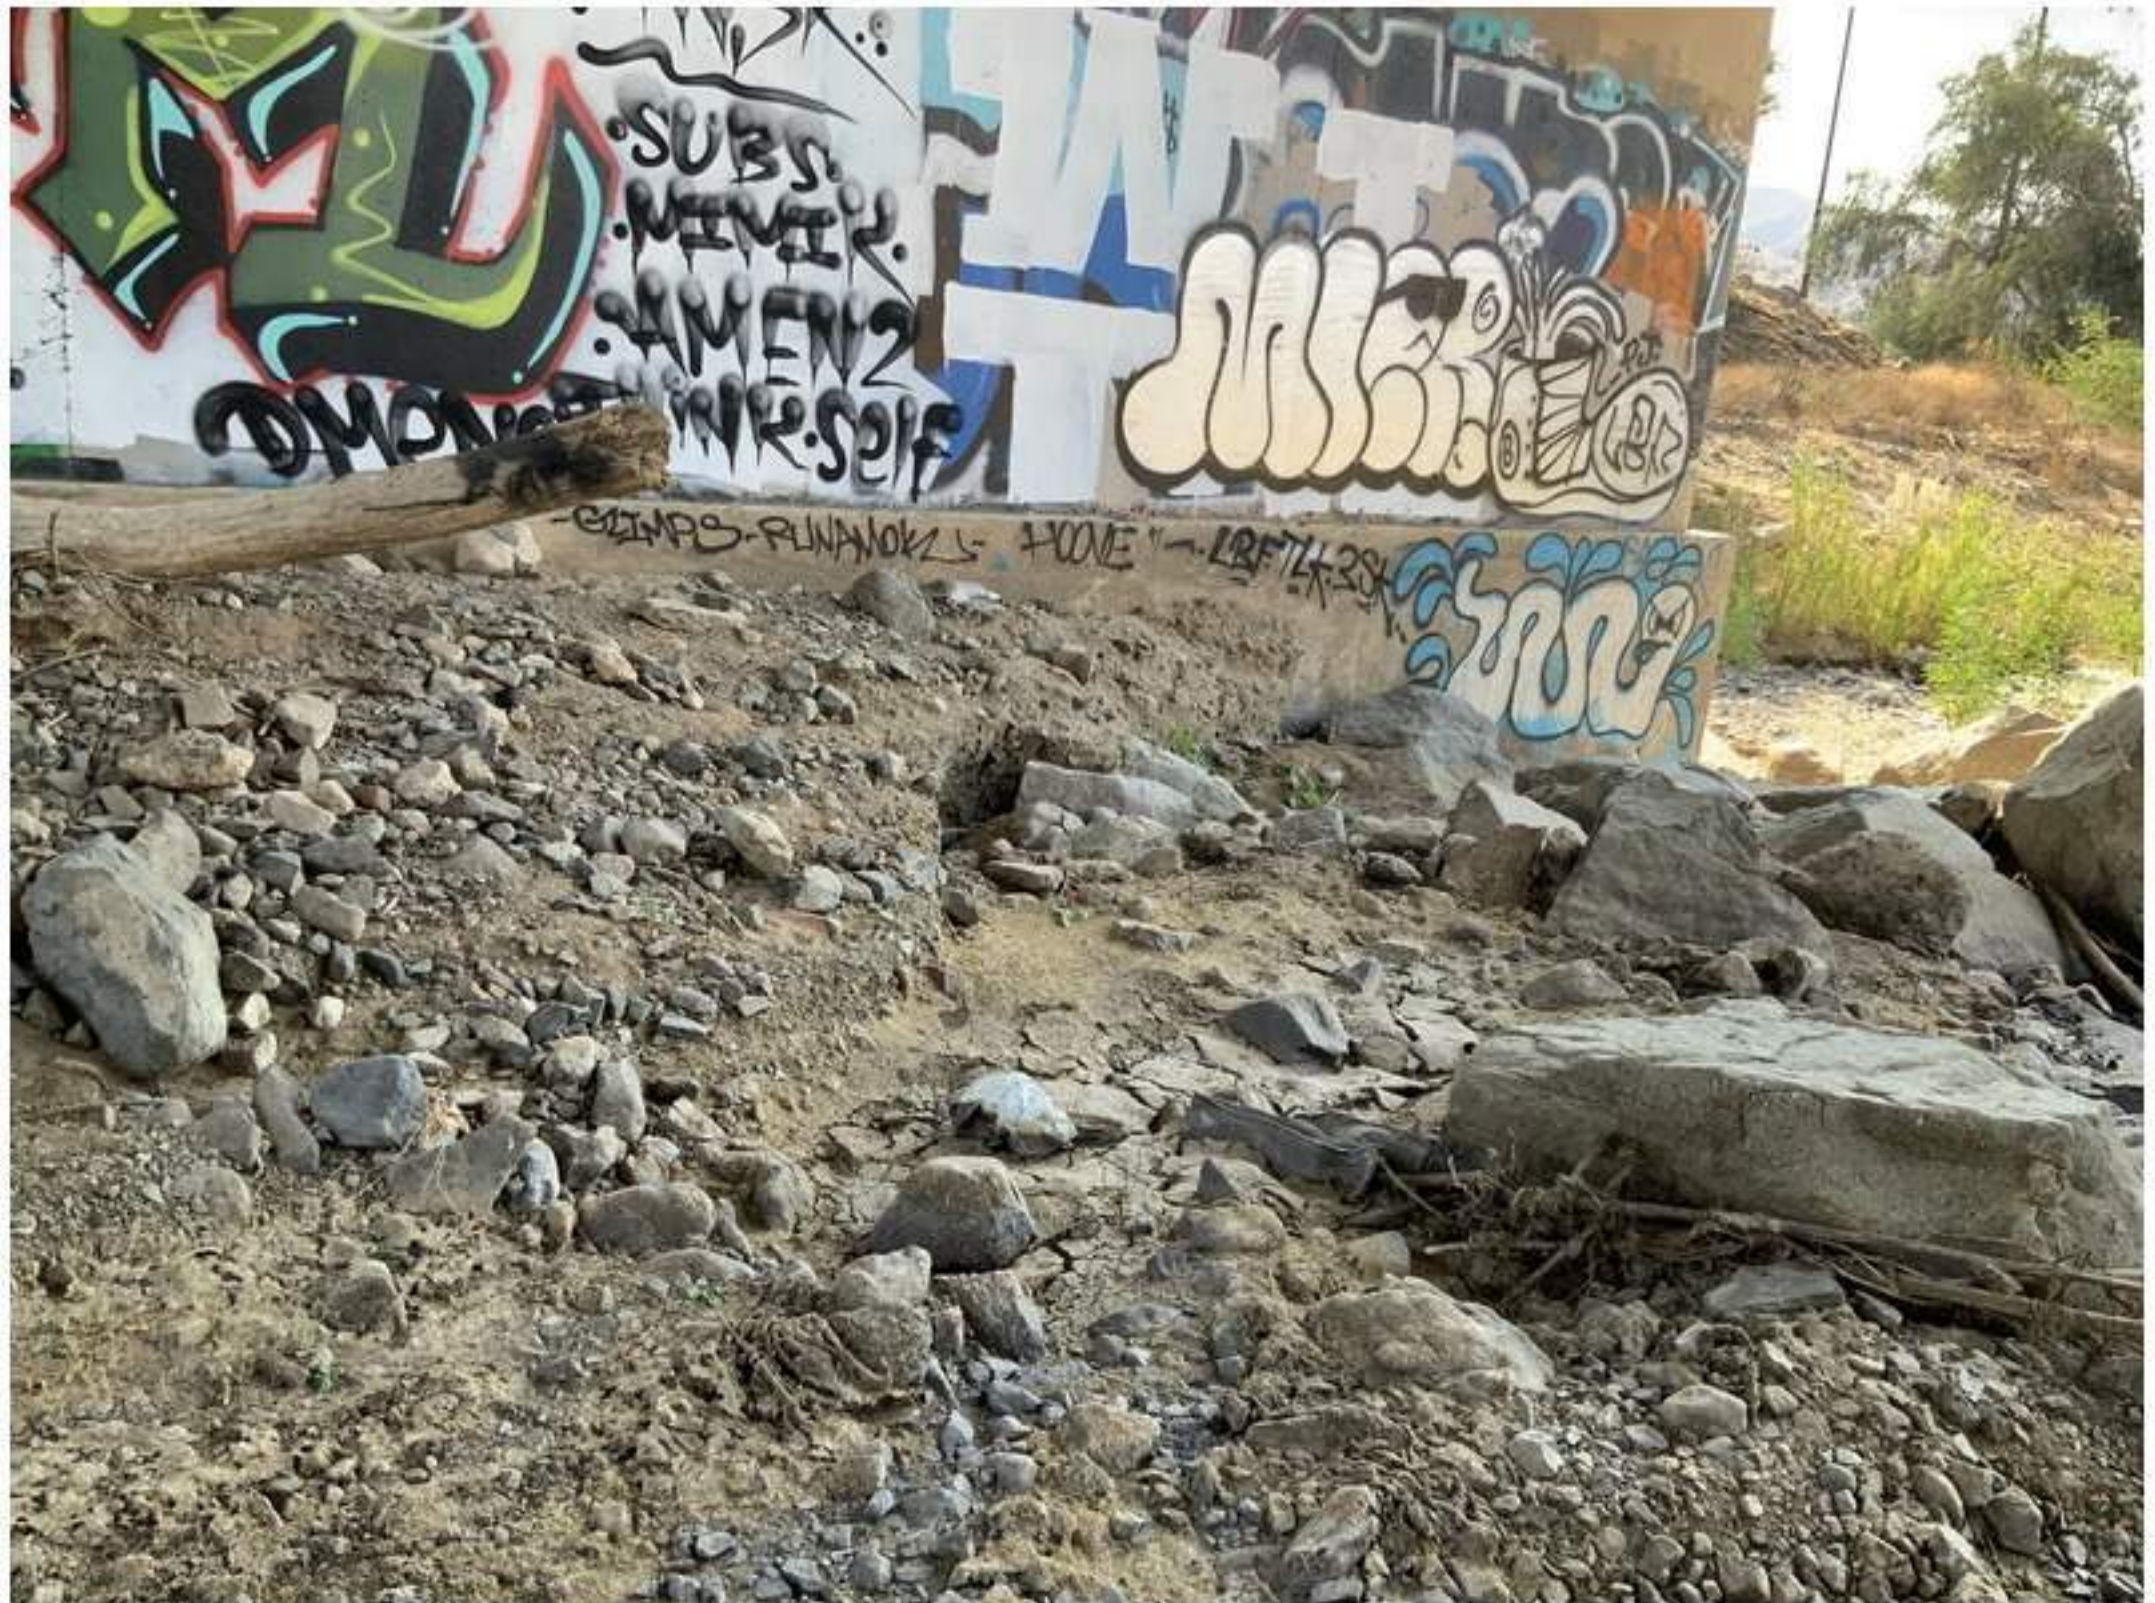
Exposed Pier Wall Footings

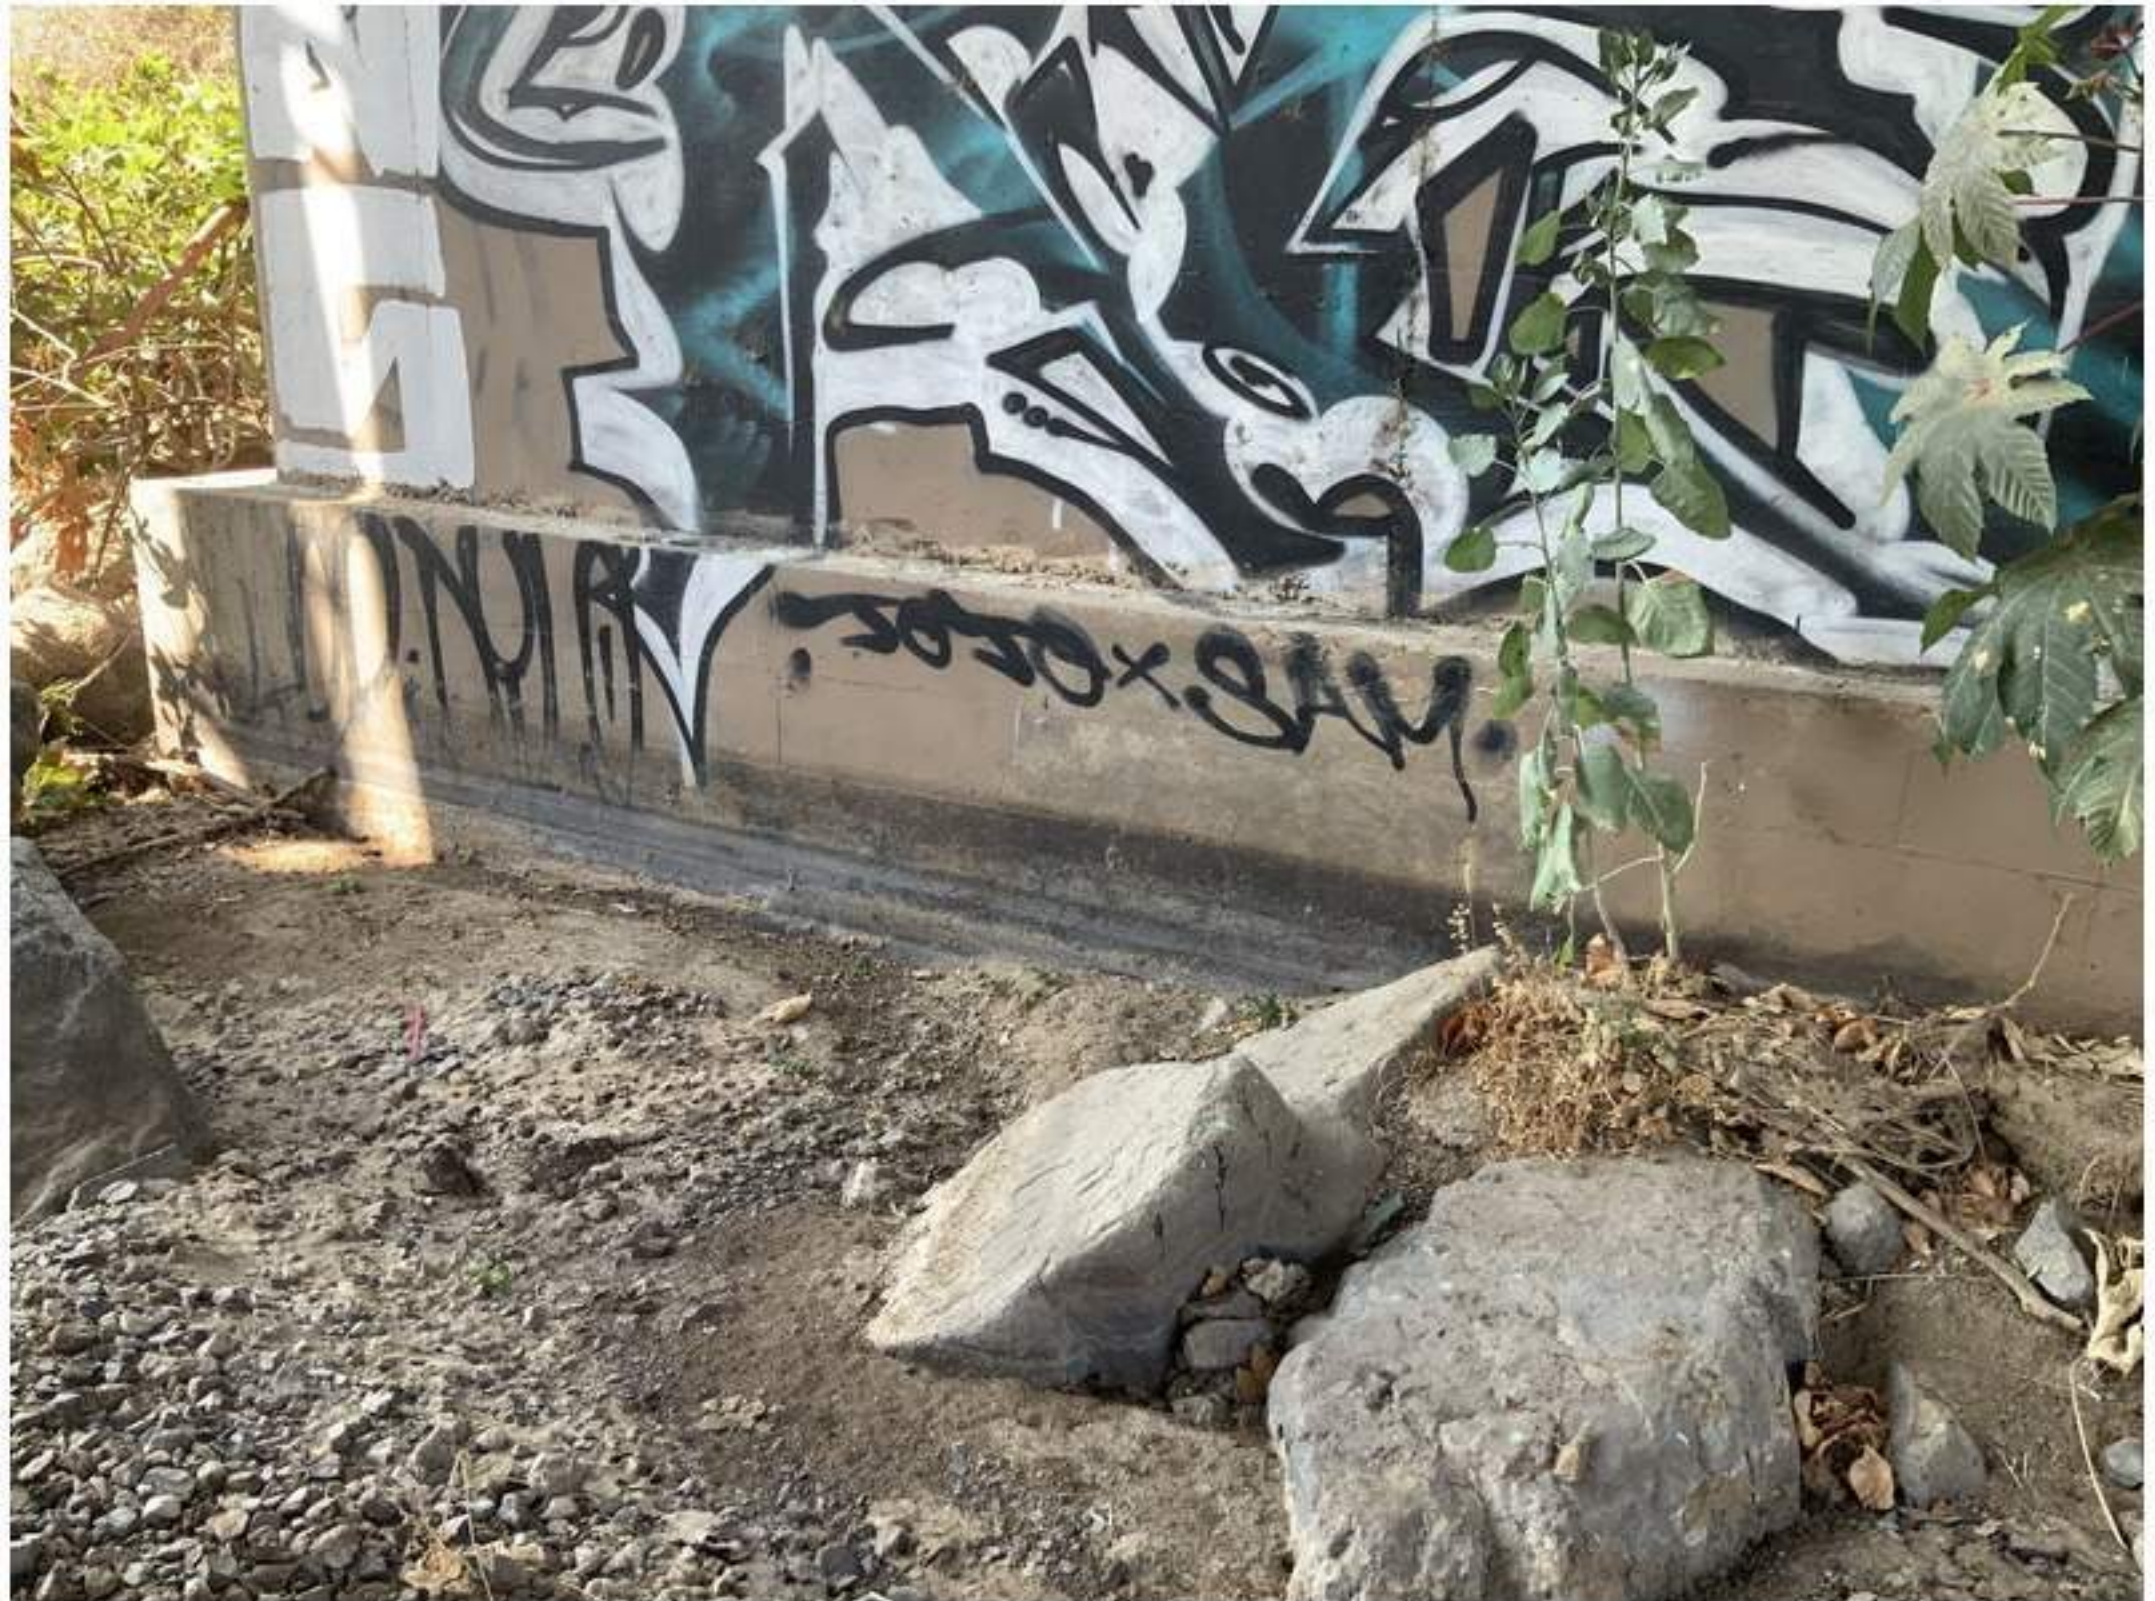
Exposed Pier Wall Footings
