# BRIDGE REHABILITATION ASSESSMENT

## DAWSON CANYON ROAD OVER TEMESCAL WASH

Prepared by:  
Kleinfelder, Inc.  
770 First Avenue, Suite 400  
San Diego, CA 92101  
Kleinfelder Job No. 20222889

March 17, 2022

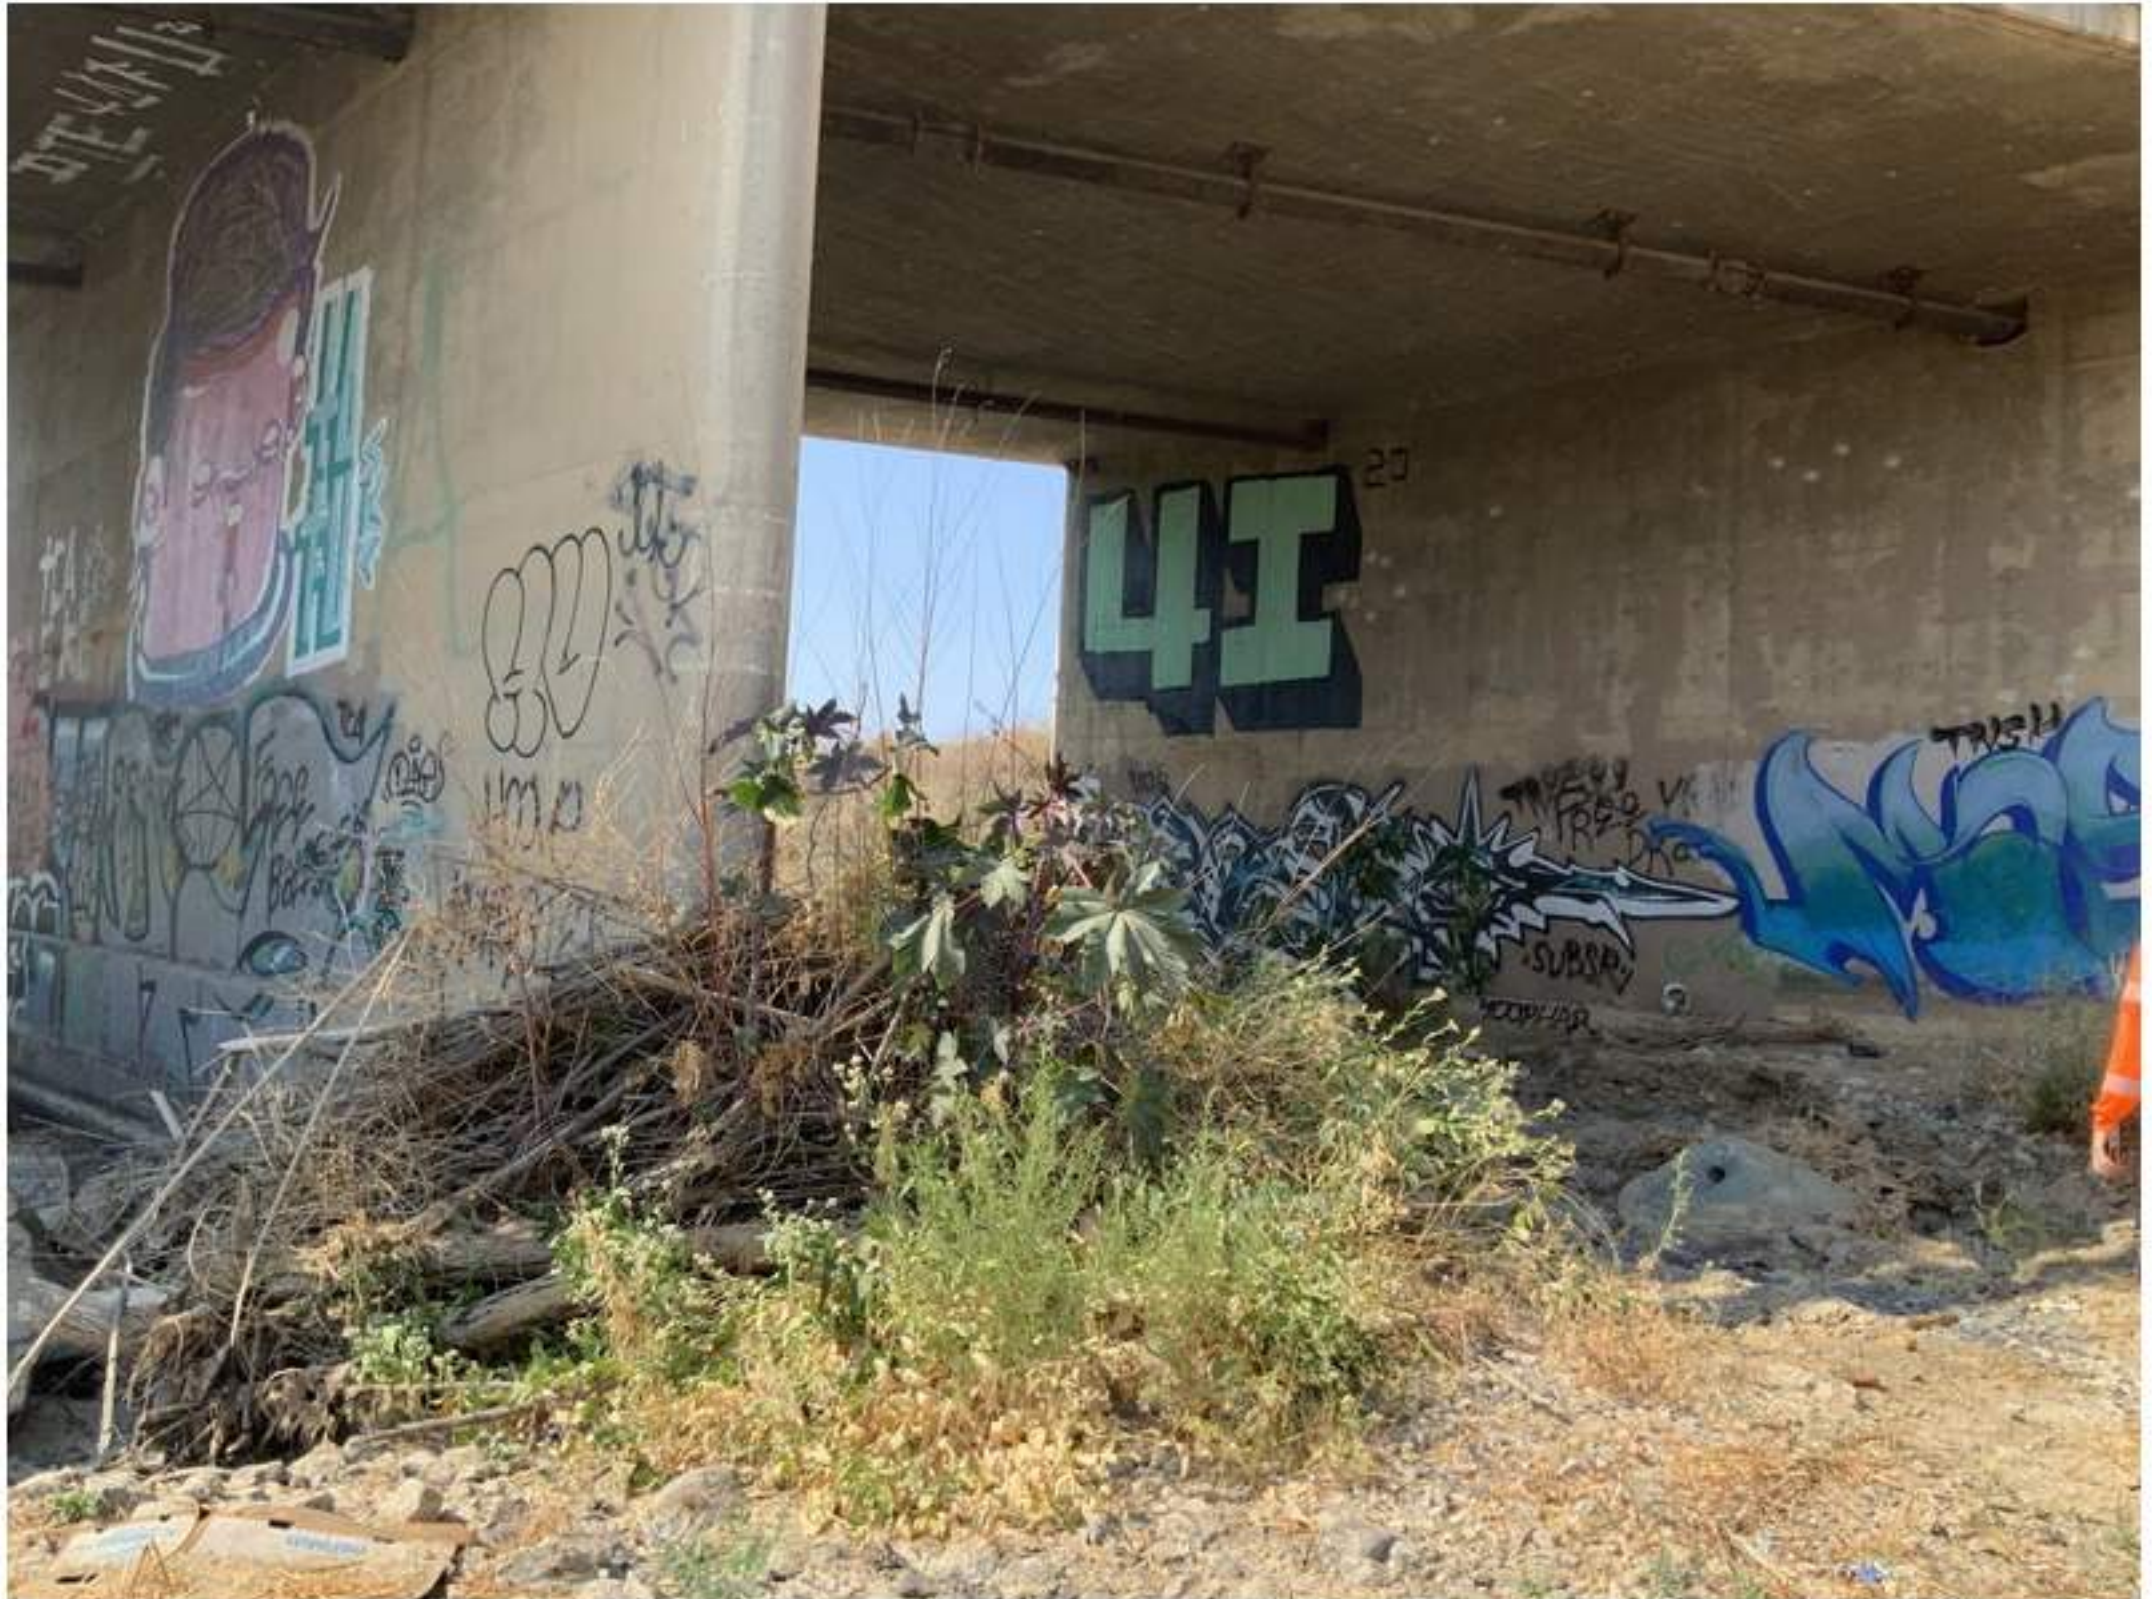
Photo No. 108  
Debris At The Pier

- Rock riprap at Piers
- Remove debris at Piers

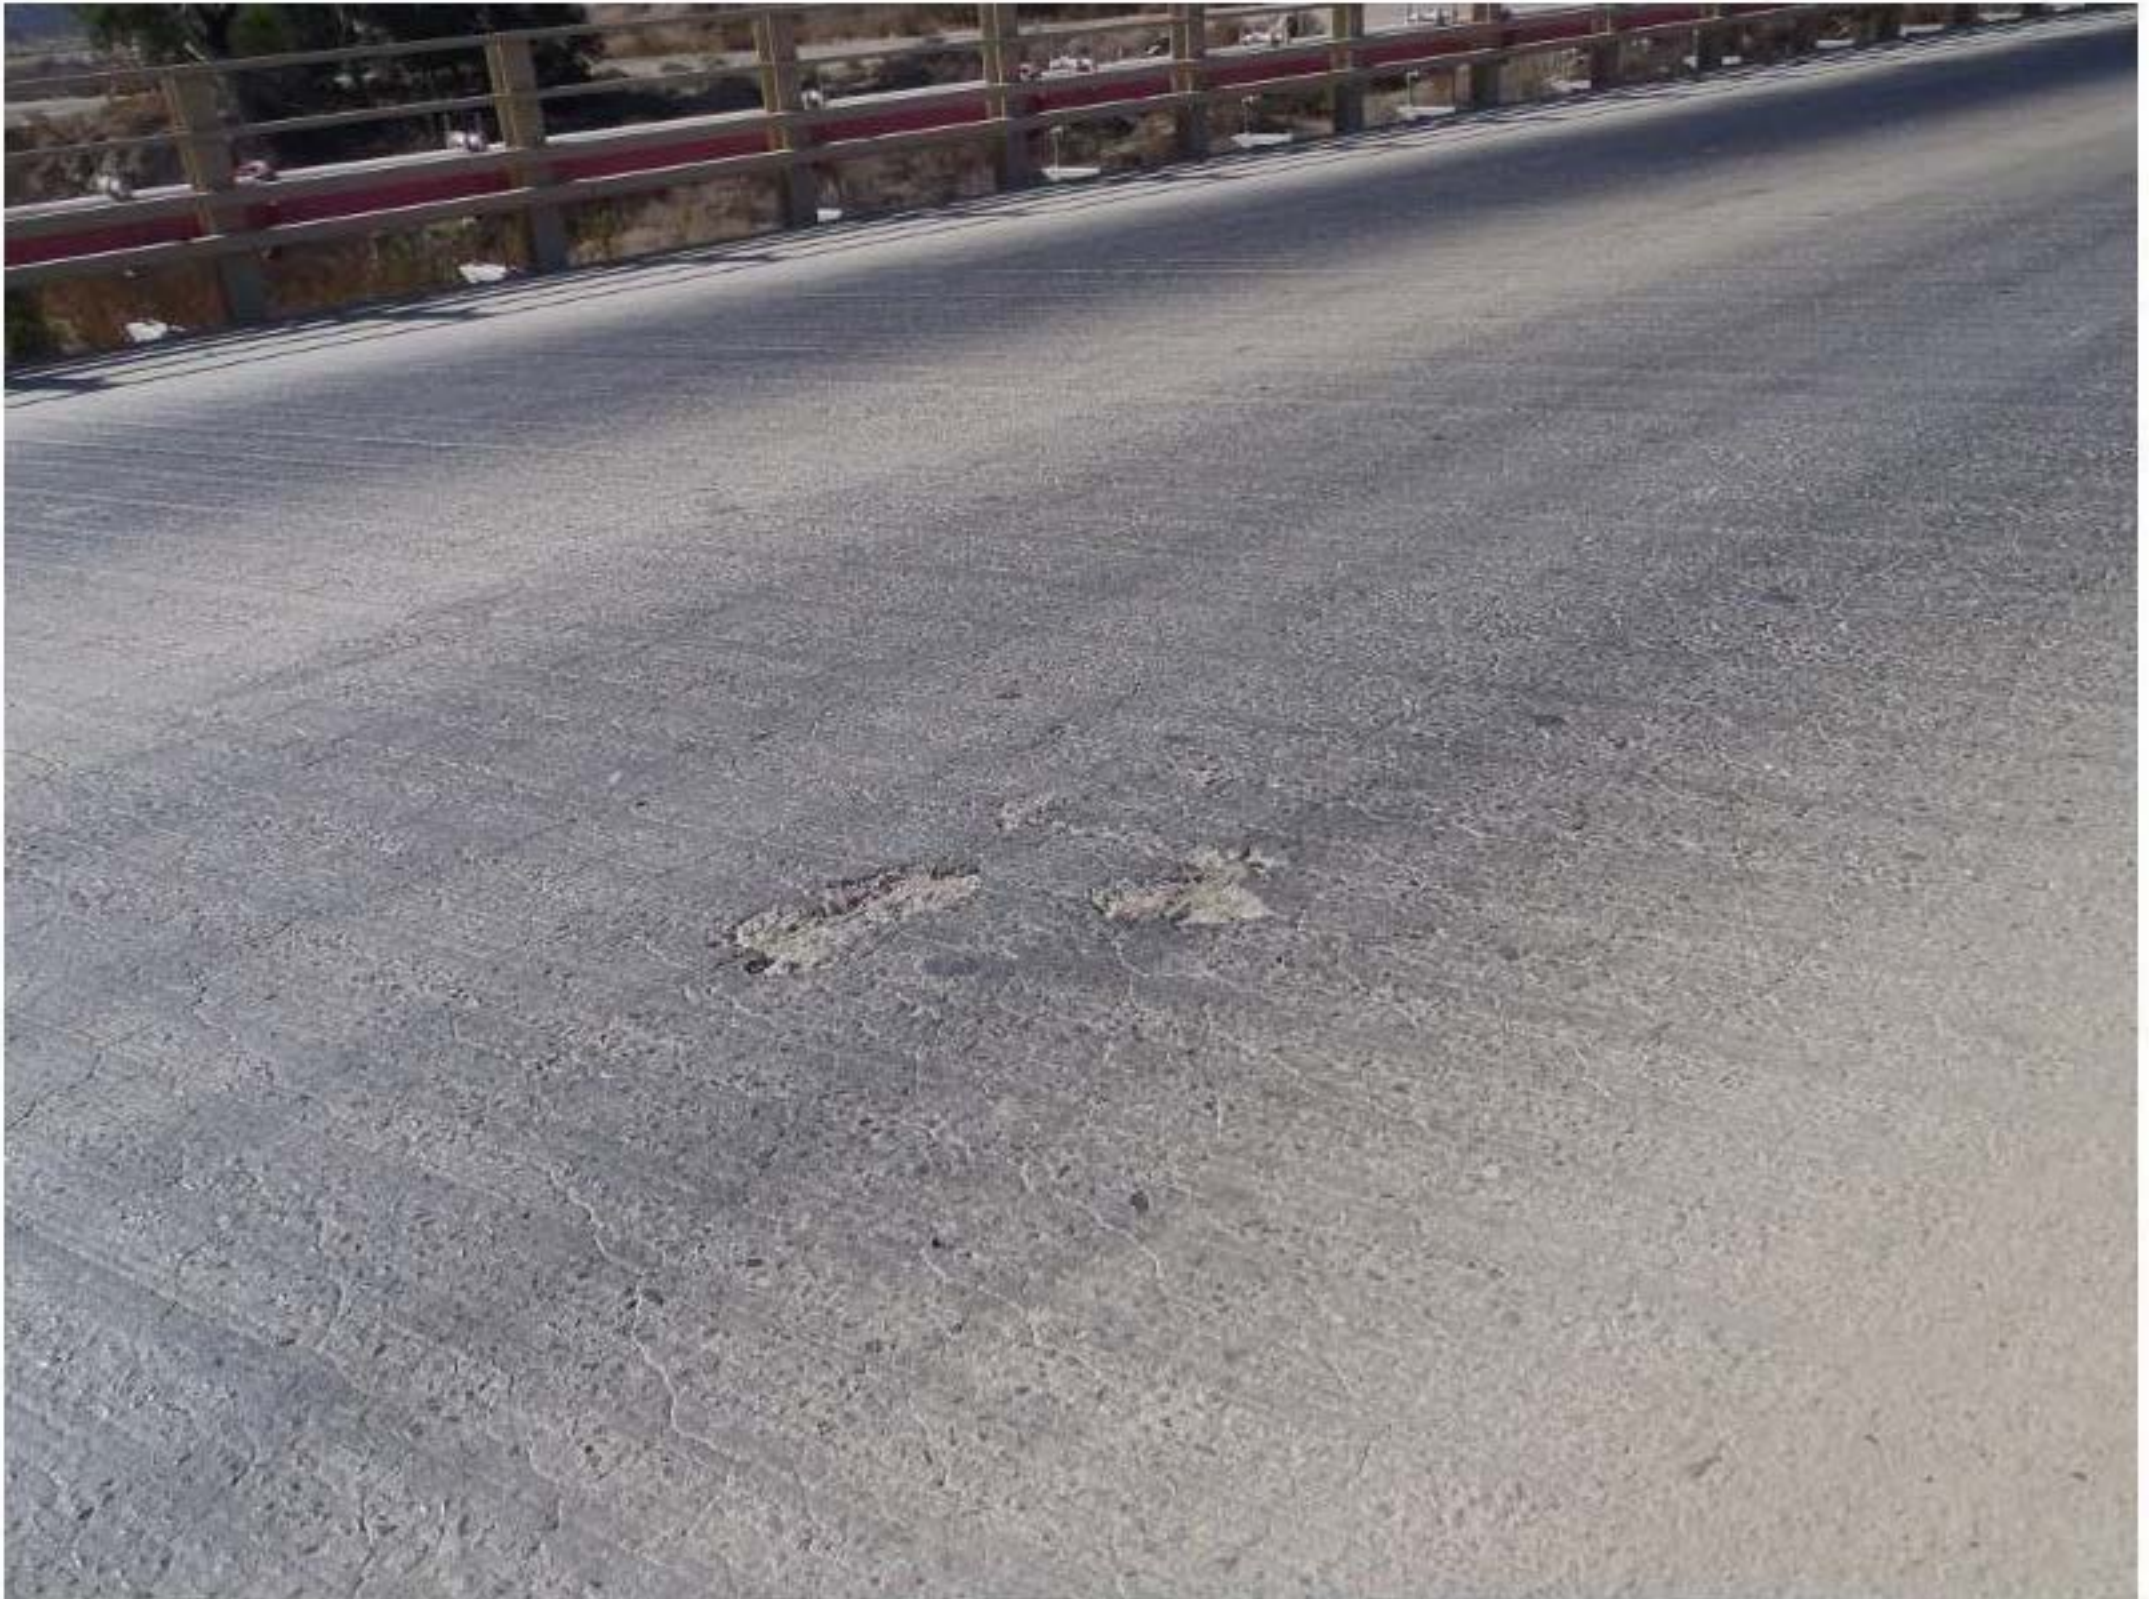
A MINOR SPALL ON THE TOP OF DECK NEAR NORTHERN ABUTMENT

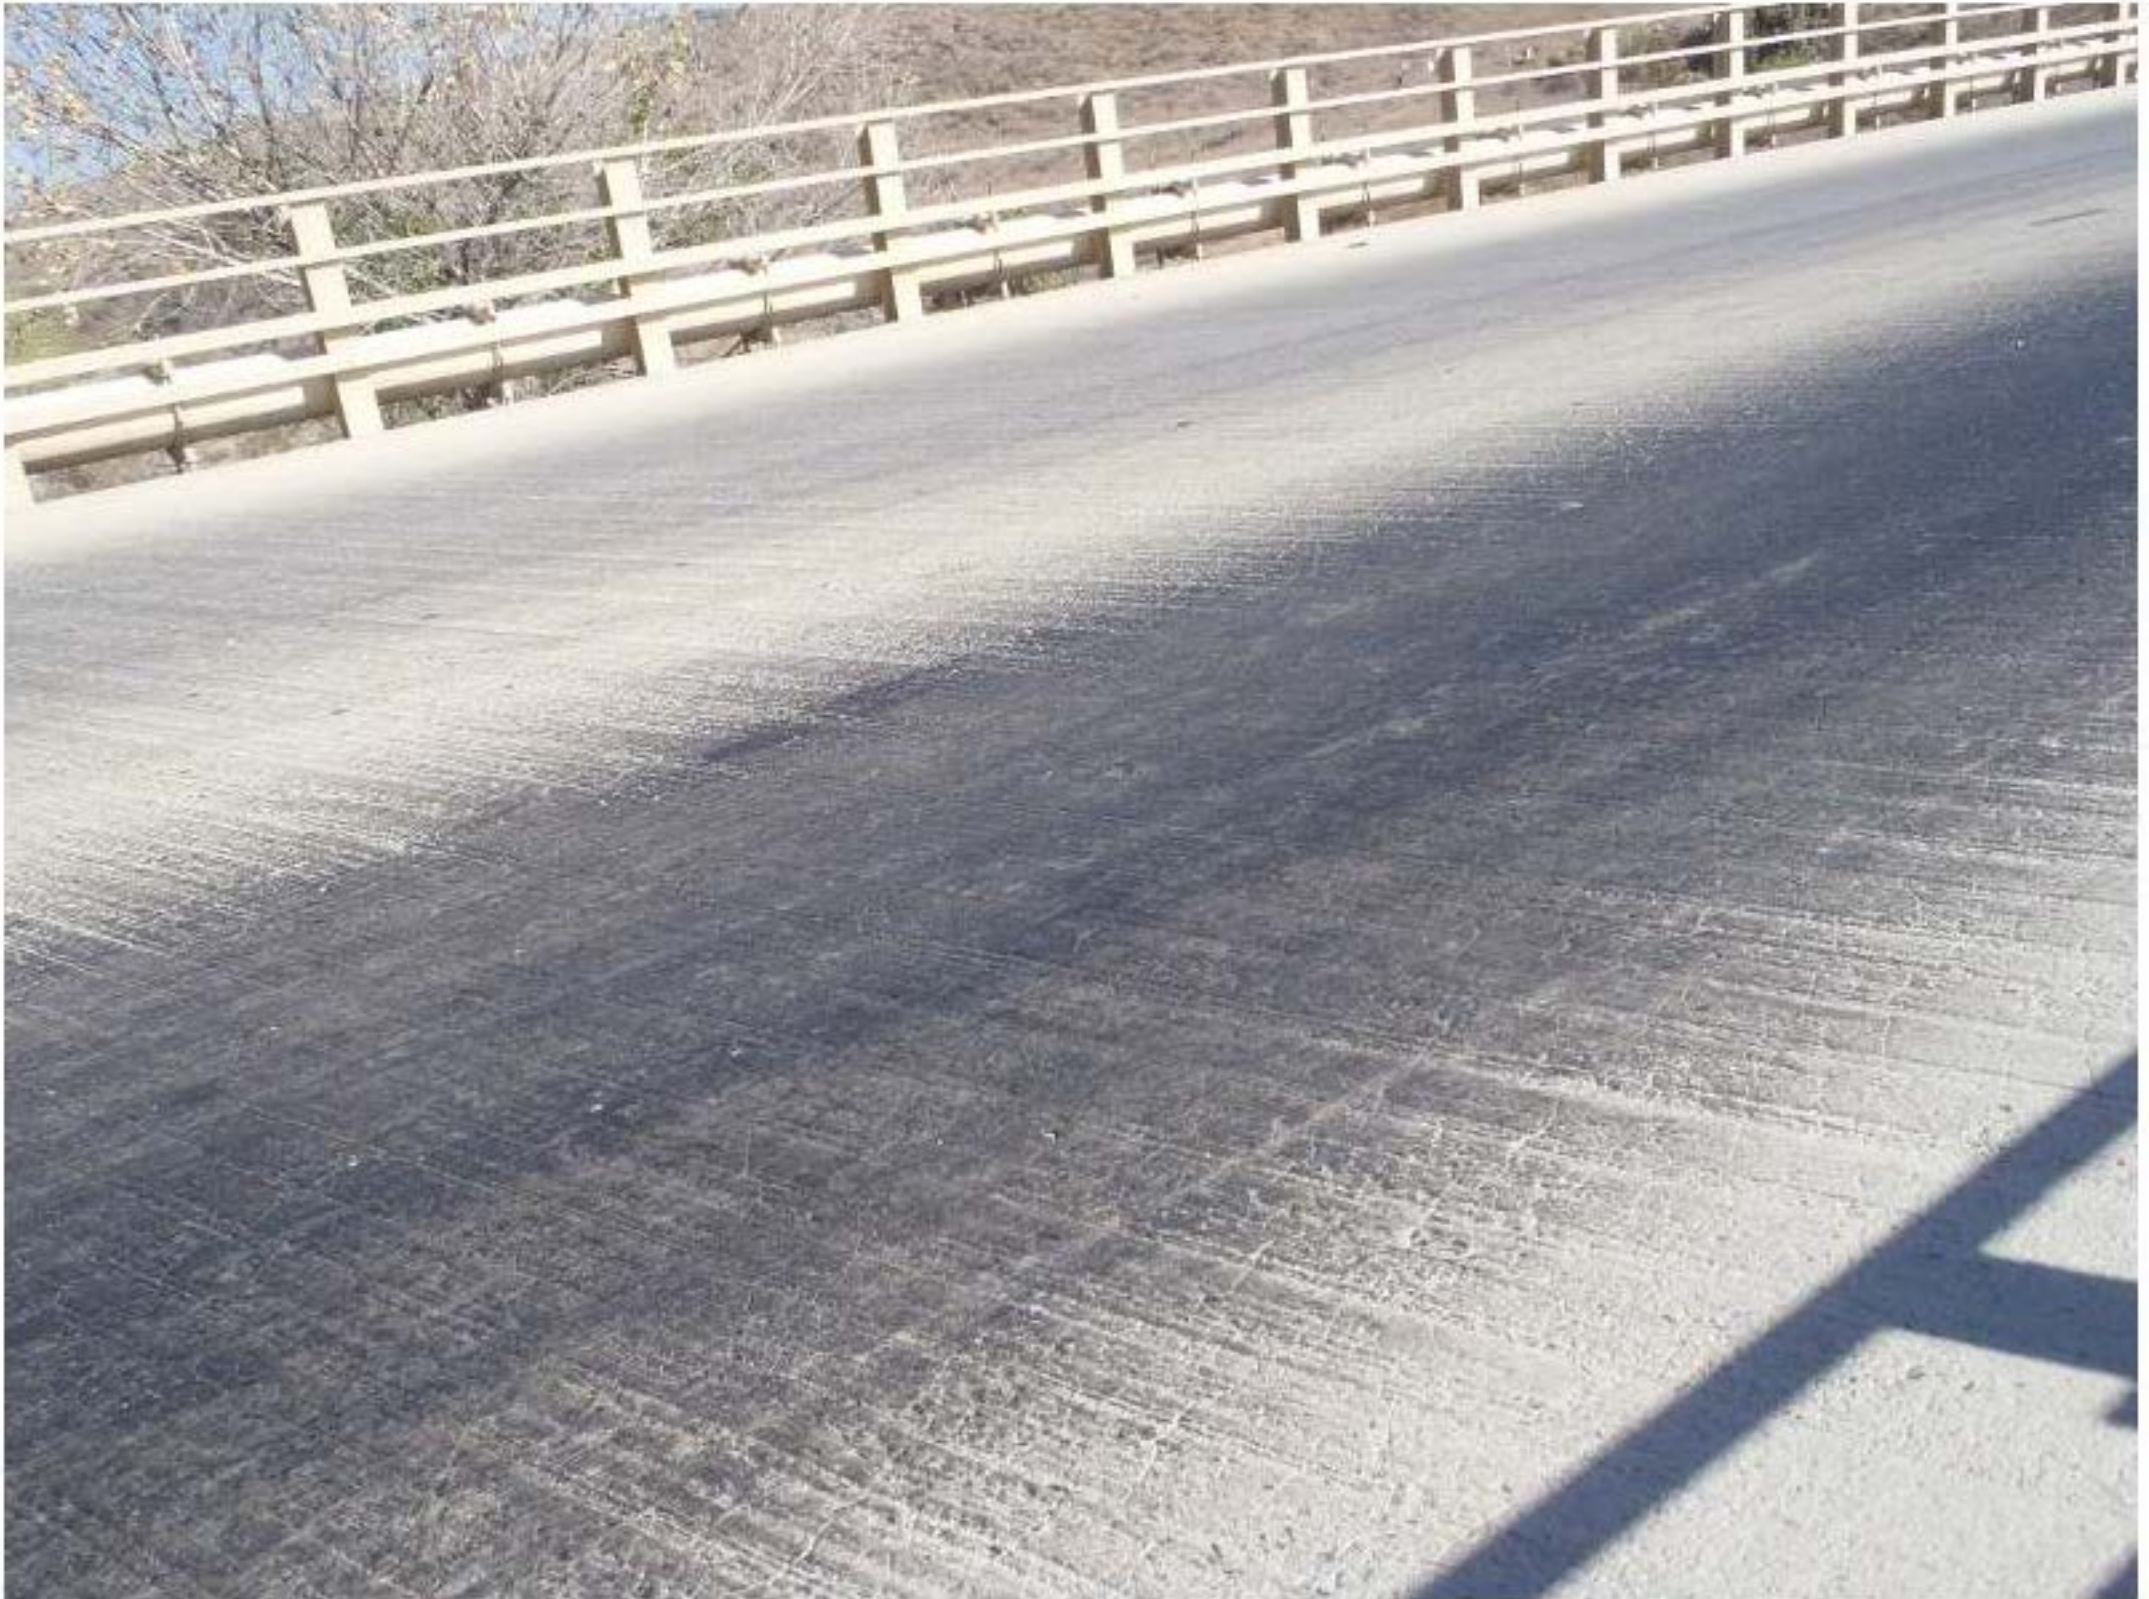
| Elem No. | Defect /Prot | Element Description | Env | Total Qty | Units | Qty in each | Condition | State | |
|---|---|---|---|---|---|---|---|---|---|
| The concrete deck exhibits map pattern cracks, 0.05 to 0.06 inches wide, spacing 9 to 18 inches. | | | | | | | | | |

Photo No. 1  
TYPICAL DECK SURFACE CONDITION

Clean the concrete deck and fill the cracks by coating the bridge deck with methacrylate resin.

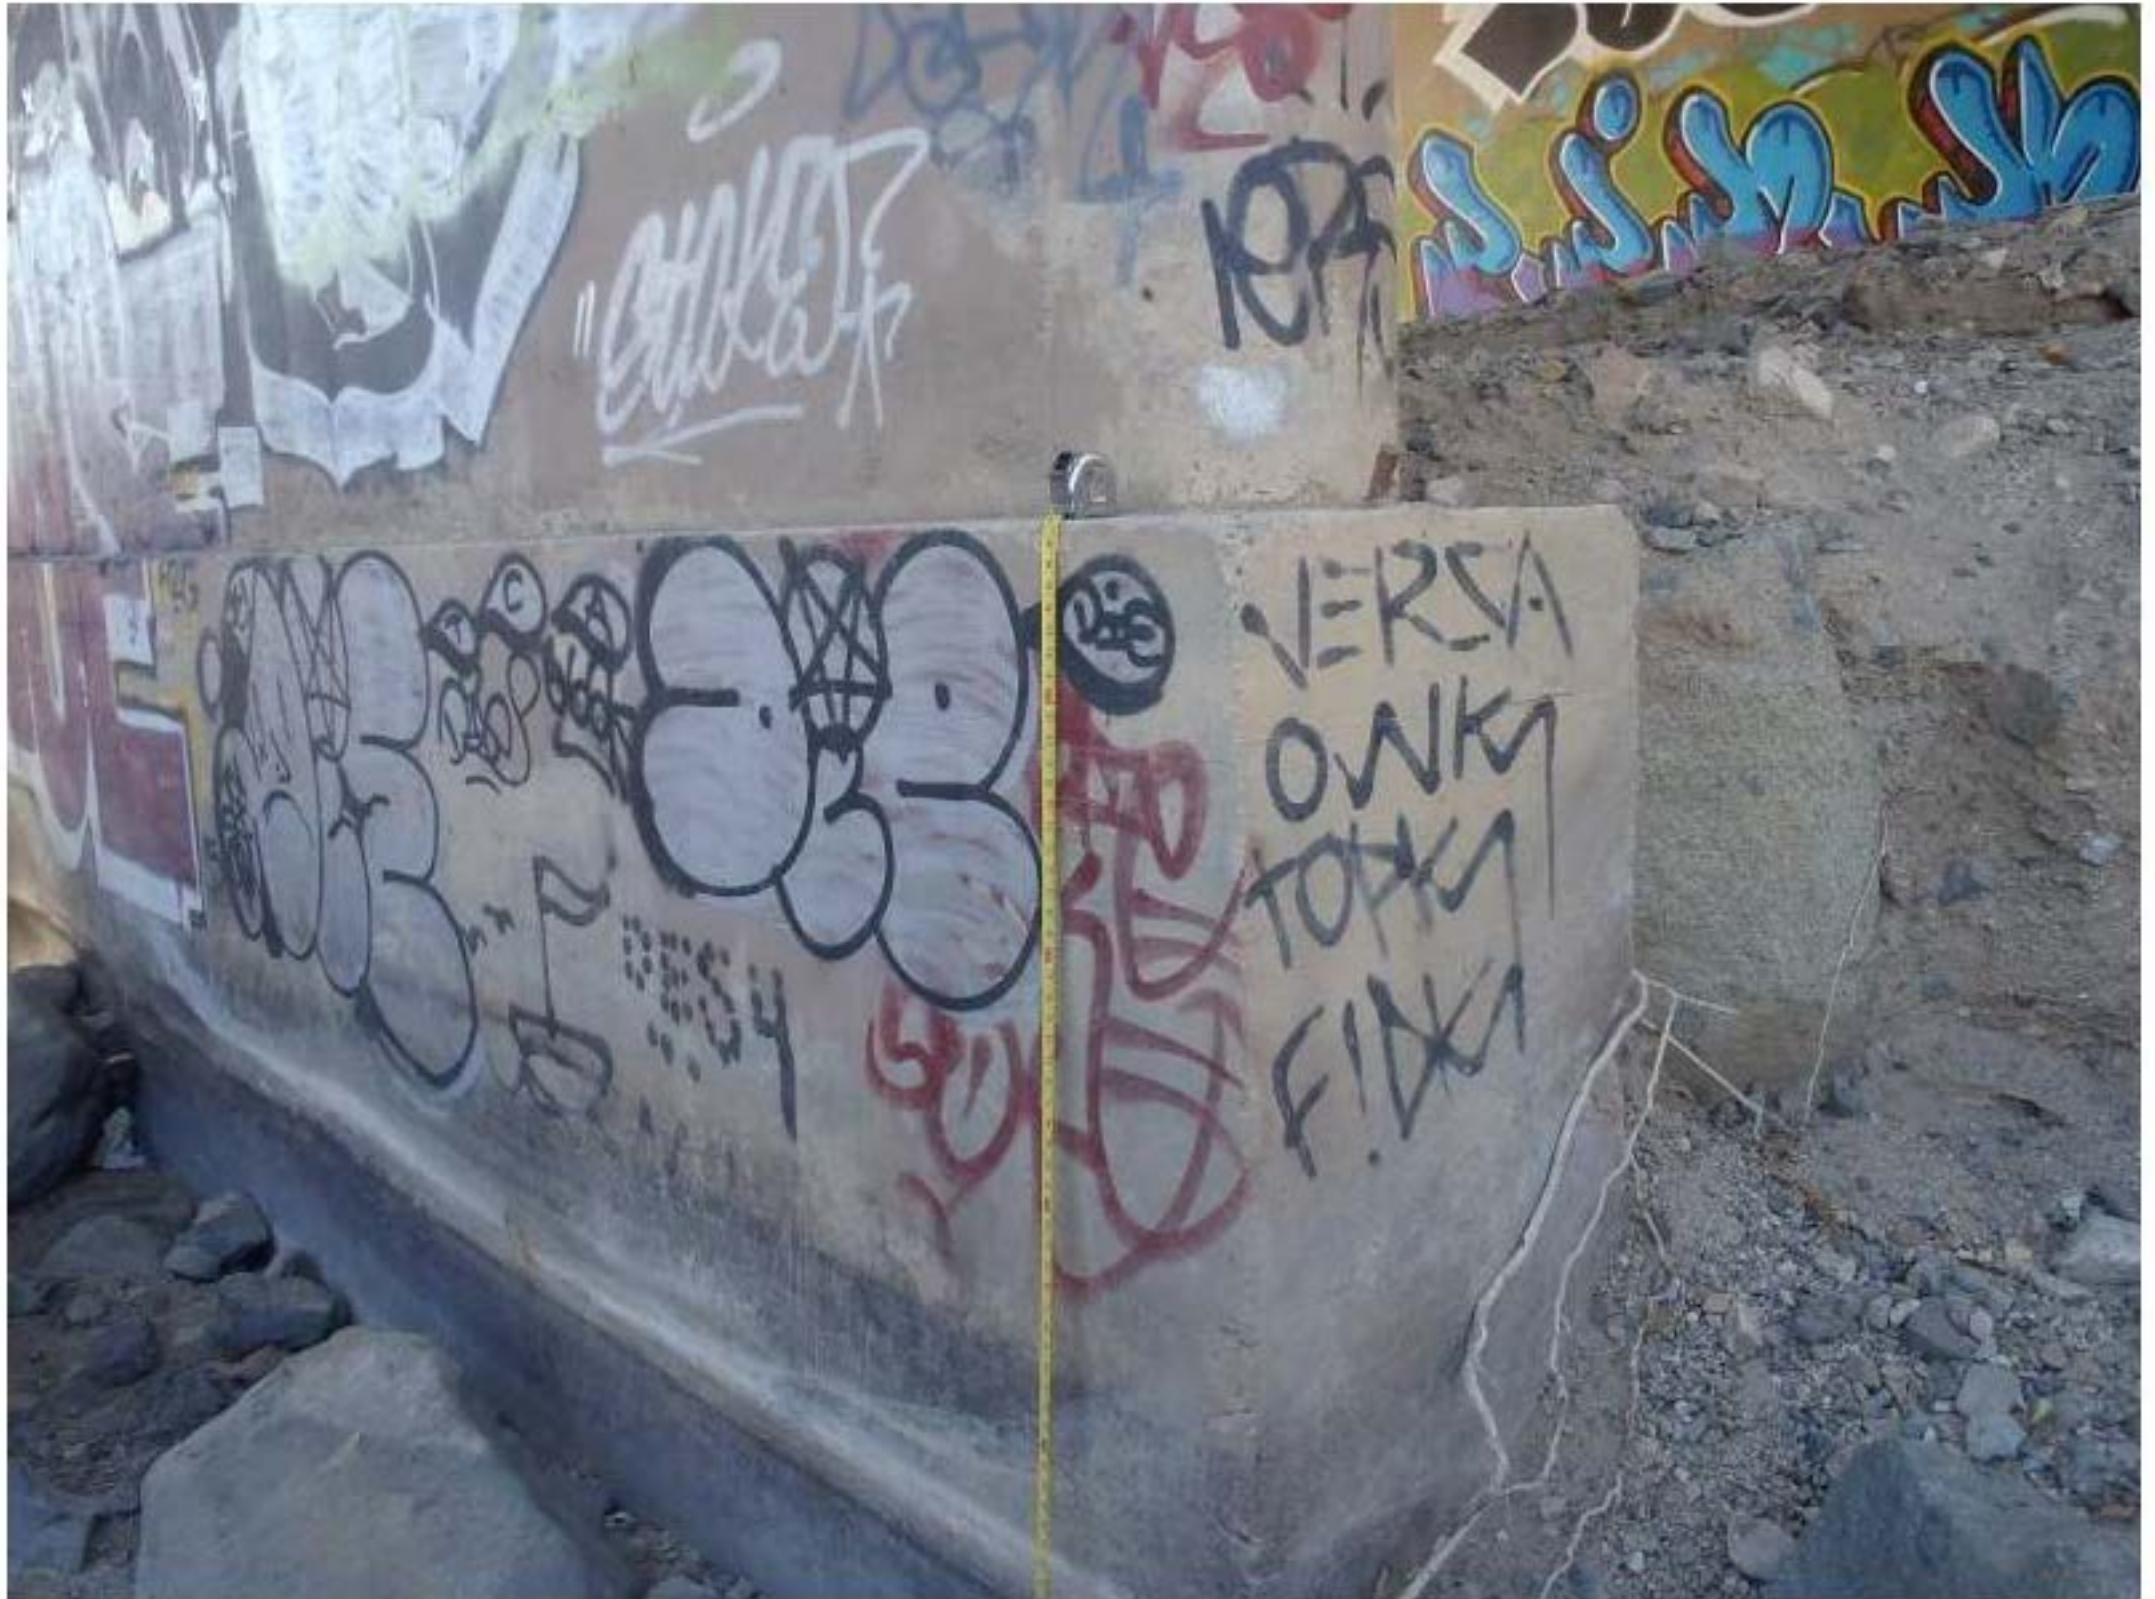
EXPOSED FOOTING AT NORTHWESTERN END OF BENT 3
