**1050 St. Elizabeth Drive**

## **Tree Report**

December 9, 2020

**Tree Report**  
1050 St. Elizabeth Drive  
San Jose CA

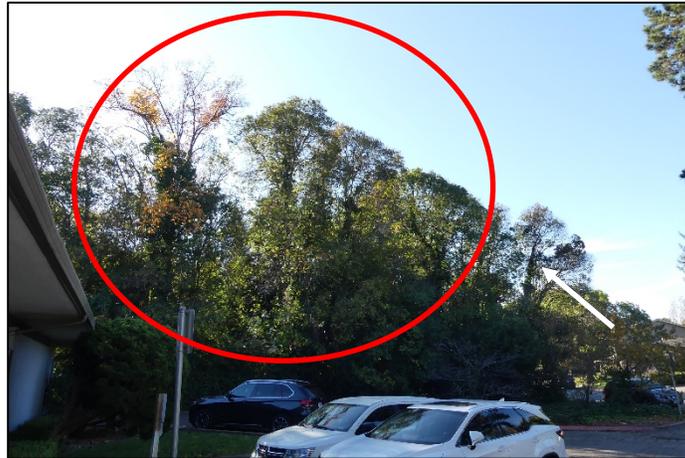
Glossy privets #86 – 89 were located in the southwest corner of the site (Photo 1, following page). Trees #86, 87 and 88 appeared to be off-site, located behind a wire fence. Tree #89 was on-site near St. Elizabeth Drive. Trees were mature in development with narrow crowns. Trunk diameters ranged from 15 to 18 in. All trees had multiple stems arising low on the trunk. Tree condition was fair due to overall form, history of trimming on the project side of the fence, and lack of overall vigor.

**Photo 1.** Looking south from building entry. Tuliptree #85 and glossy privets #86 87 and 88 (red circle) were located behind a wire fence. Glossy privet #89 (white arrow) was located onsite.

- Tuliptree #85 was located off-site to the south (see Photo 1). This mature tree was approximately 21" in diameter and in fair condition.
- Blue Colorado spruce #90 was located in an interior courtyard. I estimated the trunk diameter to be 15 in. Overall condition was good.
- Jacaranda #91 was located in an interior courtyard. I estimated the trunk diameter to be 6 in. Overall condition appeared to be excellent.

Based on my evaluation of the plans, I recommend preservation of the four off-site trees (#85 – 88) and removal of the 12 on-site trees. The 12 on-site trees are located within the proposed development area.

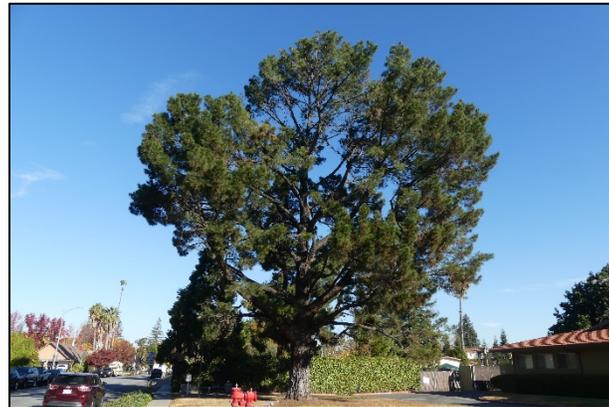
Monterey pines #76 and 78 were mature trees on the west side of the site. Tree #76 was 45 in. in diameter and in fair condition (Photo 2). The crown was rounded and somewhat rangy in form. Tree #78 was 29 in. and in poor condition. The tree leaned sharply to the south and the crown was one-sided in that direction. The lower trunk of both trees had been attacked by red turpentine beetle, a boring insect that is a serious pest of the species.

**Photo 2.** Looking north at Monterey pine #76. Note rounded crown.

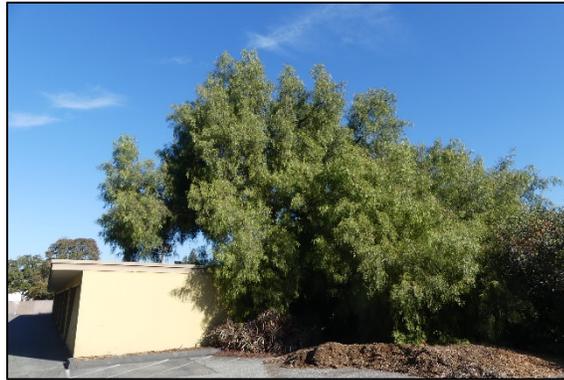
- Calif. pepper #84 was a mature tree with trunks of 28 and 19 in. (Photo 3). Overall condition was fair. The crown was wide, extending over the adjacent building, and hung to the ground.

**Photo 2.** Looking north at Calif. pepper #83. Note wide crown with branches hanging to the ground.
