## PHASE I ENVIRONMENTAL SITE ASSESSMENT

### 615-749 WEST EL CAMINO REAL MOUNTAIN VIEW, CALIFORNIA

Prepared For:  
**Greystar GP II, LLC**  
**San Francisco, California**

Date  
**March 2020**

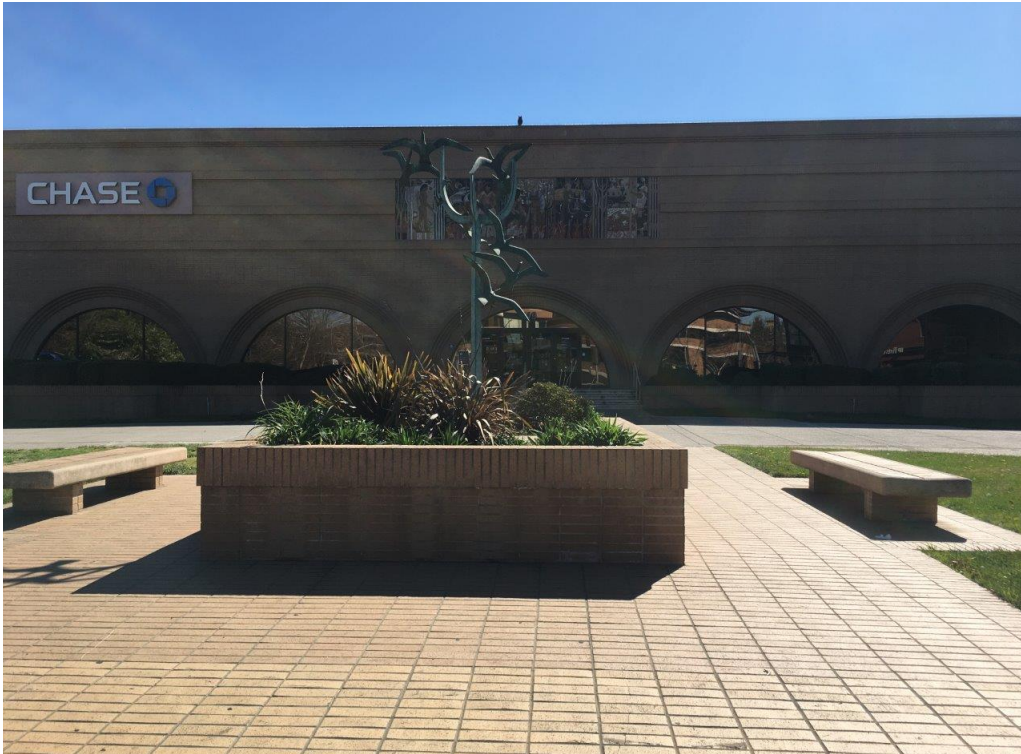
Photo 1: View of the bank from the northwestern corner of the site at the intersection of West El Camino Real and Castro Street.

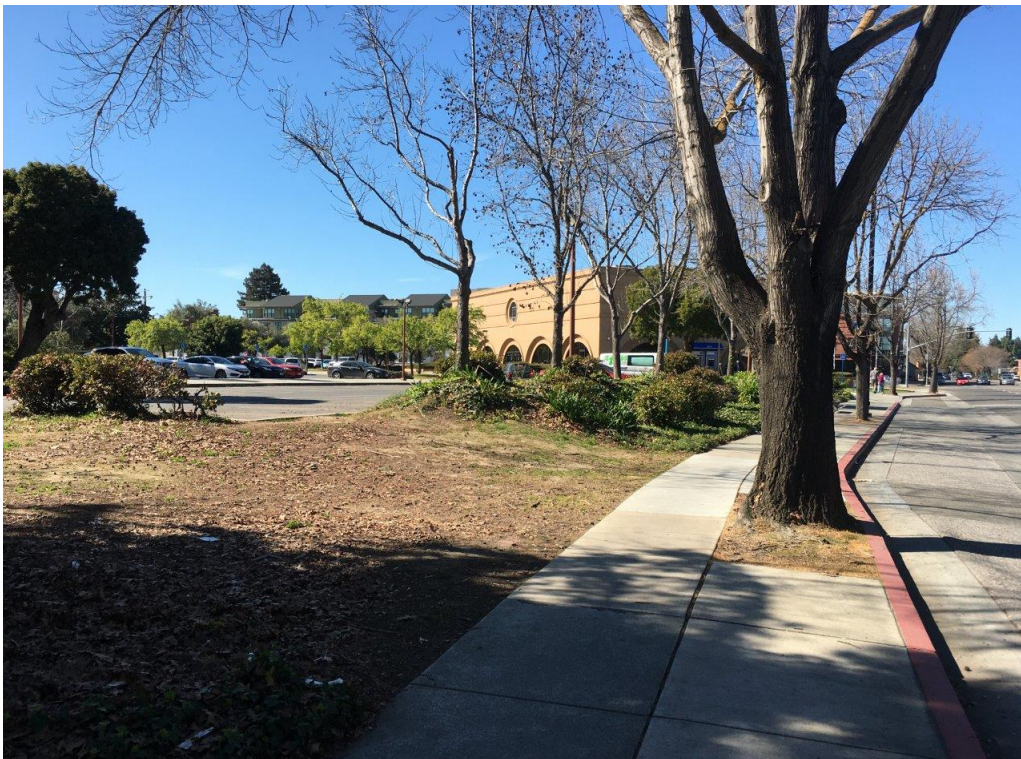
Photo 2: View of Chase Bank, landscaped areas, and parking from the northeastern site boundary.

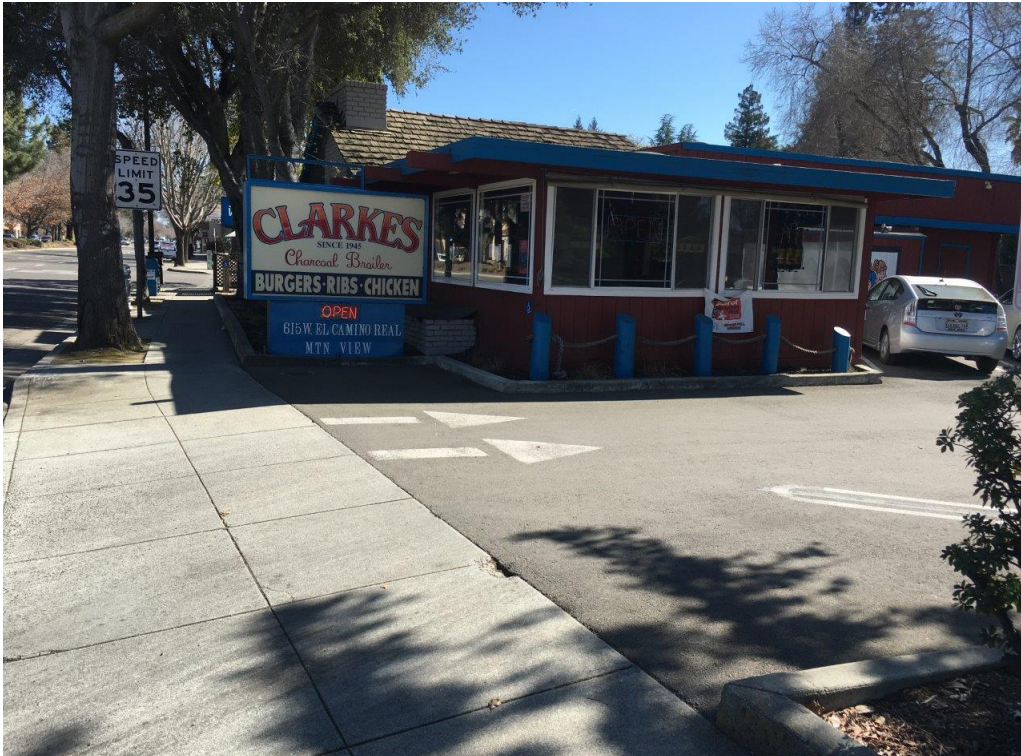
Photo 3: View of Clarke's Charcoal Broiler and driveway that provides access to Parcel 2 from West El Camino Real.

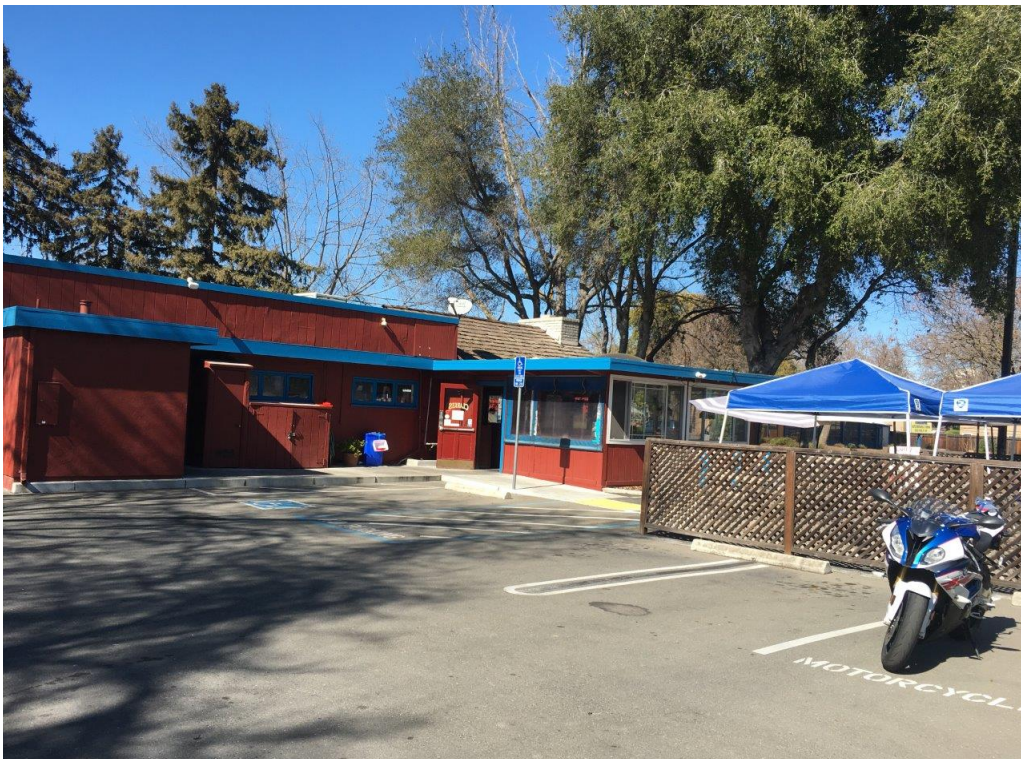
Photo 4: View of parking at Clarke's Charcoal Broiler from the southeastern site boundary.

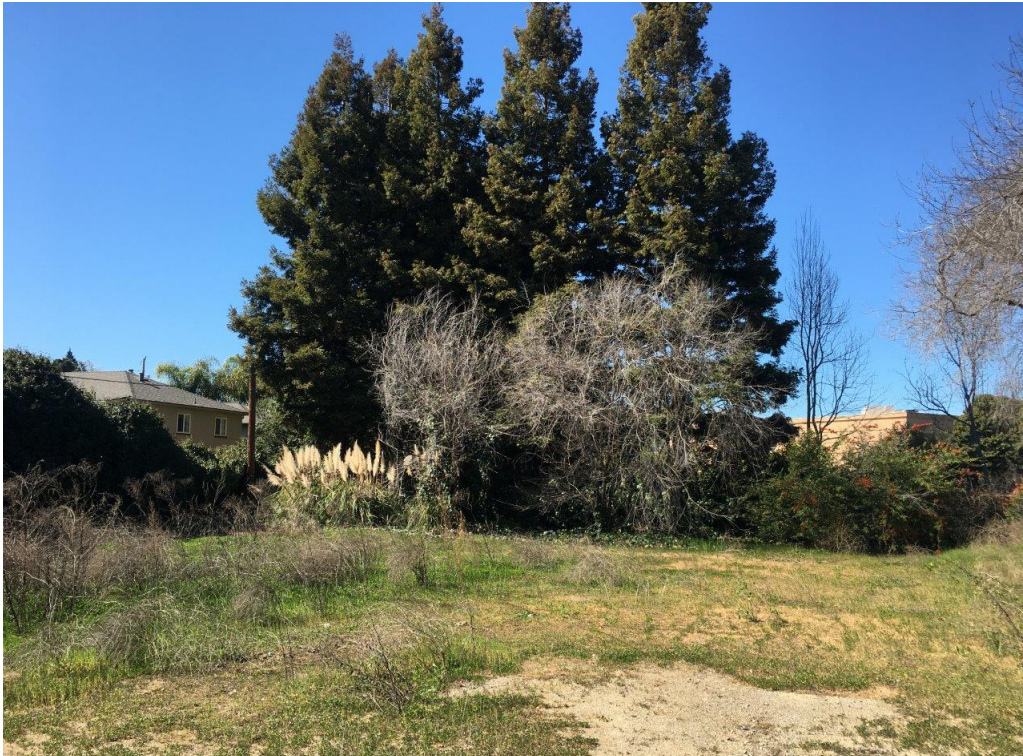
Photo 5: View of unpaved vacant lot in the southeastern portion of Parcel 2.

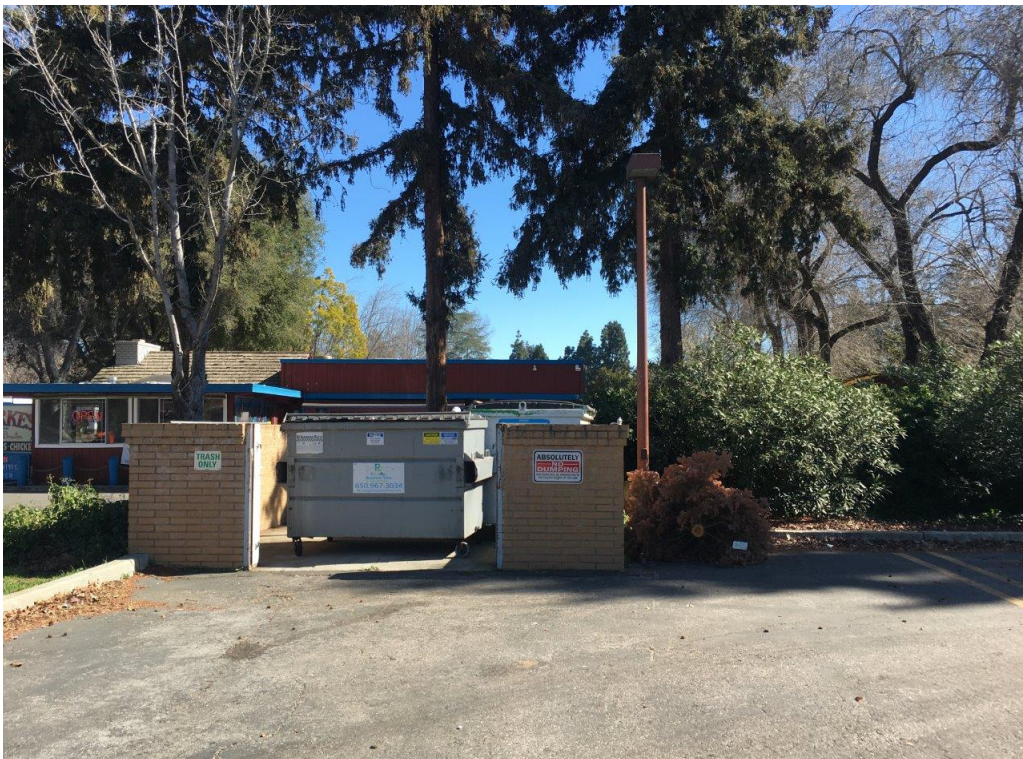
Photo 6: View of general trash and recycling collection area in the paved parking lot southeast of Chase Bank.

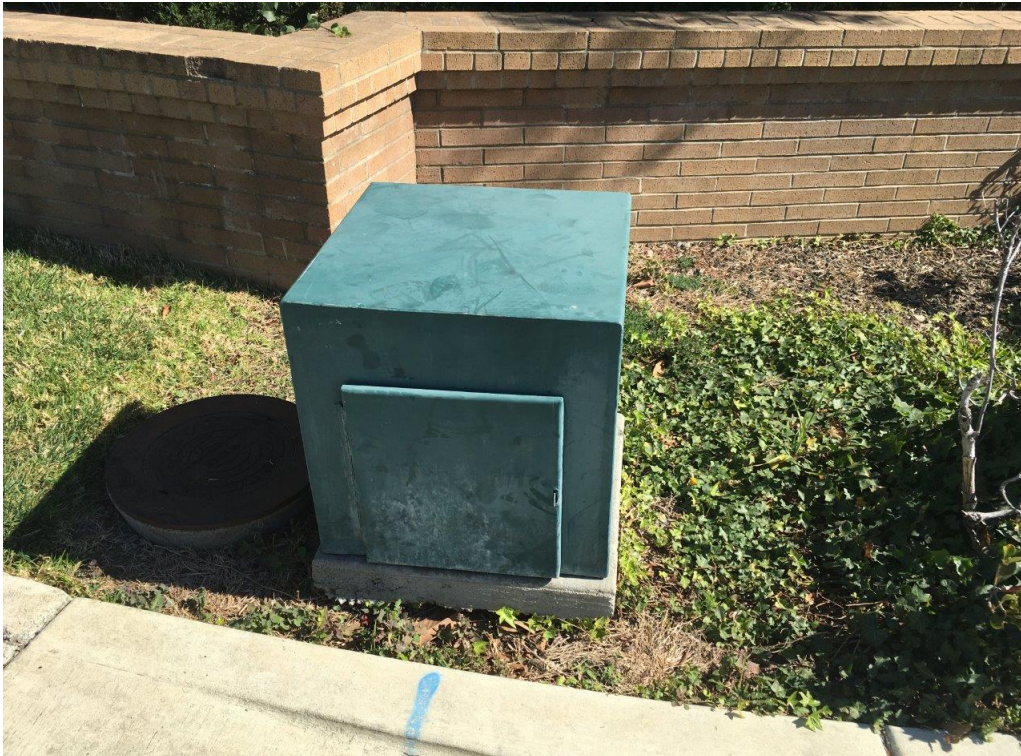
Two pad-mounted transformers are present near the southwestern site boundary. The units were not labeled as to their PCB content. Ramboll saw no indication of leaks or releases from electrical equipment observed during the site visit. Because the installation date of the units is unknown and may predate the 1979 federal ban on the manufacture of PCBs, it is possible that the transformer oils contain PCBs.

Photo 7: View of an unlabeled pad-mounted transformer along the northwestern site boundary.

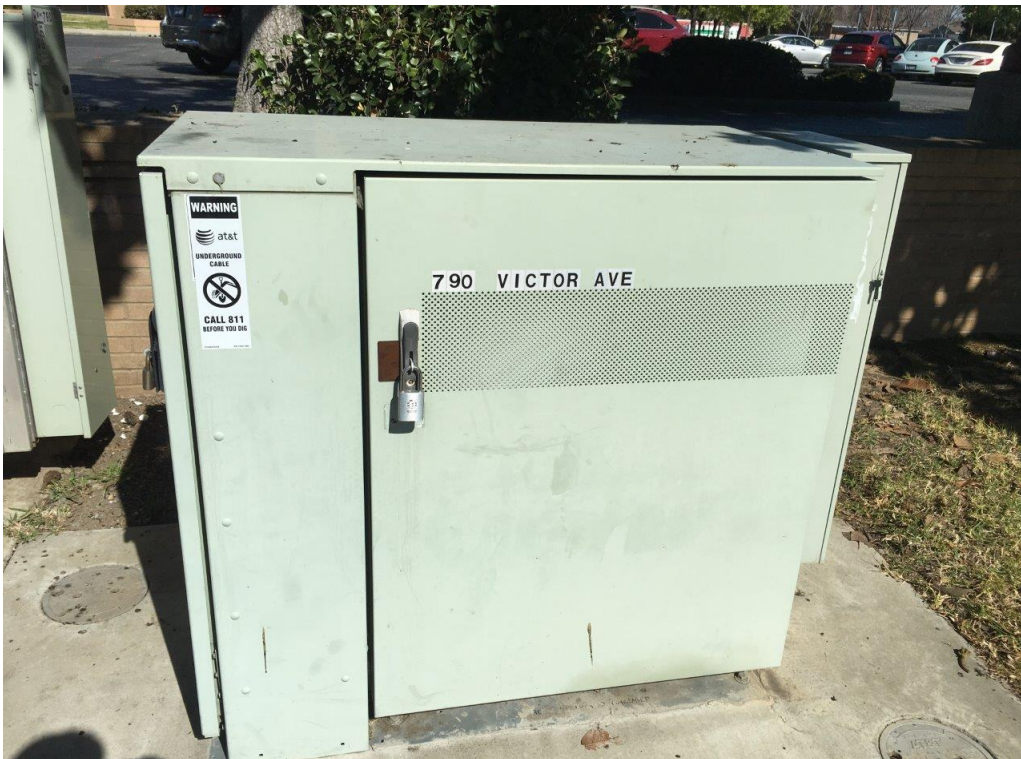
Photo 8: View of an unlabeled pad-mounted transformer along the northwestern site boundary.

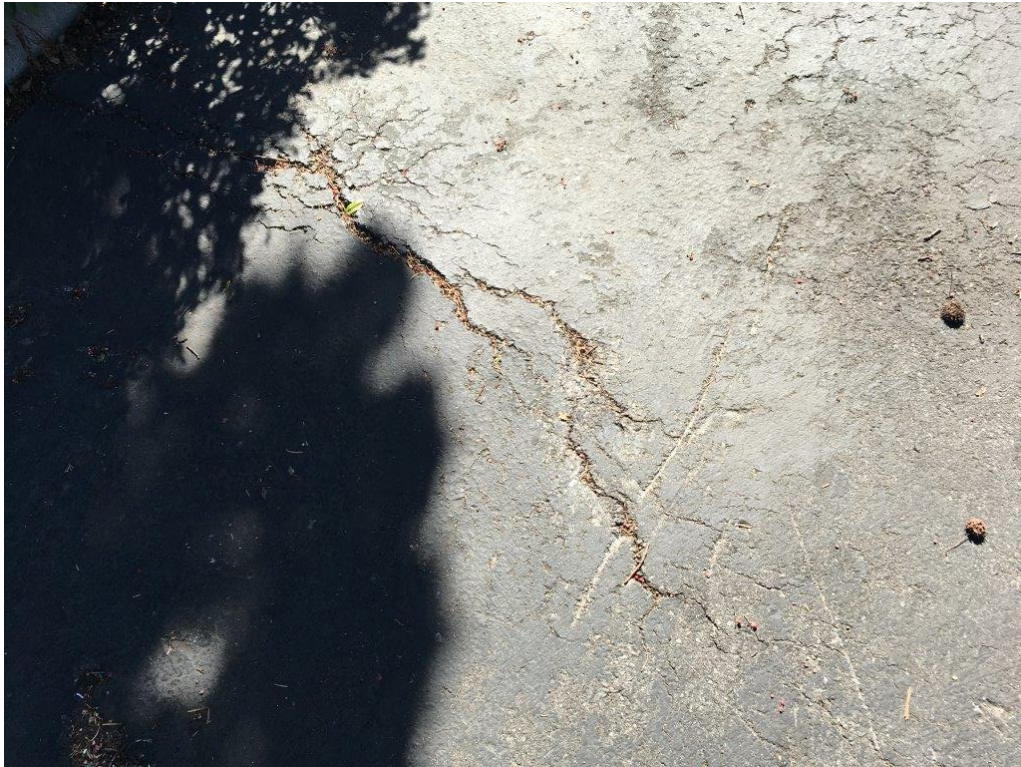
Ramboll observed evidence of minor pavement staining in the asphalt-paved parking area located in the center of the site. Pavement in the vicinity of the observed staining appeared to be in good condition, with no evidence of cracking.

Photo 9: View of minor cracks in the asphalt-paved parking area in the central portion of the site.

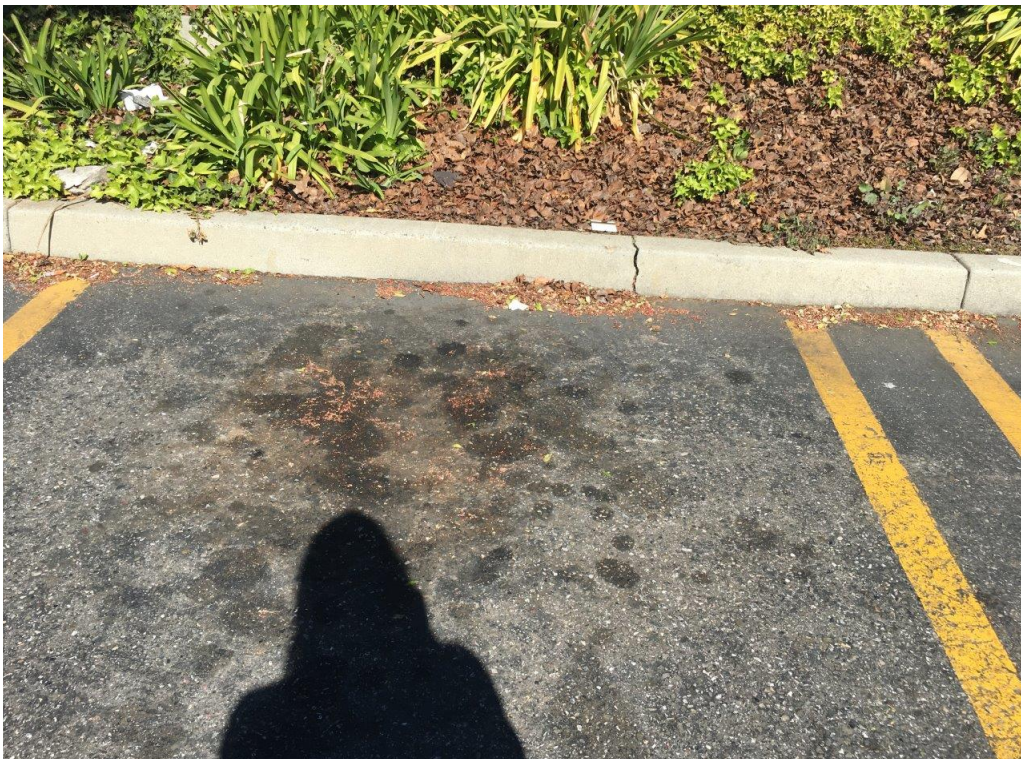
- **Pavement Staining.** Ramboll observed multiple areas of exterior pavement where oil stains were apparent. The stains were limited in areal extent, the underlying pavement/flooring appeared to be intact, except for small cracks in the paved asphalt, and no stains appeared to reach floor drains or storm water drains. As such, Ramboll considers this matter to represent a *de minimis* condition.

Photo 10: View of oil staining present in the paved parking areas.

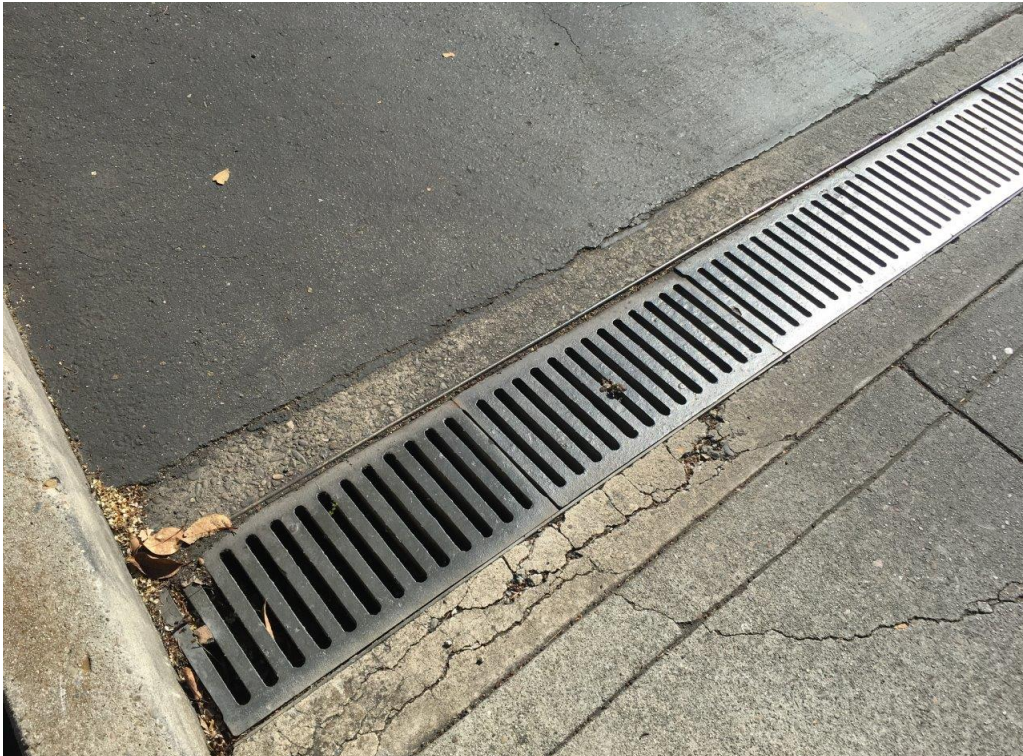
Photo 11: View of storm drain at the driveway that provides access from Castro Street.

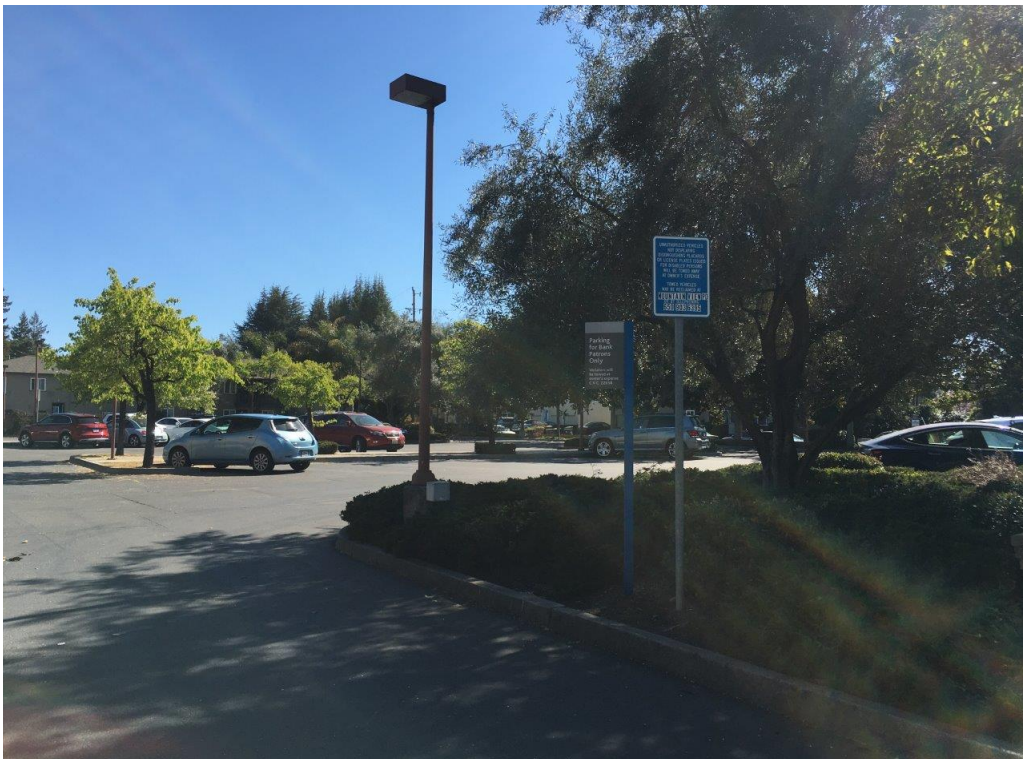
Photo 12: View of the paved parking area from the driveway off of Castro Street.
