## Preliminary Arborist Report

Bellarmino College Preparatory  
960 W. Hedding Street  
San Jose, CA

Kier & Wright  
3350 Scott Boulevard, Building 22  
Santa Clara, CA

**August 30, 2022**

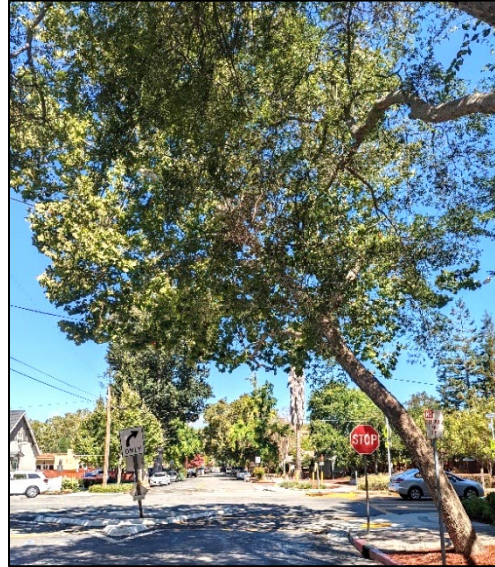
Fifty-two (52) London plane trees were growing in parking lots on the northwest side of the project area. Ninety percent (47 trees) were in good condition, with five in fair condition. Trunk diameters ranged from 5 to 21 inches, with an average diameter of 10 inches. The majority of the London planes had good structure and full, healthy crowns. Fifteen (15) had minor to moderate twig dieback or sparse crowns. London plane #119 was leaning heavily over the roadway (Photo 1).

**Photo 1.** The entire crown of London plane #119 was over the roadway due to a heavy lean.

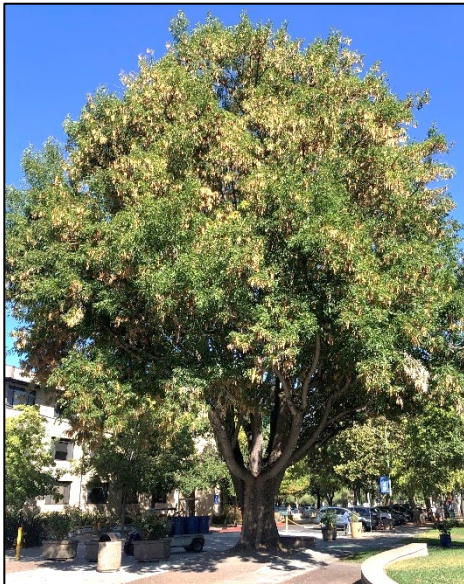
**Photo 3.** Evergreen ash #57 was the largest and healthiest ash with a diameter of 51 inches and a full crown.

Eight evergreen ash were in fair condition, and one was in good condition. Trunk diameters ranged widely from 6 to 51 inches, with an average diameter of 24 inches. Evergreen ash #57 was both the largest (51 inch diameter) and the only ash in good condition. The tree was growing in an 8 foot square planter. It had a full, rounded crown with minor twig dieback. The ashes in fair condition had more significant twig and branch dieback throughout their sparse crowns.

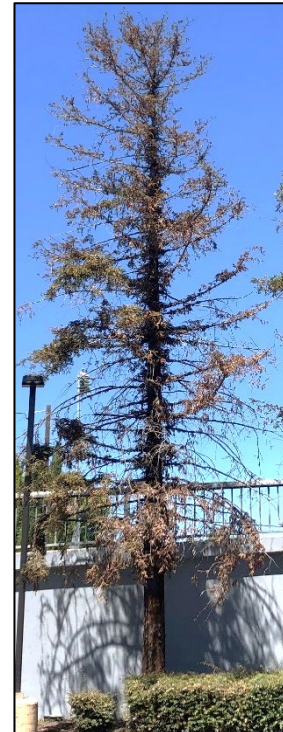
Fourteen (14) coast redwoods were growing in a parking lot fronting Hedding Street. Eleven (11) redwoods were in fair condition, and three were in poor condition. The average trunk diameter was 18 inches, and the largest tree (#172) was 24 inches. All the redwoods showed some degree of browning foliage indicative of water stress. Redwood #164 was mostly dead (Photo 2).

**Photo 2.** Redwood #164 had very little green foliage and was all but dead.

| Tree No. | Species | Trunk<br>Diameter (in.) | Protected<br>Tree? | Disposition | Comments |
|---|---|---|---|---|---|
| 164 | Coast redwood | 14 | Yes | Preserve | Poor condition |

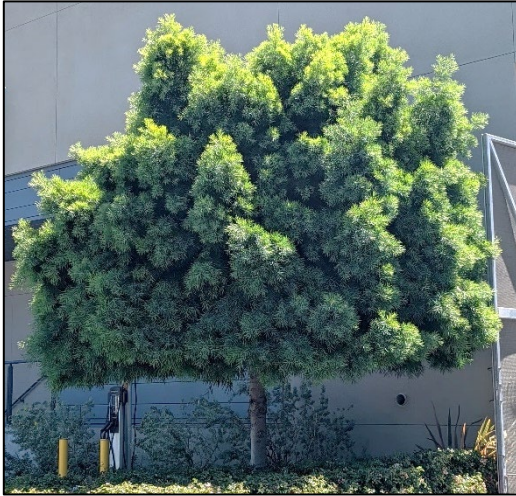
**Photo 4.** The crown of African fern-pine #185 was extremely dense.

Seven African fern-pines were in good condition. Six of the fern-pines had been planted under evergreen ash trees in a parking lot strip on the southeast side of the project area and had suppressed development. All the trees were relatively young with diameters ranging from 4 to 7 inches. African fern-pine #185 was the largest (7" diameter) and had a remarkably dense crown (Photo 4).

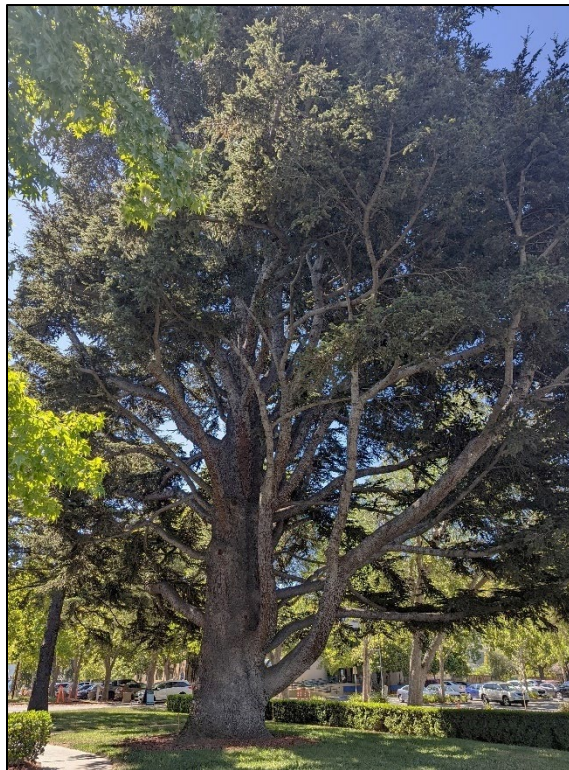
- Deodar cedars #94, 121, and 122 were in good condition. Deodar cedar #121 was the largest tree at the site with a diameter of 68 inches. The mature tree had structure typical of the species with a full crown with good color (Photo 5). Cedars #94 and 122 had trunk diameters of 29 and 29 inches, respectively.

**Photo 5.** The largest tree on site was mature deodar cedar #121 with a trunk diameter of 68 inches.

The largest tree on this site (Deodar cedar #121, 68 inch trunk diameter) is planned for preservation. The plans show a driveway being installed approximately 18 feet from the base of the tree. The area that the driveway will be installed is currently a well-irrigated lawn. There is a high likelihood that roots will be found in that area during grading operations. Due to the size and importance of this tree, special care should be taken to give as much space for this tree as possible and to minimize the amount of root loss during construction.
