**Re: Arborist Report – The Annadale Development, Sacramento, CA**

## THE ANNADALE DEVELOPMENT

## ATTACHMENT 'B' - TREE LOCATION PLAN

APN: 255-0032-005  
3816 ANNADALE LANE, SACRAMENTO, CA

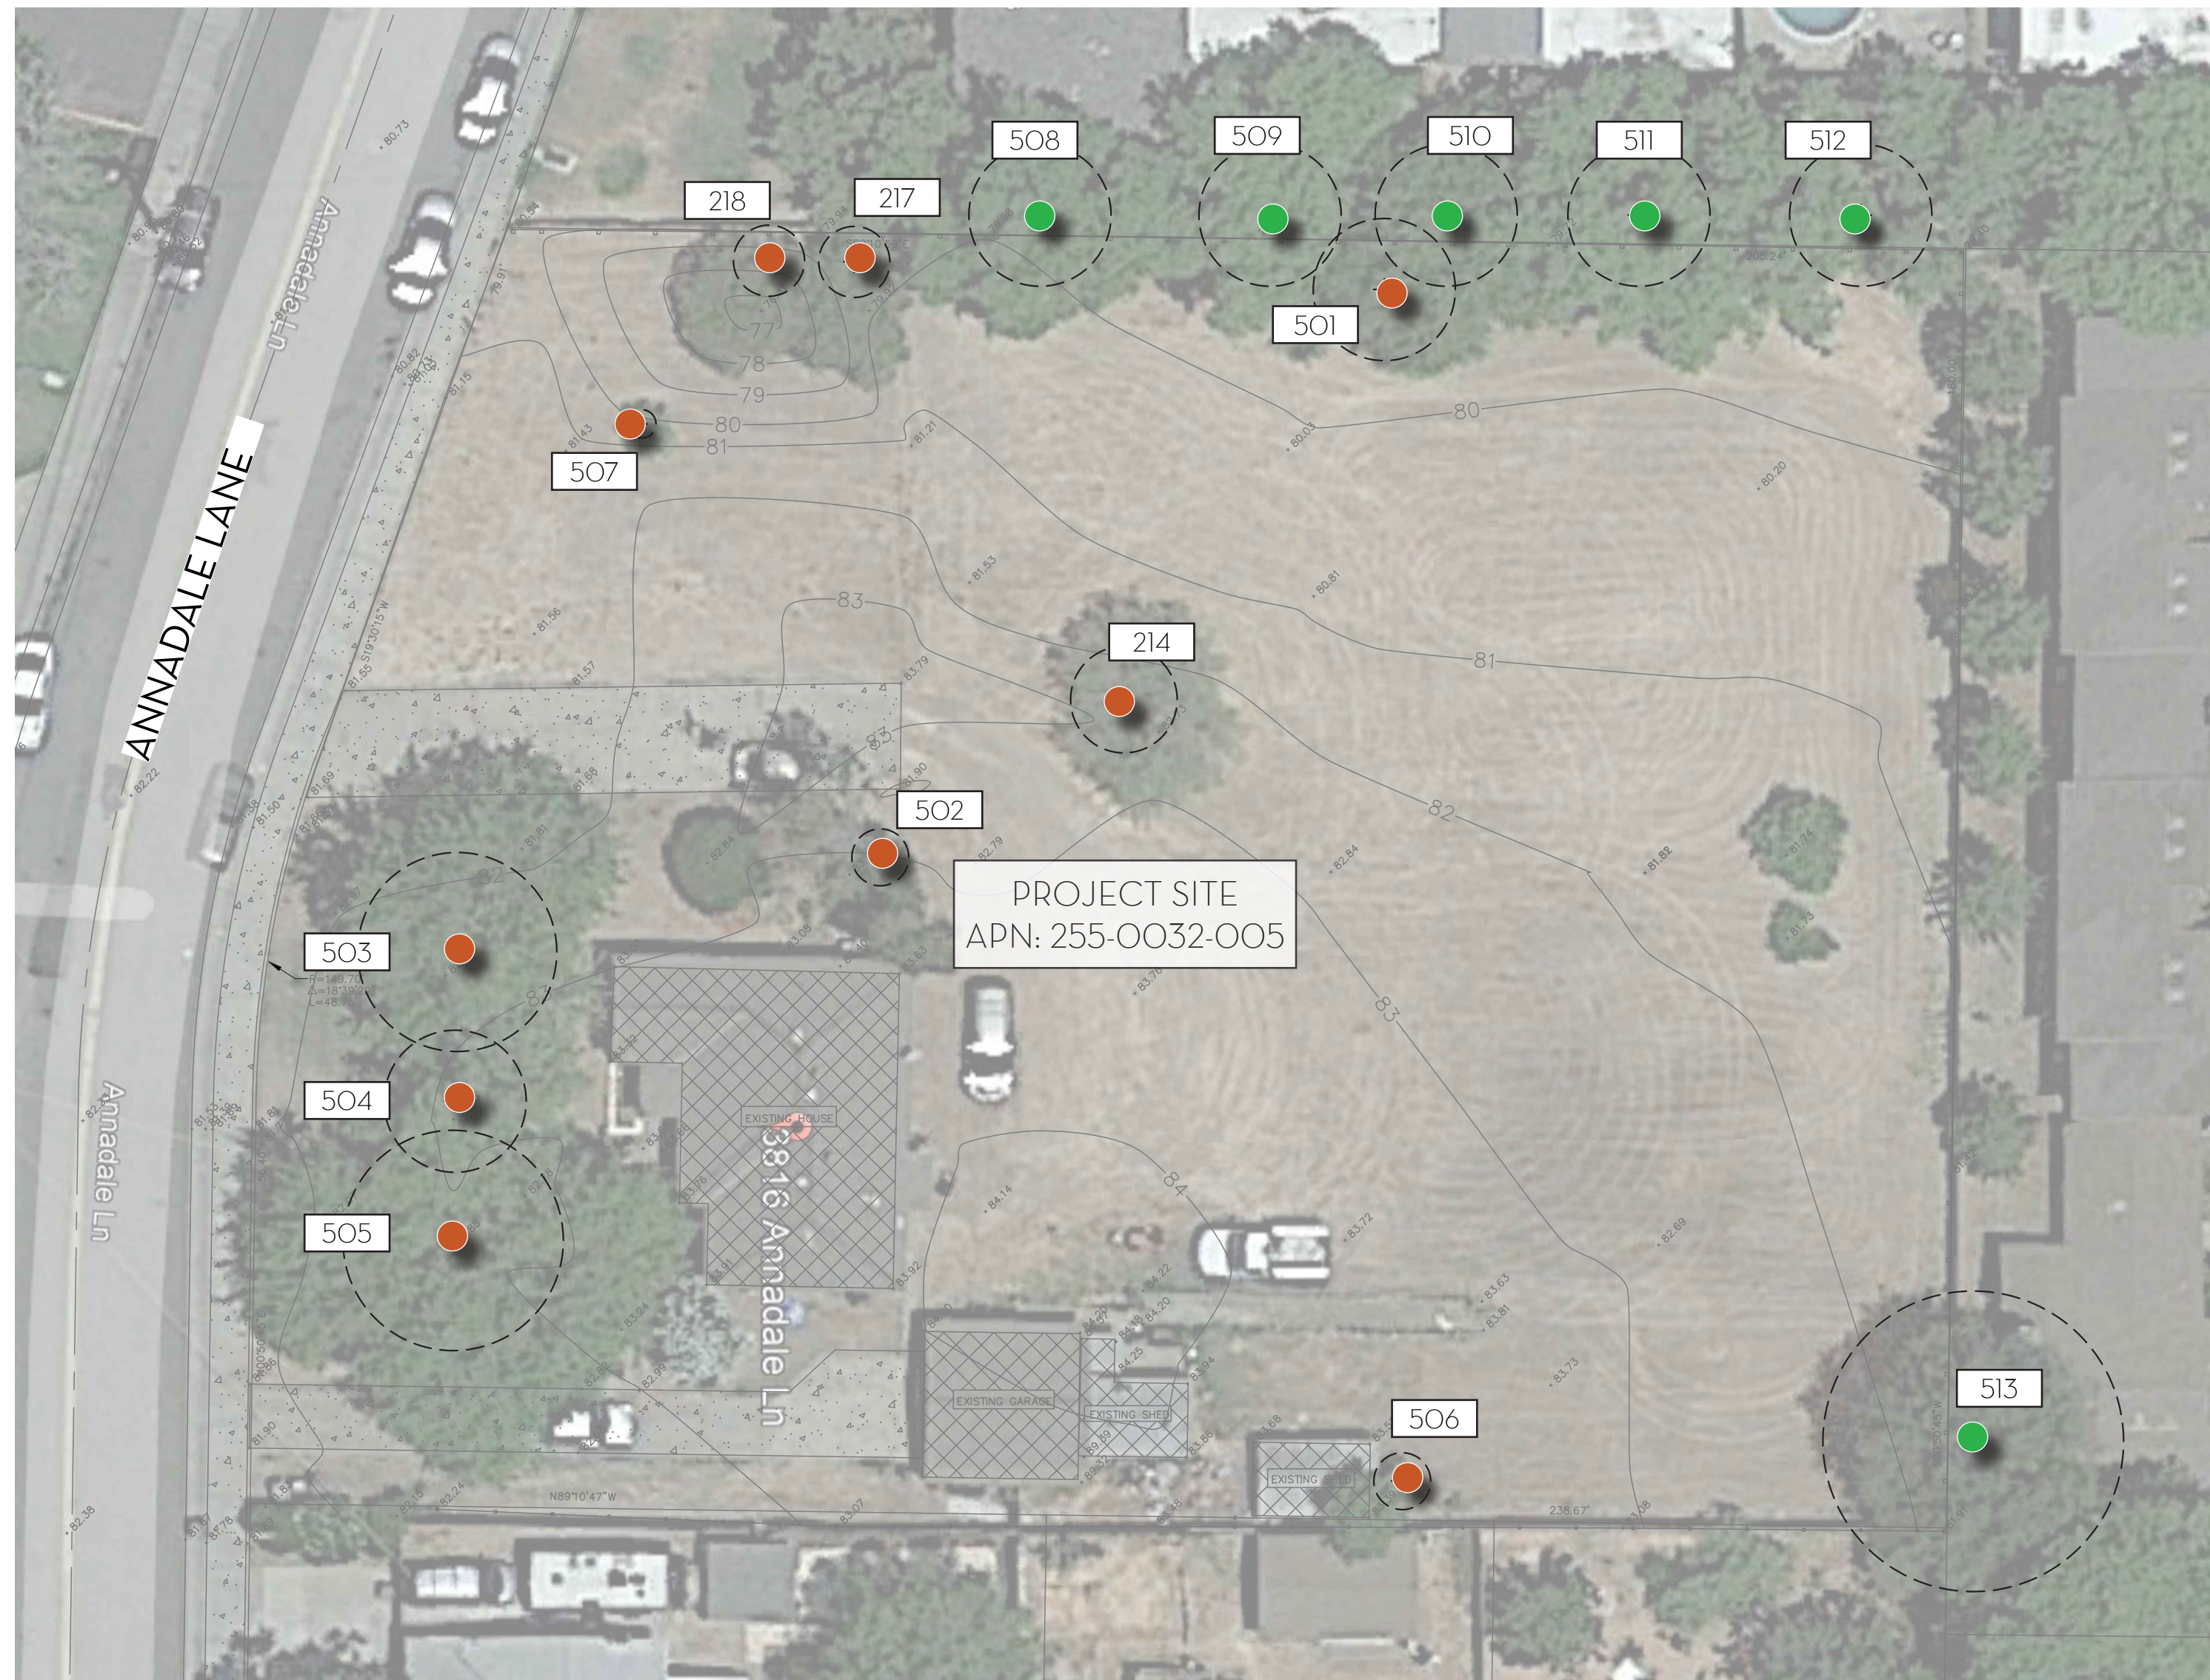
The Preliminary Site Plan proposes removing 10 of the 16 inventoried trees. All the trees proposed to be removed are growing within the project site. On-site trees inventoried were not identified as native or considered landmark/heritage trees. Only 1 of the off-site trees (#513 - *Quercus wislizenii*) that overhangs the project site is considered native and a heritage tree. Complete results of the assessment can be found in the attached [Tree Inventory & Evaluation Table](#).

The remaining 6 trees observed are growing off-site but overhang the site and may be impacted by construction activities. The 6 trees consist of 5 white ash trees and 1 interior live oak. The ash trees and oak tree driplines extend into the project site by several feet. The oak was observed to have a DSH at >19" which qualifies it as a heritage tree according to Sacramento County Code. The dripline of the live oak extends into the project site along the southeastern property line by several feet.

Tree protection fencing shall be shown on the construction drawings. Tree protection fencing shall be erected around the TPZ of the off-site trees before any site work begins. Fencing should be sturdily placed atop open soil under the dripline of the trees overhanging the project site. Tree protection fencing should be clearly marked with signs stating that the area within is a Tree Protection Zone and no one is allowed to access the area without prior authorization. If construction activities cannot be kept outside of the TPZ, before to construction, apply a 4" layer of wood chip mulch over the soil and place 3/4" min. thickness plywood over the mulch to reduce soil compaction.
