# **APPENDIX 4.1-C ARBORIST REPORT**

November 1, 2022

RE: Kortum Canyon Arborist Report

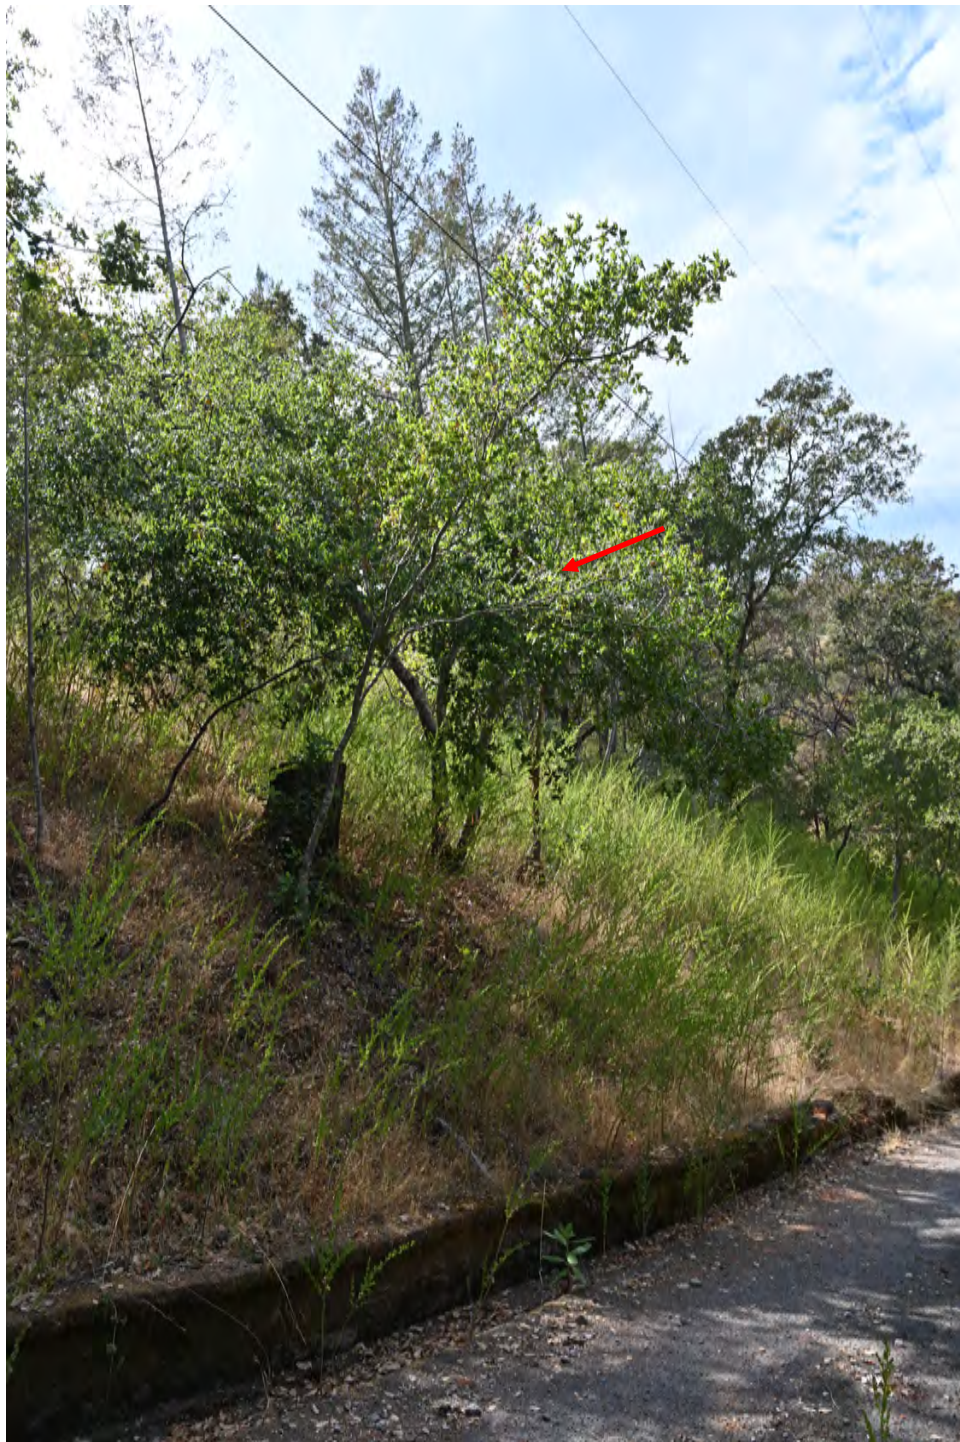
Tree #1, a coast live oak located in future road turnout. Located below electrical distribution lines and subject to clearance pruning.

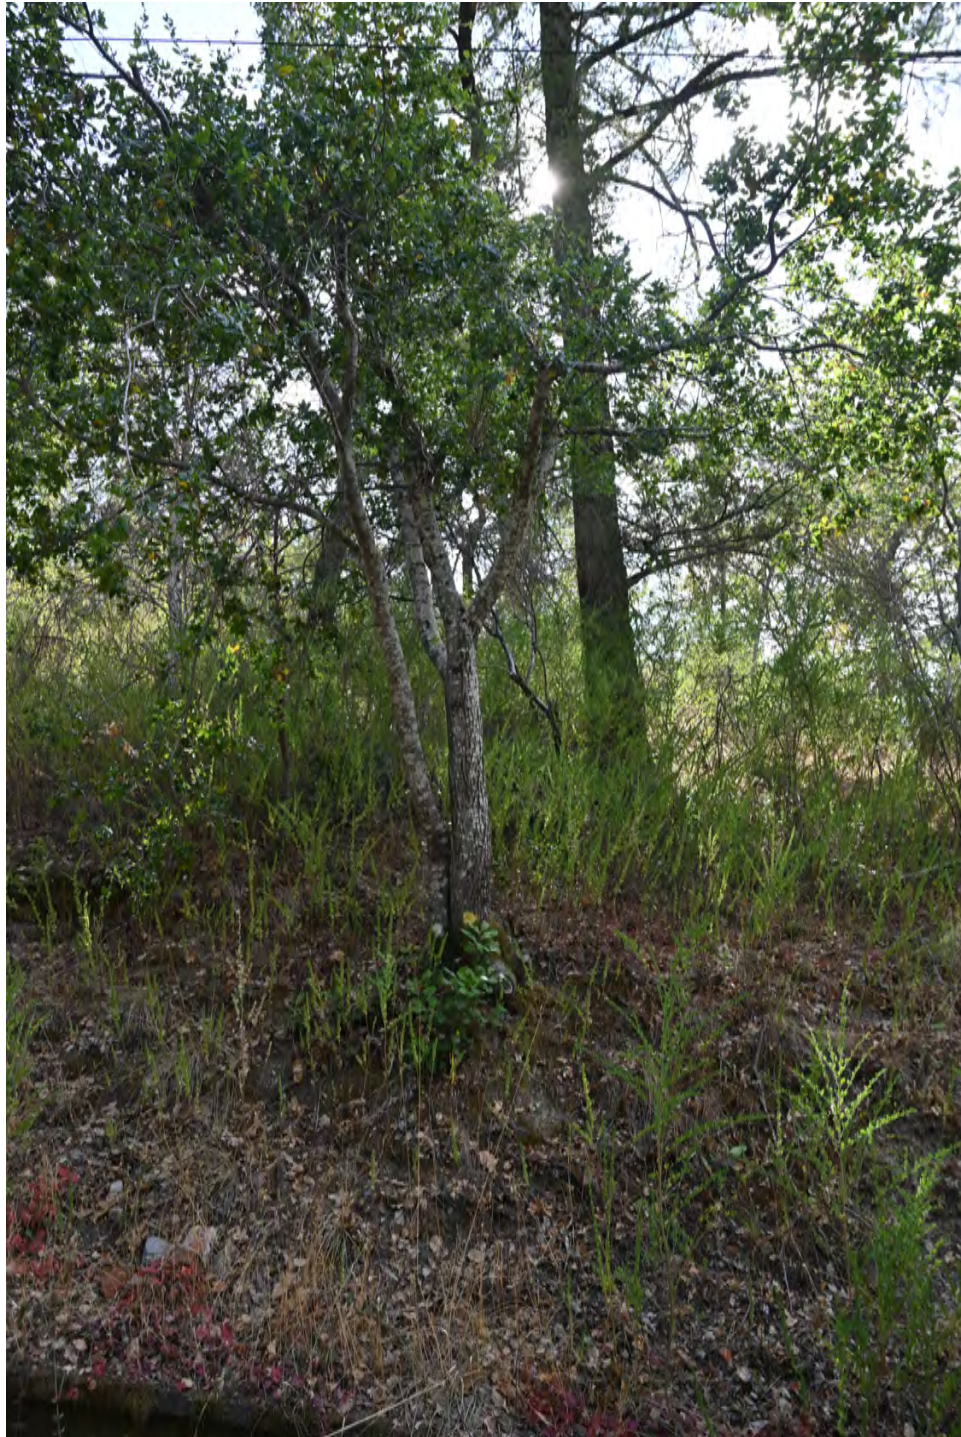
Tree #2, a coast live oak located in future road turnout. Located below electrical distribution lines and subject to clearance pruning.

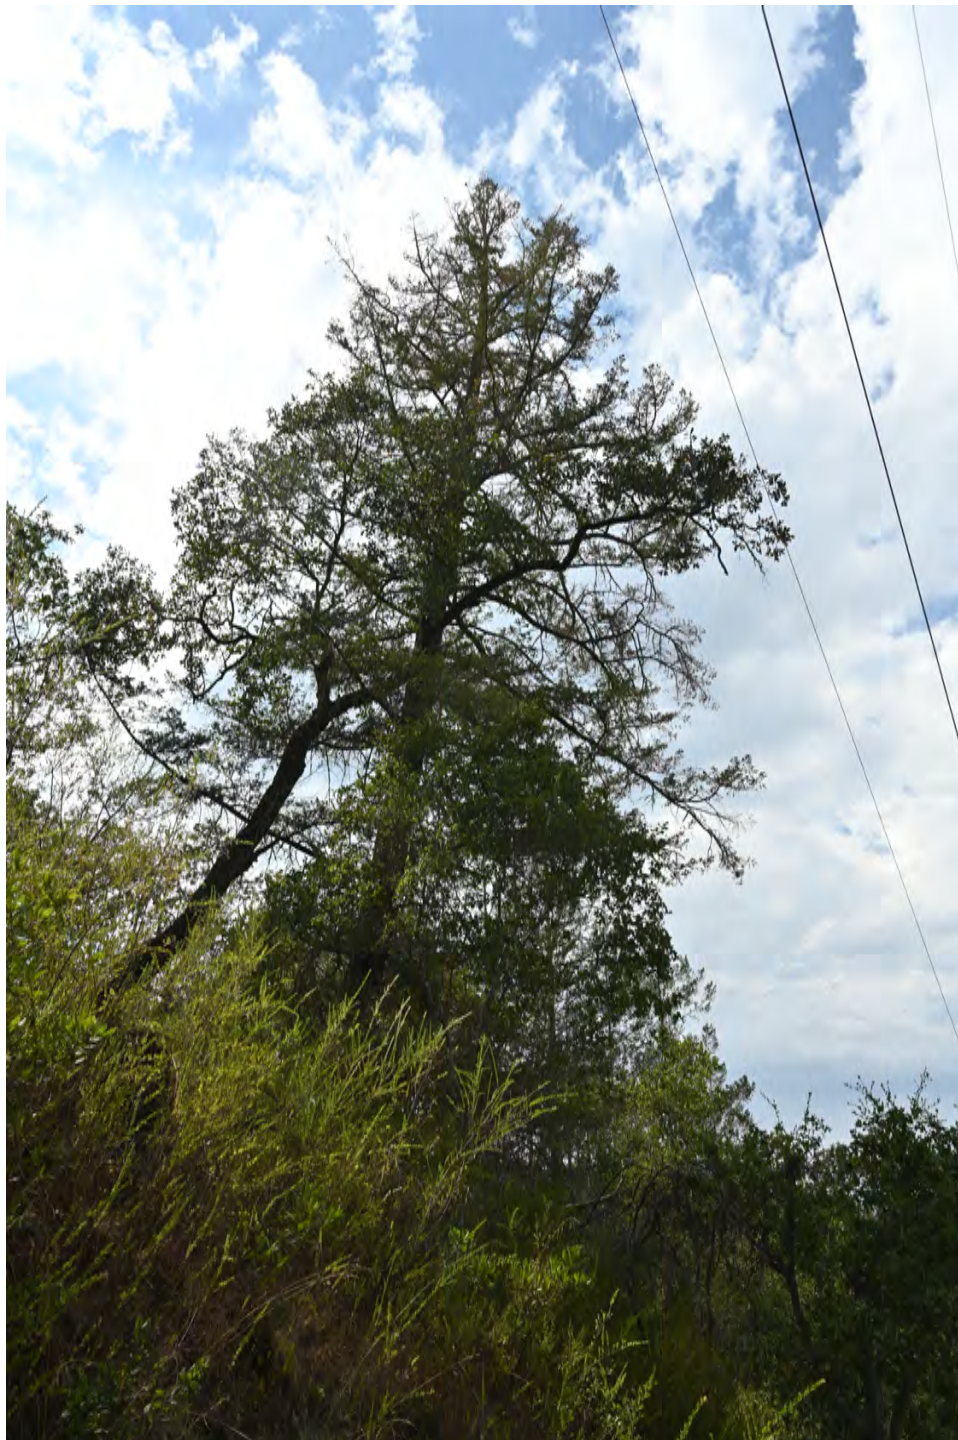
Tree #3, a Douglas fir, is in decline from boring insect attack. The tree is likely located in grading limits for road turnout.

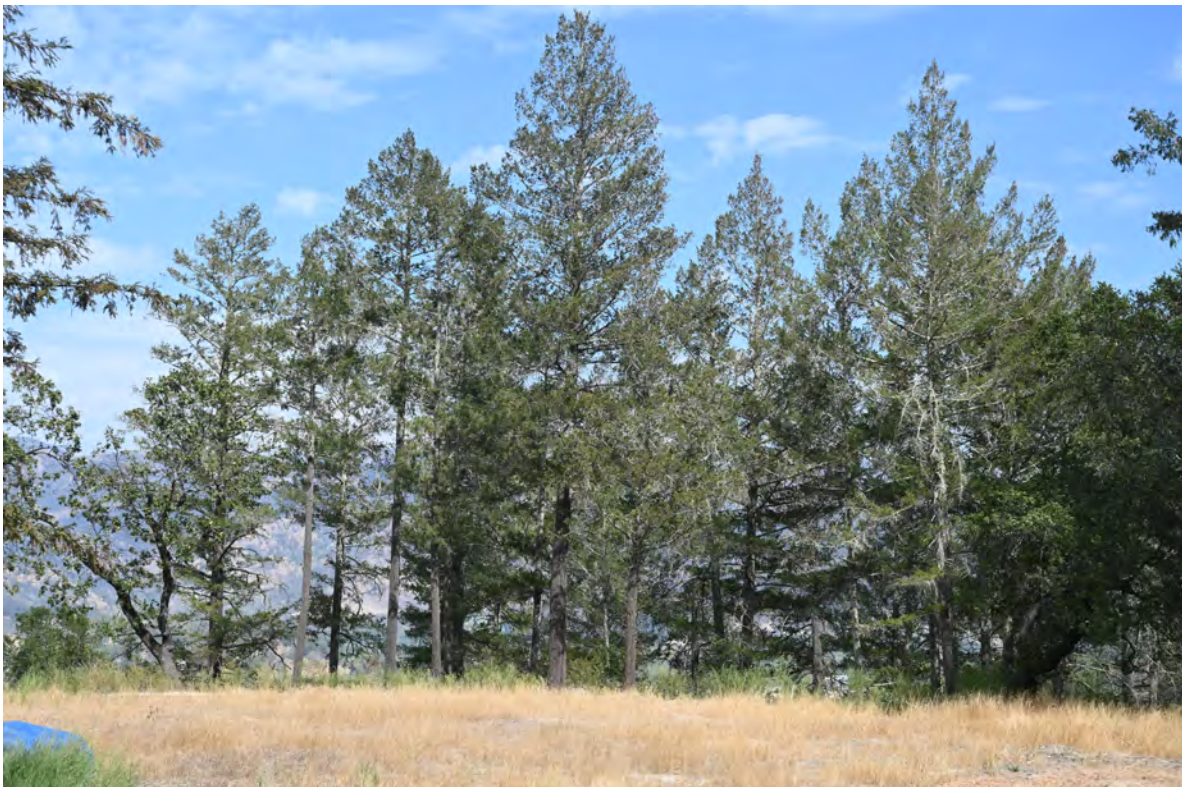
View of trees located in roadway realignment grading limits. Sixteen trees will require removal. The Douglas firs are in marginal health due to drought and boring insect attacks (flatheaded fir borer).

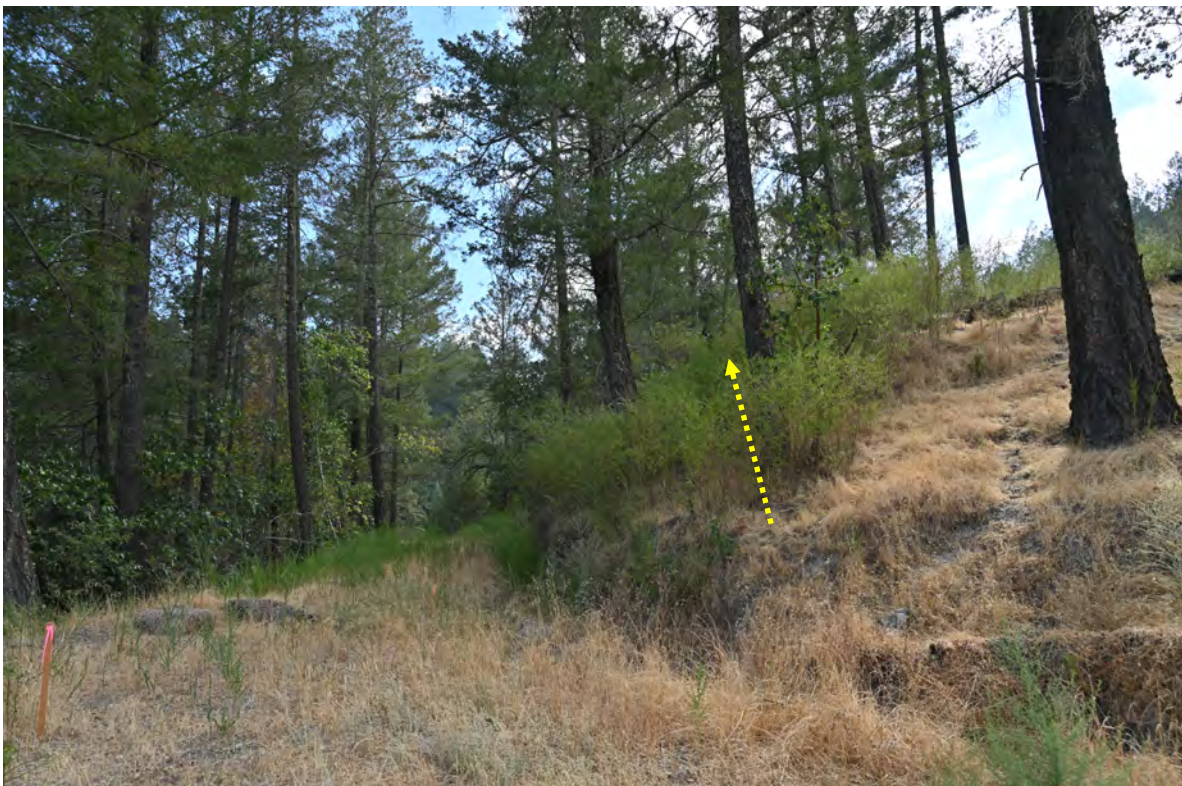
View to the south with the arrow indicating approximate roadway grading limits extending upslope and impacting 16 trees (3 oaks and 13 Douglas fir). (GPS waypoint 002.)

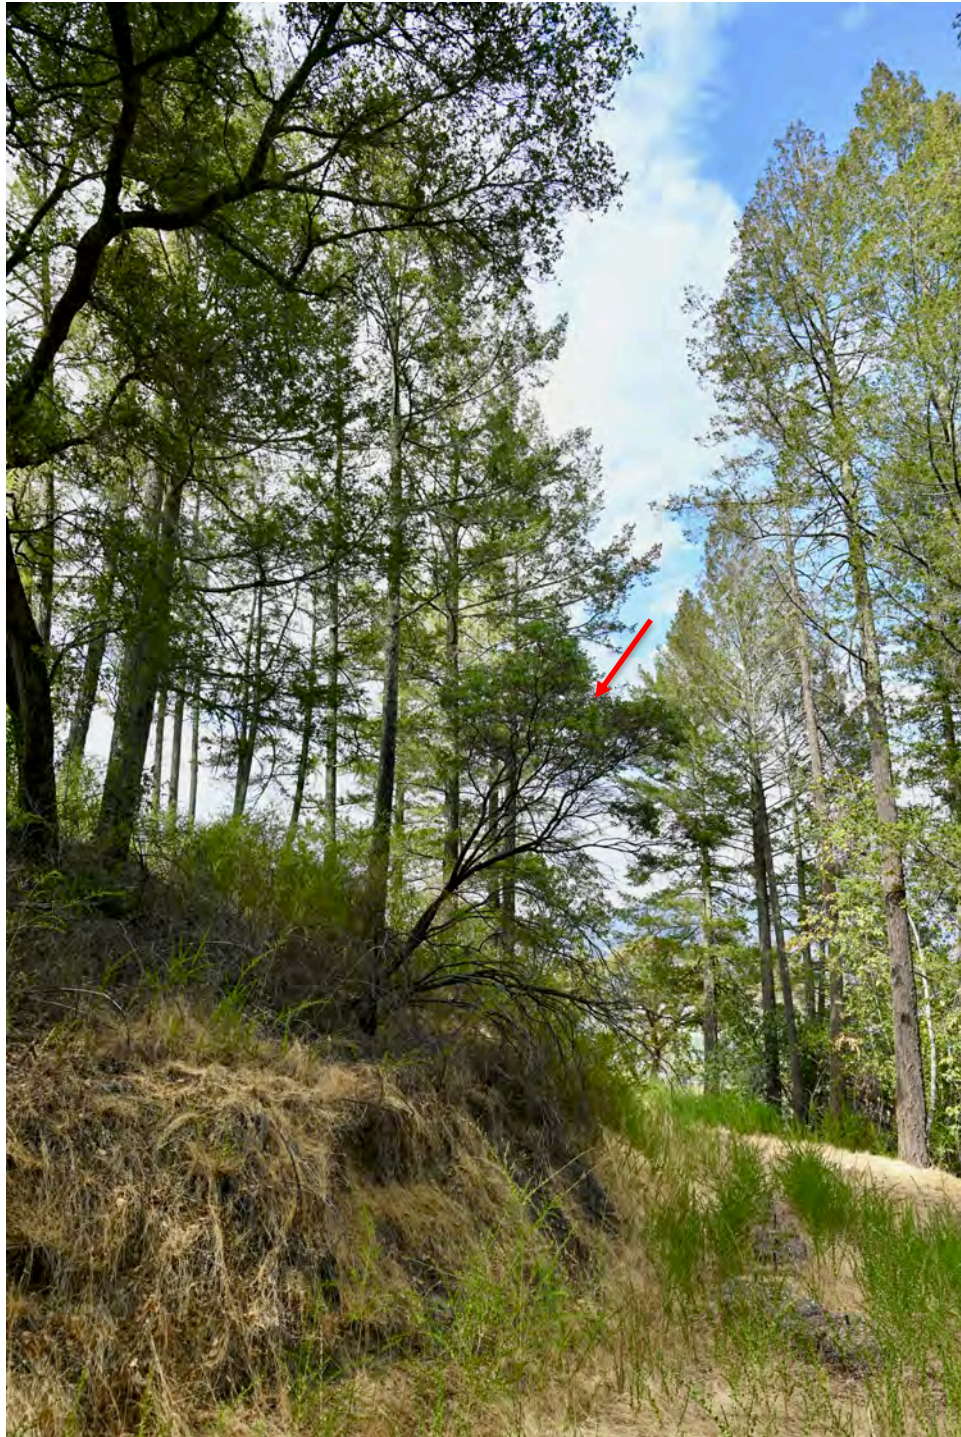
View from the north with the arrow indicating tree #9, a small coast live oak growing on the cut slope and within the grading limits. Also, the thinning crowns of the Douglas fir are evident.

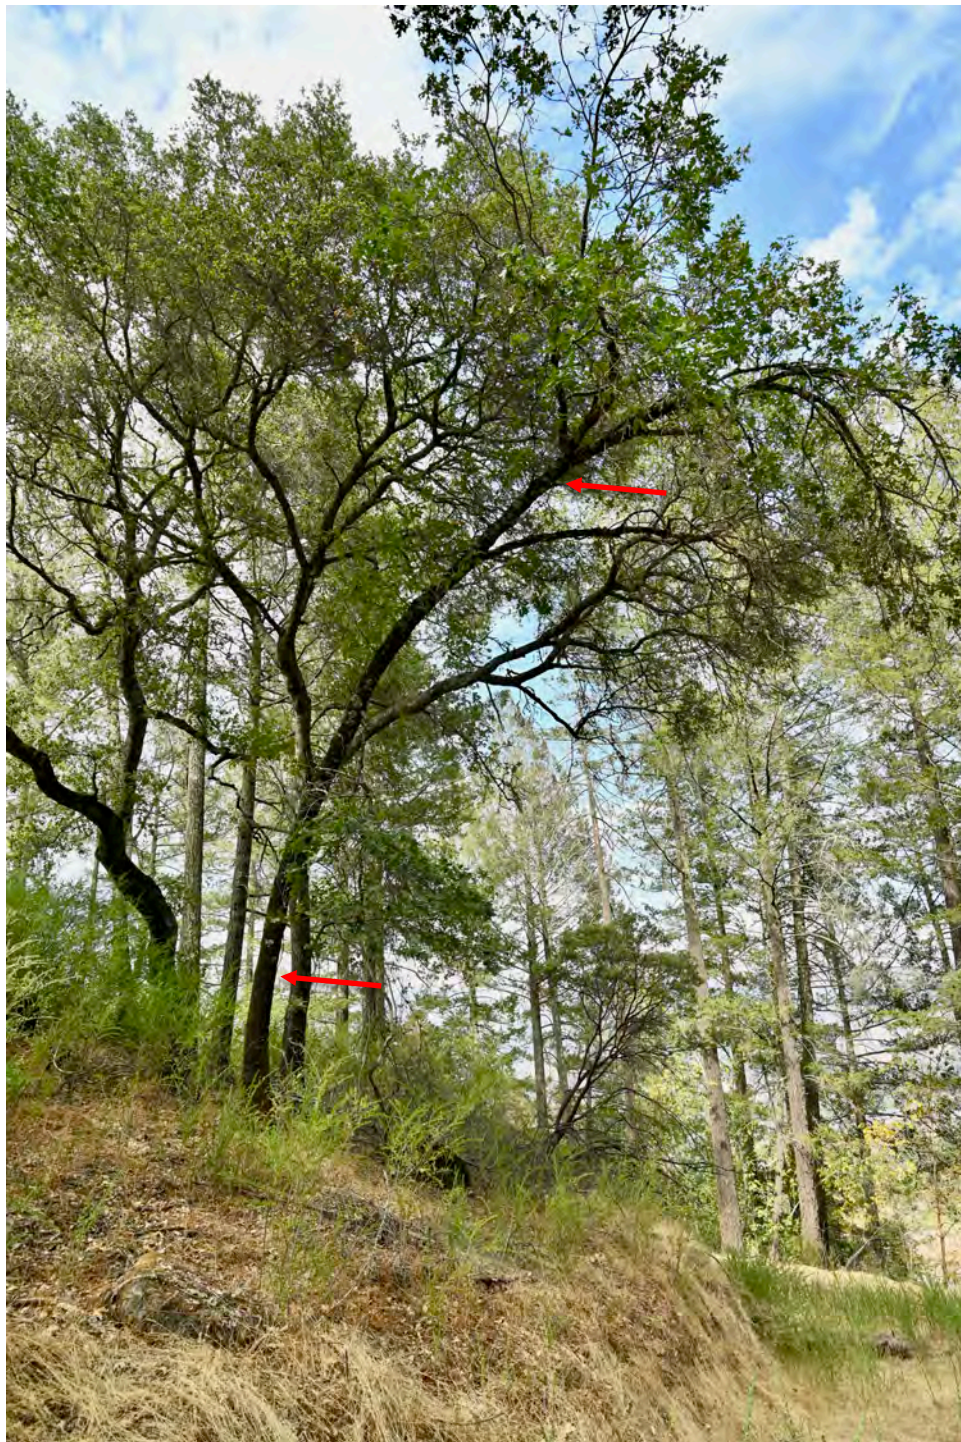
The red arrows indicate the bowed form of tree #12, a black oak. The tree is near the edge of the proposed grading limits and may require removal.

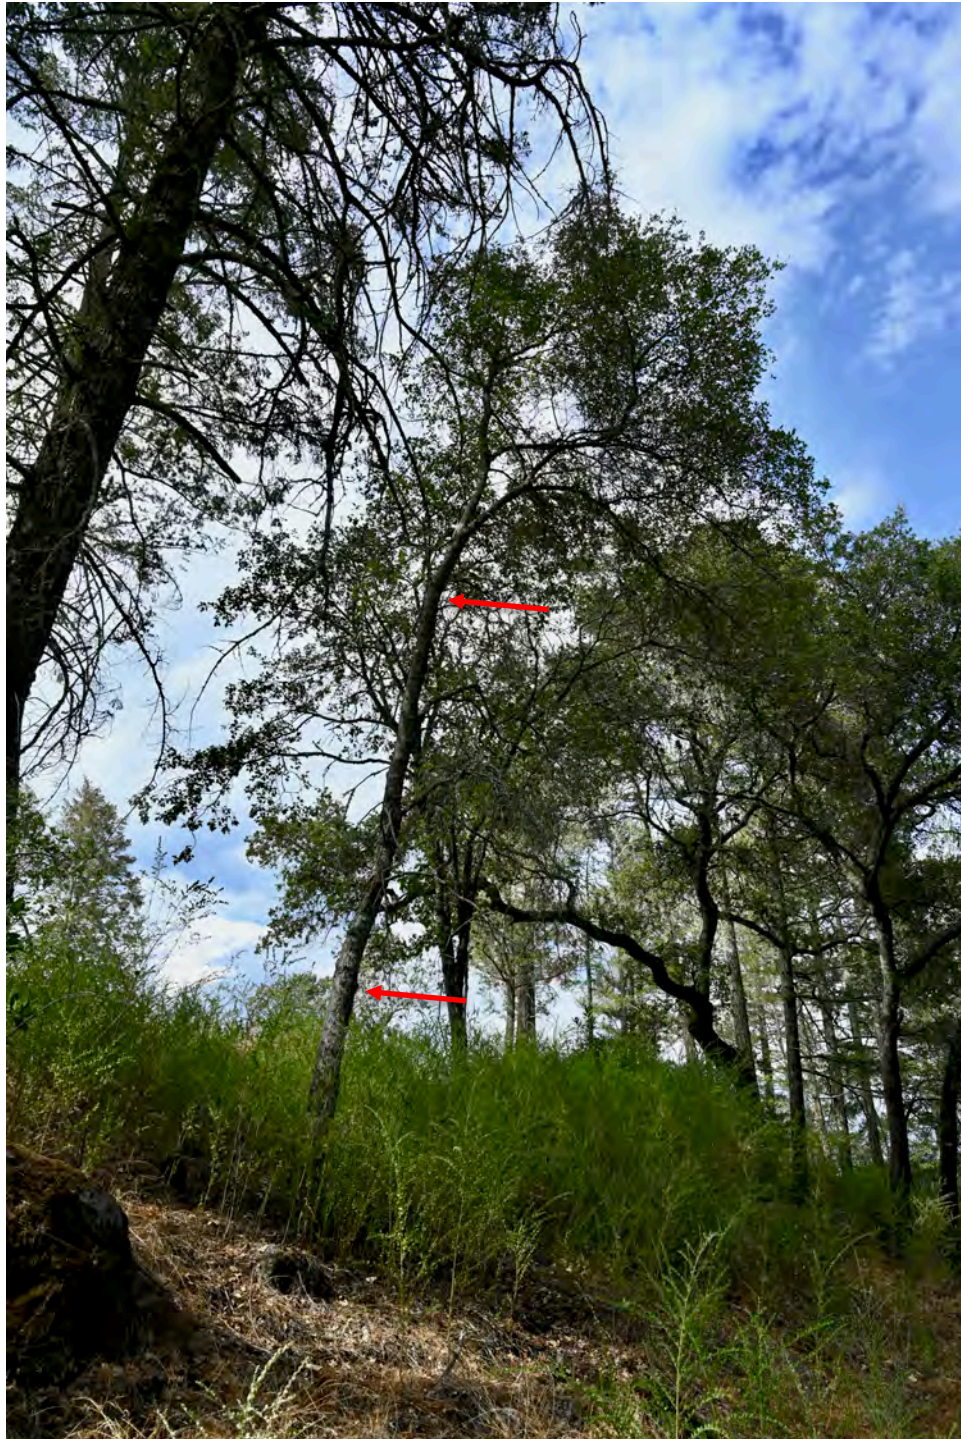
Tree #13, a coast live oak likely located in the road grading limits.

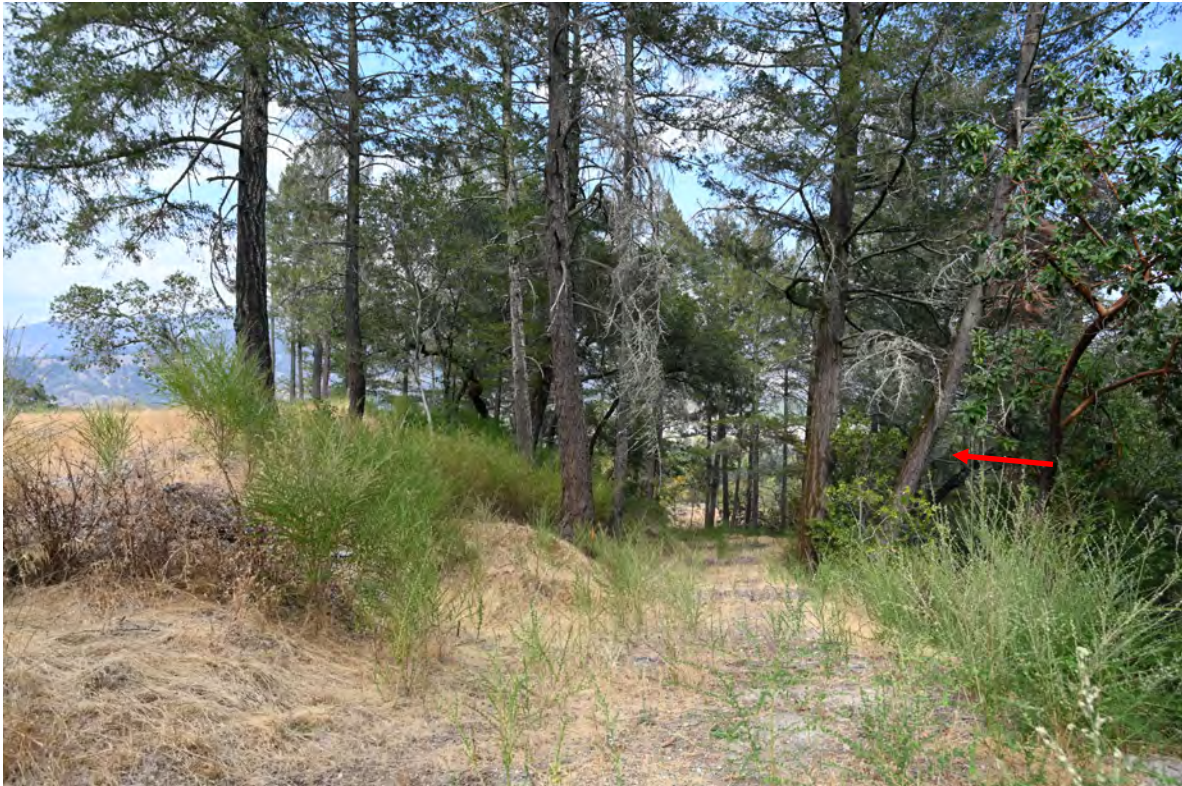
The south end of the roadway grading limits the area with trees #14 through #19. Trees #18 and #19 are on the left (arrow). Significant areas of the invasive French broom are present.

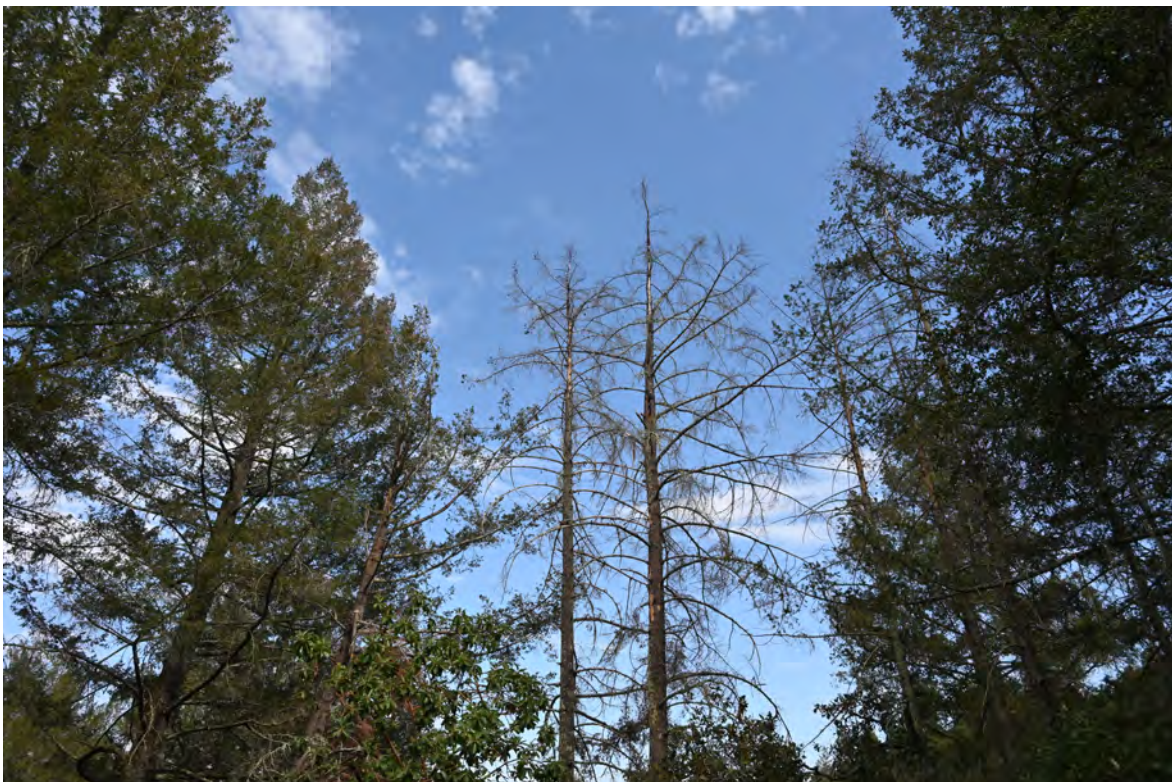
Numerous Douglas firs are either dead or in decline in this area from the FFB.

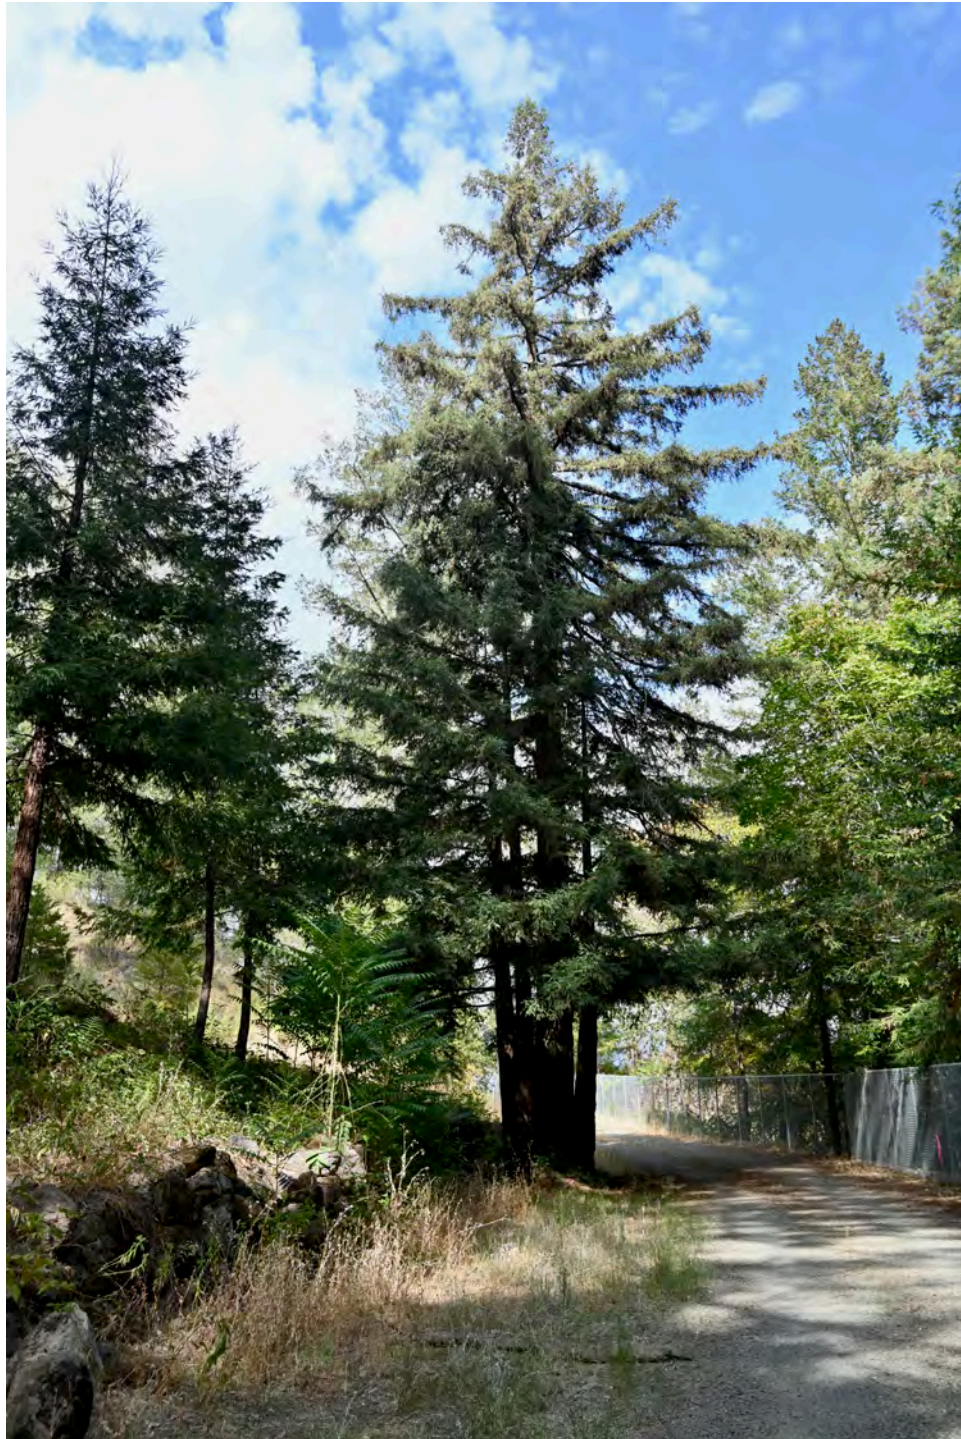
Tree #20, a coast redwood, is located in the road grading limits (GPS waypoint 003). Depending on the required minimum road width for fire equipment, efforts will be made to retain the tree.

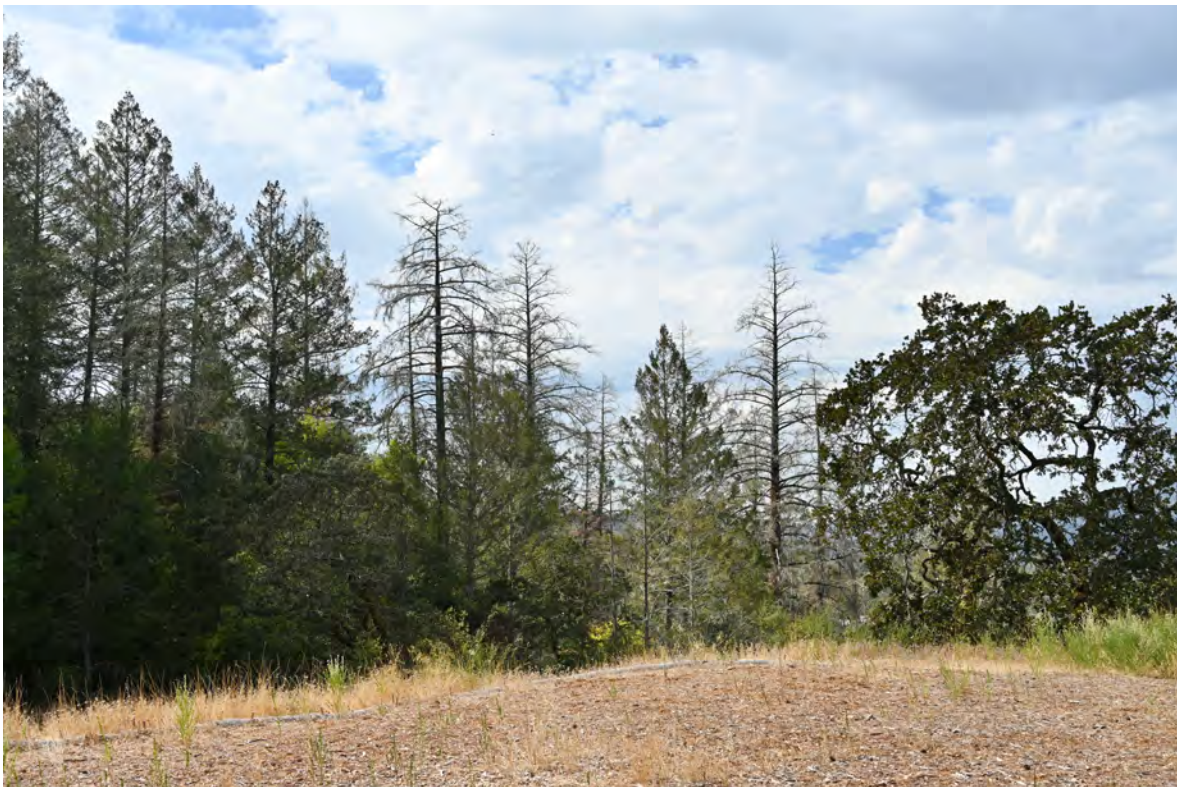
View to the northwest from the central portion of the property. The dead firs tend to be in clusters because of the method of infestation from FFB.

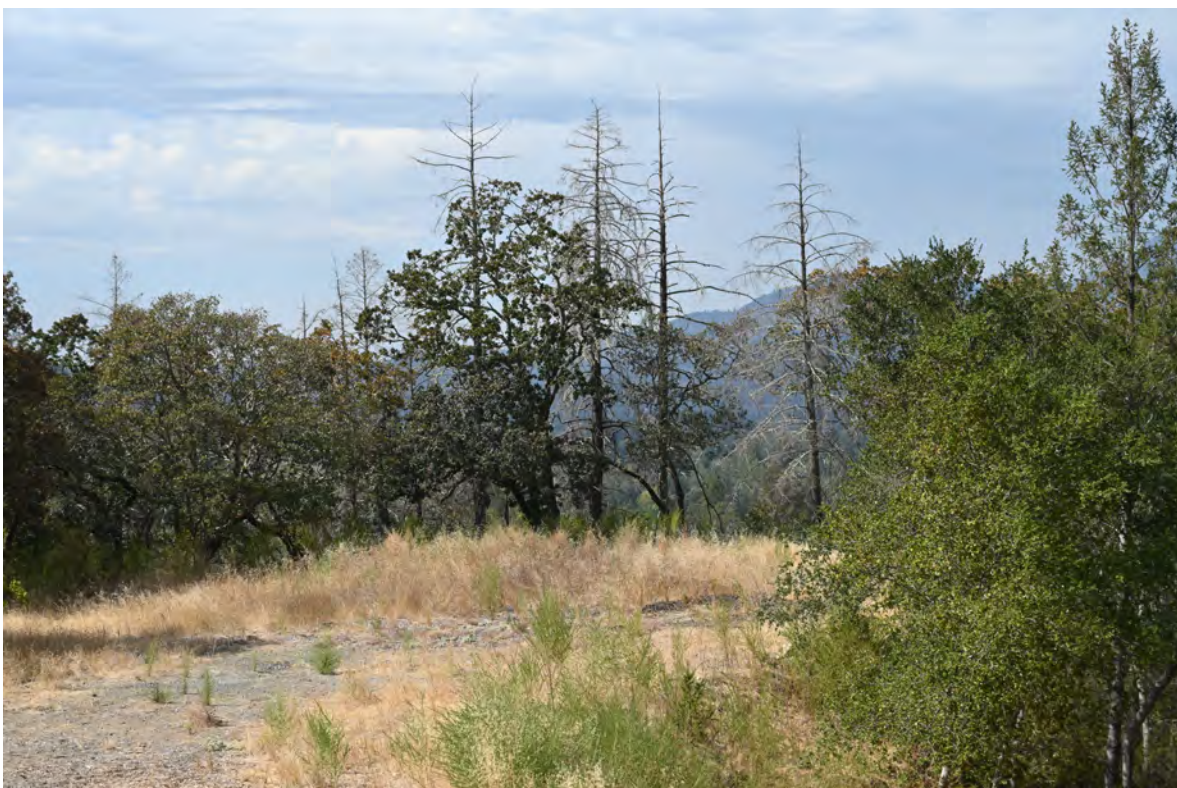
There are numerous dead firs on the north downslope side of the property. Many are on the neighboring property.

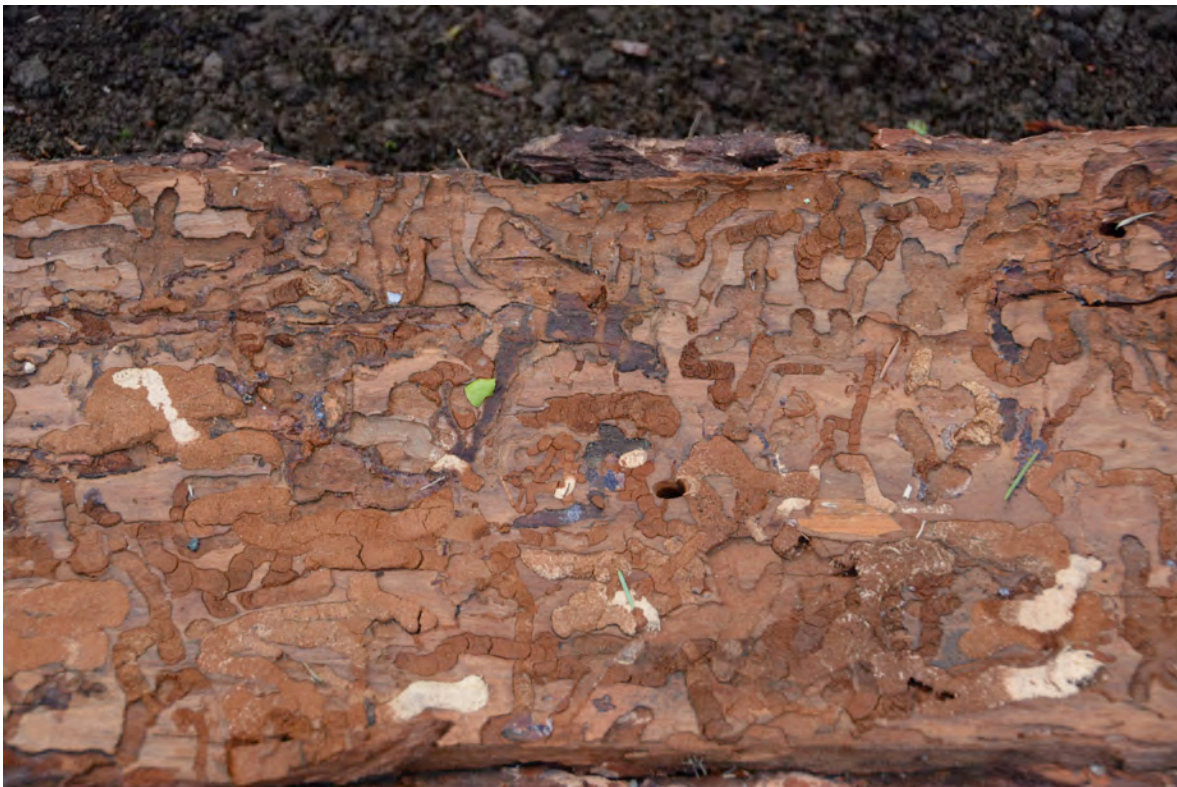
Larval galleries of the flatheaded fir borer (Kenwood, CA)

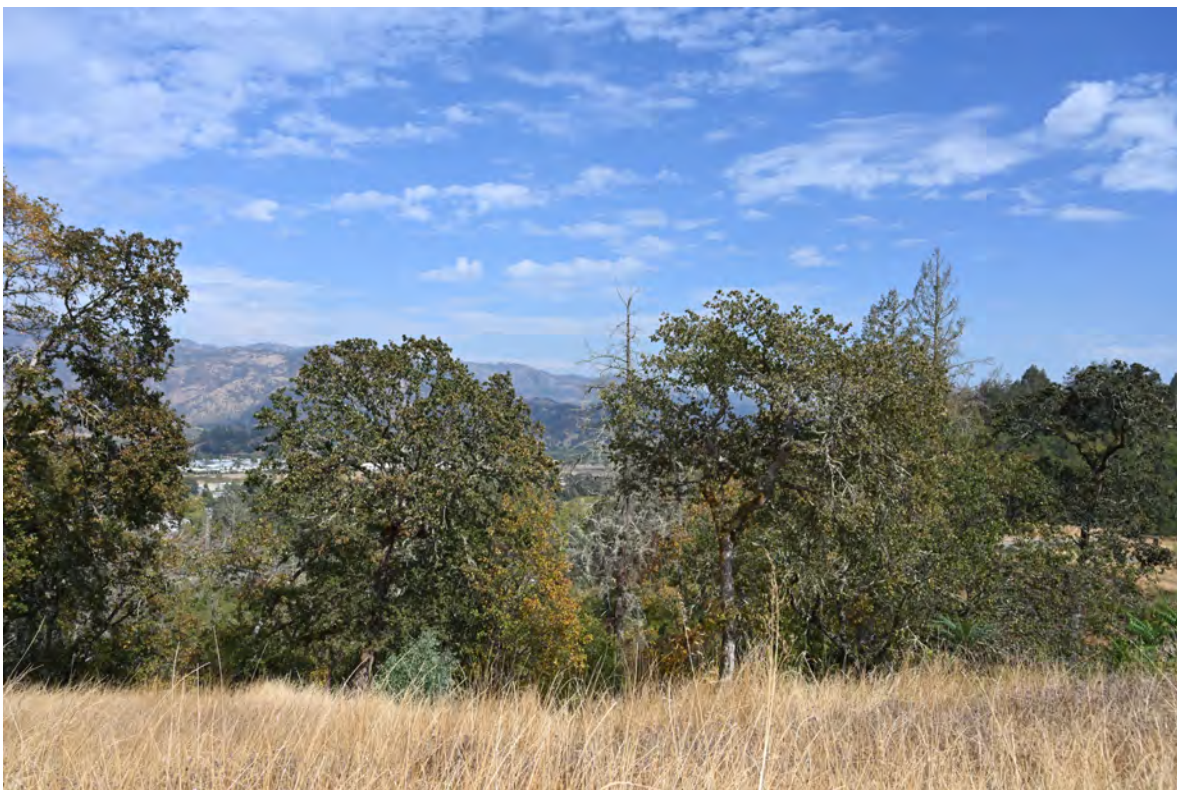
The various native oak species are generally in moderate condition despite the drought conditions.

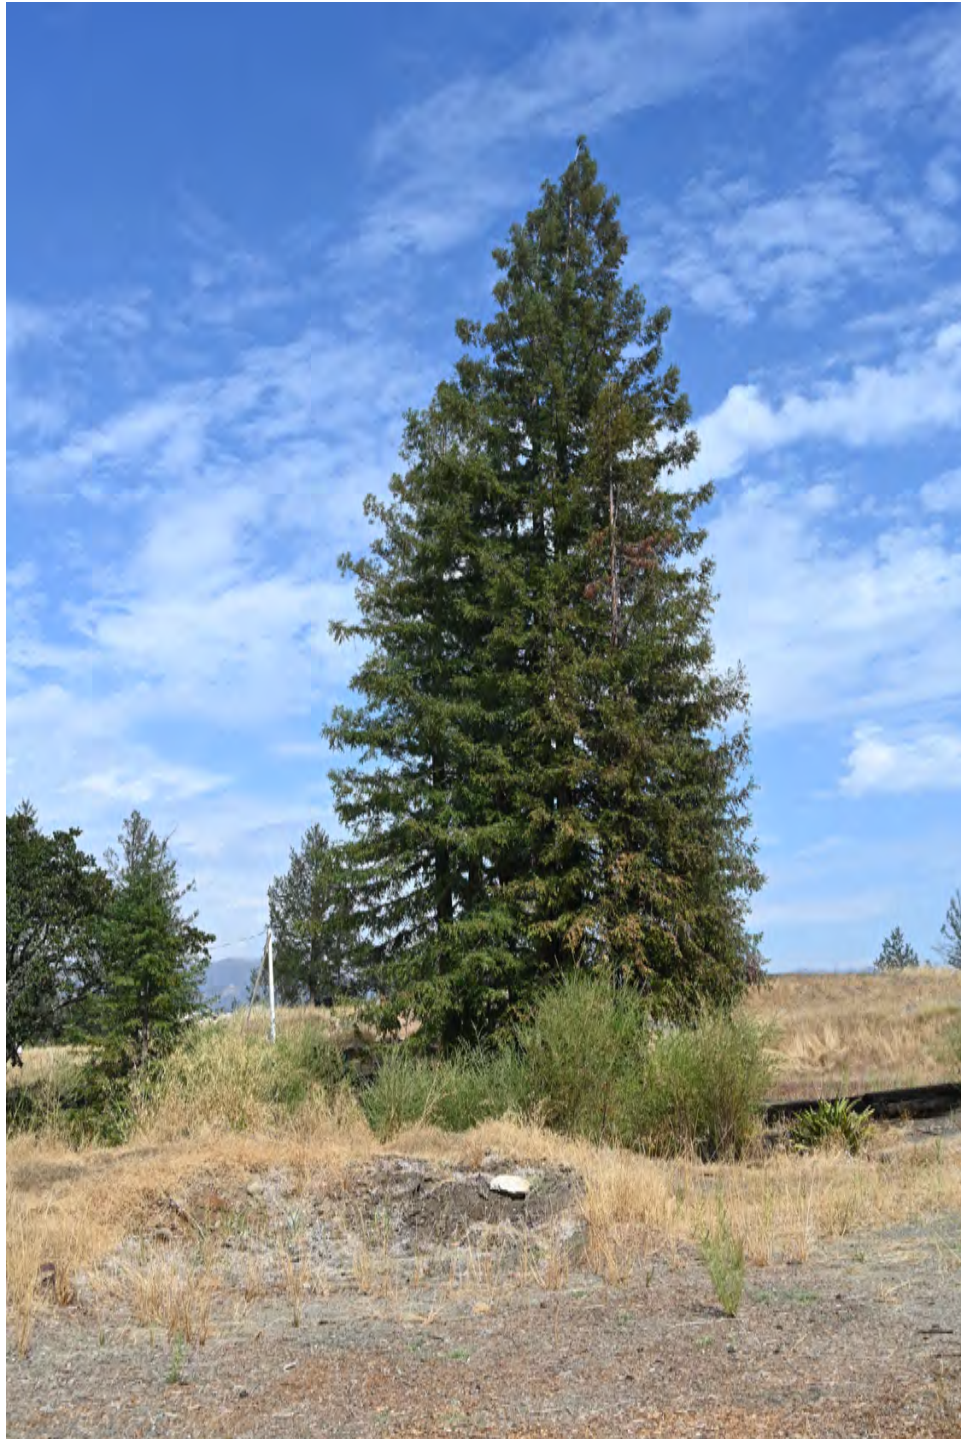
The coast redwoods on the site are also generally in moderate health.

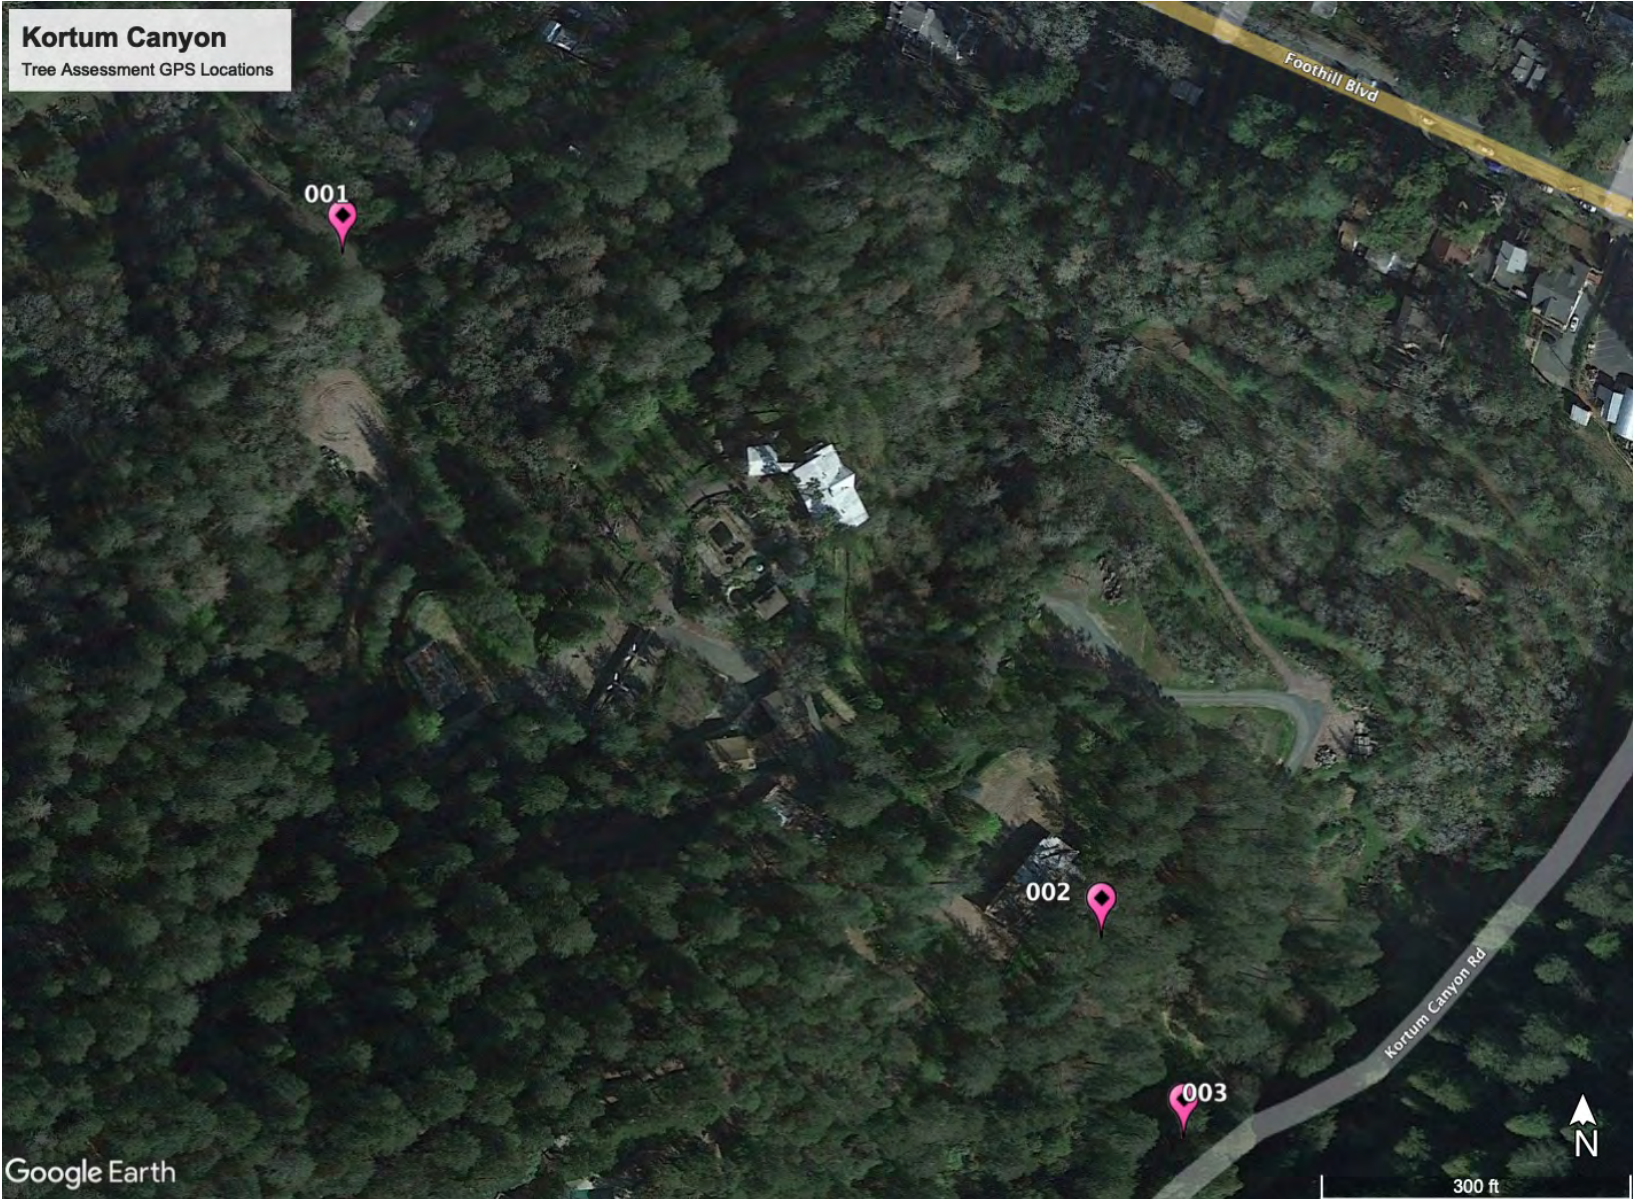
Aerial showing roadway tree impact areas.
