## **Arborist Report**

**29469 Ruus Road  
Hayward, CA 94544**

**PREPARED FOR:**  
Center Point Properties  
1111 Broadway, Suite 2130  
Oakland, CA 94607

**December 13, 2022**

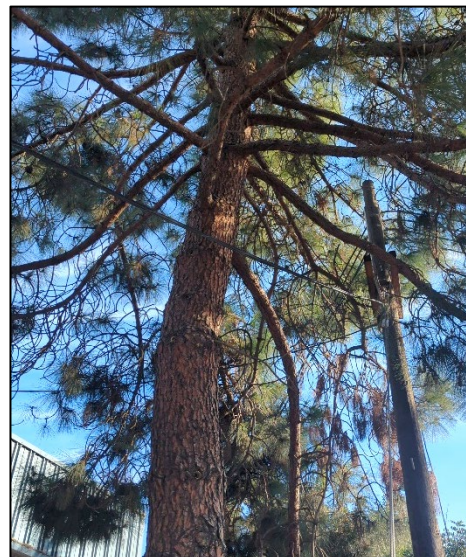
**Photo 1.** Canary Island pine #538 was growing next to a utility pole and between two utility lines.

| Tree No. | Species | Trunk<br>Diameter<br>(in.) | Protected<br>Tree? | Condition<br>1=poor<br>5=excellent | Suitability for<br>Preservation | Comments |
|---|---|---|---|---|---|---|
| 538 | Canary Island pine | 21 | Yes | 3 | Low | Upright form; slightly sparse; next to pole and lines; base against sidewalk. |

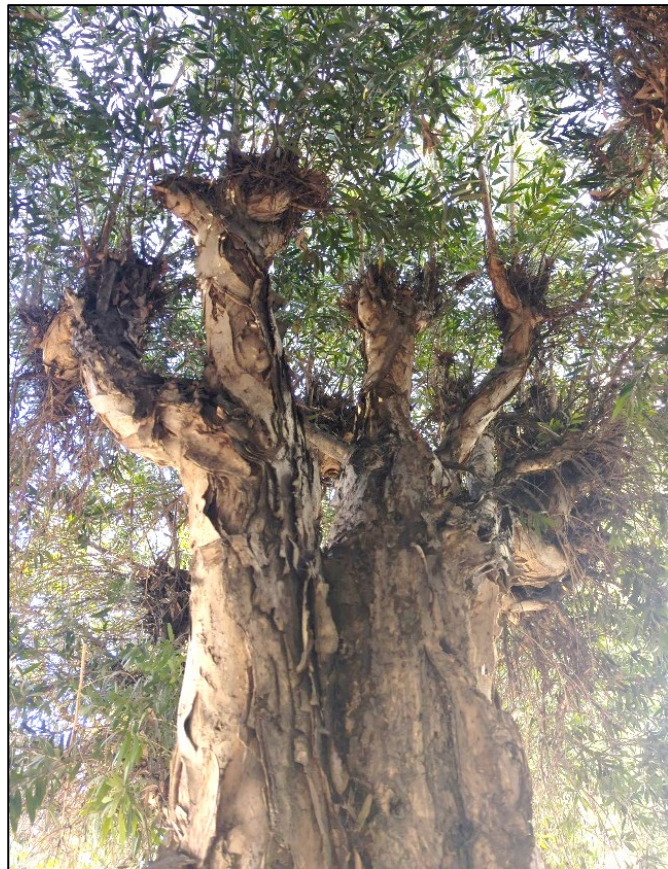
Six multi-trunked Cajeput paperbark trees were growing along Industrial Parkway West. All of the paperbark trees had been topped and were in poor condition. The crown of the trees consisted of dense sprouts at the topping wounds (Photo 2).

**Photo 2.** Cajeput paperbark tree #545 had been topped and dense sprouts made up the crown of the tree.

| Tree No. | Species | Trunk<br>Diameter<br>(in.) | Protected<br>Tree? | Condition<br>1=poor<br>5=excellent | Suitability for<br>Preservation | Comments |
|---|---|---|---|---|---|---|
| 545 | Cajeput paperbark tree | 32 | Yes | 2 | Low | Multiple attachments at base; topped; dense crown; next to building. |

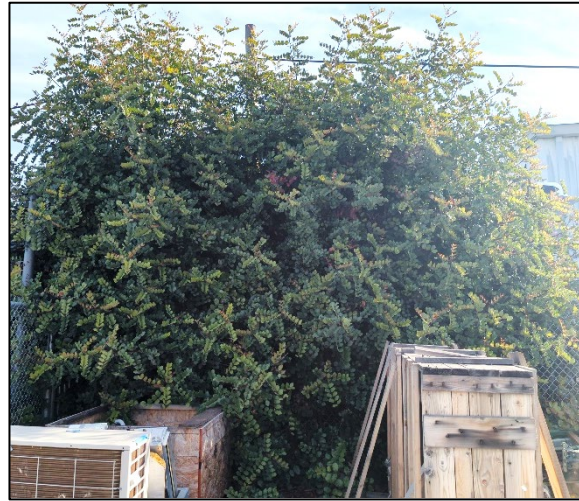
Two carobs each were in fair (#532, 535) and poor (#537, 558) condition. Carob #537 was the only single-trunked carob and had a diameter of 11 inches. The trunks of carob #558 were embedded in a chain link fence and had been topped a few feet above ground level. The tree regrew as a dense, ten foot tall shrub (Photo 3).

**Photo 3.** Carob #558 was topped and had regrown as a dense shrub.

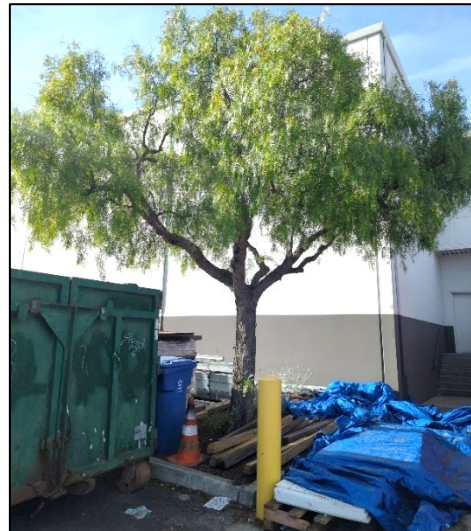
- California pepper trees #555 (good condition) and #557 (fair condition). Both trees had multiple trunks and some degree of sparseness in the crown. Debris was stacked in the planter of pepper tree #557 (Photo 4).
- Brazilian pepper #556 was in fair condition with a trunk diameter of 15 inches. The crown of the tree was sparse and numerous branches had been removed.
- Victorian box #516 was an off-site tree near the north side of the project area. The tree was a good condition with a full, dense crown.

**Photo 4.** Debris was stacked in the planting well for California pepper tree #557.
