| 1. Tree Expert:<br>Leonard Markowitz, Certified Arborist # WE 0342, PCA # 070070<br>1684 Meander Dr. Simi Valley, CA 93065 lenmtree@aol.com (805) 813-2134 | | |
| 4. APN#: <b>5534-004-001</b><br><b>Location/geographic Description:</b> 1201-1217 N. Gower St. between Lexington and Fountain Ave. North of Santa Monica Blvd.<br>That portion of Block 11 of the Colegrove, in the City of Los Angeles, County of Los Angeles, State of California, as per map recorded in book 53, page 10 of miscellaneous records in the office of the county recorder of said county. | | |
| 5. Date Prepared: 4-20-2022 | 6. Date Inspected: 4-15-2022<br>Date Trees Tagged: 4-15-2022 | |
| 7. <b>PTR Purpose:</b><br>The City of Los Angeles planner has asked to conduct a tree report which includes the location, type, size, and general condition of trees and shrubs on-site and within public r-o-w.<br>This report is being prepared at the request of the City of Los Angeles Board of Public Works and in accordance with the City of Los Angeles Protected Tree and Shrub Ordinance No. No.186,873 | | |

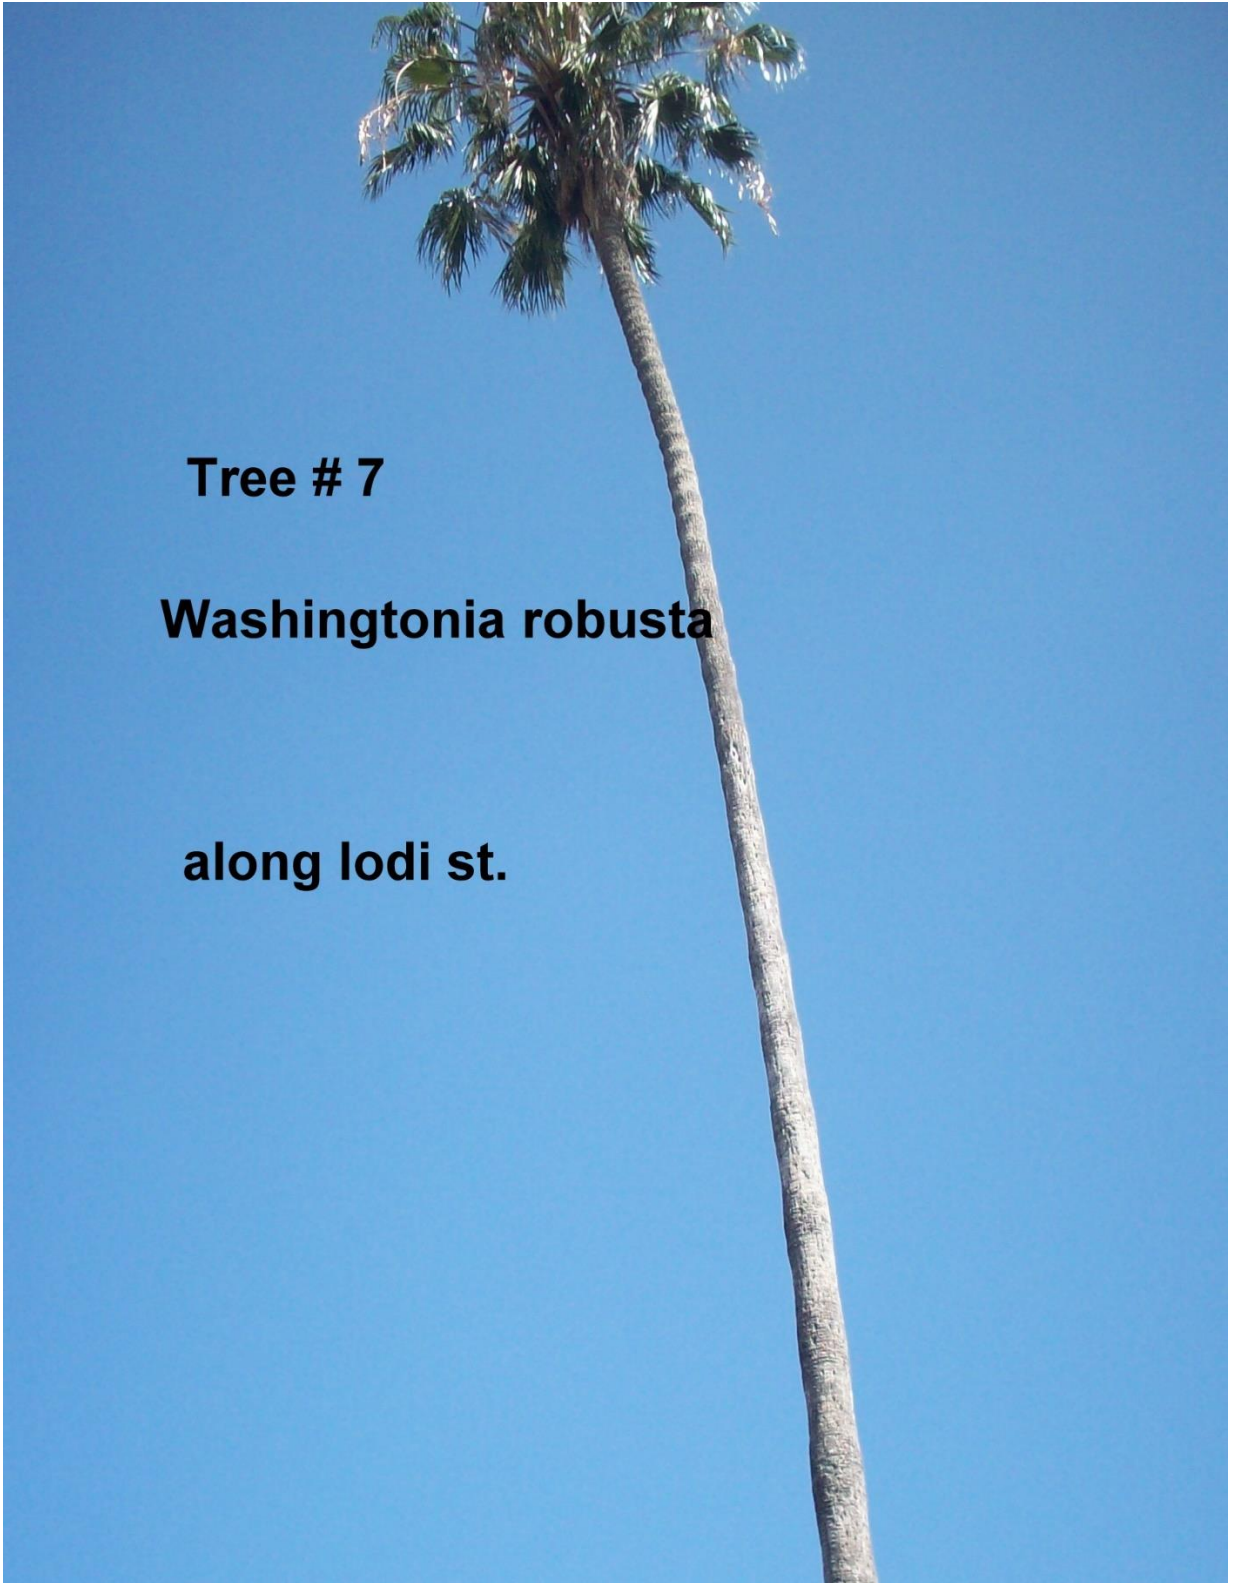
**Tree # 7**

**Washingtonia robusta**

**along Iodi st.**

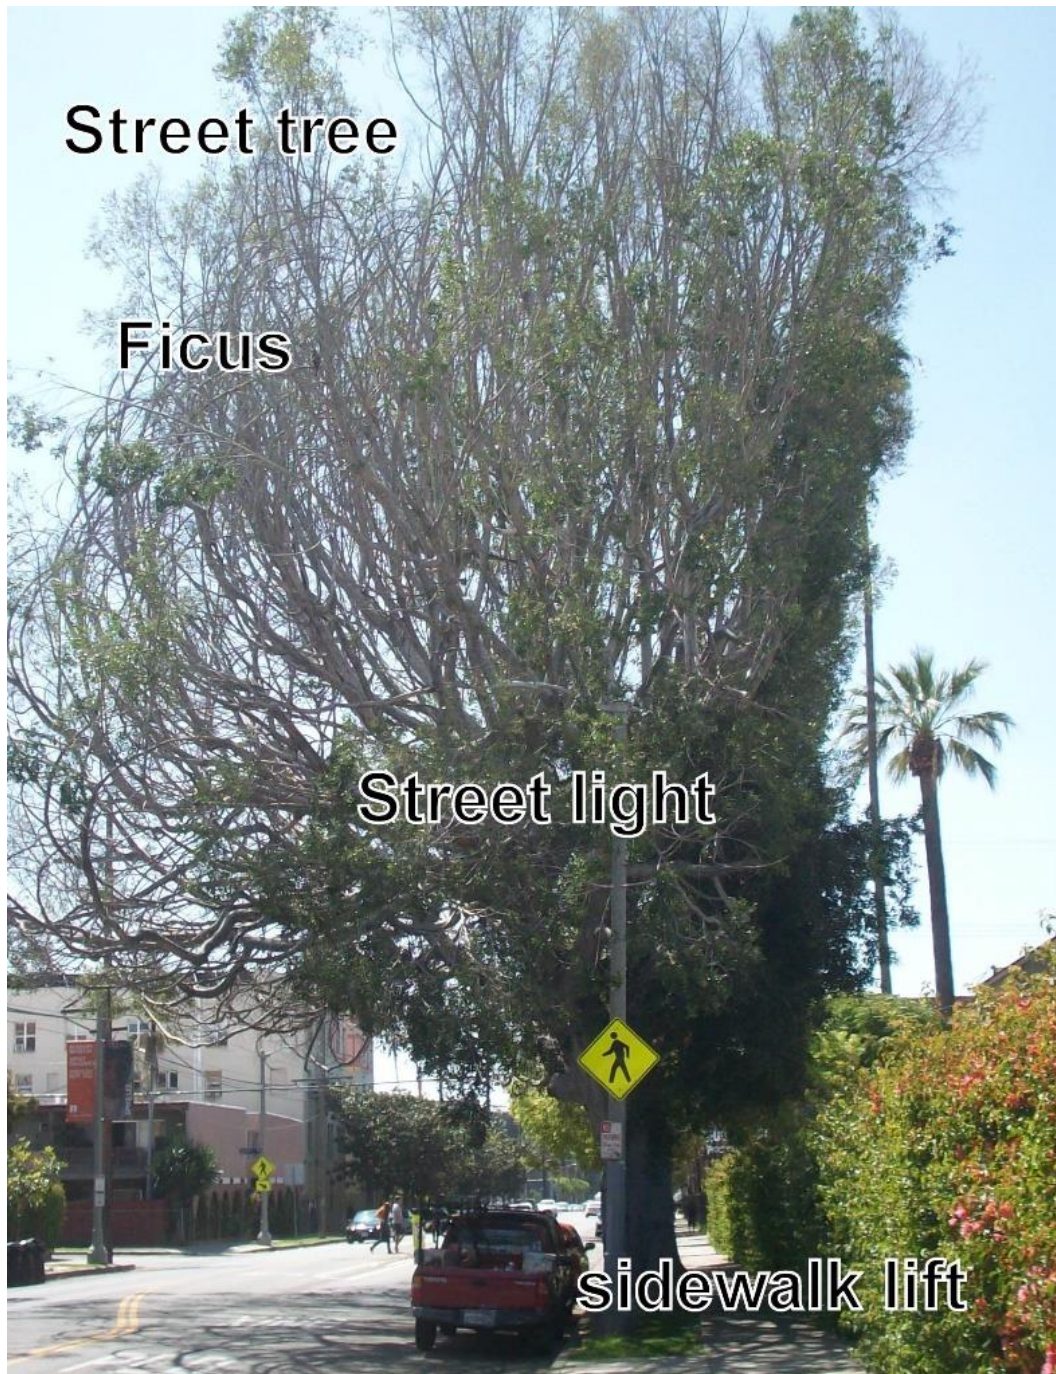
Street tree

Ficus

Street light

sidewalk lift
