Kielty Arborist Services

July 6, 2020

Site: Great America Parkway and Tasman Drive

KIELTY ARBORISTS SERVICES, LLC
Tree Survey

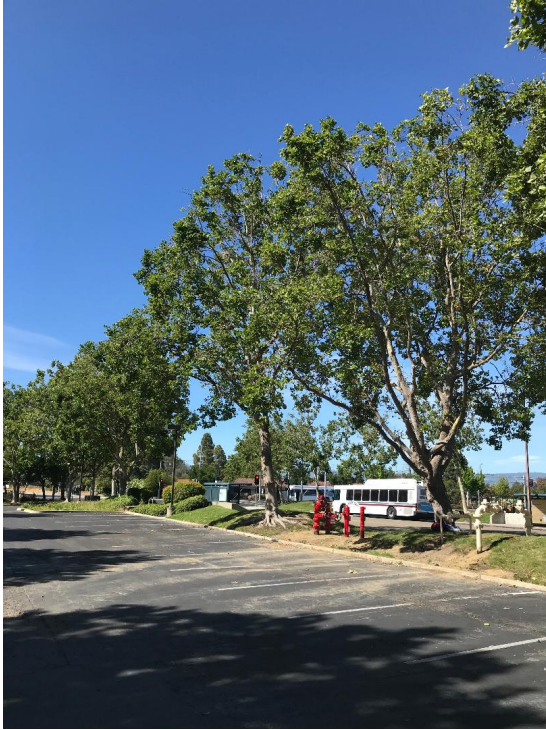
London plane trees growing within the parking lot in small planting pits are growing slow and are not in as good of health as the trees growing in the wide street tree planting strip. All of the London plane trees were given fair to good condition ratings.

Showing London plane street trees in fair to good condition

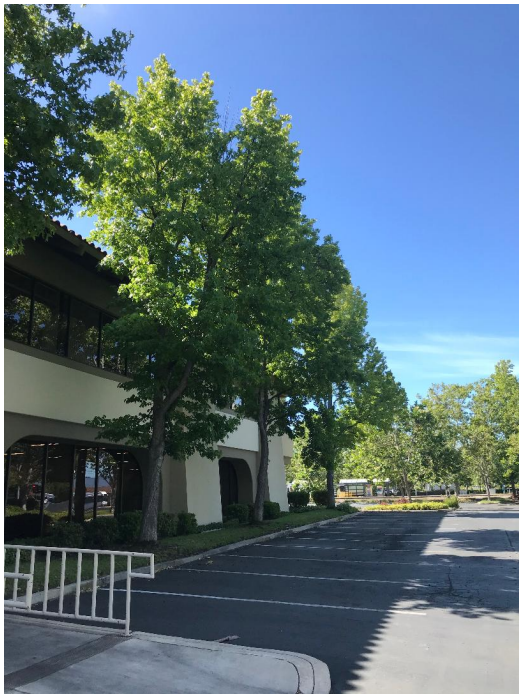
Some of the trees are within a few feet of the existing buildings on site. Demolition would have a high impact on the trees located near the existing buildings. Liquidambar trees were used near the existing buildings on site as well as a few other species. Liquidambar trees develop large roots know to cause extensive hardscape damage.

Showing liquidambar trees close to existing building

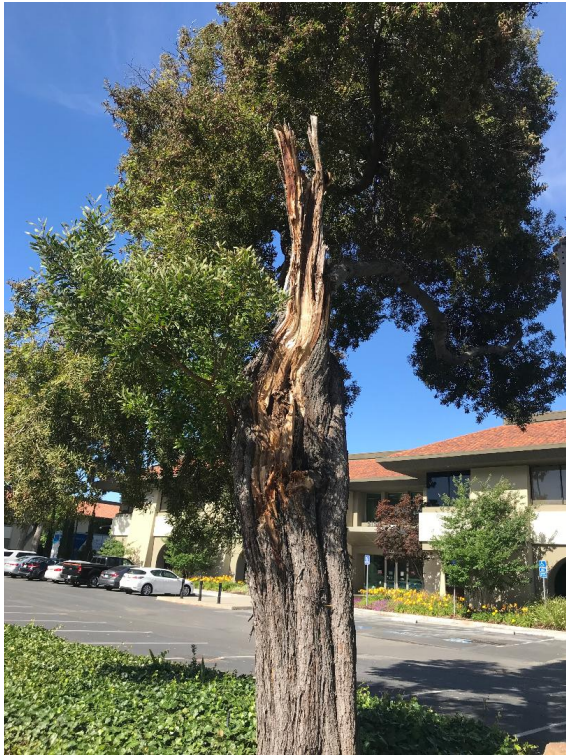
Poor species such as black acacia trees and eucalyptus trees were observed growing within the property. The large eucalyptus trees are a poor choice for a parking lot tree. Red iron bark eucalyptus trees within the existing parking lot planting strips are an extremely poor choice as they are known to lose limbs. Black acacia trees have been planted in the past along Great America Parkway as street trees. This species is extremely invasive and has weak wood. Black acacia tree #39 has recently lost a large codominant leader. Decay was observed within the trunk. This tree is hazardous and should be removed as soon as possible.

Showing failed black acacia tree #39

38	Black acacia	<i>Acacia melanoxylon</i>	20.8	40%	30/25	Fair vigor, Poor form, Leans over street
39	Black acacia	<i>Acacia melanoxylon</i>	25.5	0%	30/20	HAZARD! REMOVE! Recent large codominant limb failure.
40	Black acacia	<i>Acacia melanoxylon</i>	28.8	40%	30/25	Fair to poor vigor, Poor form, Dieback, Poor unions, Invasive

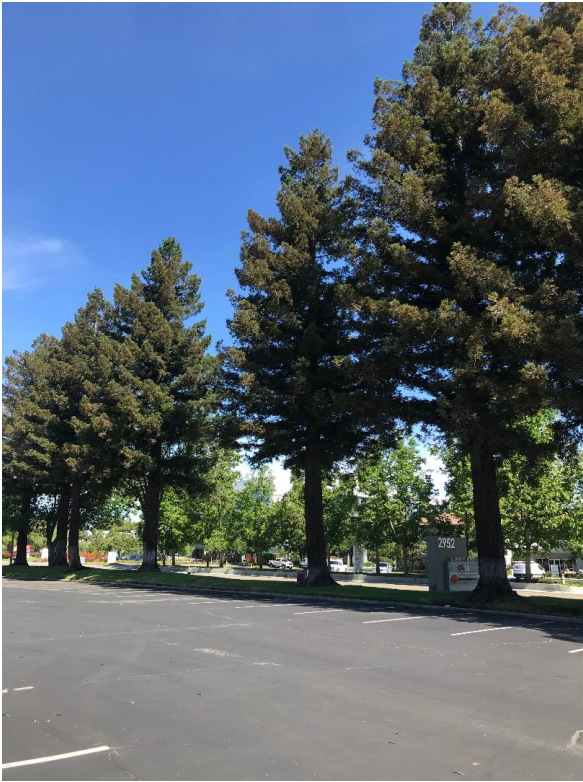
Showing redwood trees to be retained

The redwood trees to be retained are all in good condition. The trees are growing in a wide planting strip between the street and existing parking lot. A parking lot is proposed in the same location as the existing parking lot near these trees. If possible, no excavation should take place within 25 feet of these trees. The existing parking lot within 25 feet of the large redwood trees could be repaved to fix the minor damages caused by expanding root growth with new parking spaces painted on the asphalt. Existing curbs could also be retained with minor repairs to the curb done where needed. The adjacent sidewalk is recommended to be retained near the redwood trees as well. Where needed minor repairs can be done to the sidewalk. During the proposed work, the entire planting strip where the redwood trees are located will need to be fenced off by tree protection fencing. Fencing must be installed underneath the tree canopy spread where possible. Any utility work planned should be at least 25 feet from the redwood trees to be retained. The redwood trees require frequent supplemental irrigation to maintain a healthy canopy. The existing irrigation near these trees should be retained as a part of the project.

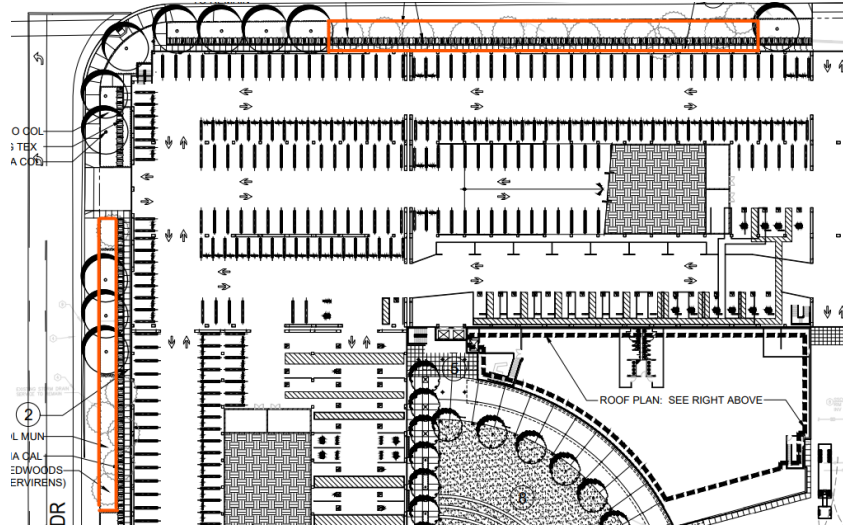
Red lines indicating the recommended tree protection zones

Tree protection zones should be installed and maintained throughout the entire length of the project. Fencing for tree protection zones should be 6' tall, metal chain link material supported by metal 2" diameter poles, pounded into the ground to a depth of no less than 2'. The location for the protective fencing for the protected trees on site should be installed no closer to the trunk than the dripline (canopy spread) in order to protect the integrity of the tree. The location of the tree protection fencing may be modified by the planning director. When it is not possible to place tree protection fencing at the dripline because of the proposed work or existing hardscapes, the tree protection fencing shall be placed at the edge of the proposed work or hardscapes. No equipment or materials shall be stored or cleaned inside the protection zones. Areas where tree protection fencing needs to be reduced for access, should be mulched with 6" of coarse wood chips with ½ inch plywood on top. The plywood boards should be attached together in order to minimize movement. The spreading of chips will help to reduce compaction and improve soil structure. All tree protection measures must be installed prior to any demolition or construction activity at the site. The non-protected trees are recommended to be protected in the same manner as the protected trees on site. No signs, wires, or any other object shall be attached to the trees. Below is a diagram showing the recommended tree protection zones for the redwood trees to be retained.
