California Tree and Landscape Consulting, Inc.

June 13, 2021

SUBJECT: ARBORIST REPORT FOR TREES GROWING ON PROPERTY NEXT TO 6801 SANTA JUANITA AVENUE, ORANGEVALE, CA FOR PROPOSED SUBDIVISION APN 213-0241-002

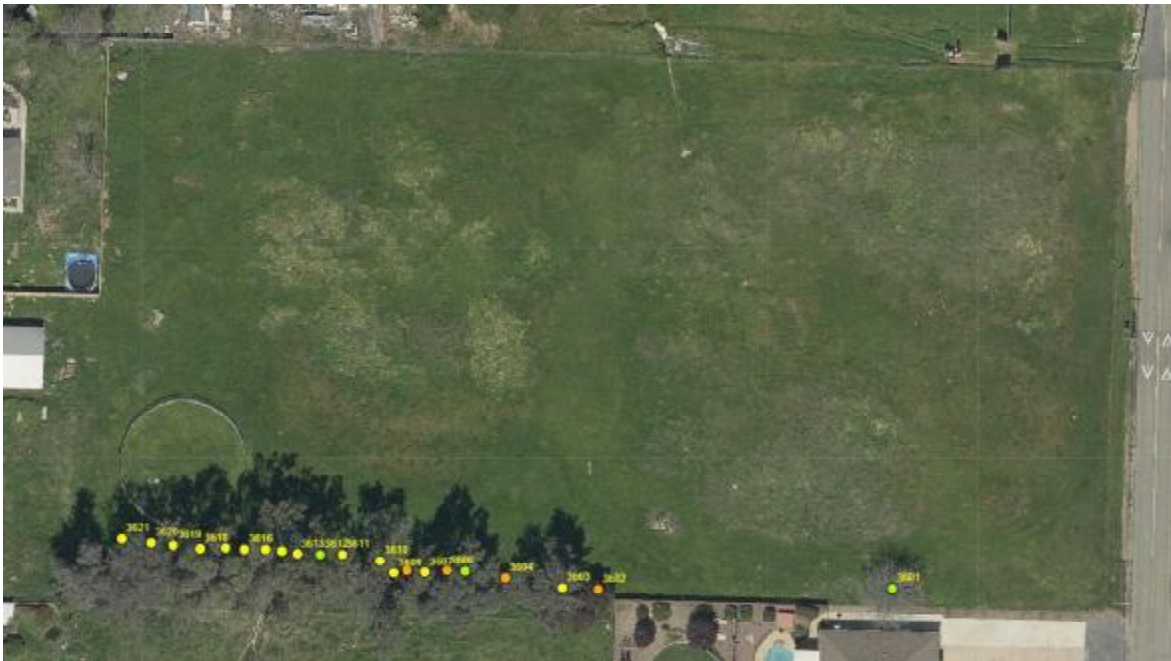
Aerial Image of site with Tree Numbers in approximate locations

6801 Santa Juanita Ave Orangevale Arborists Report for proposed subdivision June 13, 2021
and tree protection zones based on canopy radius.

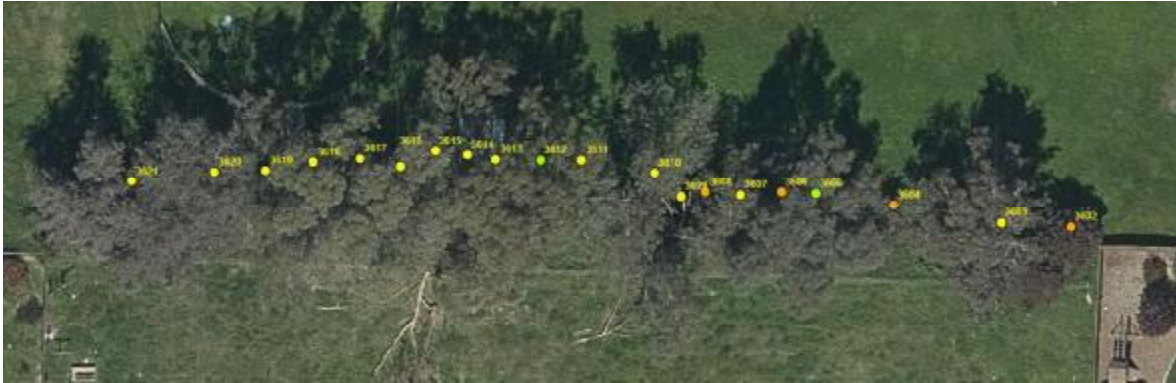
Aerial image of trees enlarged in approximate locations.
