**FAULT STUDY
PROPOSED WAREHOUSE DEVELOPMENT**

NEC Todd Avenue and 10th Street

Azusa, California

Project No.: **22G144-2**

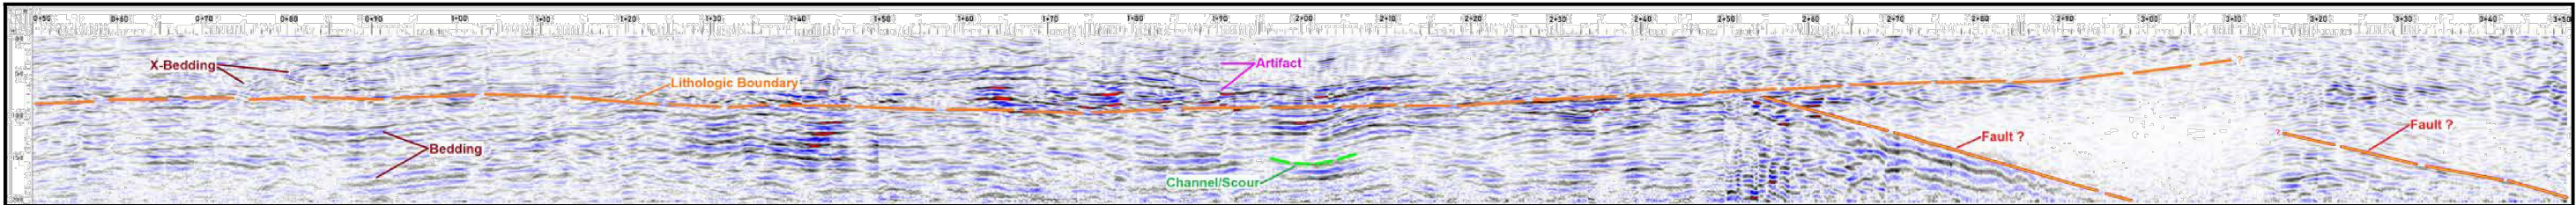
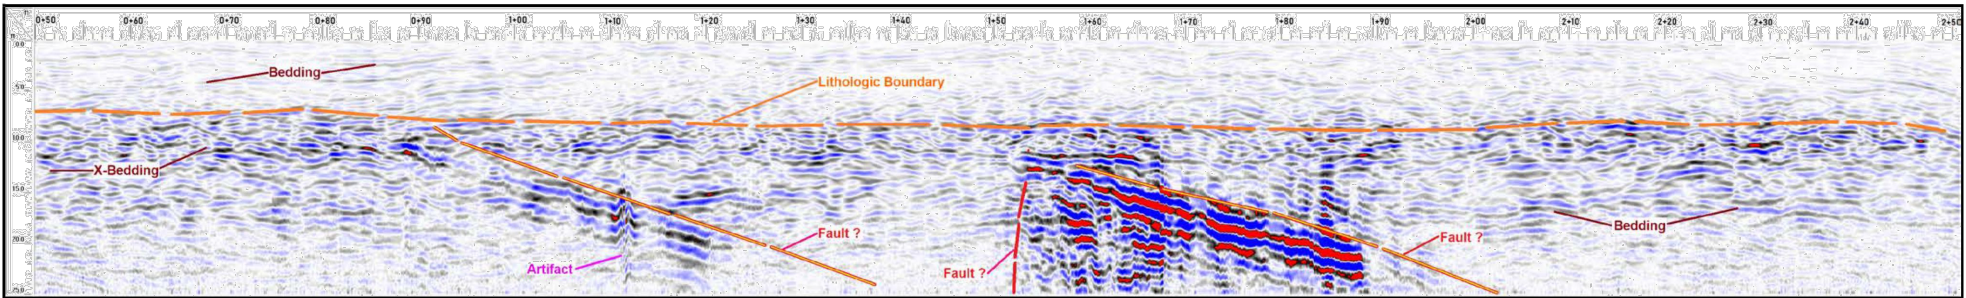
GROUND PENETRATING RADAR	
PROPOSED INDUSTRIAL DEVELOPMENT	
AZUSA, CALIFORNIA	
SCALE: 1" = 20'

These horizontal discontinuous layers are considered to be caused by channel deposits. Two anomalous features were identified approximately 8 to 10± feet below the bottom of both trenches. The anomalous features were encountered at Station 2+54 and 3+15 at Fault Trench No. FT-1 and at Station 0+91 and 1+58 at Fault Trench No. FT-2. These two anomalous features dip between 13 to 19 degrees downward to the north. These two anomalous features are suggestive of low-angle thrust faulting. In addition, the sediments north of the anomalous features appear to dip slightly to the north, which is an opposite direction to the expected deposition of the upper alluvial fan deposits in this area. The north-dipping layers are likely due to back-tilting of the alluvium associated with the low-angle thrust faulting. The two anomalous features are approximately 60 feet apart in each trench. It appears that the anomalous features are related due to the similar apparent structure and the similar distance apart. When the two anomalous features are connected between both fault trenches, the resulting line is nearly parallel to the mapped Upper Duarte Fault trace to the south of the site. Therefore, SCG considers these anomalous features to likely be low-angle thrust faults associated with the Upper Duarte Fault which is mapped to the south of the site. A copy of the Ground Penetrating Radar results is available on Plate 5 of this report.

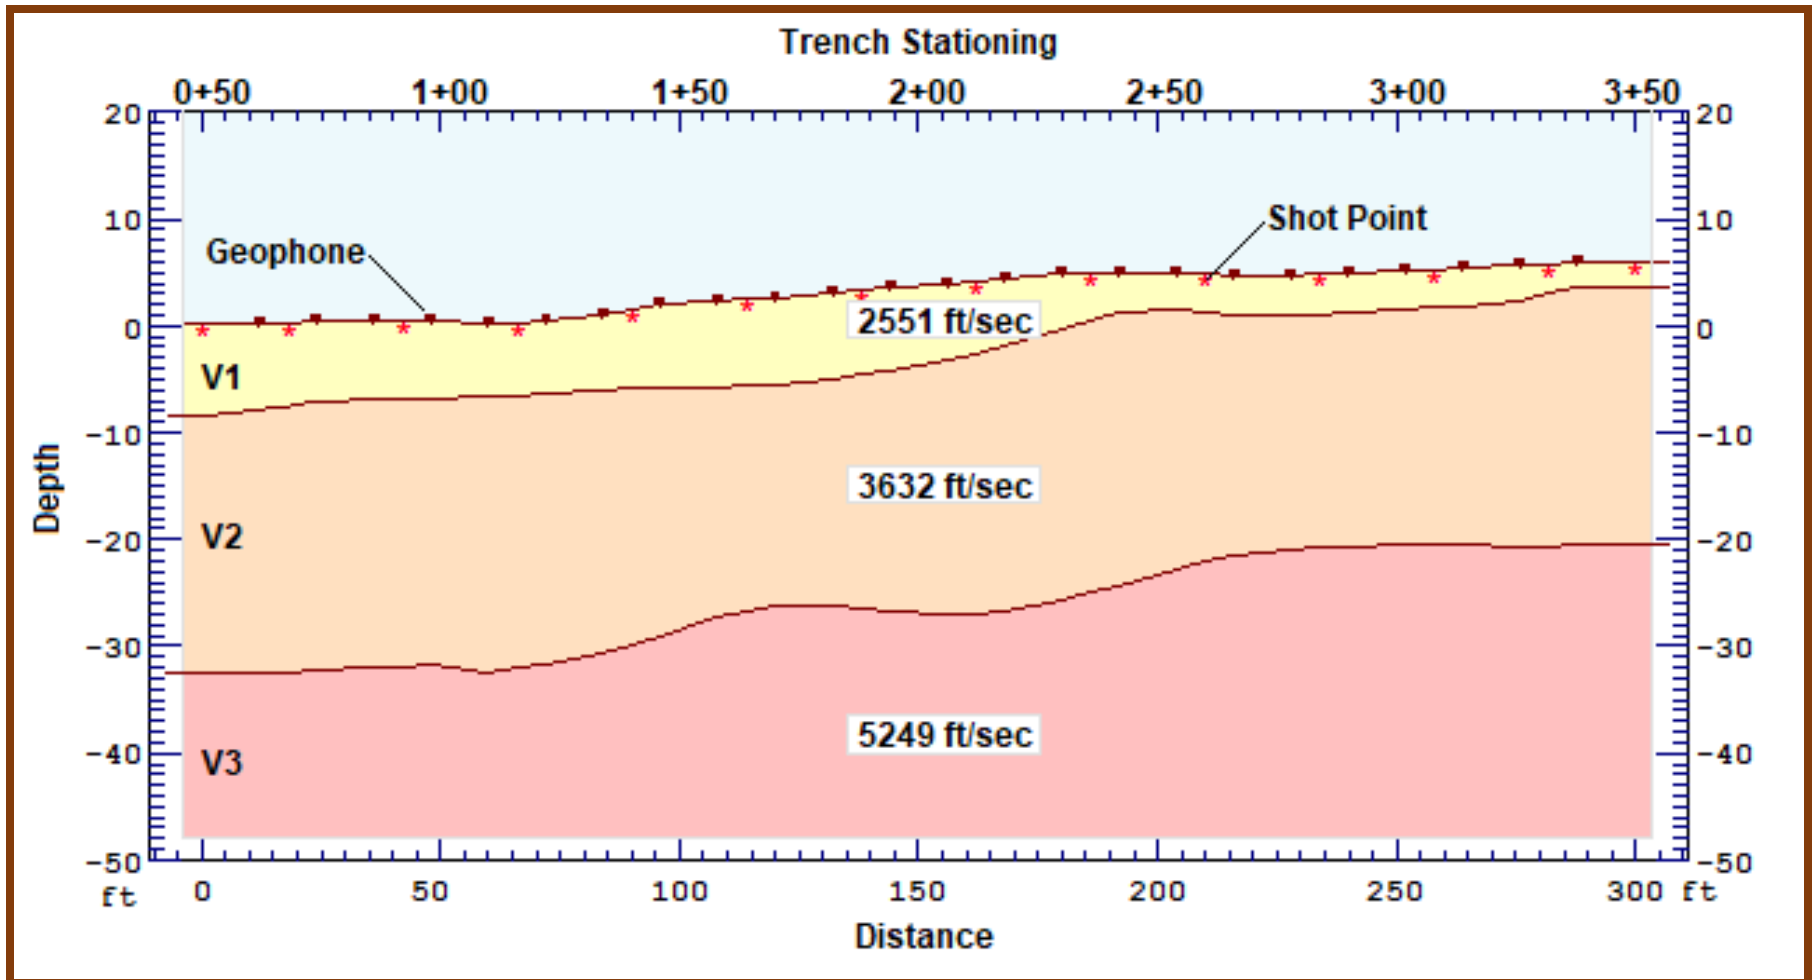
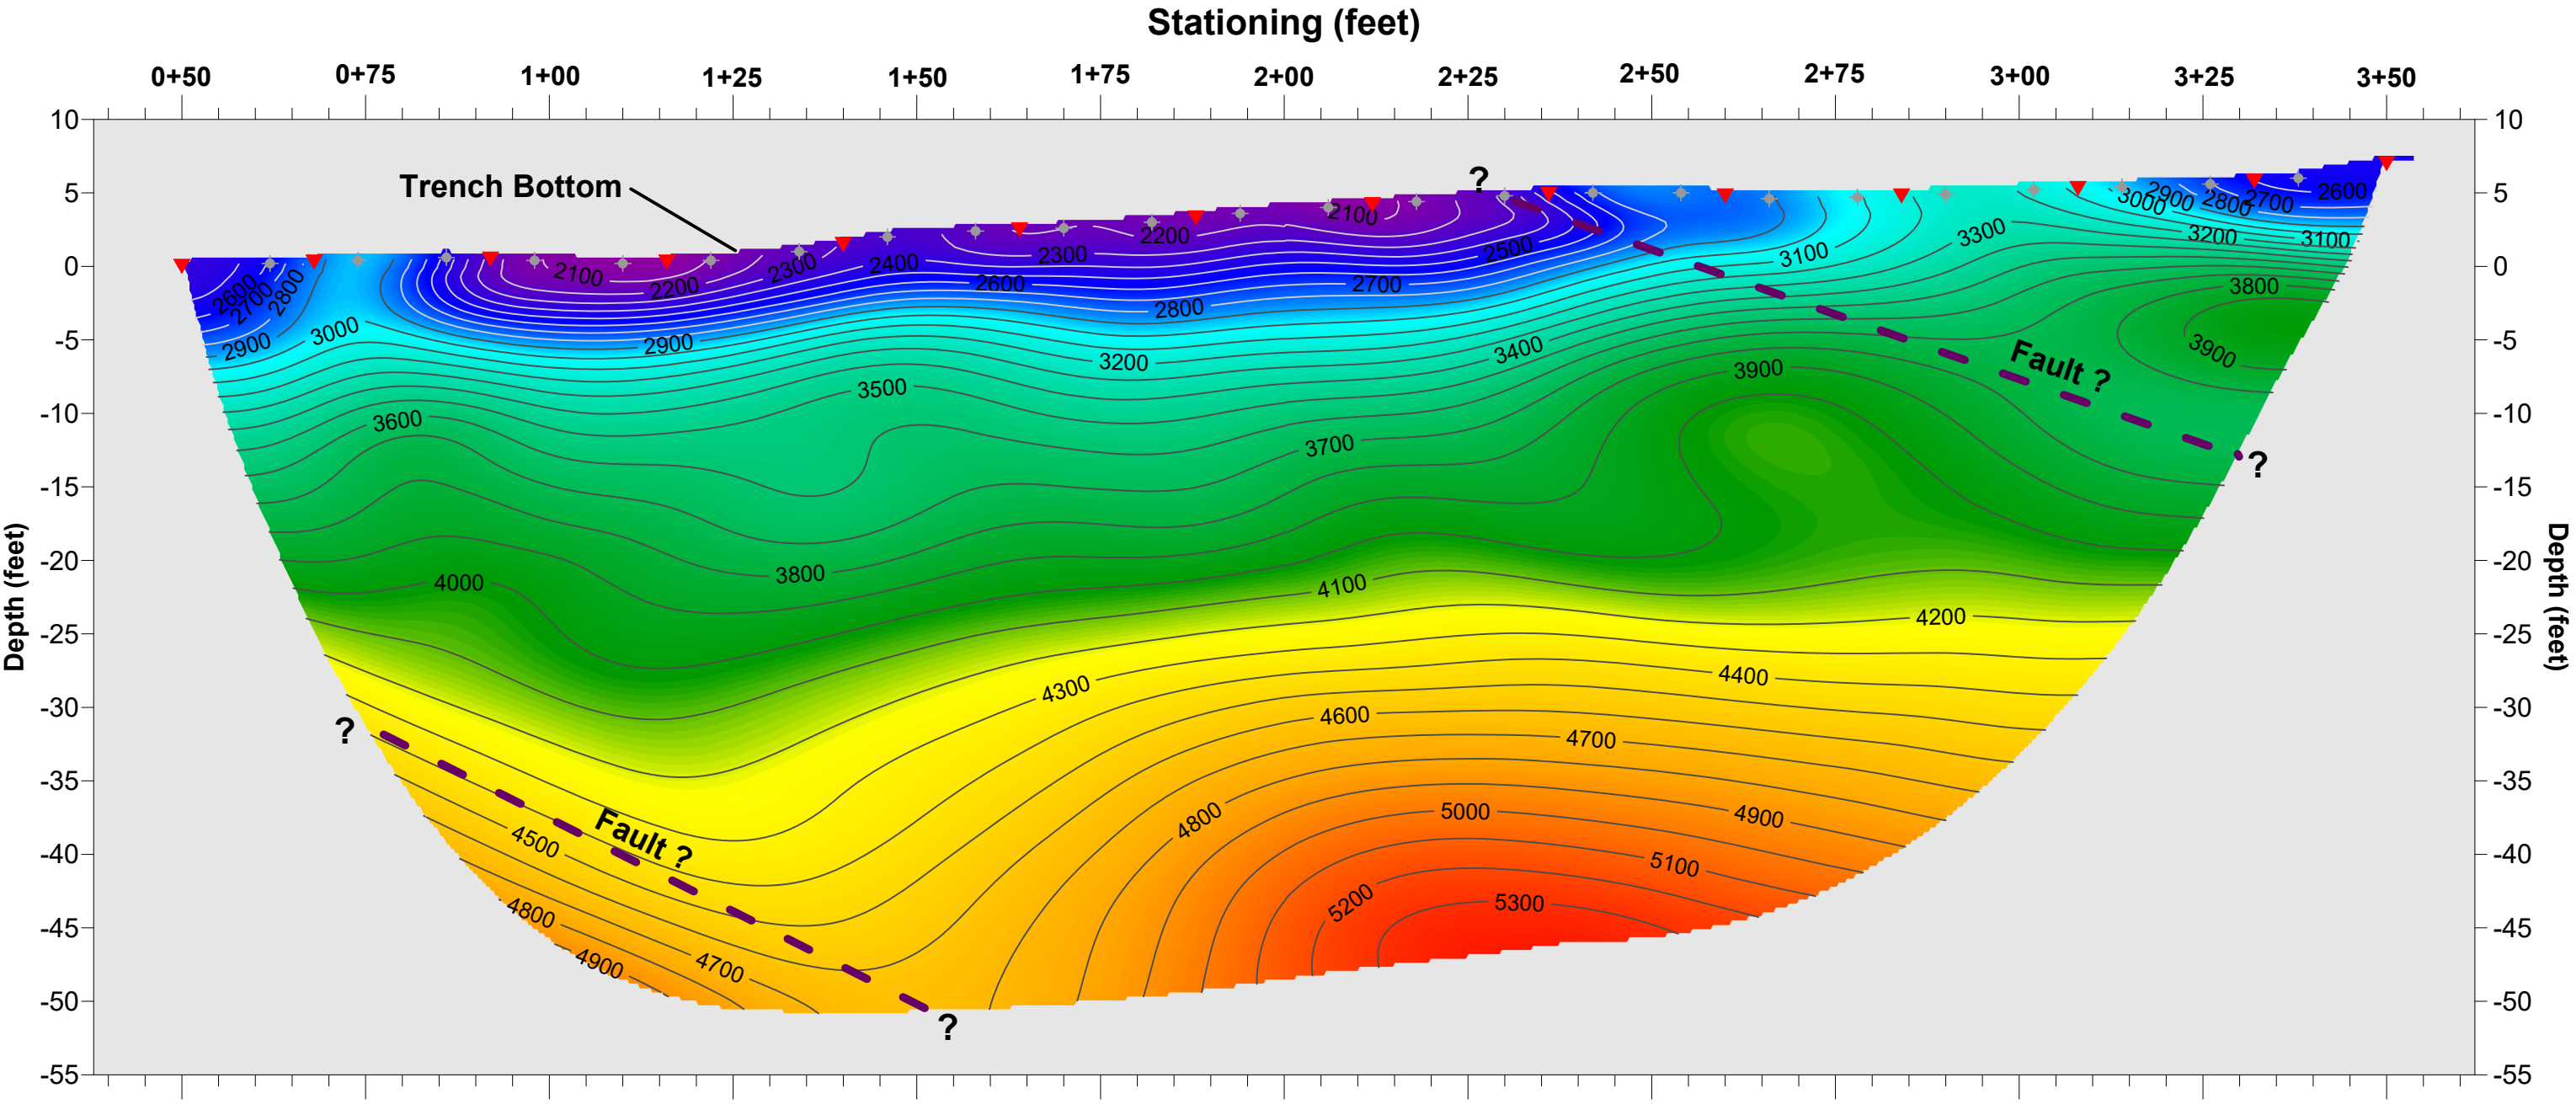
SEISMIC LINE S-1

- The groundwater discrepancy observed by LPI during the drilling of their borings indicates the presence of a groundwater barrier, likely a fault. An anomaly observed in the seismic refraction survey correlates with this discrepancy.

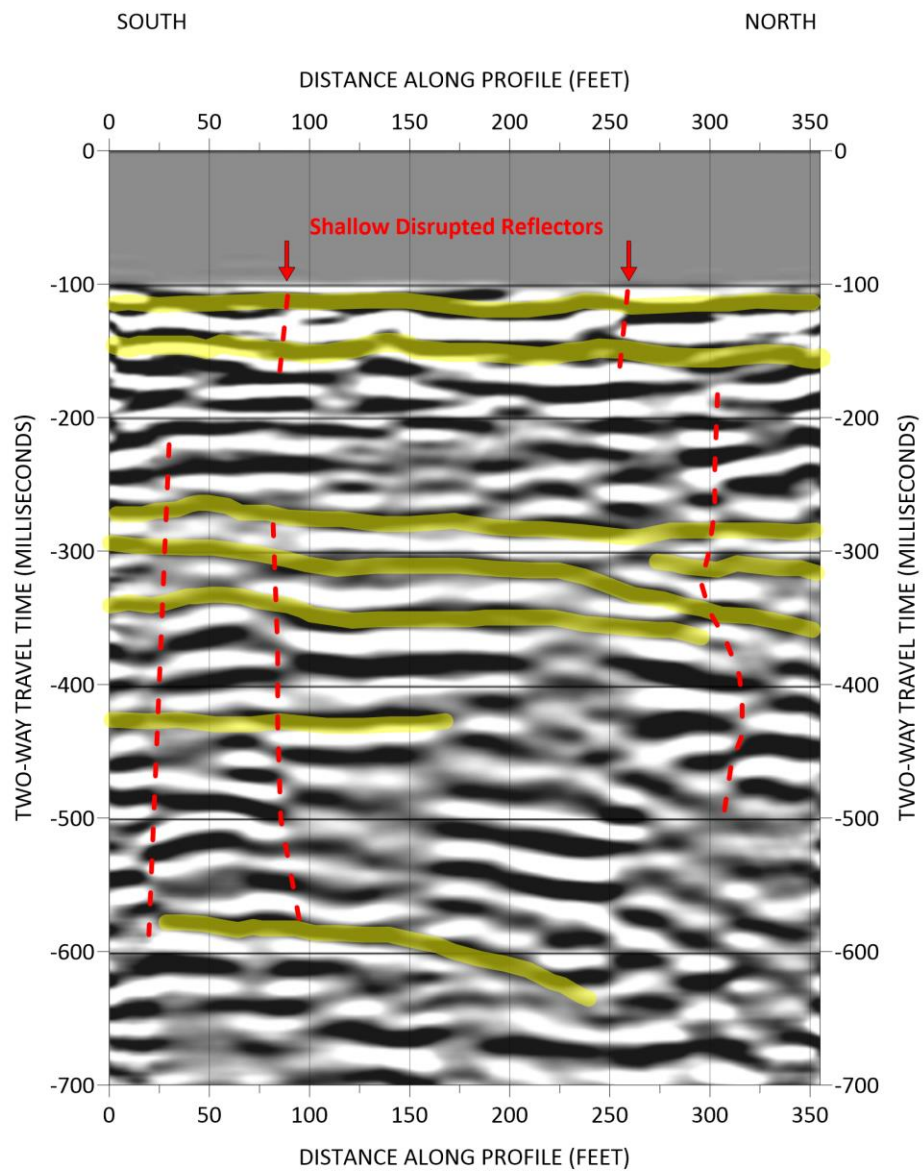
Appendix Figure 5 – Seismic Line Interpreted Section

Additionally, SCG contracted GeoVision to perform a Seismic Reflection Survey near the western property line. The seismic reflection line is identified as GV S-1. The result of this survey is presented in a separate report included as Appendix F of this report. The purpose of this survey was to screen the area beneath the seismic line for a fault which may act as a groundwater barrier. The results of the Seismic Reflection Survey indicate that GeoVision was unable to definitively interpret any features observed in the data set as being caused by a shallow fault.
