Arborist Report

Client: Chris Borello

Site: 1000 South Deanza Blvd. San Jose, CA 95129

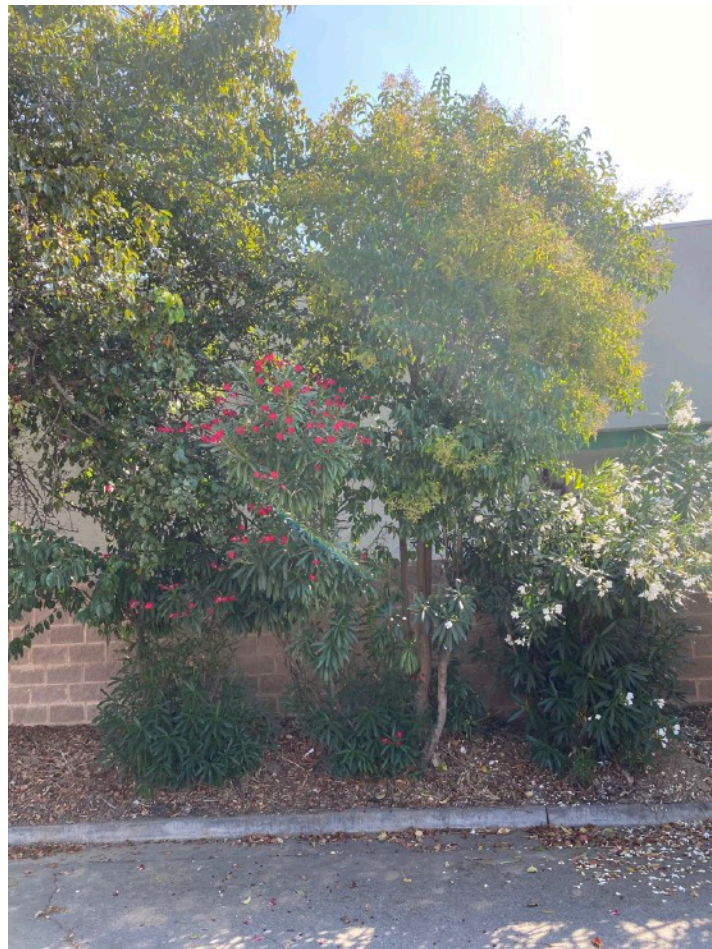
2001	Texas Privet	Ligustrum Japonicum	Multi - stem Creating a D.B.H. of 6"	16'	8'	Fair
------	--------------	---------------------	--	-----	----	------

Observations: This tree is not viable for landscape use.
Recommendations: Remove

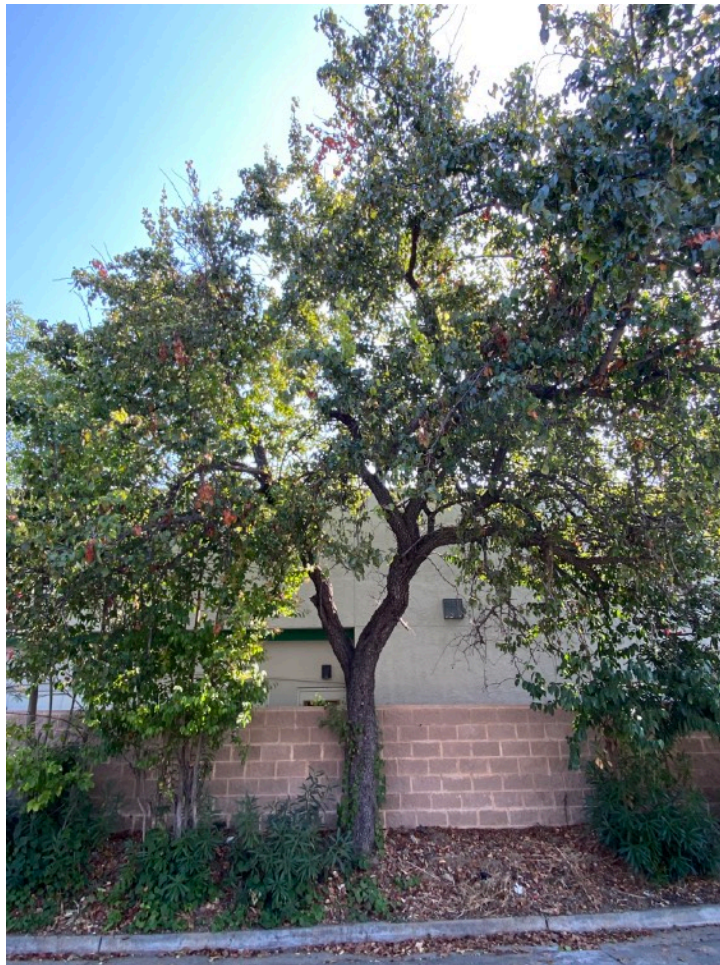
2002	Evergreen Pear	Pyrus Kawakamii	15"	30'	30'	Poor
------	----------------	-----------------	-----	-----	-----	------

Observations: This tree is not viable for landscape use.
Recommendations: Remove

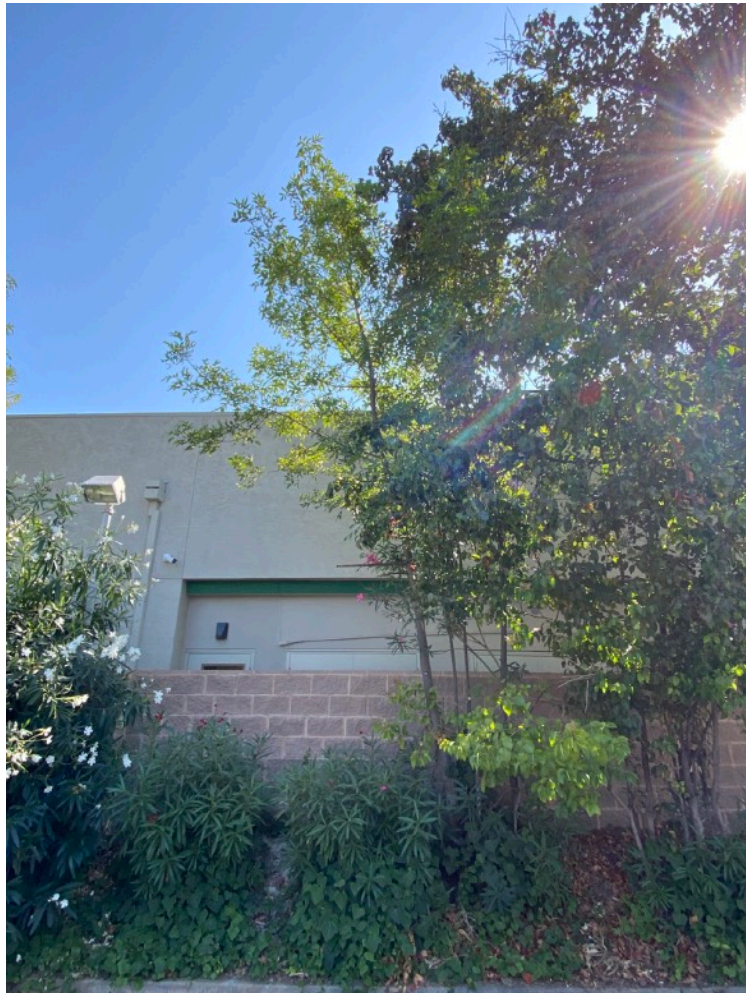
2003	Raywood Ash	Fraxinus Angustifolia	Multi - stem Creating a D.B.H. of 4"	28'	8'	Fair
------	-------------	--------------------------	--	-----	----	------

Observations: This tree is not viable for landscape use.
Recommendations: Remove

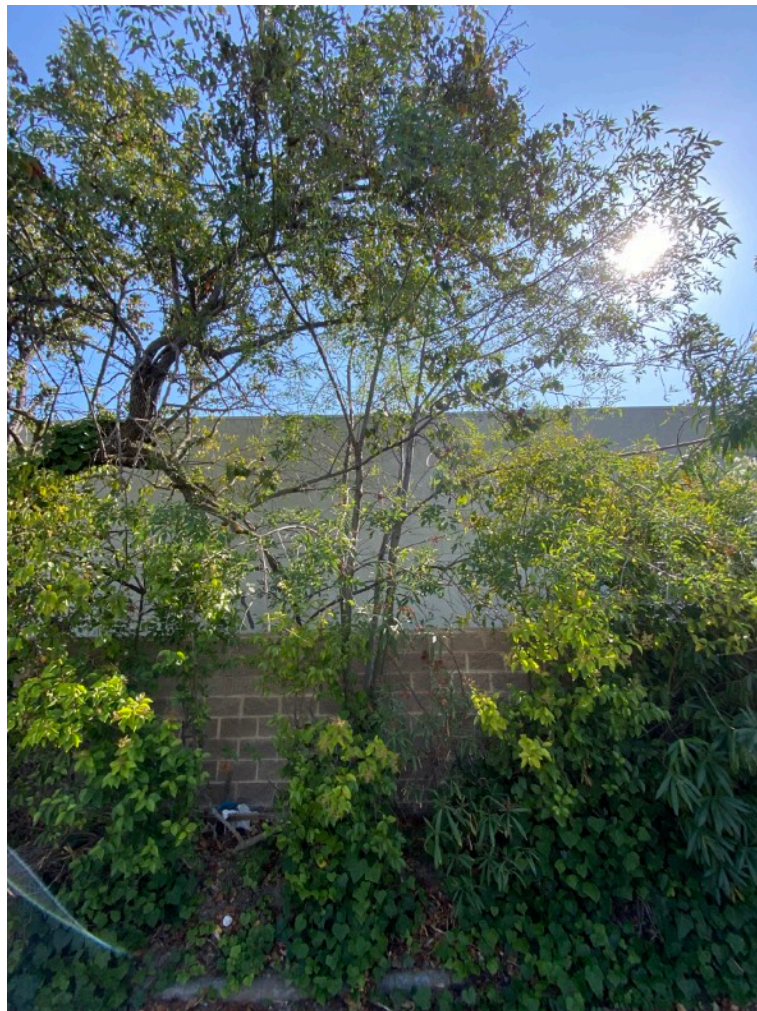
2004	Raywood Ash	Fraxinus Angustifolia	Multi - stem Creating a D.B.H. of 6"	30'	9'	Fair
------	-------------	--------------------------	--	-----	----	------

Observations: This tree is not viable for landscape use.
Recommendations: Remove

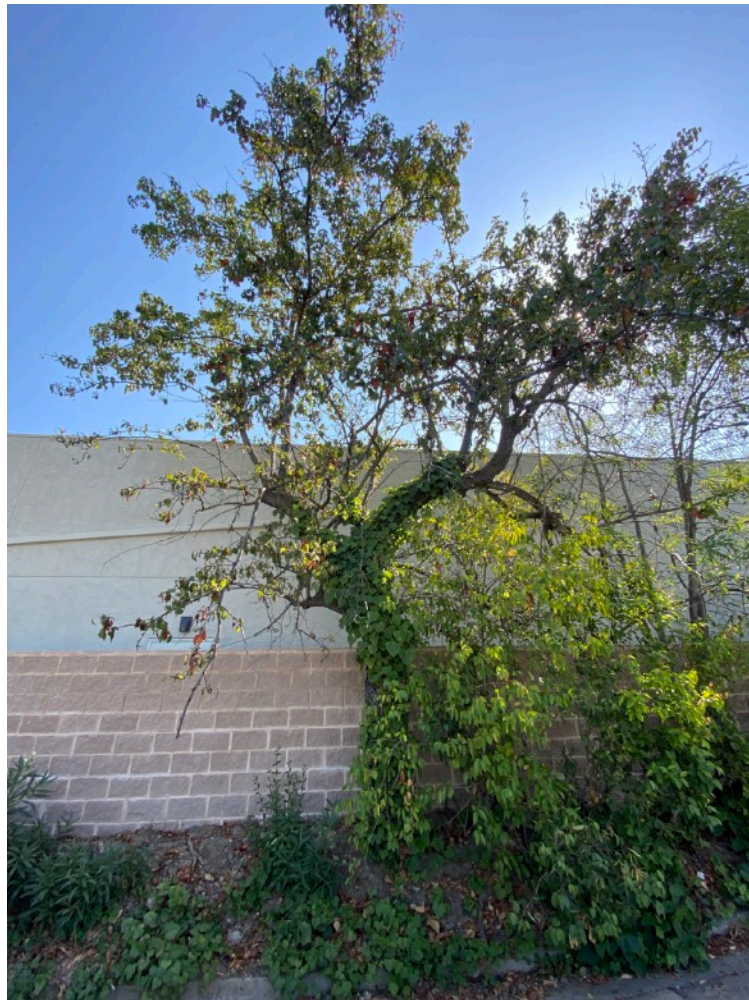
2005	Evergreen Pear	Pyrus Kawakamii	18"	31'	25'	Poor
-------------	----------------	-----------------	-----	-----	-----	------

Observations: This tree is not viable for landscape use.
Recommendations: Remove

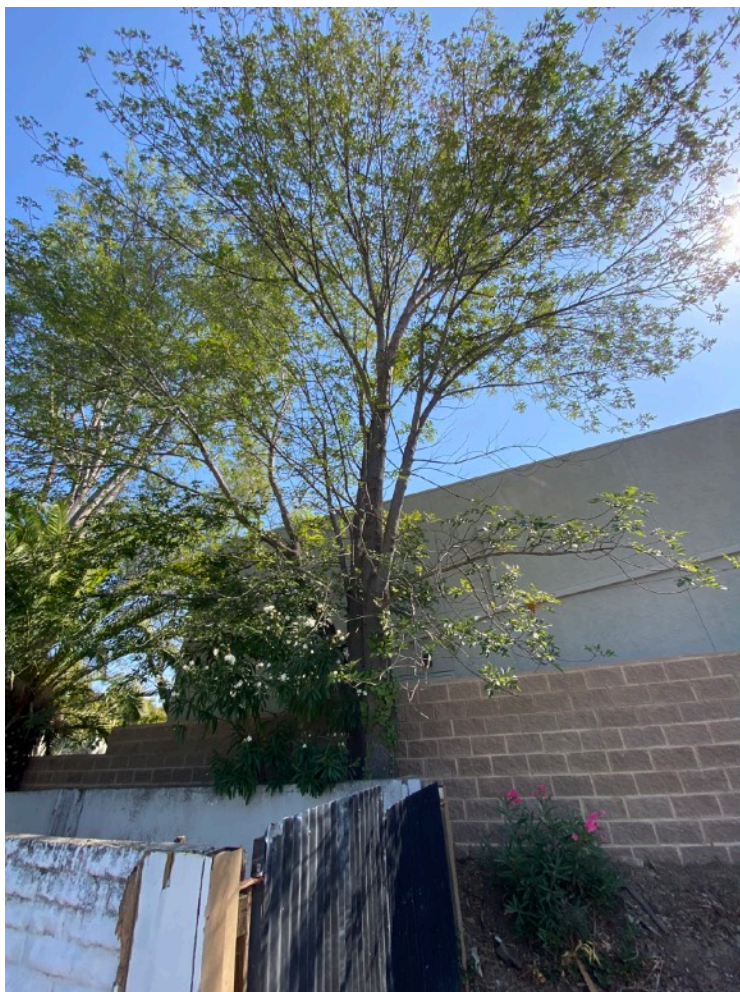
2006	Raywood Ash	Fraxinus Angustifolia	Multi - stem Creating a D.B.H. of 22"	50'	32'	Fair
-------------	-------------	--------------------------	---	-----	-----	------

Observations: This tree is not viable for landscape use.
Recommendations: Remove

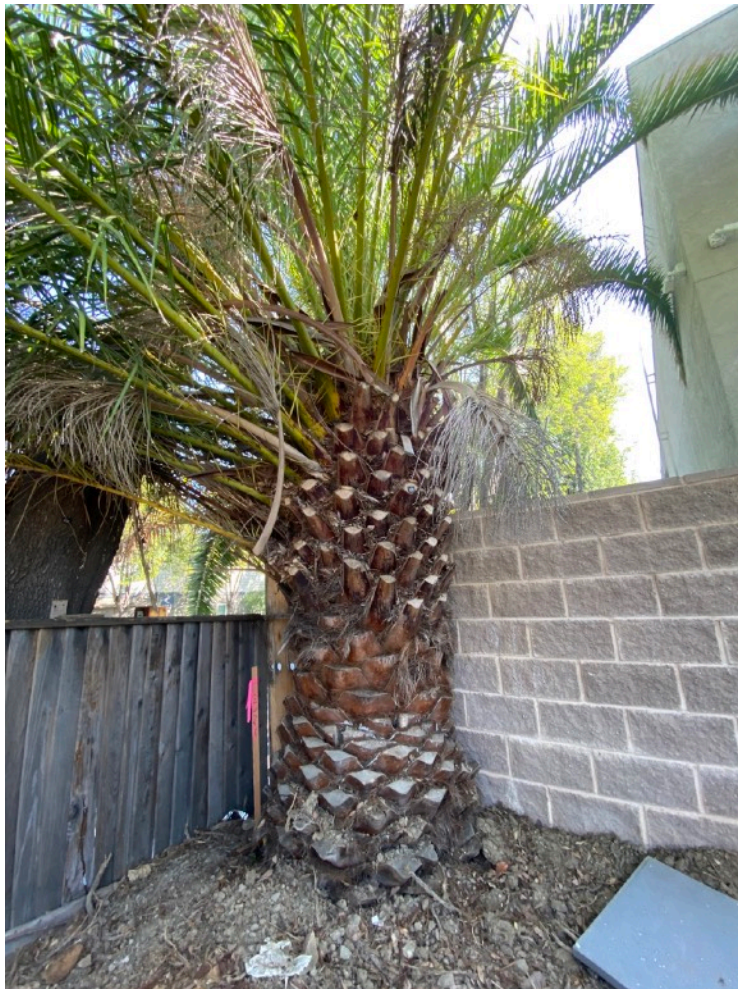
2007	Canary Island Date Palm	Phoenix Canariensis	26"	20'	35'	Fair
-------------	----------------------------	------------------------	-----	-----	-----	------

Observations: This tree is not viable for landscape use.
Recommendations: Remove

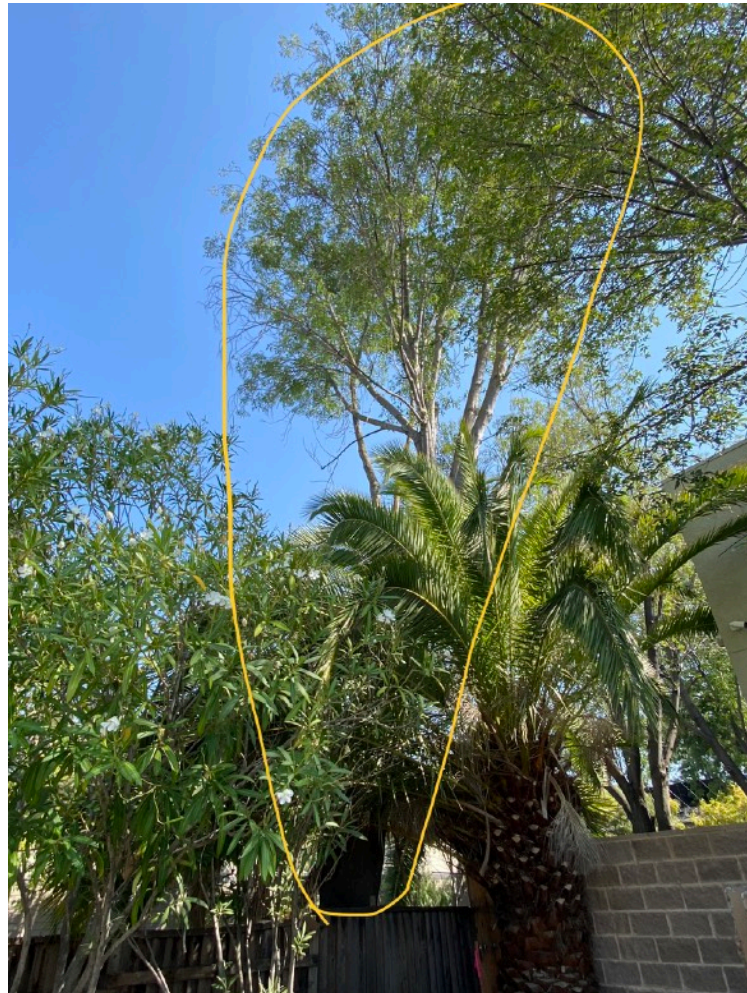
2008	Raywood Ash	Fraxinus Angustifolia	26"	55'	30'	Fair
------	-------------	--------------------------	-----	-----	-----	------

Observations and recommendations : It is highly likely that roots from this tree traverse the property line and are situated on the subject lot, therefore it is imperative that there be no trench excavation along the property line. Any excavation that is required in this area should be preformed using hand tools to locate roots 2 inches or larger in diameter.

Excavating for the foundation footing, along the east side of the proposed construction, from the south corner, 30' northward and 30' westward, Moki will need to oversee the excavation for the foundation in order to monitor the cutting of major lateral roots. In order to ensure the roots are properly clean cut and treated to minimize the impact on the tree (tag 2008) with a 30" trunk diameter.

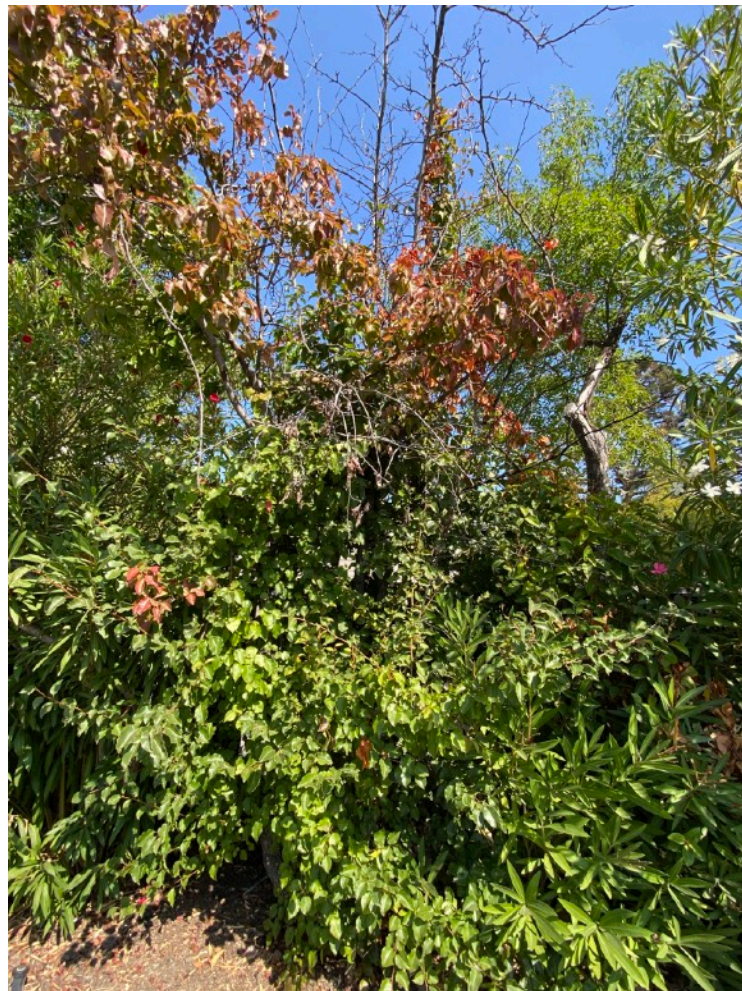
2009	Bradford Flowering Pear	Pyrus calleryana	Multi - stem Creating a D.B.H. of 6"	12'	6'	Poor
------	----------------------------	---------------------	--	-----	----	------

Observations: This tree is not viable for landscape use.
Recommendations: Remove

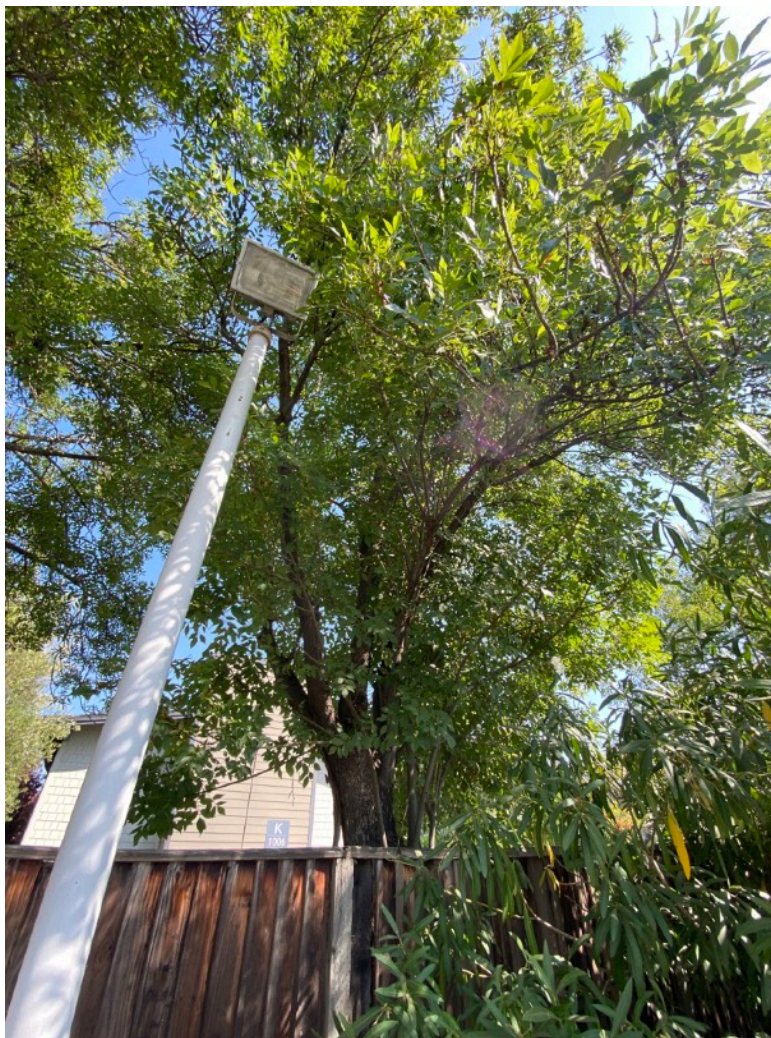
2010	Raywood Ash	Fraxinus Angustifolia	15"	28'	20'	Fair
-------------	-------------	--------------------------	-----	-----	-----	------

Observations and recommendations : It is highly likely that roots from this tree traverse the property line and are situated on the subject lot, therefore it is imperative that there be no trench excavation along the property line. Any excavation that is required in this area should be preformed using hand tools to locate roots 2 inches or larger in diameter.

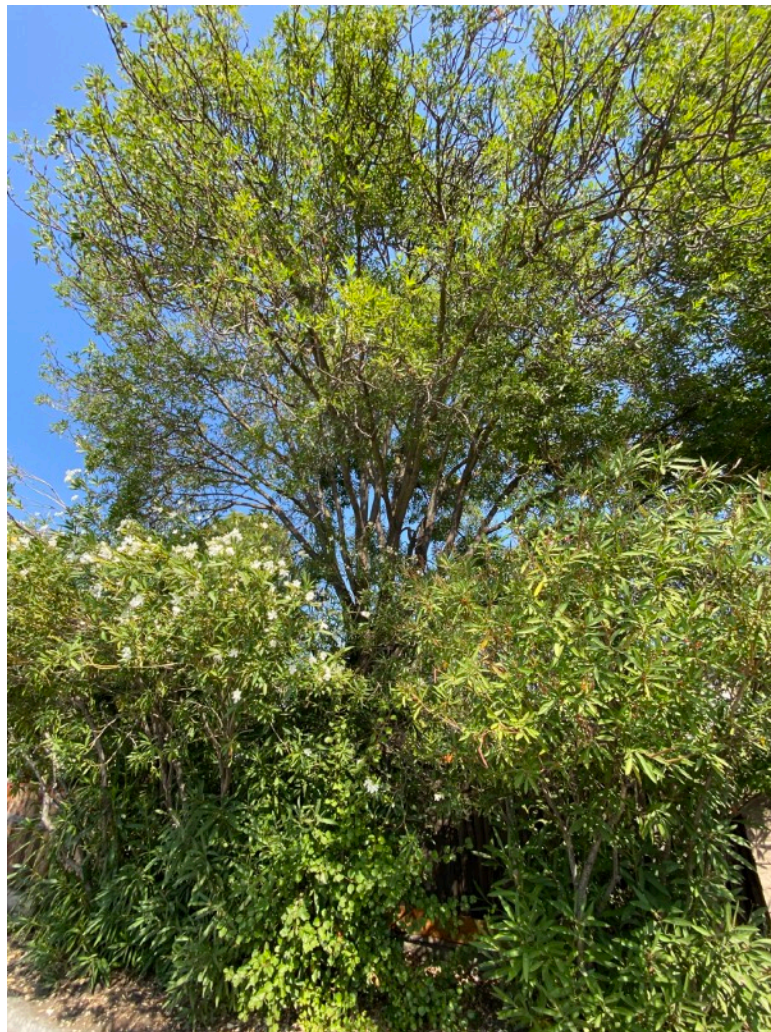
2011	Raywood Ash	Fraxinus Angustifolia	18"	30'	35'	Fair
------	-------------	--------------------------	-----	-----	-----	------

Observations and recommendations : It is highly likely that roots from this tree traverse the property line and are situated on the subject lot, therefore it is imperative that there be no trench excavation along the property line. Any excavation that is required in this area should be preformed using hand tools to locate roots 2 inches or larger in diameter.

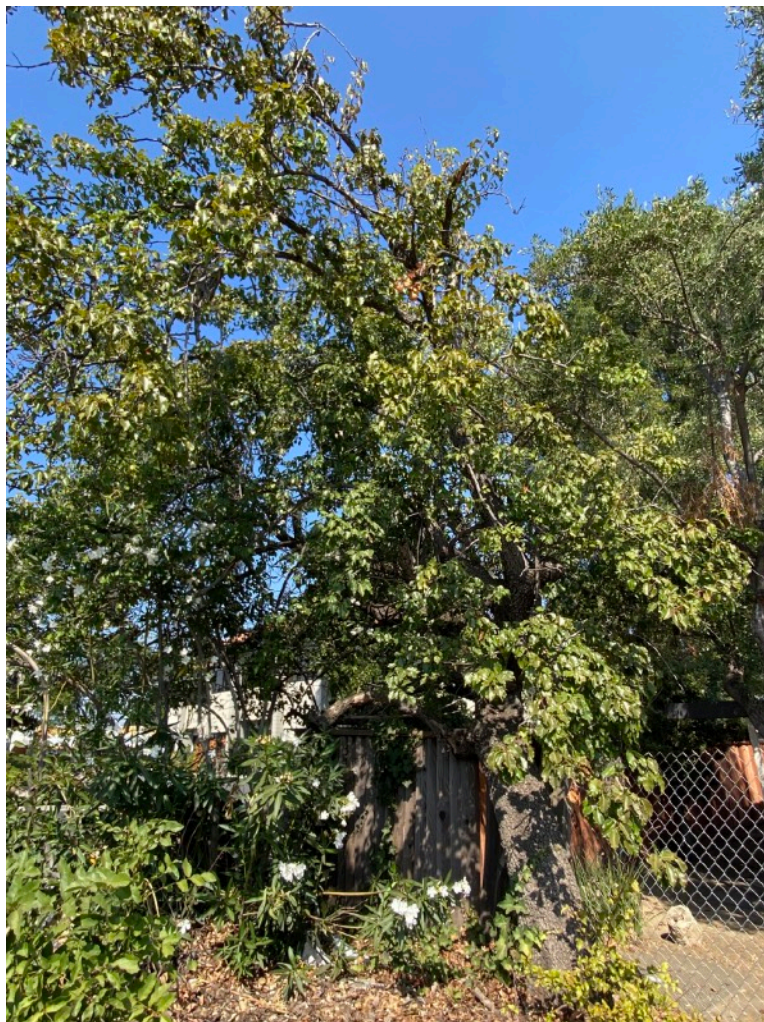
2012	Evergreen Pear	Pyrus Kawakamii	14"	20'	30'	Poor
-------------	----------------	-----------------	-----	-----	-----	------

Observations: This tree is not viable for landscape use.
Recommendations: Remove

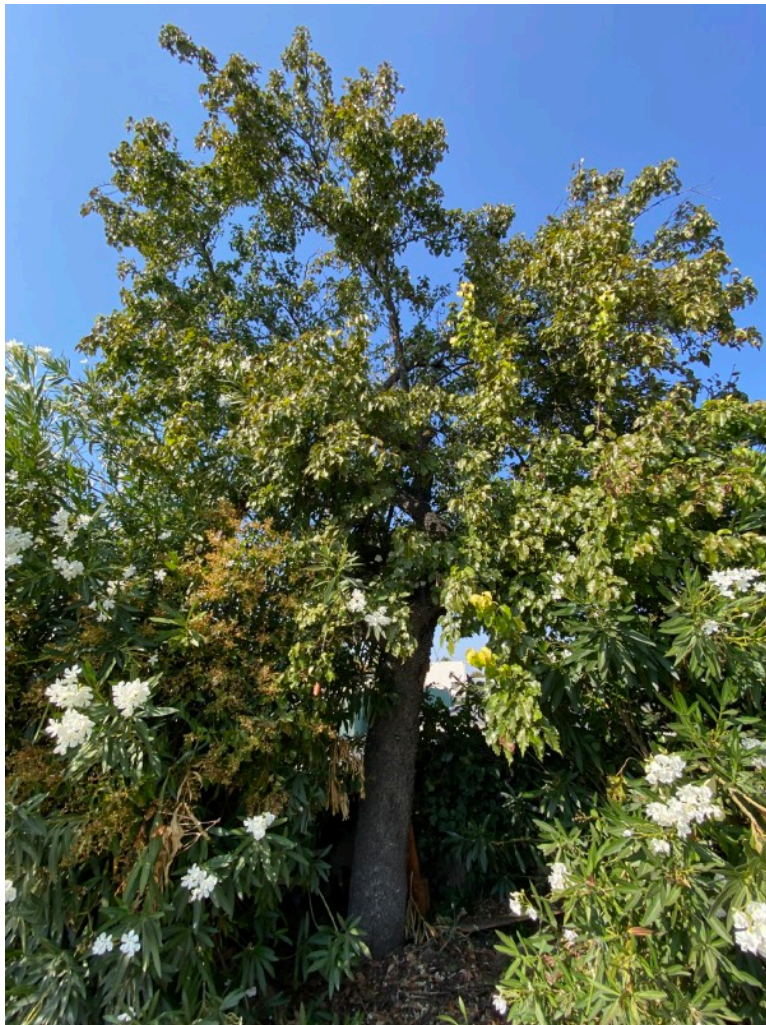
2013	Evergreen Pear	Pyrus Kawakamii	15"	35'	32'	Fair
-------------	----------------	-----------------	-----	-----	-----	------

Observations: This tree is not viable for landscape use.
Recommendations: Remove

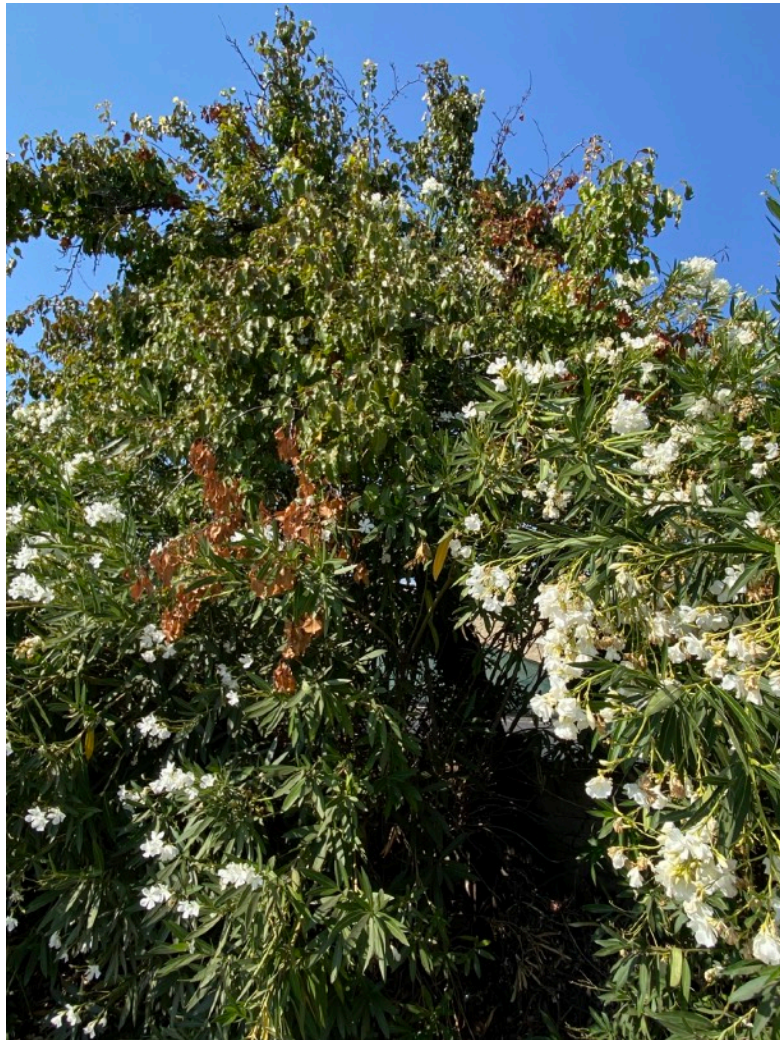
2014	Evergreen Pear	Pyrus Kawakamii	10"	16'	27'	Poor
------	----------------	-----------------	-----	-----	-----	------

Observations: This tree is not viable for landscape use.
Recommendations: Remove

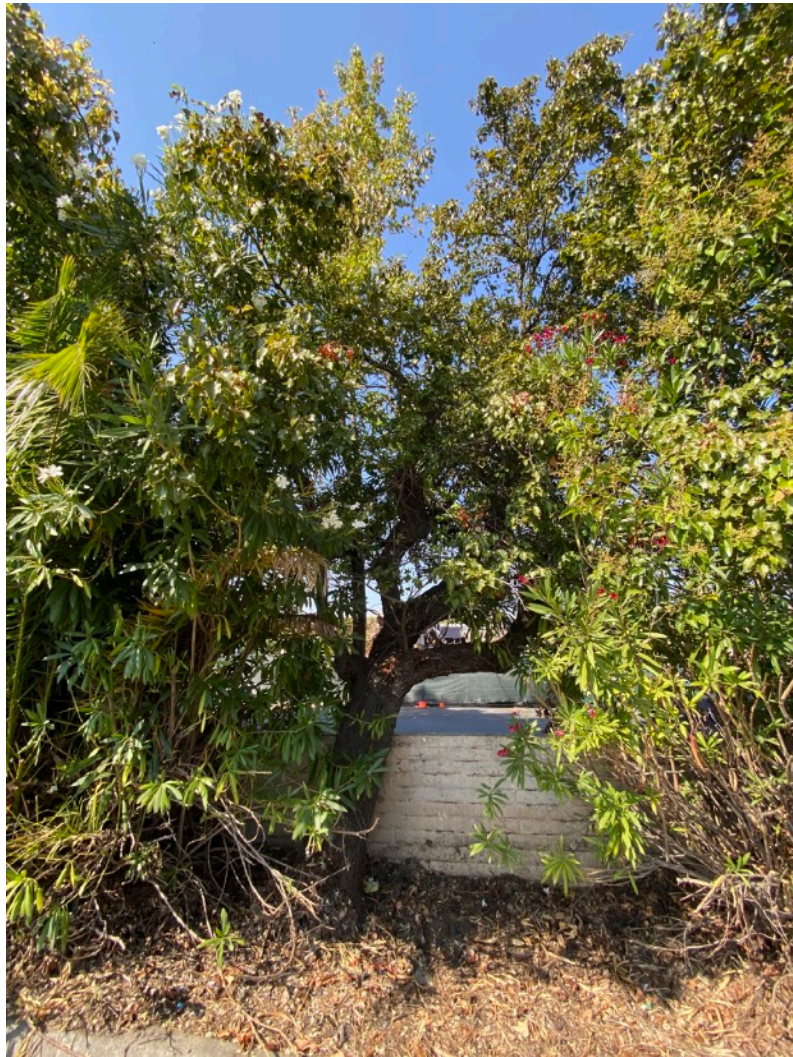
2015	Evergreen Pear	Pyrus Kawakamii	14"	27'	35'	Poor
------	----------------	-----------------	-----	-----	-----	------

Observations: This tree is not viable for landscape use.
Recommendations: Remove

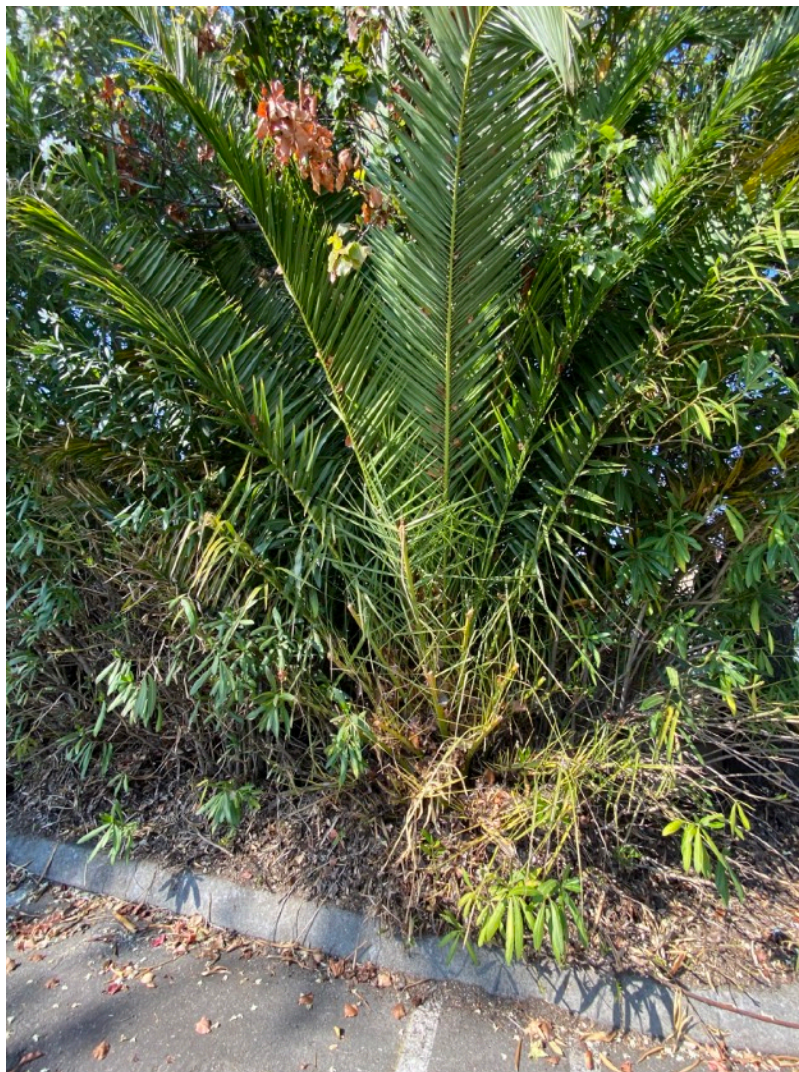
2016	Canary Island Date Palm	Phoenix Canariensis	25"	12'	15'	Poor
-------------	----------------------------	------------------------	-----	-----	-----	------

Observations: This tree is not viable for landscape use.
Recommendations: Remove

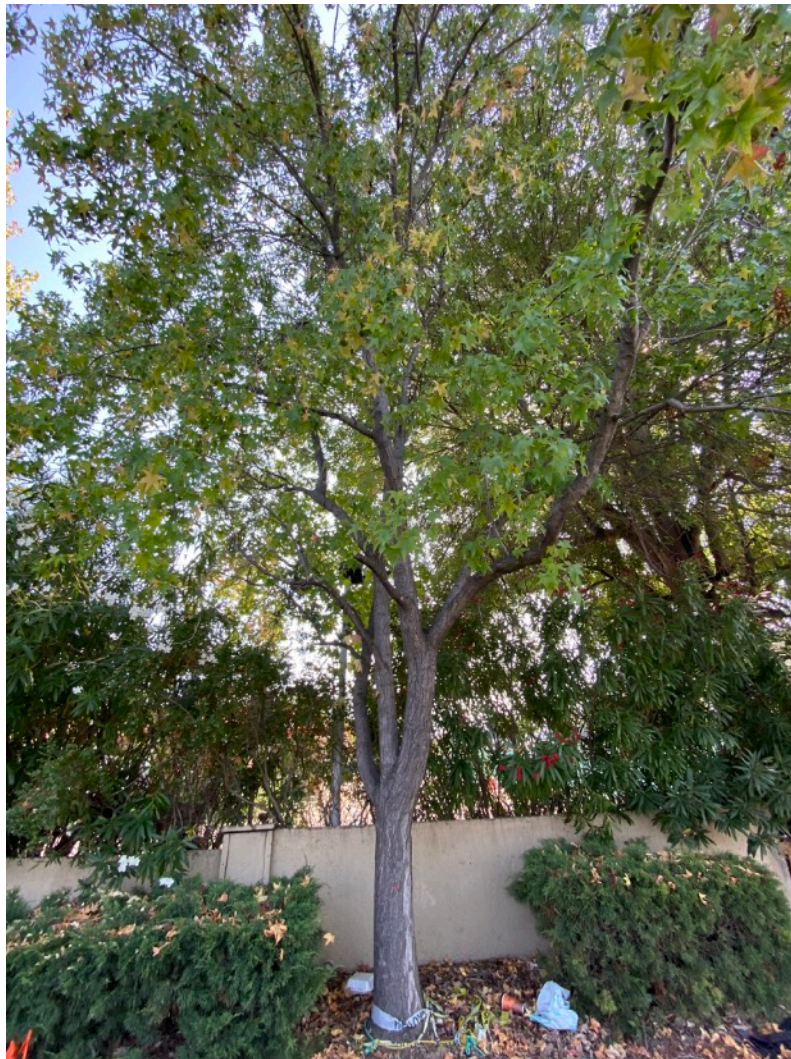
2017	Sweetgum	Liquidambar Styraciflua	12"	27'	35'	Fair
------	----------	----------------------------	-----	-----	-----	------

Observations and recommendations: Based on the proposed construction plans we do not anticipate any negative impact on this tree.

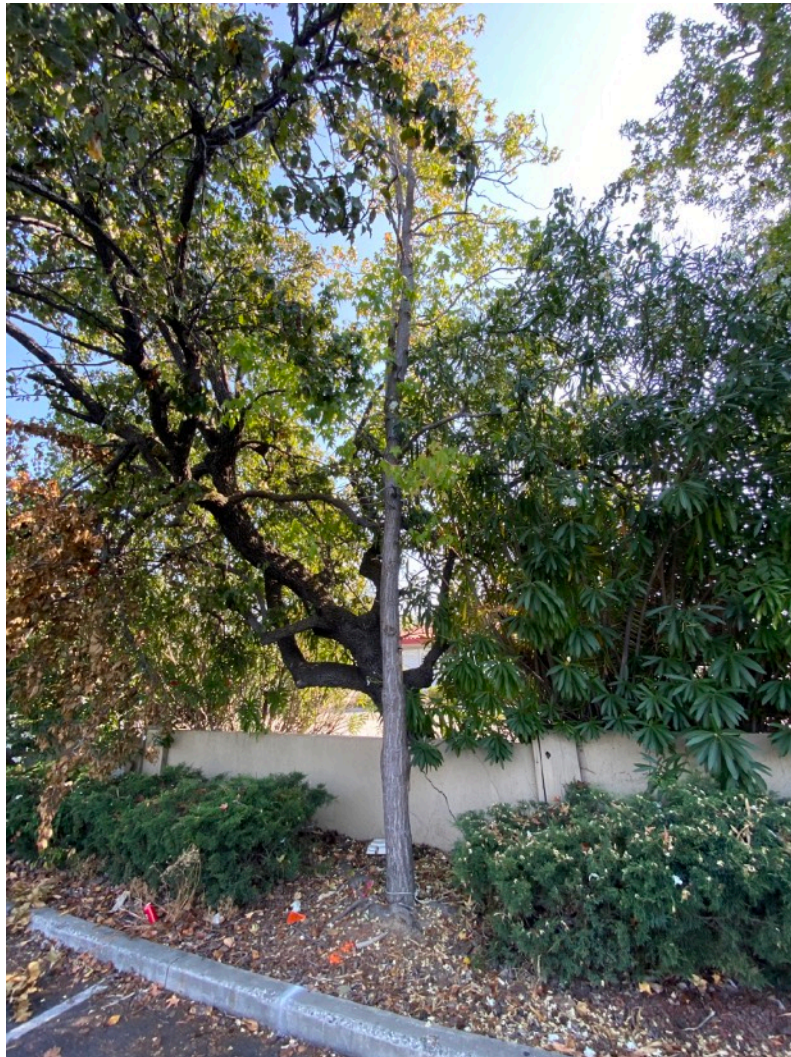
2018	Sweetgum	Liquidambar Styraciflua	7"	35'	7'	Poor
-------------	----------	----------------------------	----	-----	----	------

Observations and recommendations: Based on the proposed construction plans we do not anticipate any negative impact on this tree.

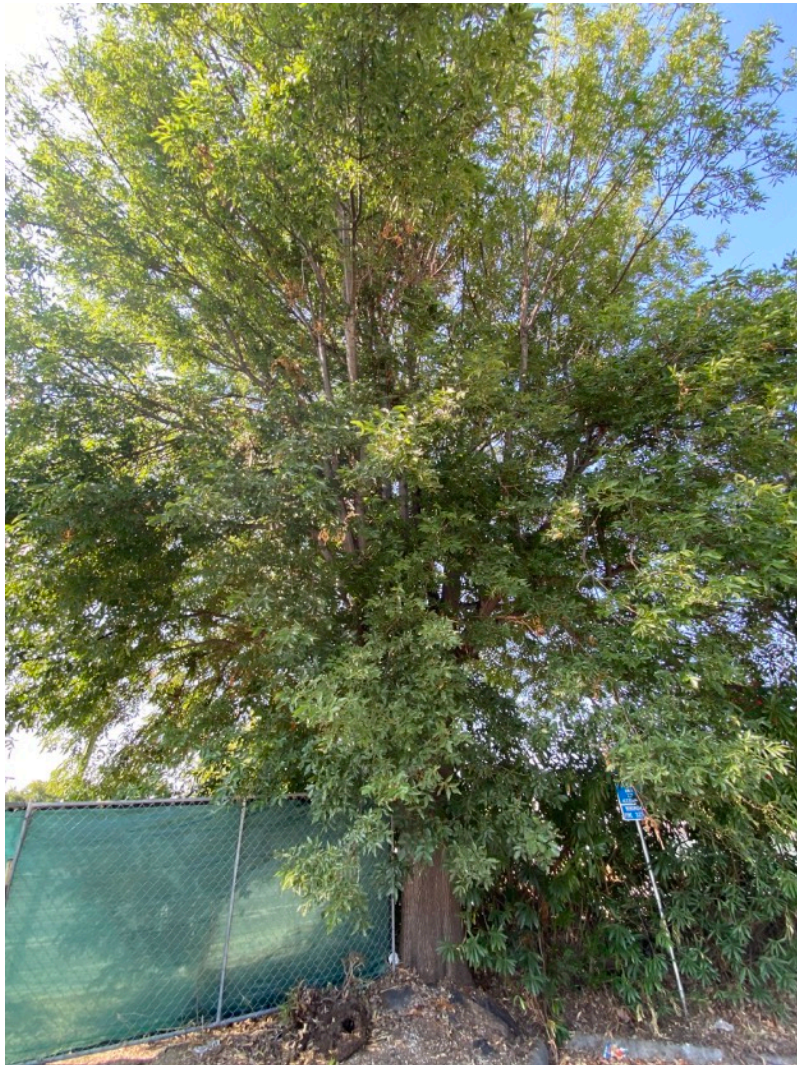
2019	Raywood Ash	Fraxinus Angustifolia	28"	60'	45'	Poor
------	-------------	--------------------------	-----	-----	-----	------

Observations: This tree is not viable for landscape use.
Recommendations: Remove
