Phase I Environmental Site Assessment Report

**Parcel Number 0459-053-54
Adelanto, California**

**Converse Project No. 22-16-122-01
April 4, 2022**

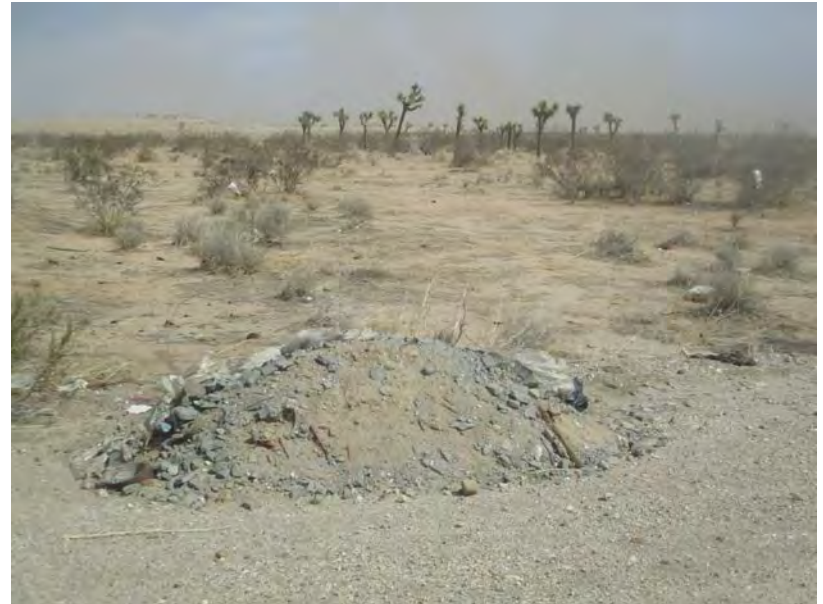
- A pile of construction material (concrete, sand and dirt) appeared dumped along the south side of the Subject Property.
- Discarded trash (paper, wood, plastic), automobile car seats and tires were observed on the south and east Property boundaries.
- Blown in trash in the form of paper and plastic was observed throughout the Subject Property.
- Buried fiber optics were observed bordering the eastern Property boundary.
- A petroleum pipeline is located along Adelanto Road.

- The construction material, discarded trash and blown in trash are not RECs, as no signs of staining on the soil was observed.
- The fiber optic line located along the east side of the Property is not a REC.

Construction debris.

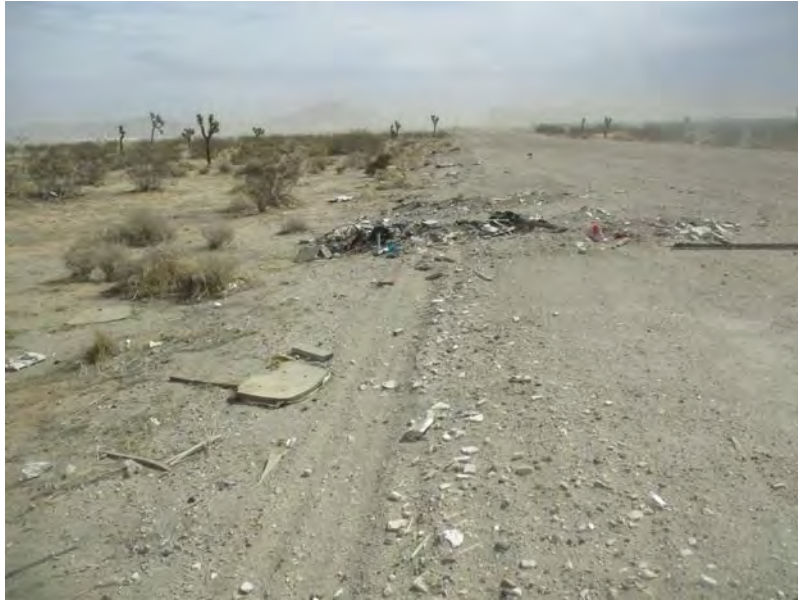
View of trash along south Property boundary.

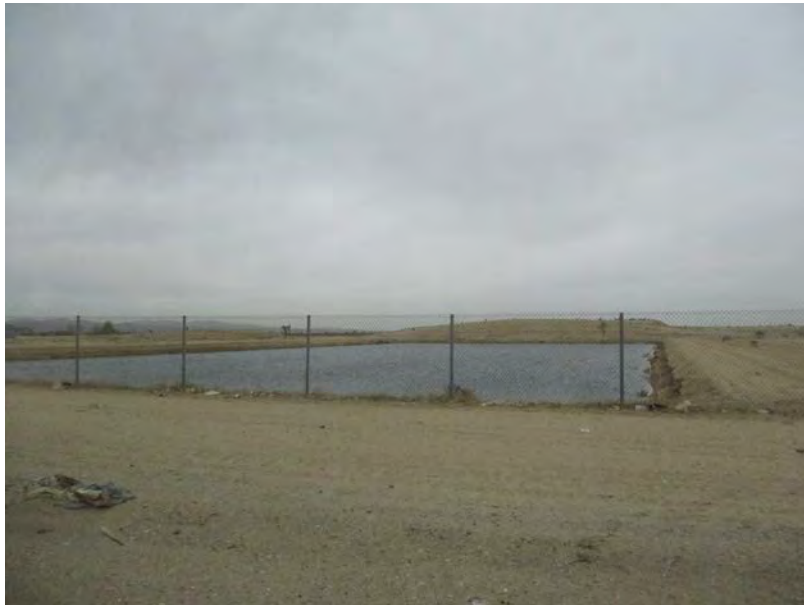
- Adelanto WWTP, located at 19101 Jonathan Street, adjacent to the north-northwest of the Subject Property is identified on the WDR Waste Discharge database. This site is an active wastewater treatment facility and groundwater has been identified as contaminated with nitrate as Nitrogen (N). Groundwater monitoring wells have been installed in and around the facility, with the highest concentration of nitrate as N located in MW-8, which is located at least ½ mile from the Property. Nitrate as N was found to be below the action level in the latest groundwater sampling event, April 2020, and has shown a consistent decrease since 2018. Semi-annual groundwater sampling is ongoing, and to date no remediation has been deemed warranted. The RWQCB is providing local oversight.

North adjacent WWTP.

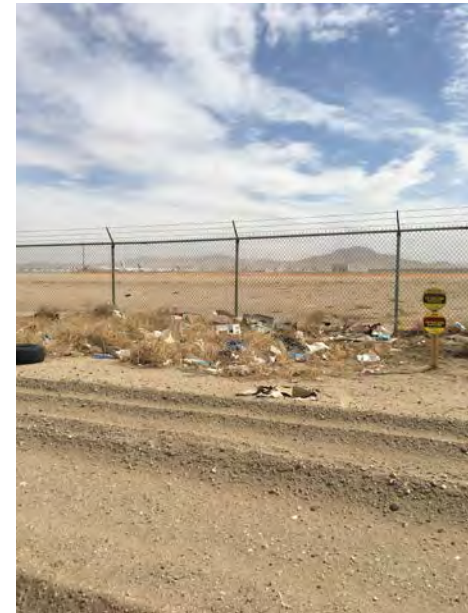
- The hazardous liquid pipeline is operated by Calnev Pipeline Co. (Operator ID No. 26125) and consists of a 16.79 mile long pipeline containing Non-HVL Product.

Pipeline located along Adelanto Road.
