# Appendix I

PEI Project #23-5794A

**Subject: June 7, 2024 Phase I Environmental Site Assessment Addendum  
Limited Soil Pile Excavation Observations  
Summer Villas - 9350 Sheldon Road, Elk Grove, 95624**

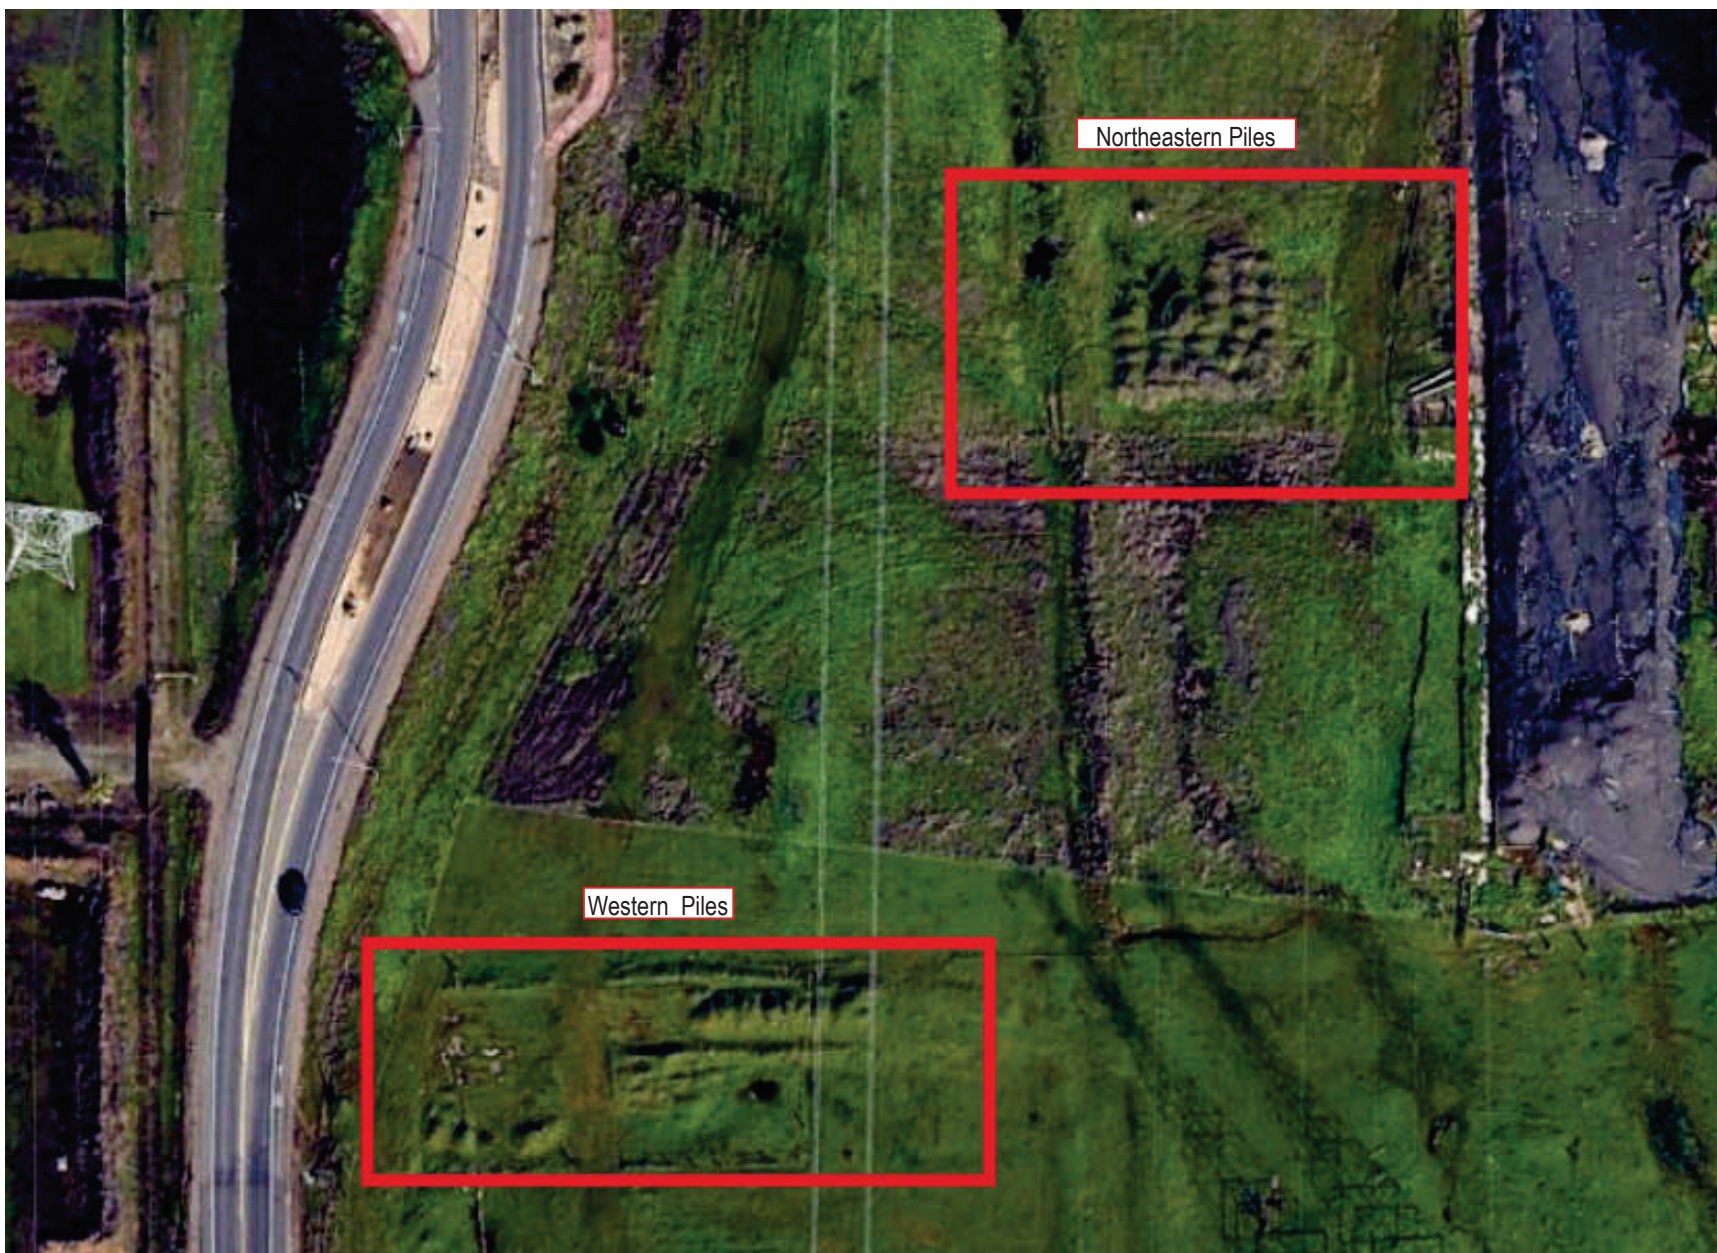
1

In an effort to address the concerns of EGPD, PEI completed oversight of trenching efforts associated with “additional stockpiles identified by Geocon” on the northeastern and western portions of the property (see **Figure 1**).

For the "additional soil piles" identified by Geocon on the northeastern and western portions of the property (**Figure 1**), 22 trenches/exavations were completed in these areas. Twelve trenches were completed on soil piles in the northeastern portion of the property (**Figure 2**) and ten trenches were completed on the western portion of the property (**Figure 3**). With the exception of Trench 21 in the western portion of the property, no significant debris, staining, odor, or volatile component impacts were detected during the exploratory trenching in the 22 completed trenches.

Soil Piles Identified by Geocon/City of Elk Grove  
Summer Villas – 9350 Sheldon Road, Elk Grove, CA

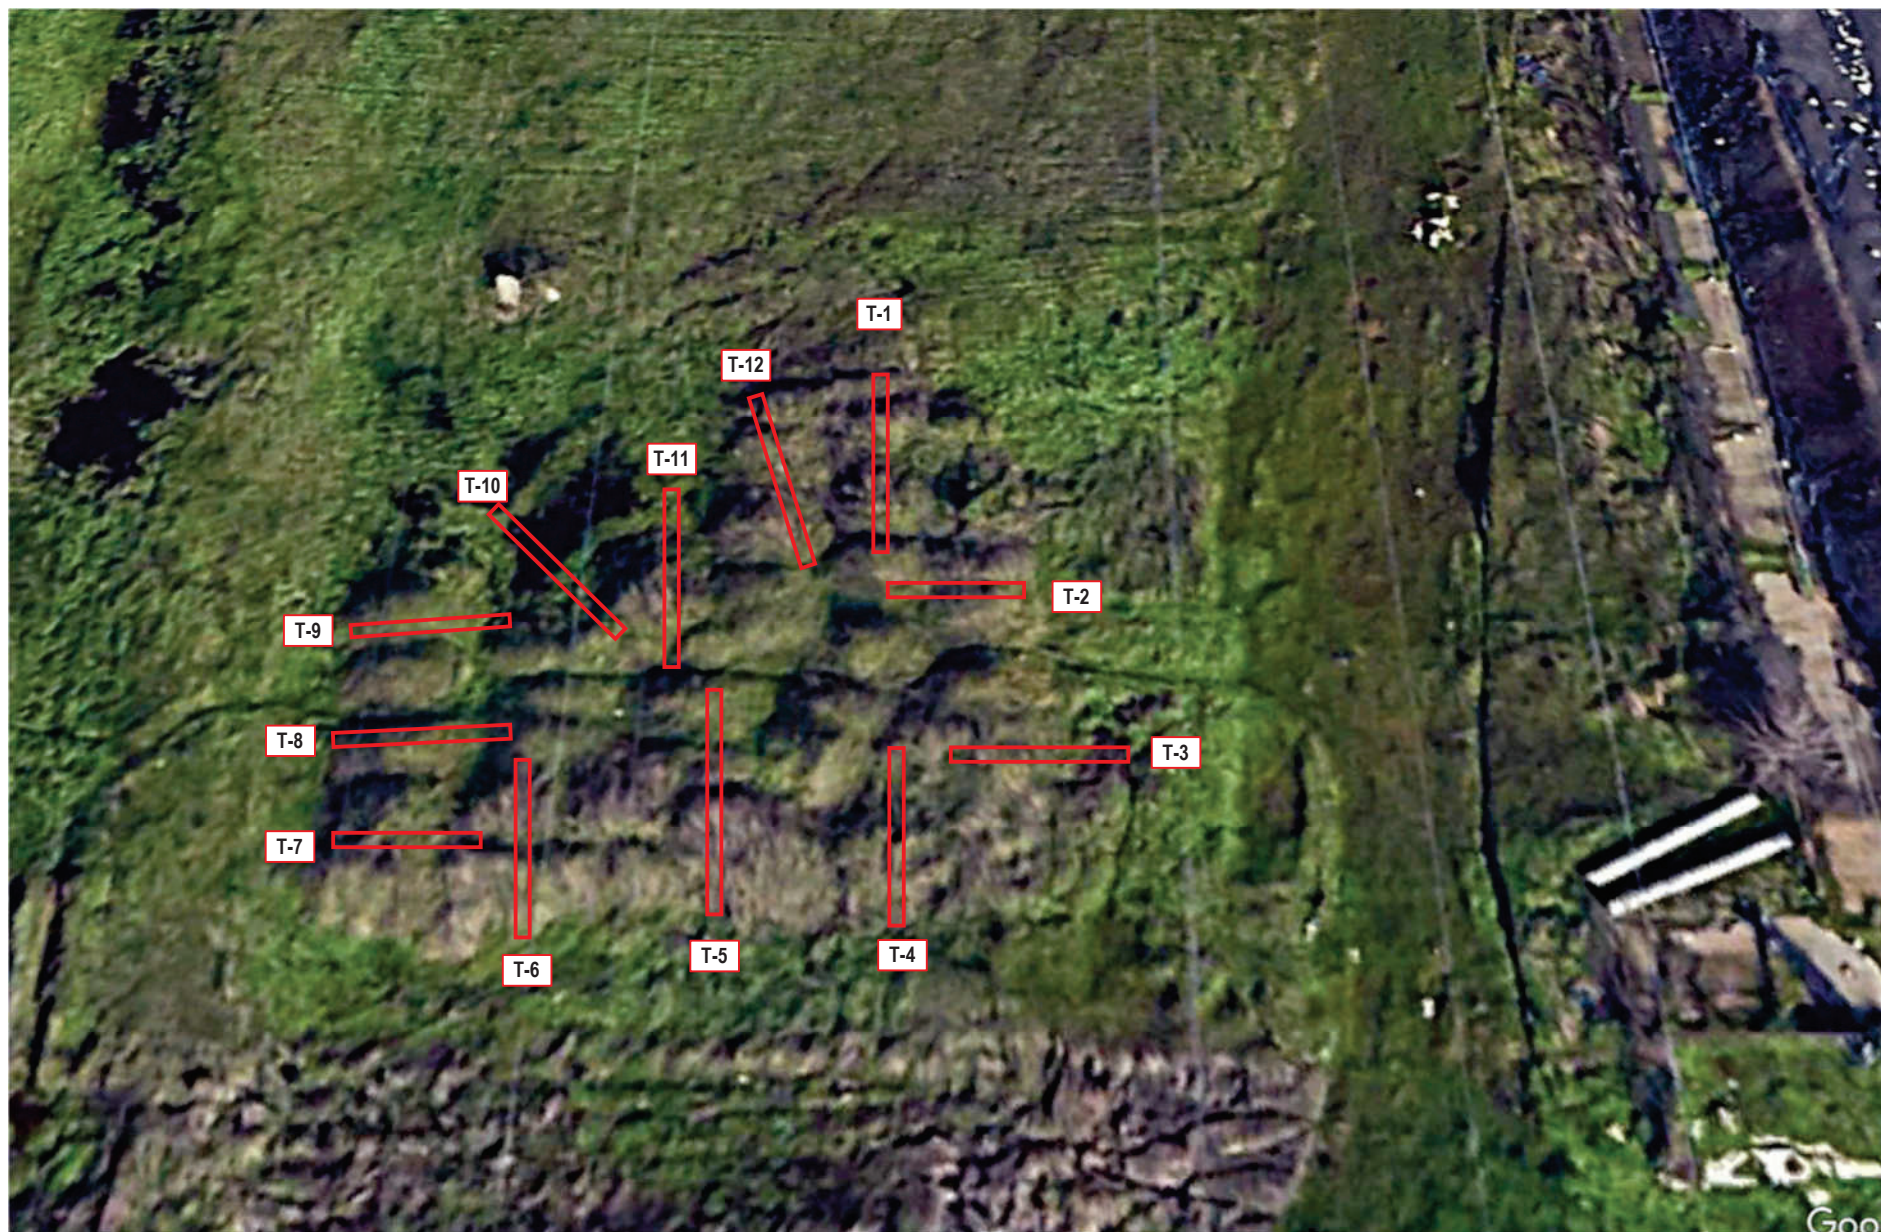
2

With the exception of a small piece of 1-inch PVC piping in trench T-6, no debris was noted in the 12 trenches completed in the northeastern soil piles. The soils observed in the trenches contained no visual indications of staining. The soils observed in the trenches contained no indications of odors indicative of environmental impacts (e.g., hazardous constituents of concern). In addition, a soil sample from each trench was collected into a Ziploc bag for field screening with a PID calibrated to an isobutane standard. Vapor concentrations for each of the soil samples ranged from 6.5 to 7.3 ppm and did not indicate a concern for constituents of concern with volatile organic compounds (VOCs).

Based on the field observations, no impact with debris or constituents of concern were observed that warranted additional assessment (e.g., soil sampling with laboratory analysis).

Northeastern Soil Piles  
Summer Villas – 9350 Sheldon Road, Elk Grove, CA

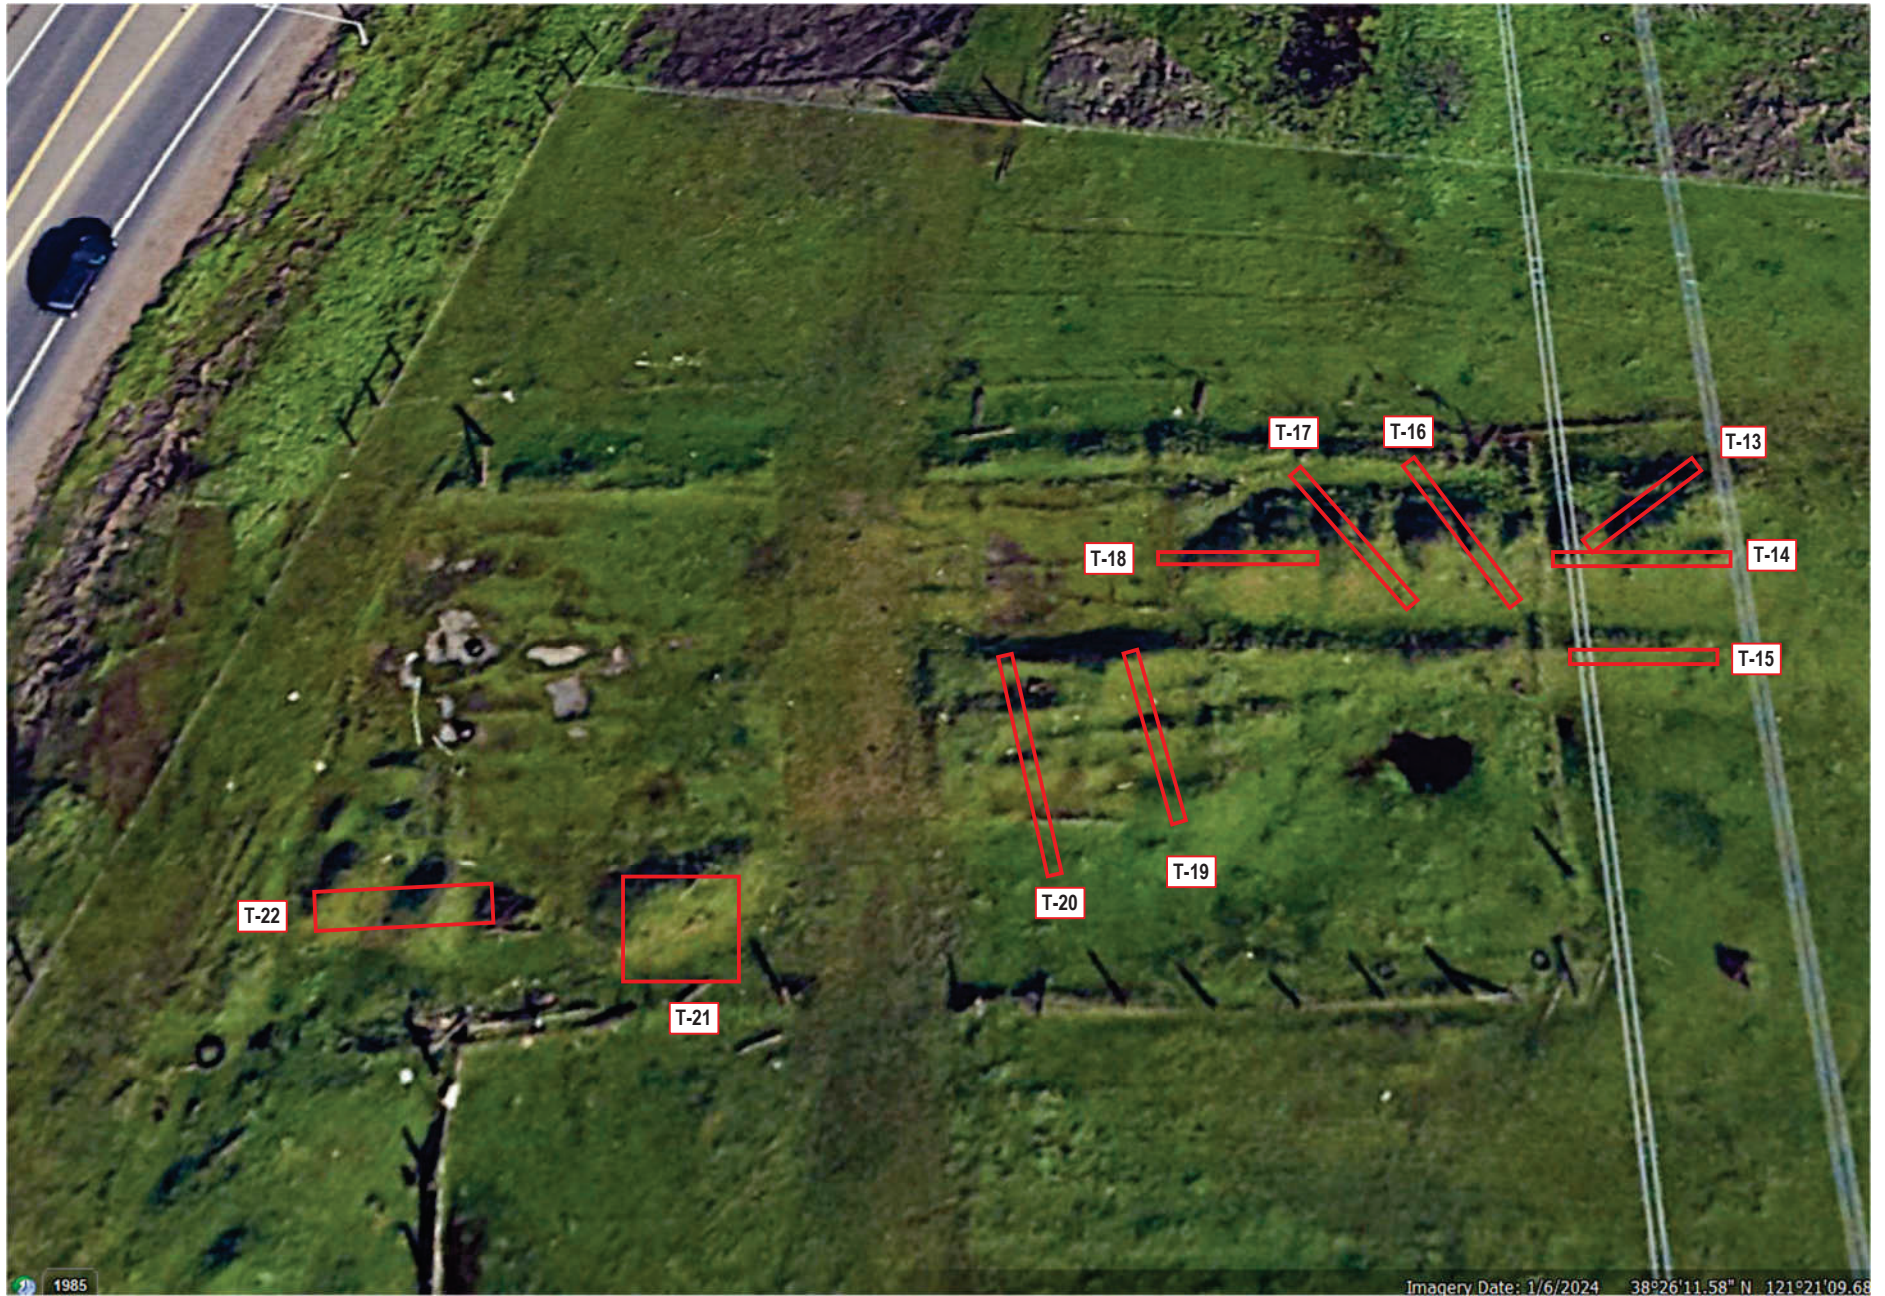
3

Based on the field observations of the ten trenches in the western spoil piles (T13 to T-22), no indications of hazardous constituents of concern were observed that warranted additional assessment (e.g., soil sampling with laboratory analysis).

Western Soil Piles  
Summer Villas – 9350 Sheldon Road, Elk Grove, CA

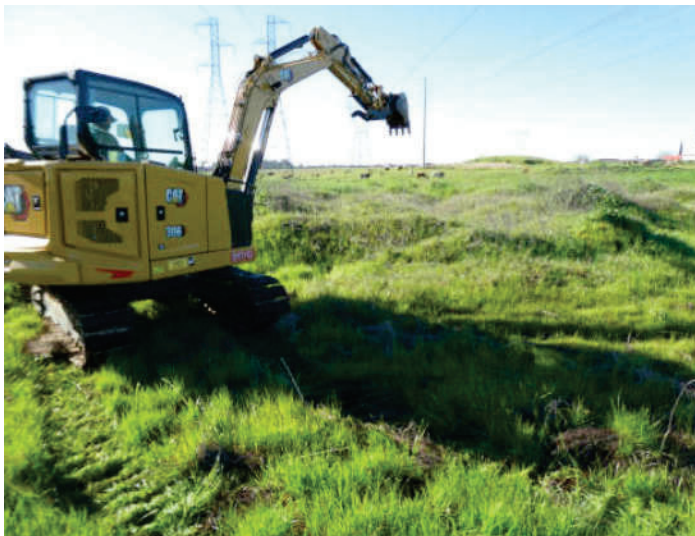
At approximately 8:30 am, PEI met with a client-provided excavator and operator to oversee and observe the trenching efforts. The northern soil piles appear to be approximately 25 individual piles of soil that were laid adjoining each other in an approximate “square” approximately 65 feet by 65 feet. The soil piles ranged in height from 3 to 4 feet high and were substantially covered by seasonal grasses.

Photo #1:  
Northeastern soil piles (pre  
trenching)

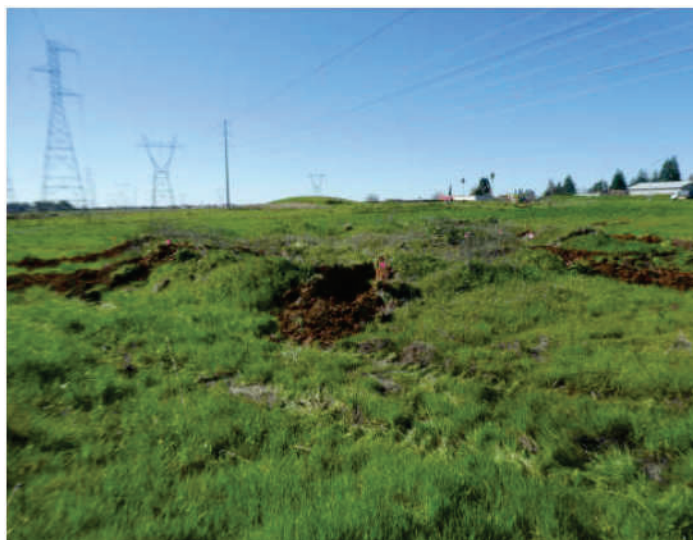
Photo #2:  
Northeastern soil piles  
Exploratory trenches T-1, T-2  
(center & left) and T-12 (right)

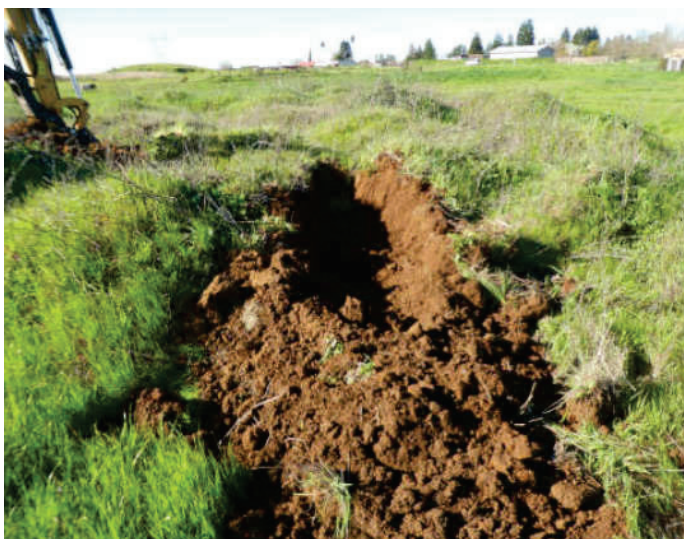
Photo #3:  
Northeastern soil piles  
Trench T-1

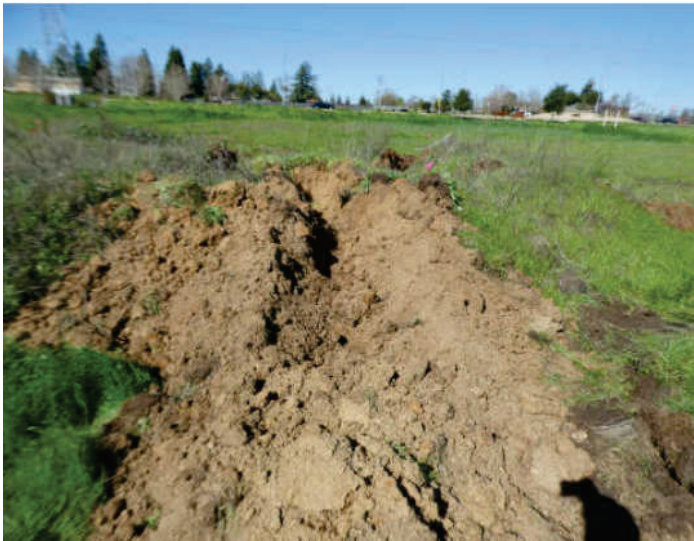
Photo #4:  
Northeastern soil piles  
Trench T-2

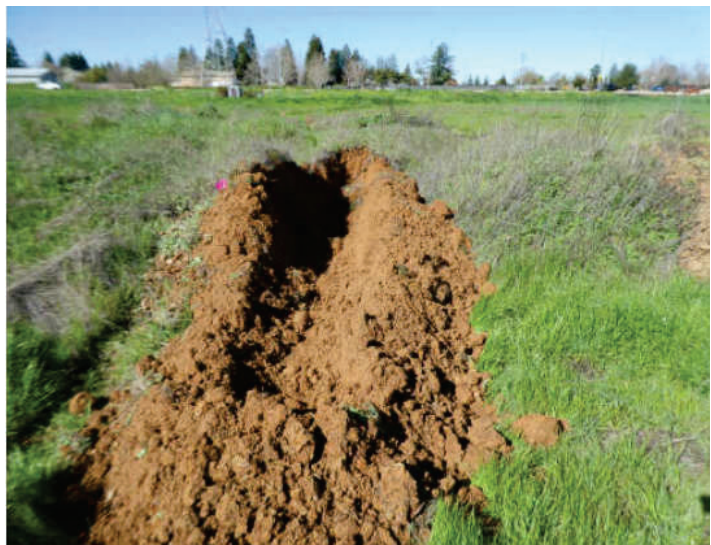
Photo #5:  
Northeastern soil piles  
Trench T-3

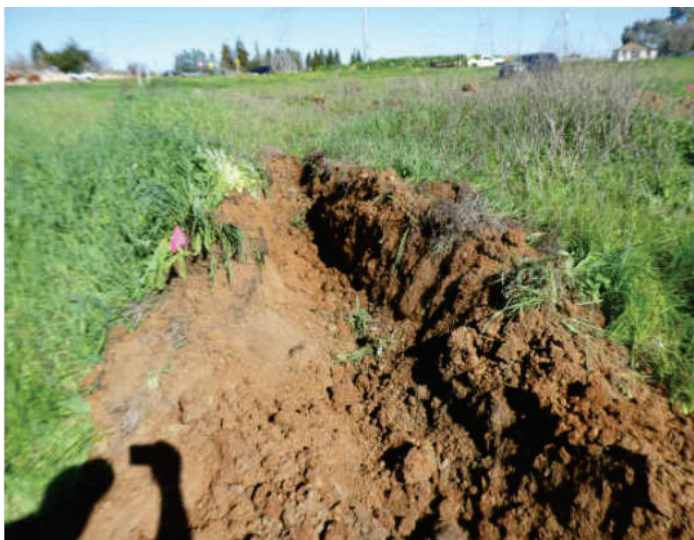
Photo #6:  
Northeastern soil piles  
Trench T-4

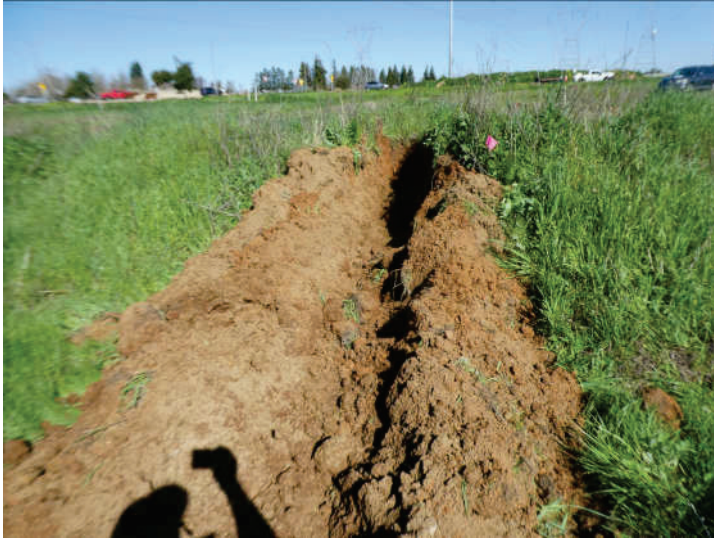
Photo #7:  
Northeastern soil piles  
Trench T-5

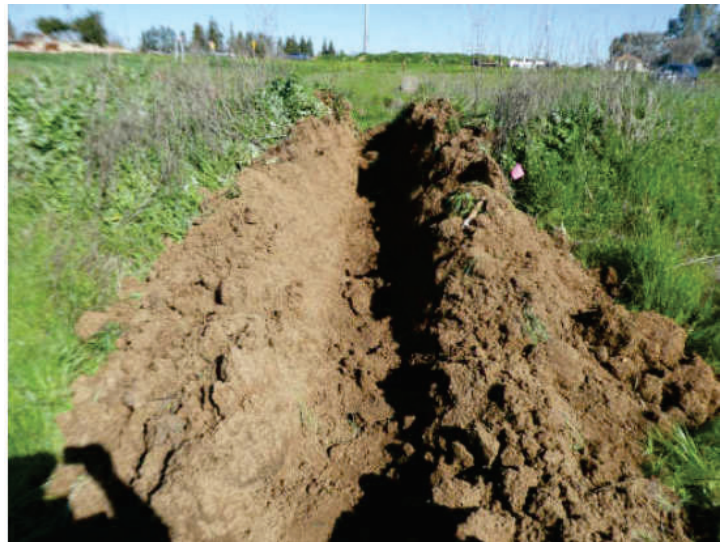
Photo #8:  
Northeastern soil piles  
Trench T-6

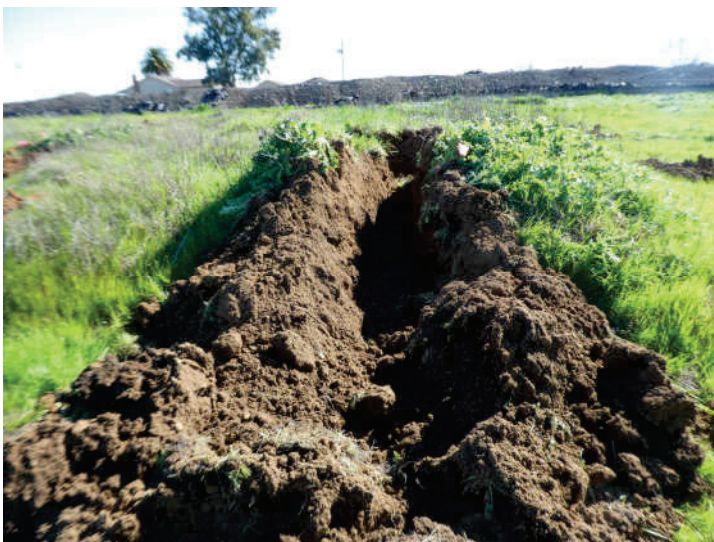
Photo #9:  
Northeastern soil piles  
Trench T-7

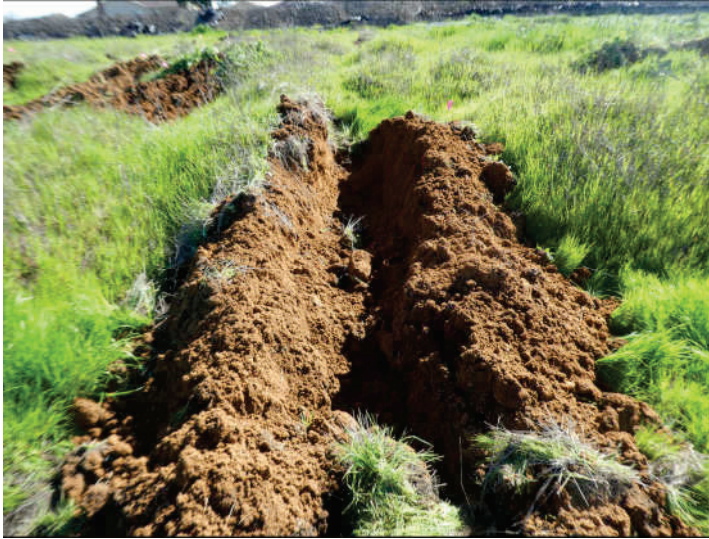
Photo #10:  
Northeastern soil piles  
Trench T-8

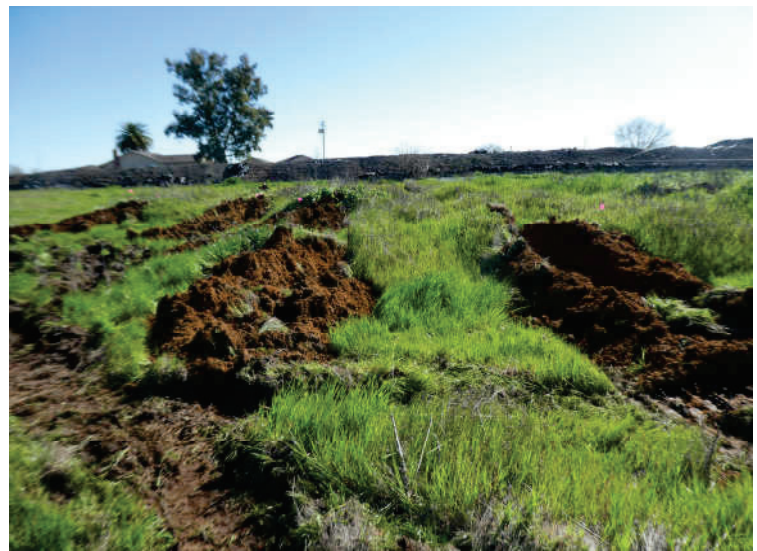
Northeastern soil piles  
Trenches T-8 to T-12  
(left to right)

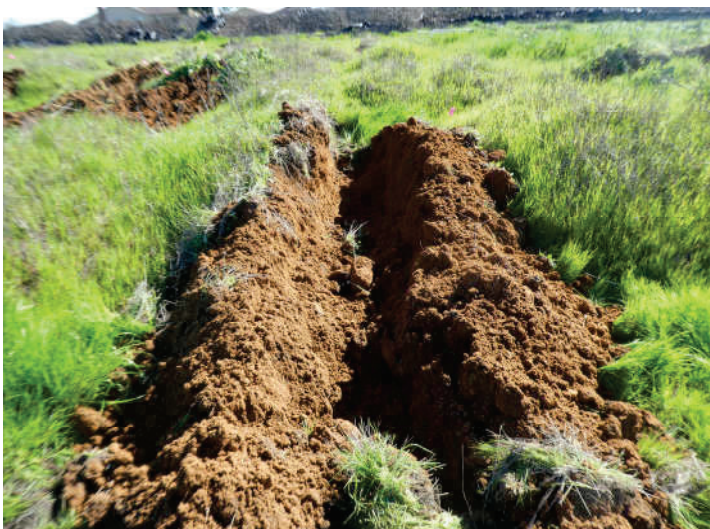
Photo #12:  
Northeastern soil piles  
Trench T-9

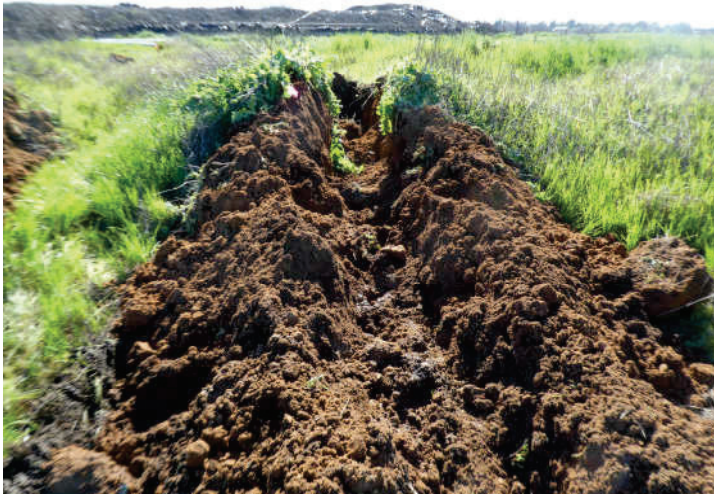
Photo #13:  
Northeastern soil piles  
Trench T-10

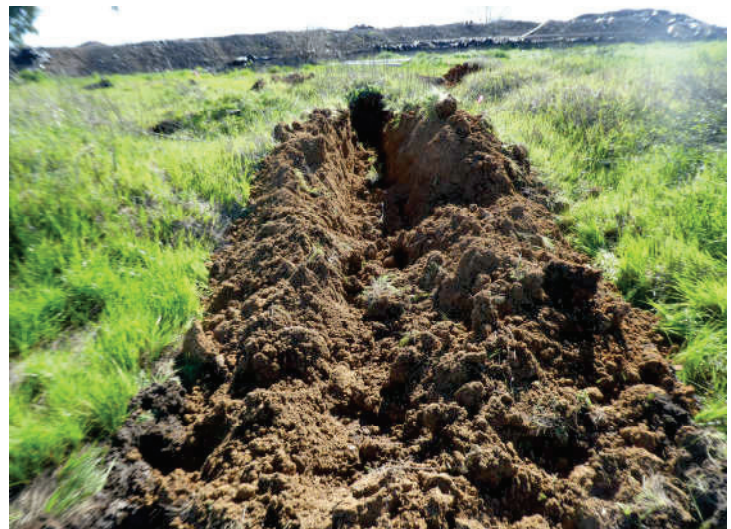
Photo #14:  
Northeastern soil piles  
Trench T-11

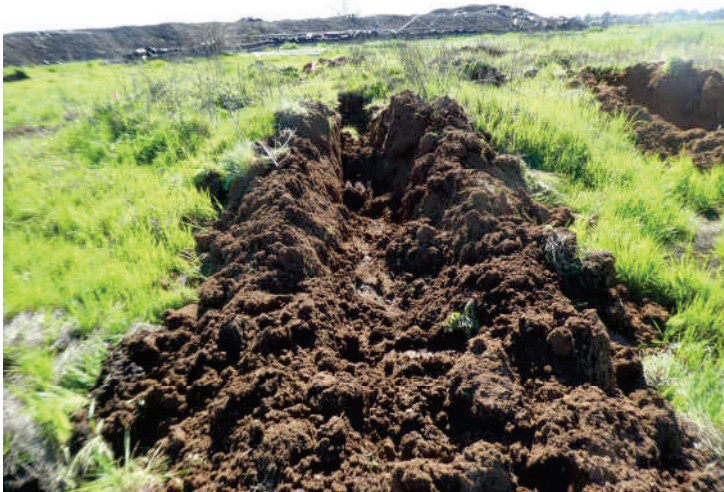
Photo #15:  
Northeastern soil piles  
Trench T-12

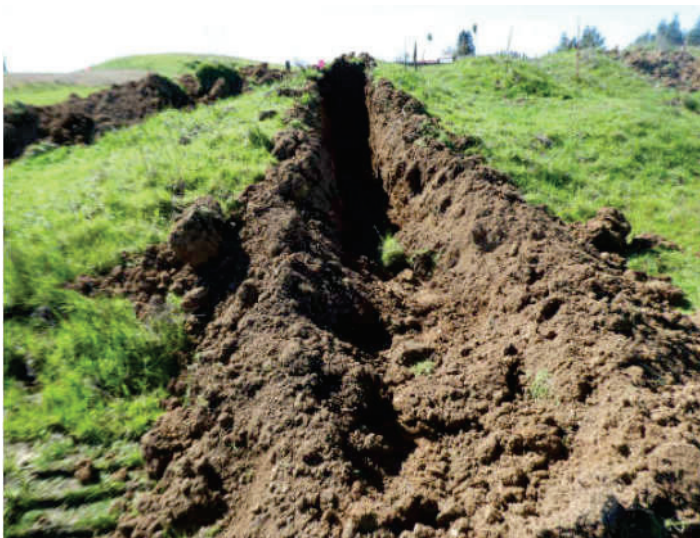
Photo #16:  
Western soil piles  
Trench T-1

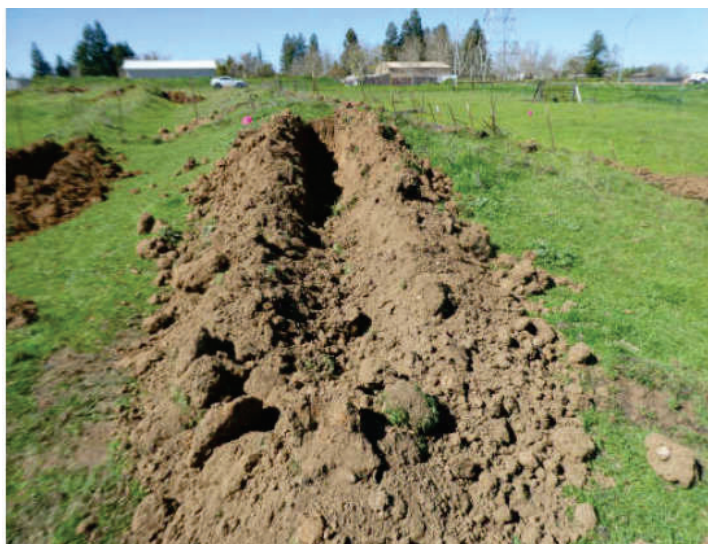
Photo #17:  
Western soil piles  
Trench T-2

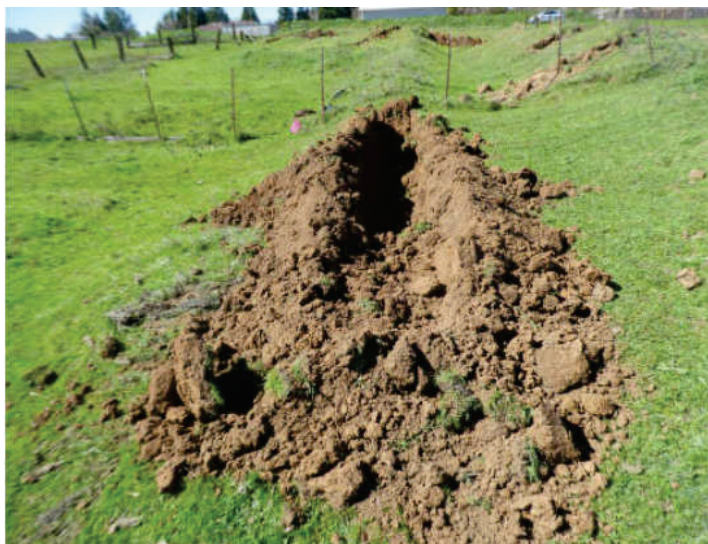
Photo #18:  
Western soil piles  
Trench T-3

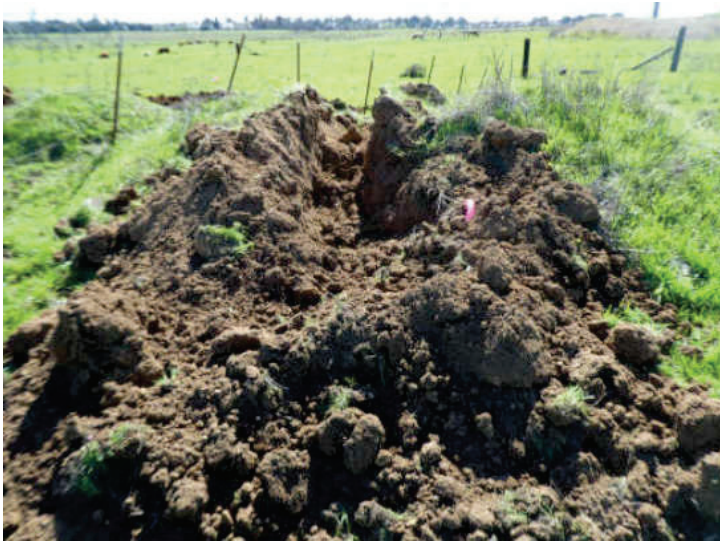
Photo #19:  
Western soil piles  
Trench T-4

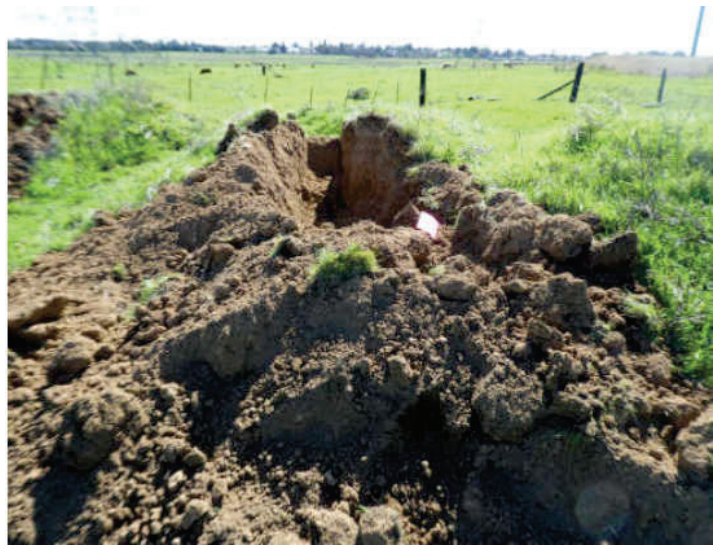
Photo #20:  
Western soil piles  
Trench T-5

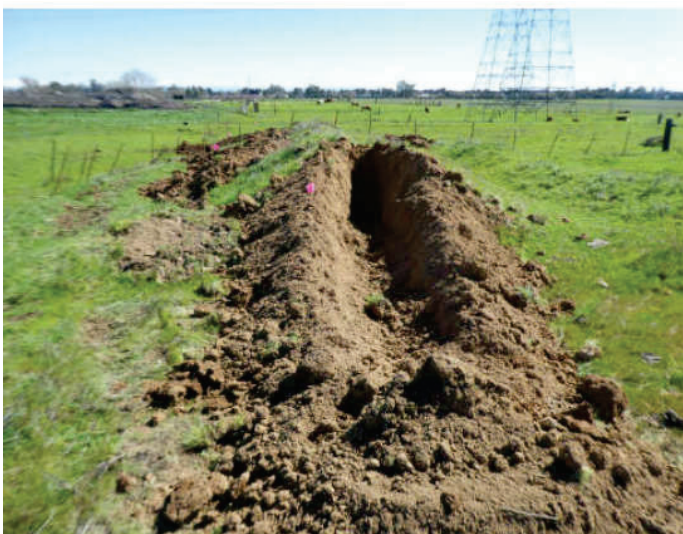
Photo #21:  
Western soil piles  
Trench T-6

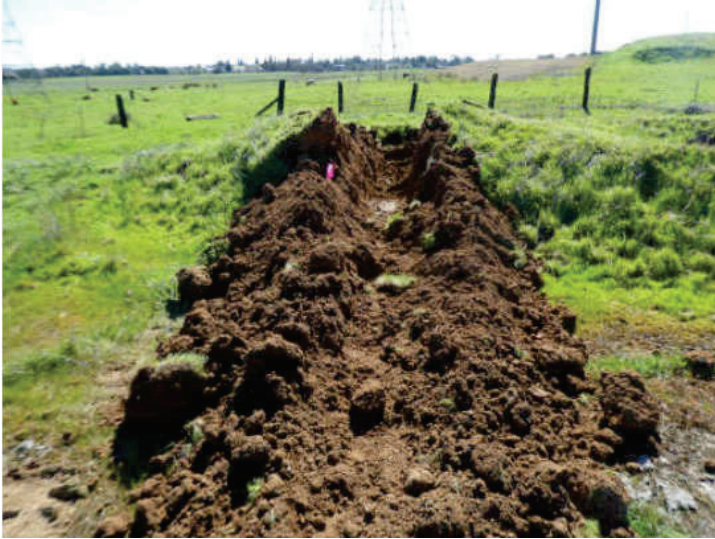
Photo #22:  
Western soil piles  
Trench T-7

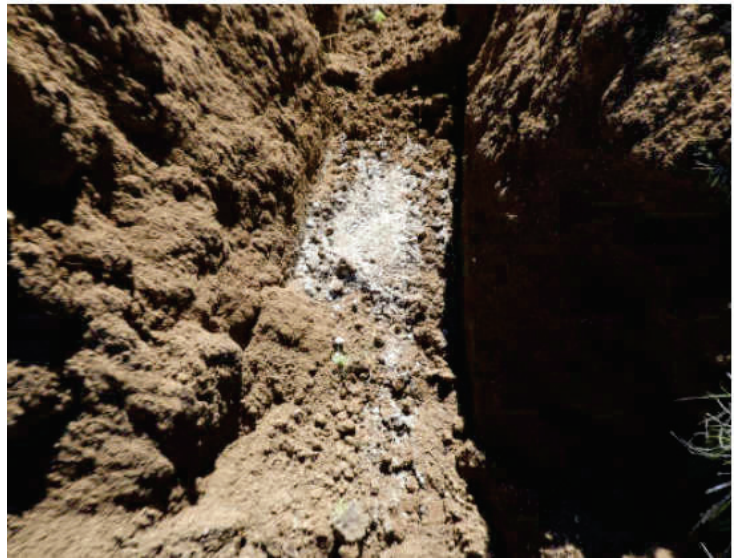
Photo #23:  
Western soil piles  
Trench T-7 (gravel bottom)

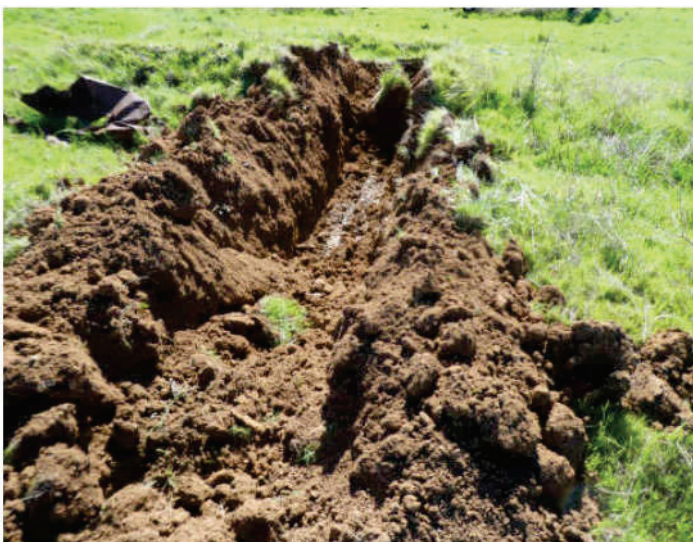
Photo #24:  
Western soil piles  
Trench T-8

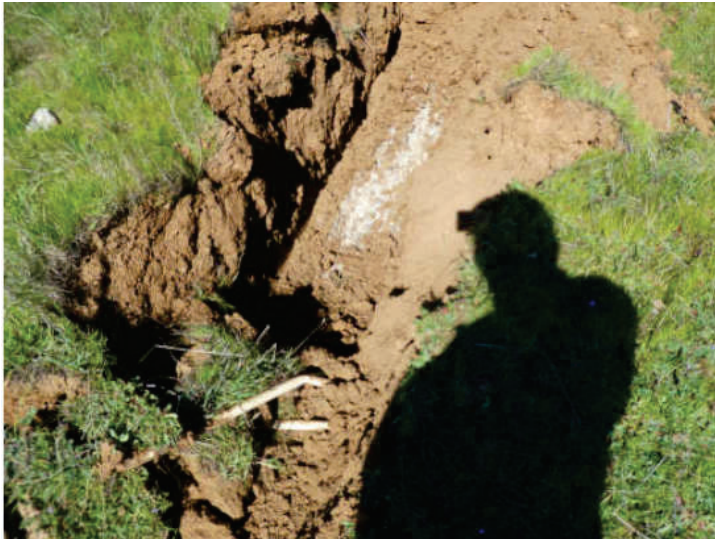
Photo #25:  
Western soil piles  
Trench T-8 (gravel bottom)

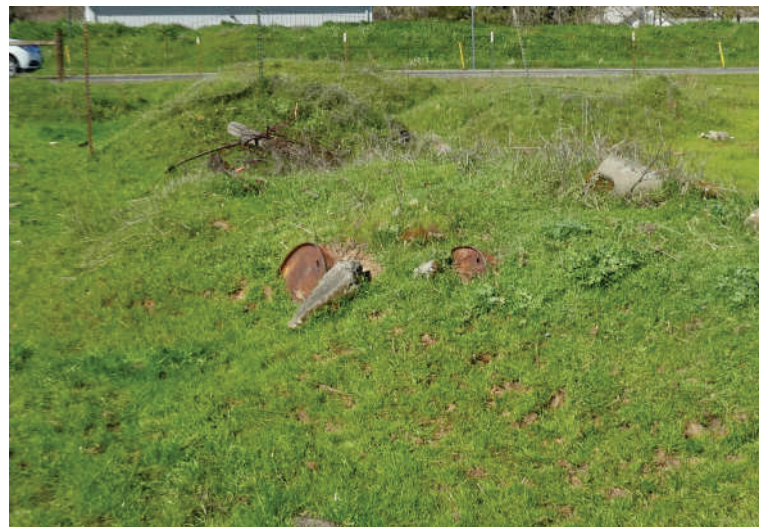
A soil pile on the south border of the southwestern corner, contained visual evidence of debris including a brick, concrete, and the edge of two rusted 55-gallon drums. Visually, the drums appeared to be filled with soil, and no significant vapors were detected in the vicinity using a PID. Trench T-21 was completed in this area. However, due to the debris observed, T-21 was more of a shallow excavation than a narrow trench (as described previously).

Photo #26:  
Western soil piles  
Trench T-9 - Concrete, metal  
debris (pre-trenching)

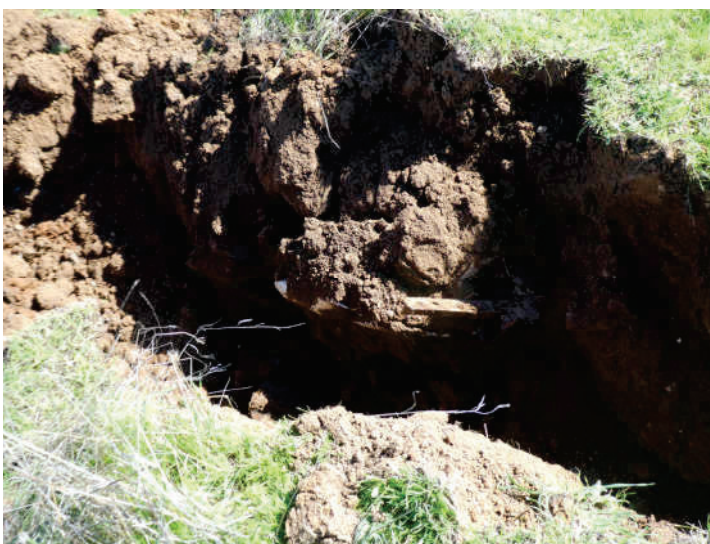
Photo #27:  
Western soil piles  
Trench T-9 - Debris

PEI directed the excavator to carefully excavate the two 55-gallon drums and segregate them and other debris from the soil pile. Vapor screening during this excavation did not indicate the presence of elevated VOCs. Debris removed from the pile included the two rusted drums (one with a galvanized trash can inside), 1-inch PVC piping, a piece of perforated PVC piping (similar to leach line material), wood plank and gravel. Based on the material removed from the excavation, it appears consistent with materials from a irrigation/watering station associated with historic dairy farming. Soil was removed to a depth of 5 feet bgs (approximately the depth of the native material). No indications of hazardous constituents were observed. Specifically, no significant staining or odors were observed in the soils within T-9. The PID did not detect elevated vapor concentrations in soils from each of these trenches and, therefore, did not indicate a concern for constituents of concern with volatile organic compounds (VOCs).

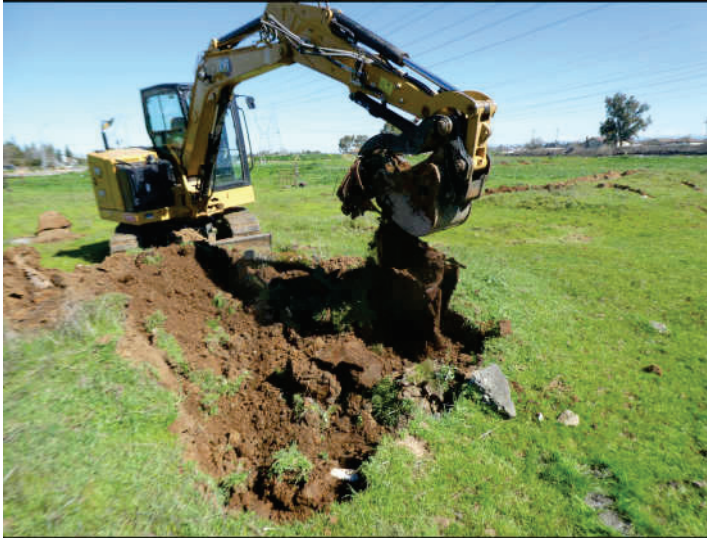
Photo #28:  
Western soil piles  
Trench T-9 - Debris

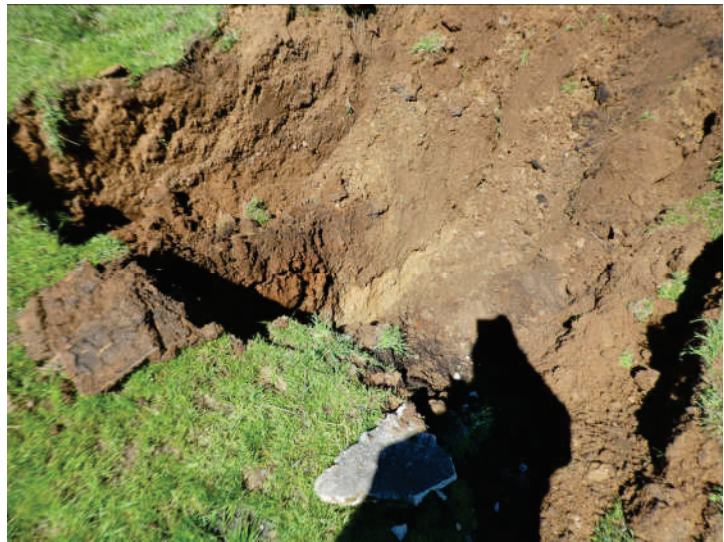
Trench 21 contained debris that included metal, concrete and gravel which was excavated approximately 5 feet. Based on the material removed from the excavation, they appear consistent with materials from an irrigation/watering station associated with historic dairy farming. Upon removal of the debris, no significant staining, odor, or volatile component impacts were detected during excavation in this area.

Photo #29:  
Western soil piles  
Trench T-9 - Bottom of excavation  
(5 feet) native soils

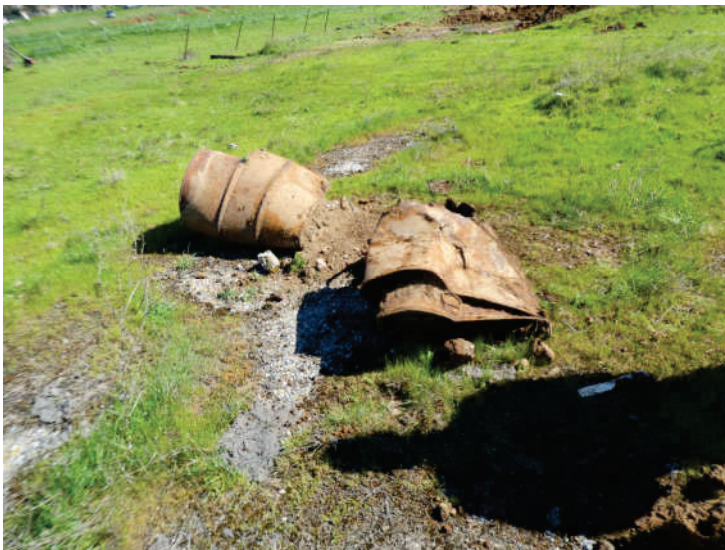
Photo #30:  
Western soil piles  
Trench T-9 - Debris from  
excavation, two 55-gallon  
drums/trash cans

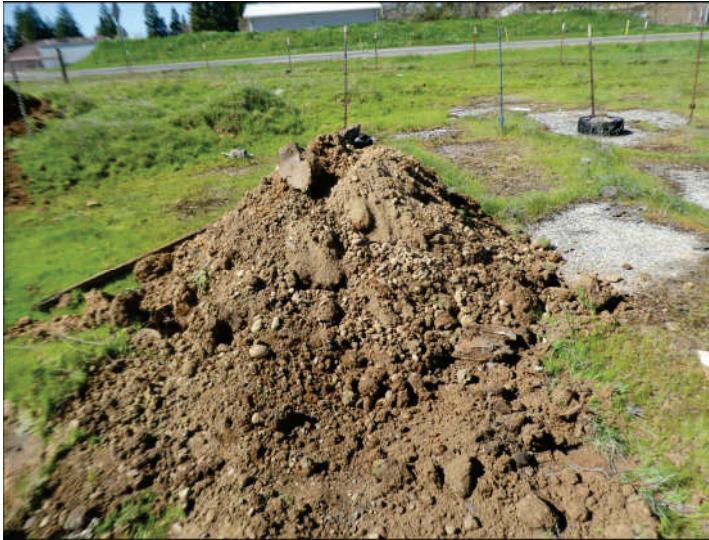
Photo #31:  
Western soil piles  
Trench T-9 - Gravel,  
concrete debris

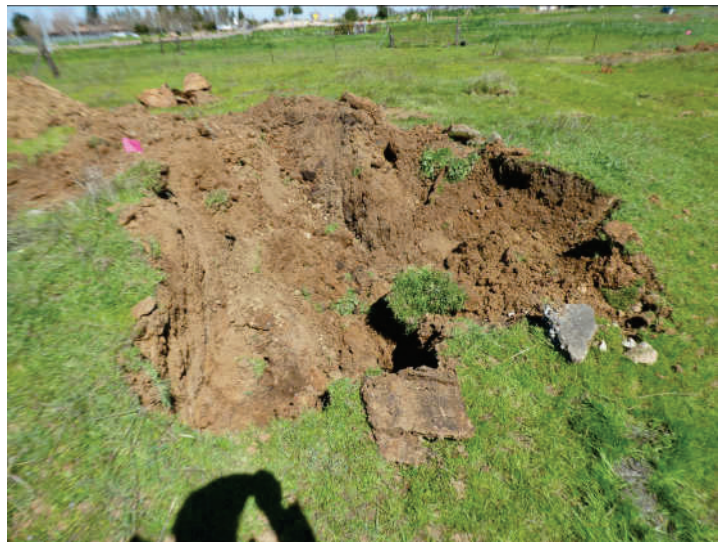
Photo #32:  
Western soil piles  
Trench T-9 - No significant  
staining or odor

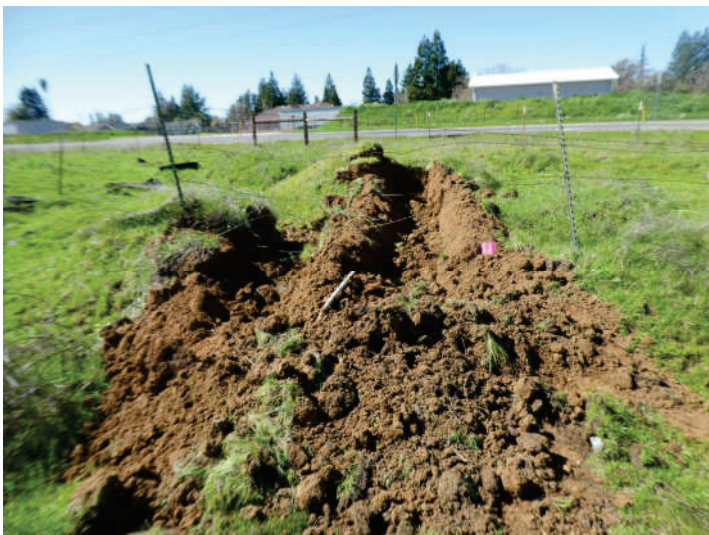
Photo #33:  
Western soil piles  
Trench T-9 - No significant  
staining or odor
