Tree Inventory Report

RE: Revised Arborist Report for Development on a Portion of Sunset Las Palmas Studio at 6650 W. Romaine in Los Angeles, Ca (APN 5532-014-039)

ARBORIST LETTER REPORT

Sunset Las Palmas Studio

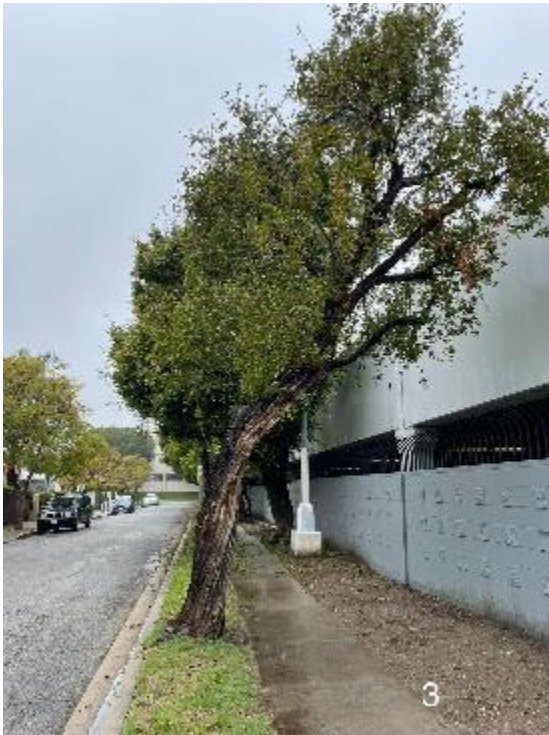
Tree 3

Based on the entitlement landscape plan and root zone calculations, three (3) trees (#22, #23, and #43) would require removal to allow for a new driveway installation. In addition, trees 3, 4, 5 (along Barton Ave) and trees 18, 19, 20, 21, 24, 25, 26 and 27 (along N. Las Palmas Ave.) are proposed for removal based on the site development plans and anticipated sidewalk and roadway dedication and improvements areas. . As shown in Appendix D, only tree 18 has moderate priority for preservation, while all other trees adjacent to the site are not recommended for preservation. Based on development plans, trees 37, 38, 39, 40, 41, and 42 (along Romaine St) could remain in place even during and after construction and because there are not sidewalk and roadway dedications and improvements anticipated in this area. However, note that all the trees along Romaine St are identified in this report as trees not recommended for preservation due to the existing condition of the trees. If any trees are to be retained, especially along Romaine St, then specific tree protection measures may be required for those trees immediately adjacent to the construction area or that may be impacted by demolition, new sidewalk features, or new footings/utilities for buildings or structures. Trees NP-1 - NP-4 will be removed during grading and will not require permitting or replacement per ordinance. Any trees removed would be replaced in accordance with the applicable tree replacement ratios and applicable ordinances.

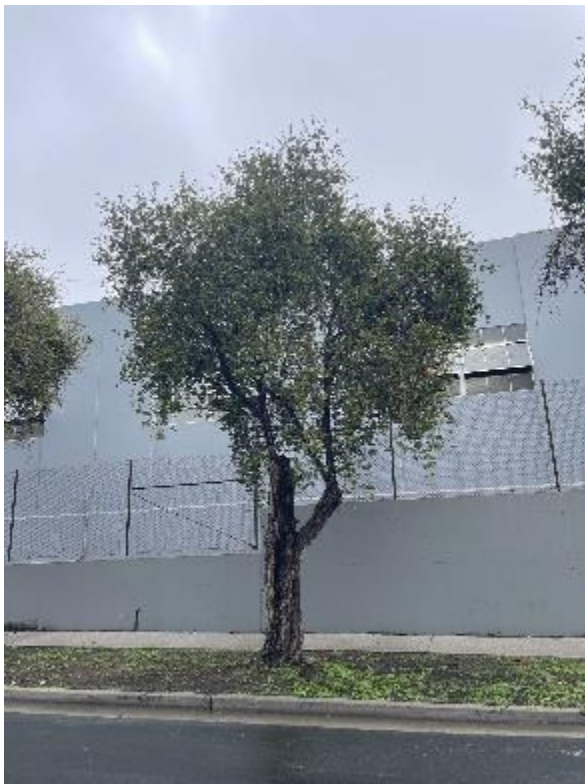
Tree 21

21	22	bottlebrush, red	Callistemon citrinus	30%	Poor		14	30	1	10	33	4		Basal Decay, Trunk Decay, Included Bark/Weak Union, Co-Dominant Stems
22	24	bottlebrush, red	Callistemon citrinus	30%	Poor		14	30	1	11	36	4		Basal Decay, Trunk Decay, Included Bark/Weak Union, Co-Dominant Stems
23	15	bottlebrush, red	Callistemon citrinus	30%	Poor		14	30	1	7	23	4		Basal Decay, Trunk Decay, Included Bark/Weak Union, Co-Dominant Stems, Serious Decline
24	22	bottlebrush, red	Callistemon citrinus	30%	Poor		14	30	1	10	33	4		Basal Decay, Trunk Decay, Included Bark/Weak Union, Co-Dominant Stems
25	28	bottlebrush, red	Callistemon citrinus	30%	Poor		14	30	1	13	42	4		Basal Decay, Trunk Decay, Included Bark/Weak Union, Co-Dominant Stems
26	20	bottlebrush, red	Callistemon citrinus	30%	Poor		14	30	1	9	30	4		Basal Decay, Trunk Decay, Included Bark/Weak Union, Co-Dominant Stems
27	18	bottlebrush, red	Callistemon citrinus	30%	Poor		14	30	1	8	27	4		Basal Decay, Trunk Decay, Included Bark/Weak Union, Co-Dominant Stems

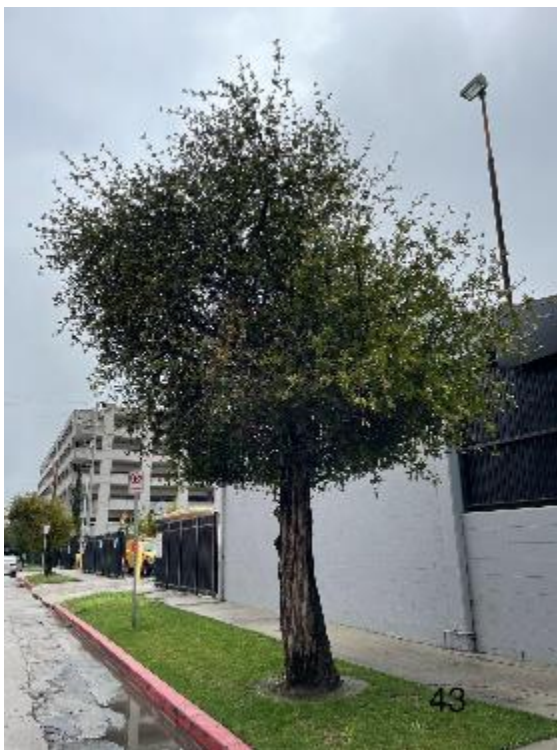
Tree 43

43	16	bottlebrush, red	Callistemon citrinus	30%	Poor		8	20	1	7	24	4		Trunk Decay, Included Bark/Weak Union, Co-Dominant Stems, Mechanical Damage, Stressed, Broken Limbs
44	16	bottlebrush, red	Callistemon citrinus	30%	Poor		8	20	1	7	24	4		
45	2	crapemyrtle, common	Lagerstroemia indica	95%	Excellent		2	12	1	1	3	1	California Pepper / Schinus molle	Root Damage/Decay, Basal Decay, Trunk Decay, Mechanical Damage, Broken Limbs
46	2	crapemyrtle, common	Lagerstroemia indica	95%	Excellent		2	12	1	1	3	1	California Pepper / Schinus molle	Excessive Lean, Root Damage/Decay, Basal Decay, Trunk Decay, Mechanical Damage
47	2	crapemyrtle, common	Lagerstroemia indica	95%	Excellent		2	12	1	1	3	1	California Pepper / Schinus molle	Root Damage/Decay, Trunk Decay, Mechanical Damage
48	28	California pepper	Schinus molle	50%	Fair		15	35	1	13	42	3		
49	20	California pepper	Schinus molle	50%	Fair		13	35	1	9	30	3		
50	16	California pepper	Schinus molle	50%	Fair		12	30	1	7	24	3

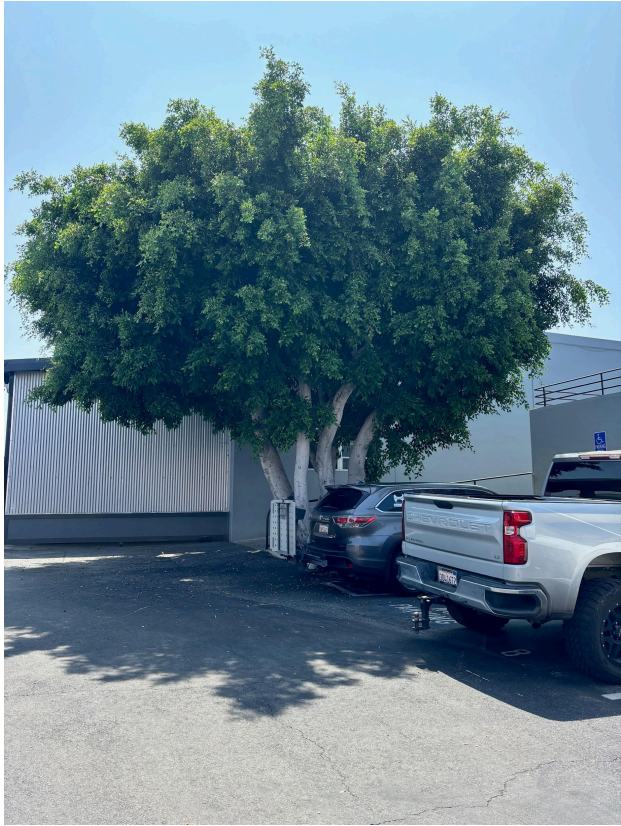
Tree NP-1

Four (4) non-protected trees were observed within the project site. One multi trunk Ficus (*Ficus microcarpa*) and three (3) queen palms (*Syagrus romanzoffiana*) were situated within the project site.
