**SEWER SYSTEM ANALYSIS
FOR THE 9407 JERICHO ROAD PROJECT
IN THE CITY OF LA MESA**

August 10, 2023

As requested by the City, a condition assessment of the existing offsite sewer facilities was conducted in Jericho Road from Manhole AQ045.00 downstream to Manhole AQ032.00. The inspection was conducted in July 2023 by San Diego Stormwater Solutions and included approximately 275 feet of 8-inch gravity sewer pipeline and four manholes. Dexter Wilson Engineering, Inc. evaluated the reports, pictures, and videos provided by San Diego Stormwater Solutions to determine whether improvements to the system are necessary. The resulting recommendations of improvements are summarized in Table 5 below. The inspection reports and pictures as received from San Diego Stormwater Solutions are provided in Appendix D; the CCTV videos can be made available to the City upon request.

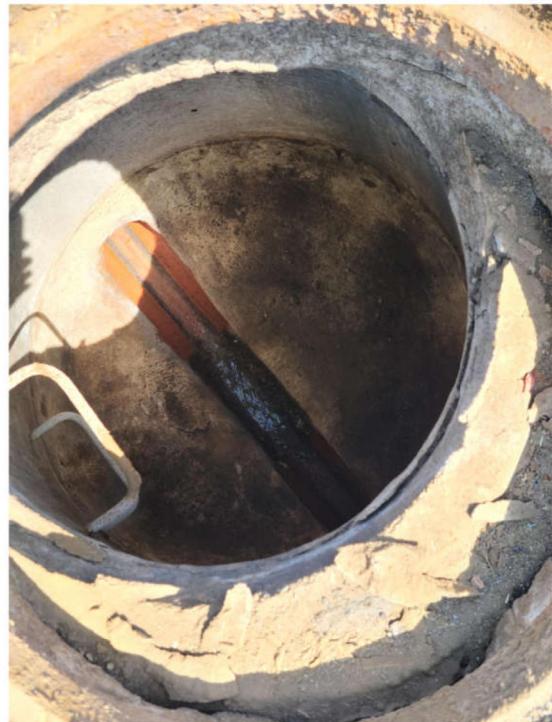
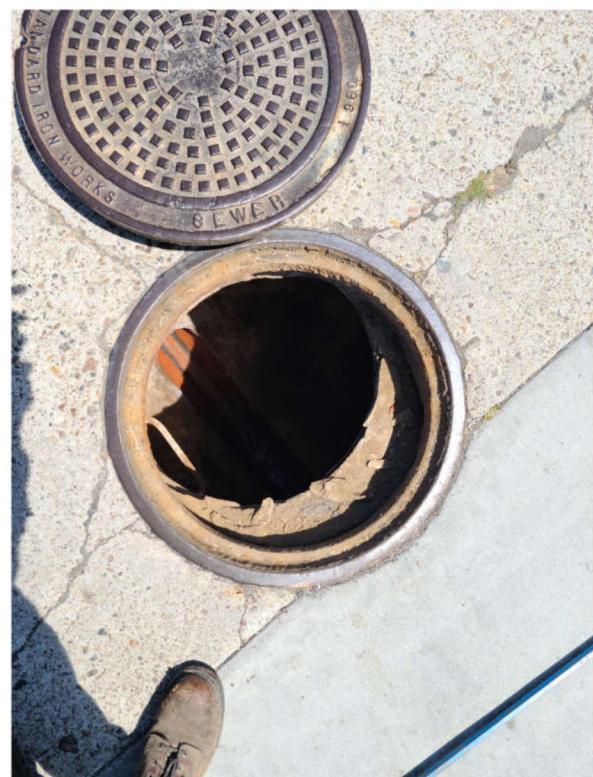
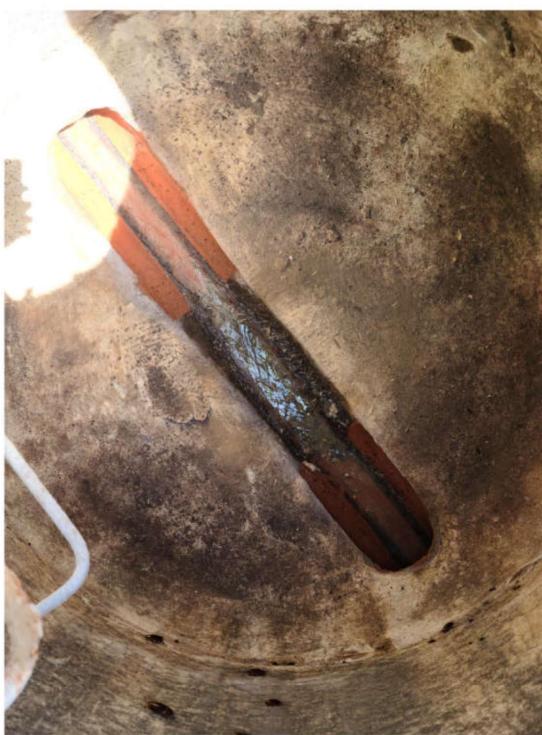
Inspection Status	Surface Inspection	Drainage Area	
Manhole Number	AQ034	Manhole Use	Sanitary
Weather (Ground Conditions)		Street	Jericho Rd
City	La Mesa	Location Details	
	Local Rural Streets - Light traffic, town and city back streets, estate streets and curbside parking areas	Additional Info	Start of Chimney is offset from frame opening.

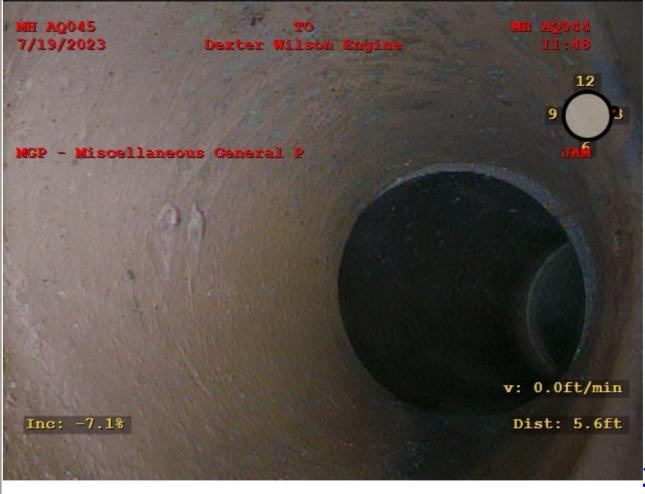
Distance	Fault Observation	Time	Picture
5.4	<p>Picture Number: 2 Tap Factory Defective Position: 2</p>	00:00:00	<p>MM AQ045 7/19/2023 TO Dexter Wilson Engine MM AQ044 11:48 12 9 3 6 v: 0.0ft/min Inc: -7.1% Dist: 5.6ft a=""> <=""></p>

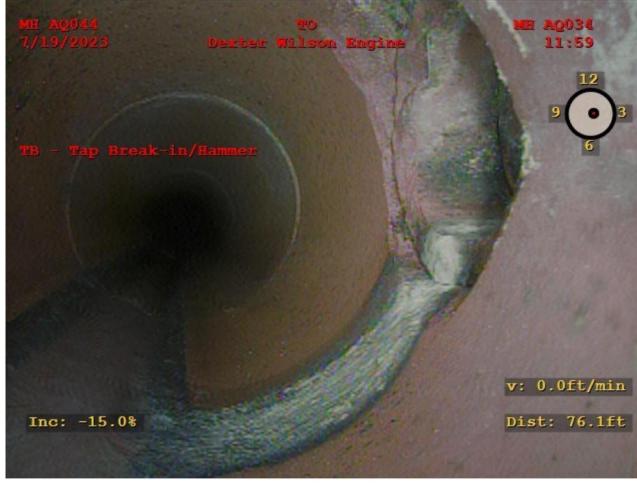
76.1	<p>Tap Break-in/Hammer Position: 2 Severity: None Size: 4</p>	00:00:00 00:00:00

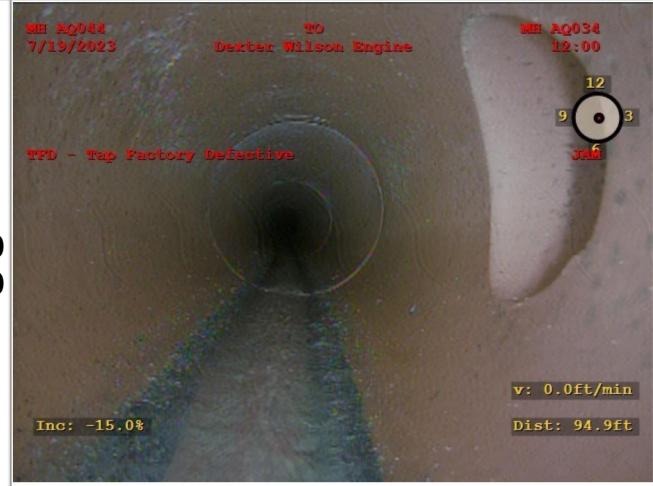
Distance	Fault Observation	Time	Picture
94.9	<p>Tap Factory Defective Position: 2 Severity: None Size: 4 Remarks: JAM Maint Weight: 3</p>	00:00:00 00:00:00

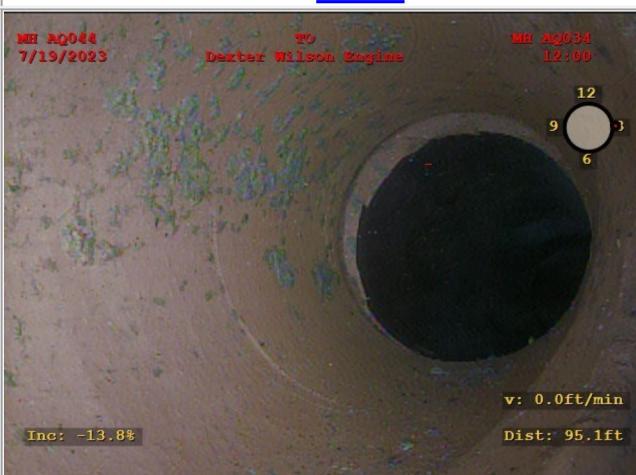
94.9	Picture Number: 2 Tap Factory Defective Position: 2	00:00:00

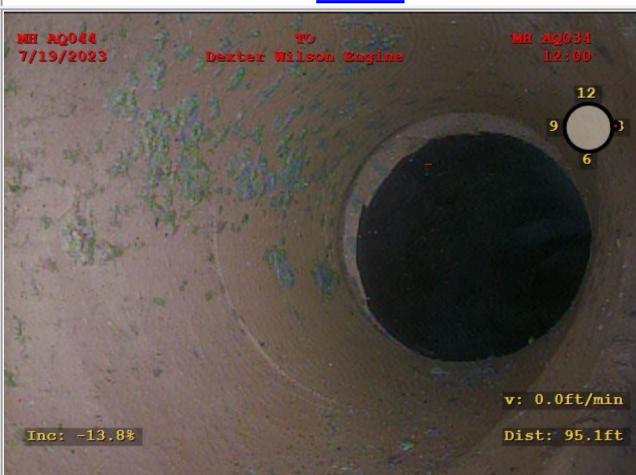
94.9	Picture Number: 3 Tap Factory Defective Position: 2	00:00:00

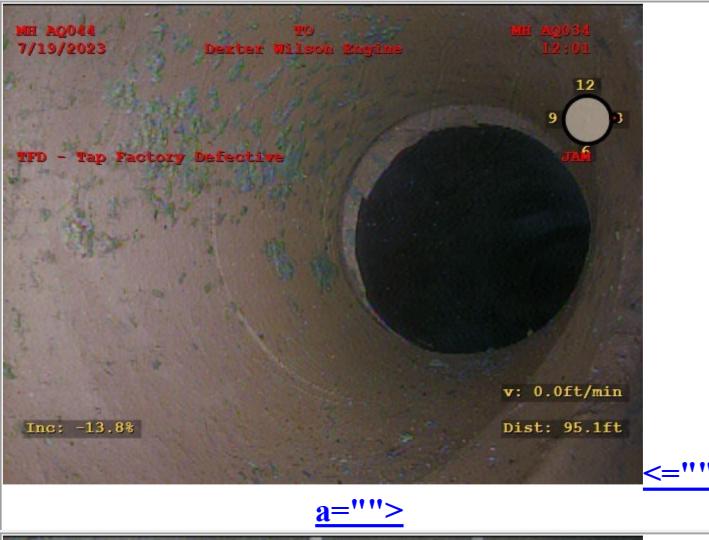
95.1	<p>Tap Factory Defective Position: 2 Severity: None Size: 4 Remarks: JAM Maint Weight: 3</p>	<p>00:00:00 00:00:00</p>

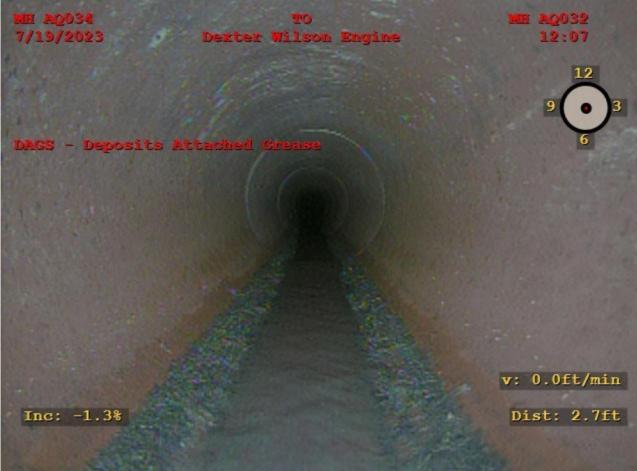
Distance	Fault Observation	Time	Picture
2.7	Deposits Attached Grease Position: 5 To 7 Severity: None Cont Defect: S01 Percent: 0 Maint Weight: 2	00:00:00 00:00:00

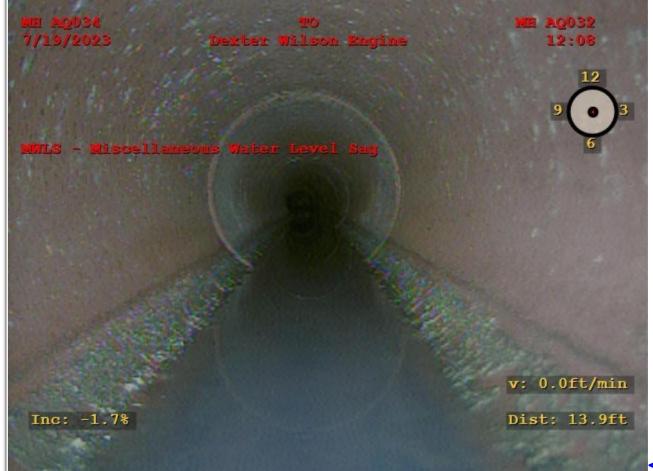
Distance	Fault Observation	Time	Picture
13.9	Miscellaneous Water Level Sag Severity: None Cont Defect: S02 Percent: 15 Struct Weight: 2	00:00:00 00:00:00

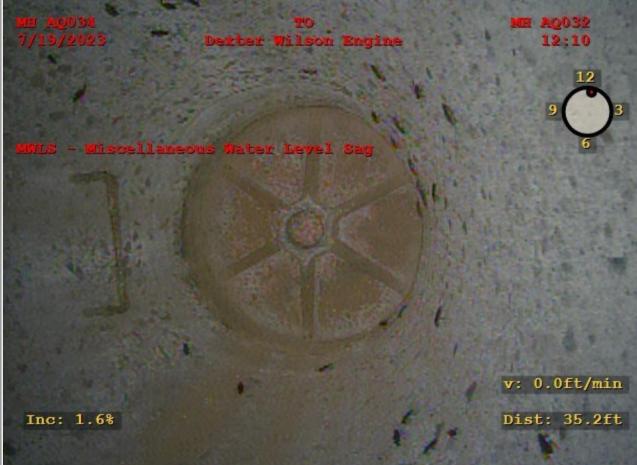
35.1	<p>Deposits Attached Grease Position: 5 To 7 Severity: None Cont Defect: F01 Percent: 0 Maint Weight: 2</p>	00:00:00 00:00:00

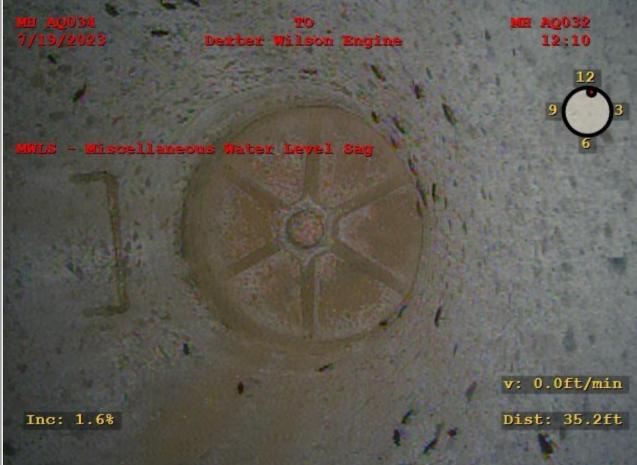
35.2	<p>Miscellaneous Water Level Sag Severity: None Cont Defect: F02 Percent: 15 Struct Weight: 2</p>	00:00:00 00:00:00
