Site Management Plan

(Tier 2, High Risk)

WDID-1_12CC415333

Humboldt County

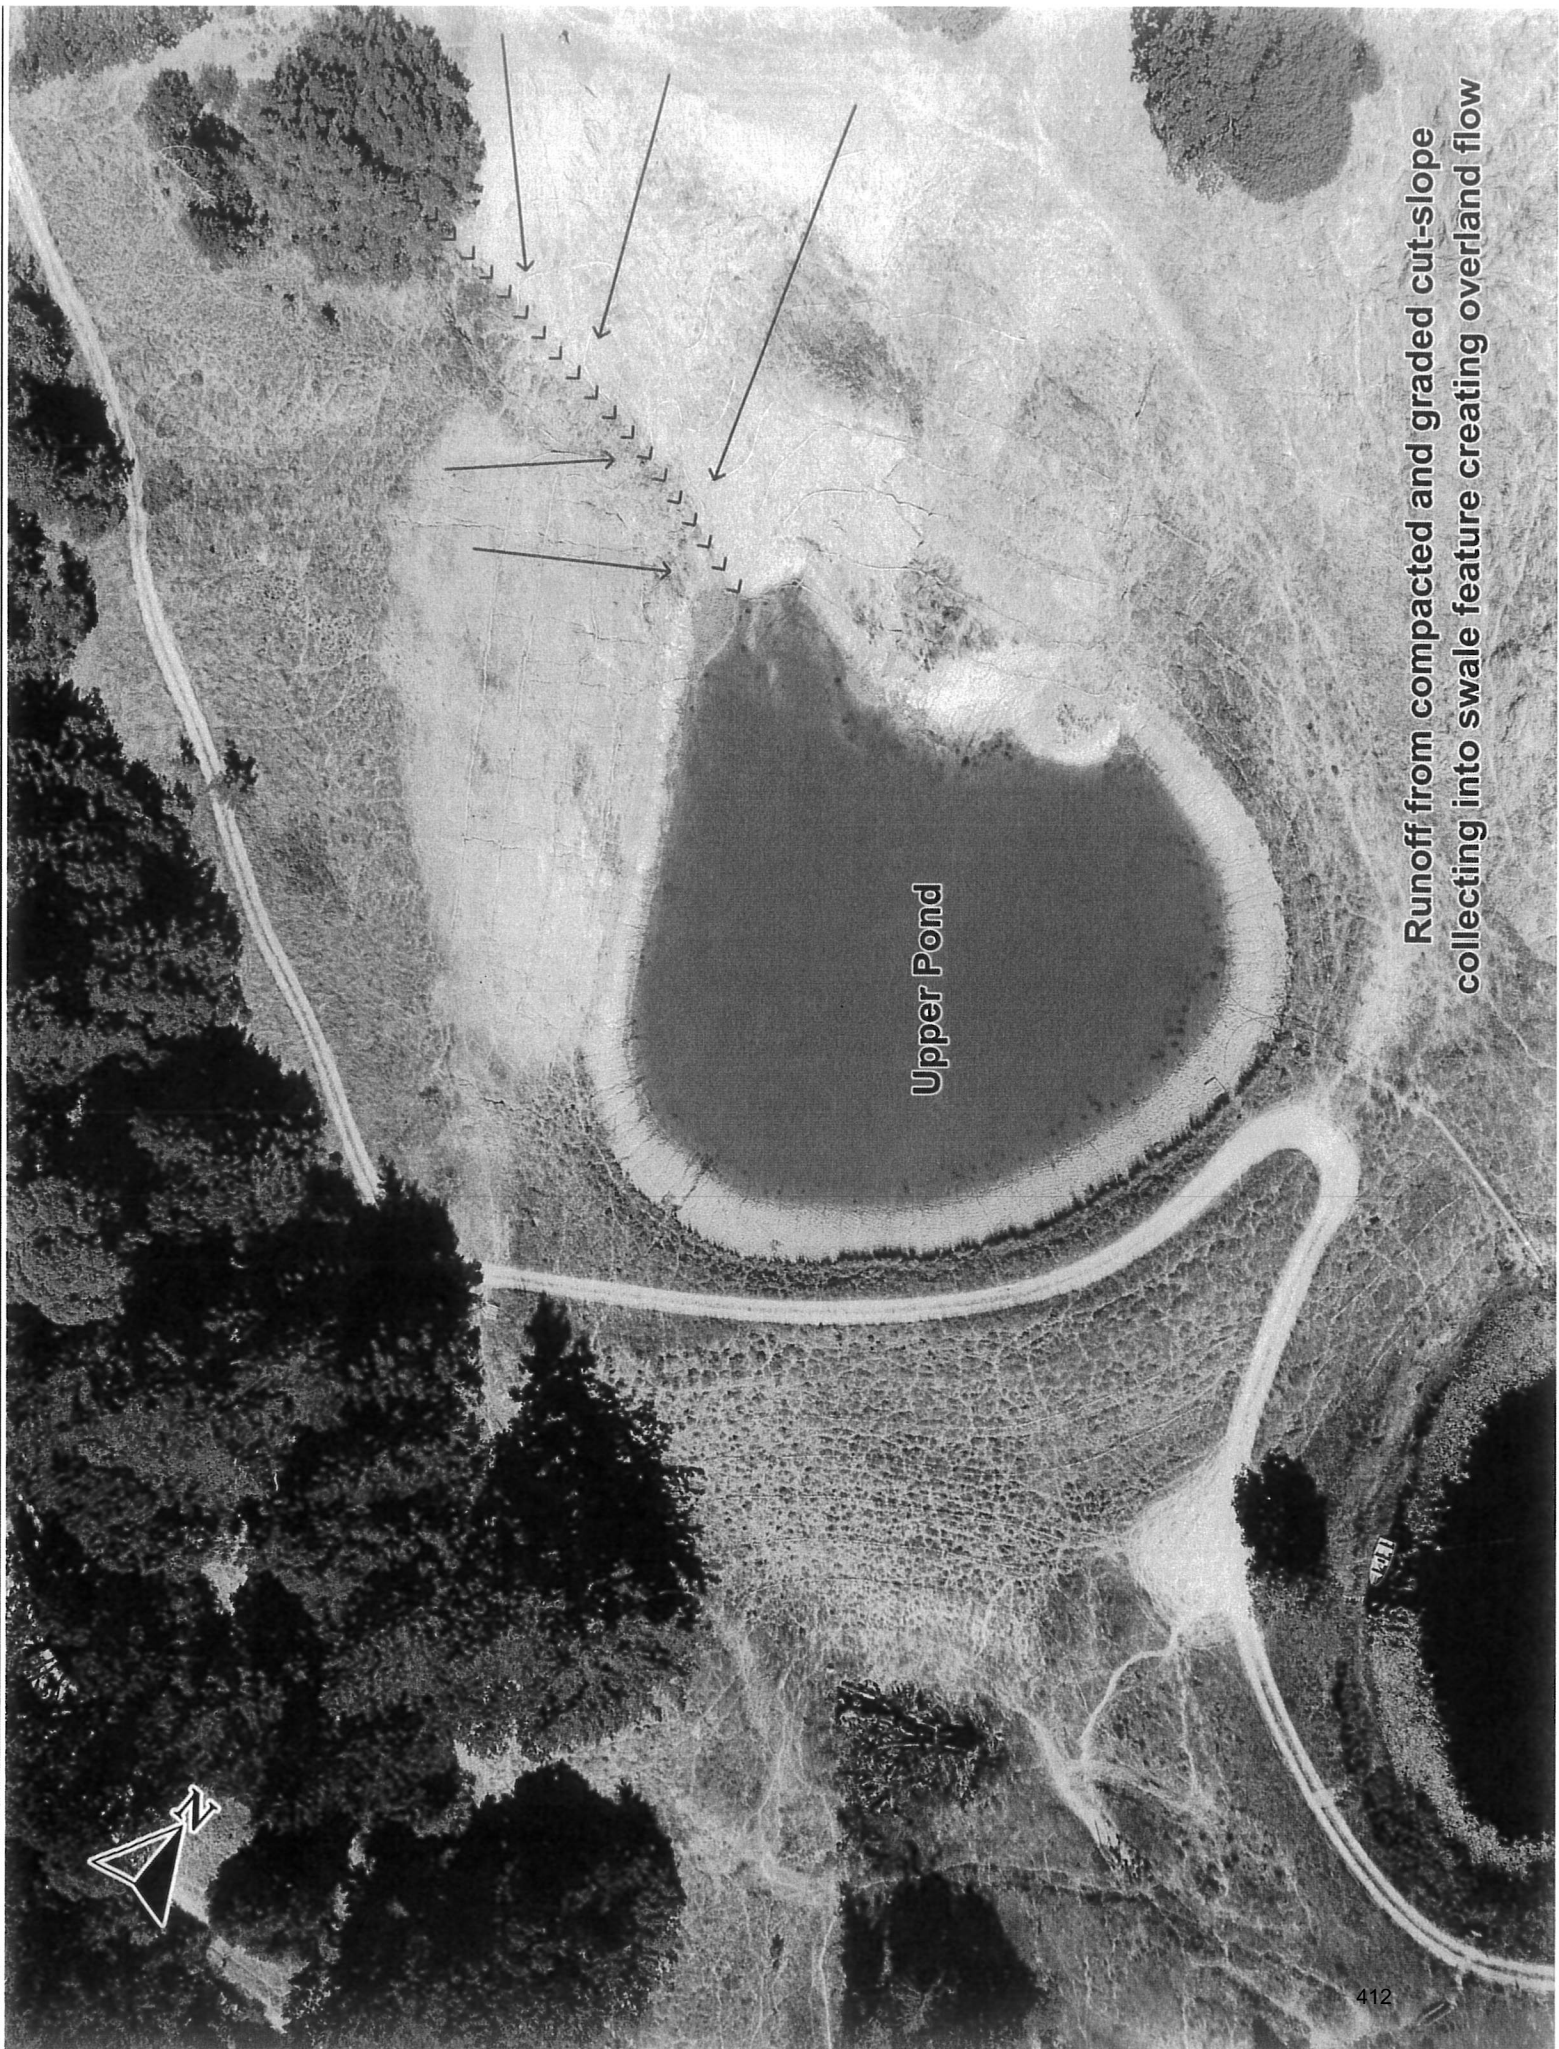
Runoff from compacted and graded cut-slope collecting into swale feature creating overland flow

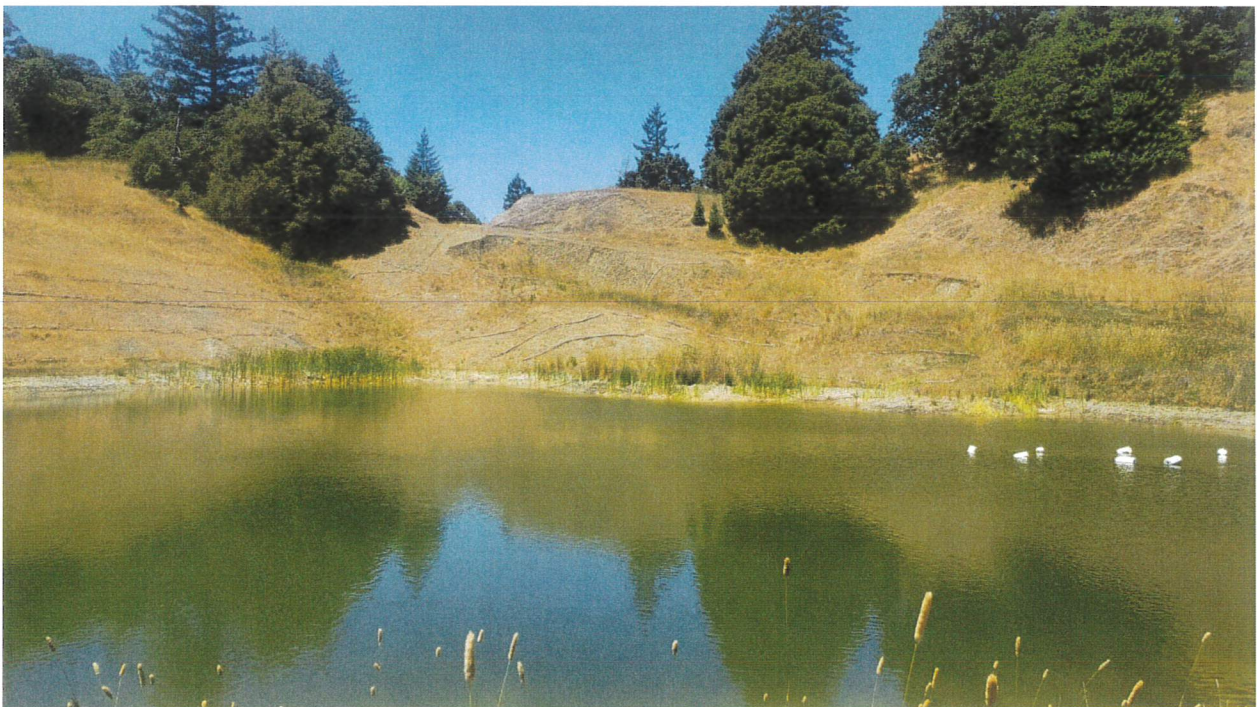
Photograph of the Upper Pond (off-stream rain catchment) look up grade towards the road fillslope failure at Site 36 taken from the pond embankment.

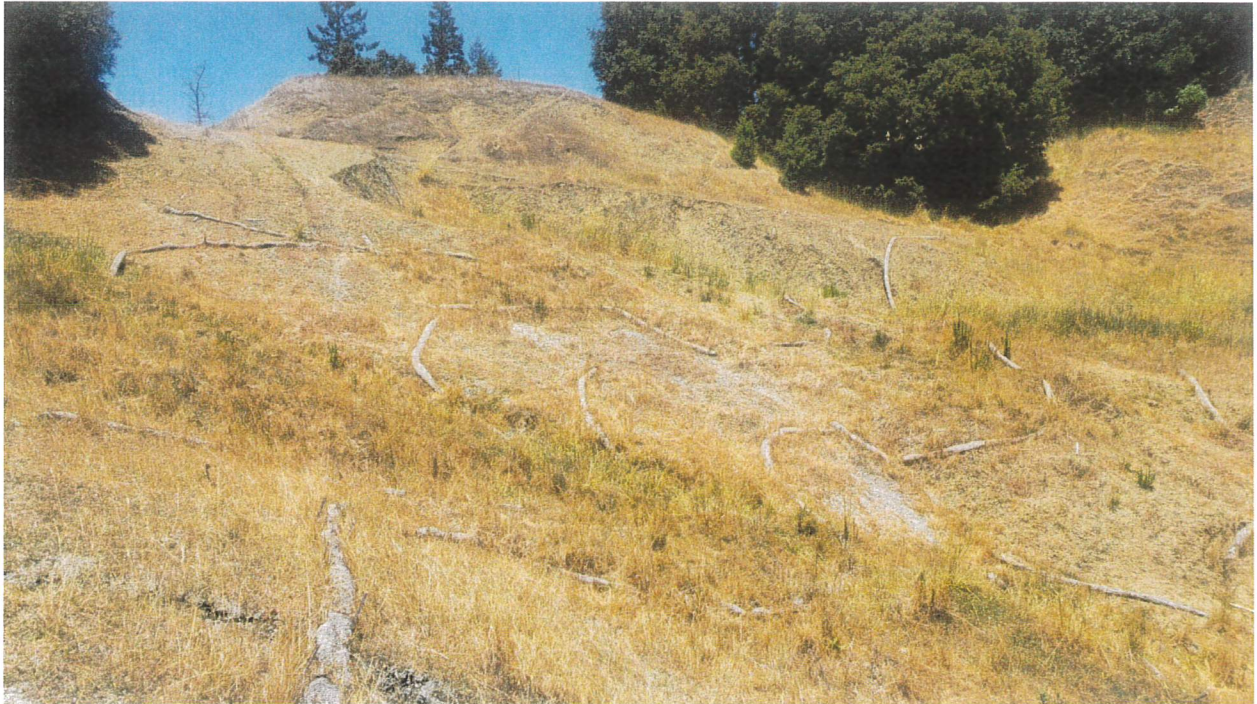
Photograph of the road fillslope failure at Site 36 taken from the west.

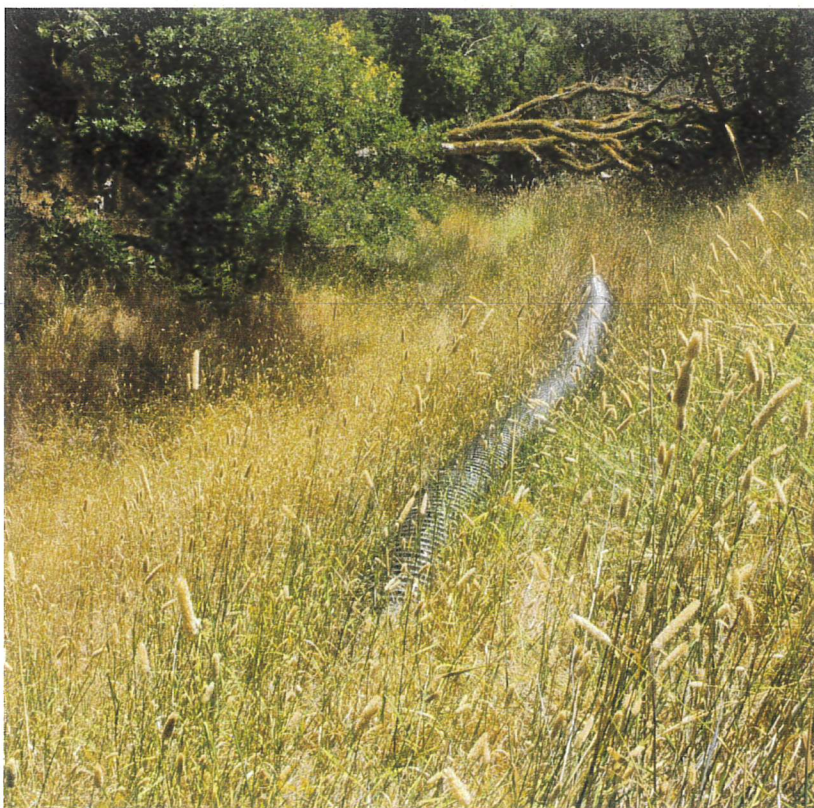
Photograph of the primary spillway (Site 38) on the Lower Pond to be removed.

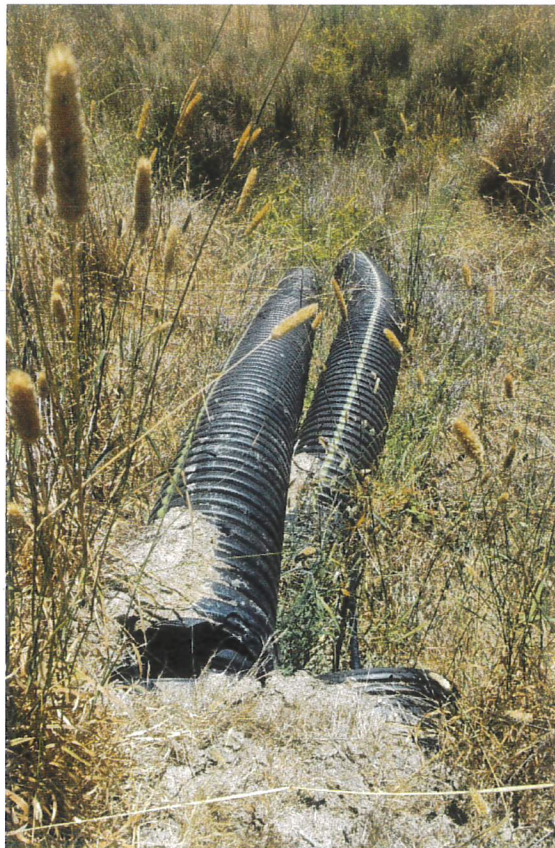
Photograph of the failing secondary spillway at Site 39. This spillway is to become the primary spillway after reconstructing of the pond embankment and installation of an anchored 24" culvert spillway.

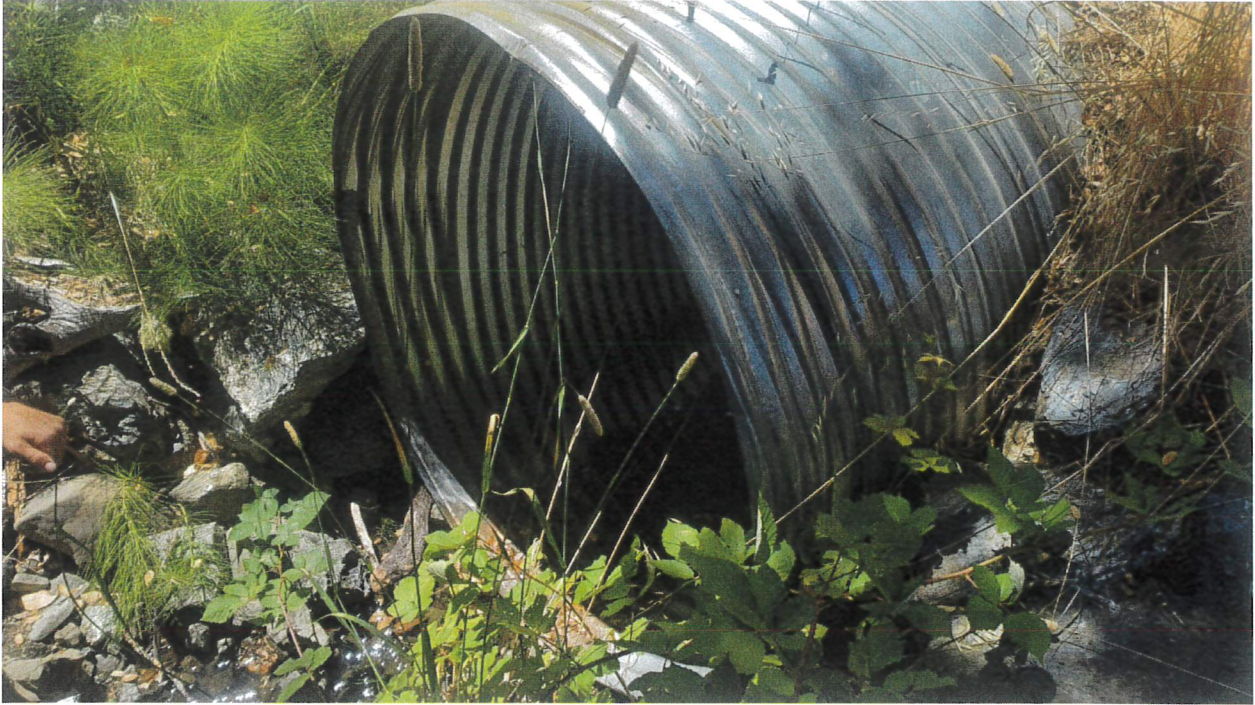
Photograph of the inlet of the watercourse crossing at Site 61.

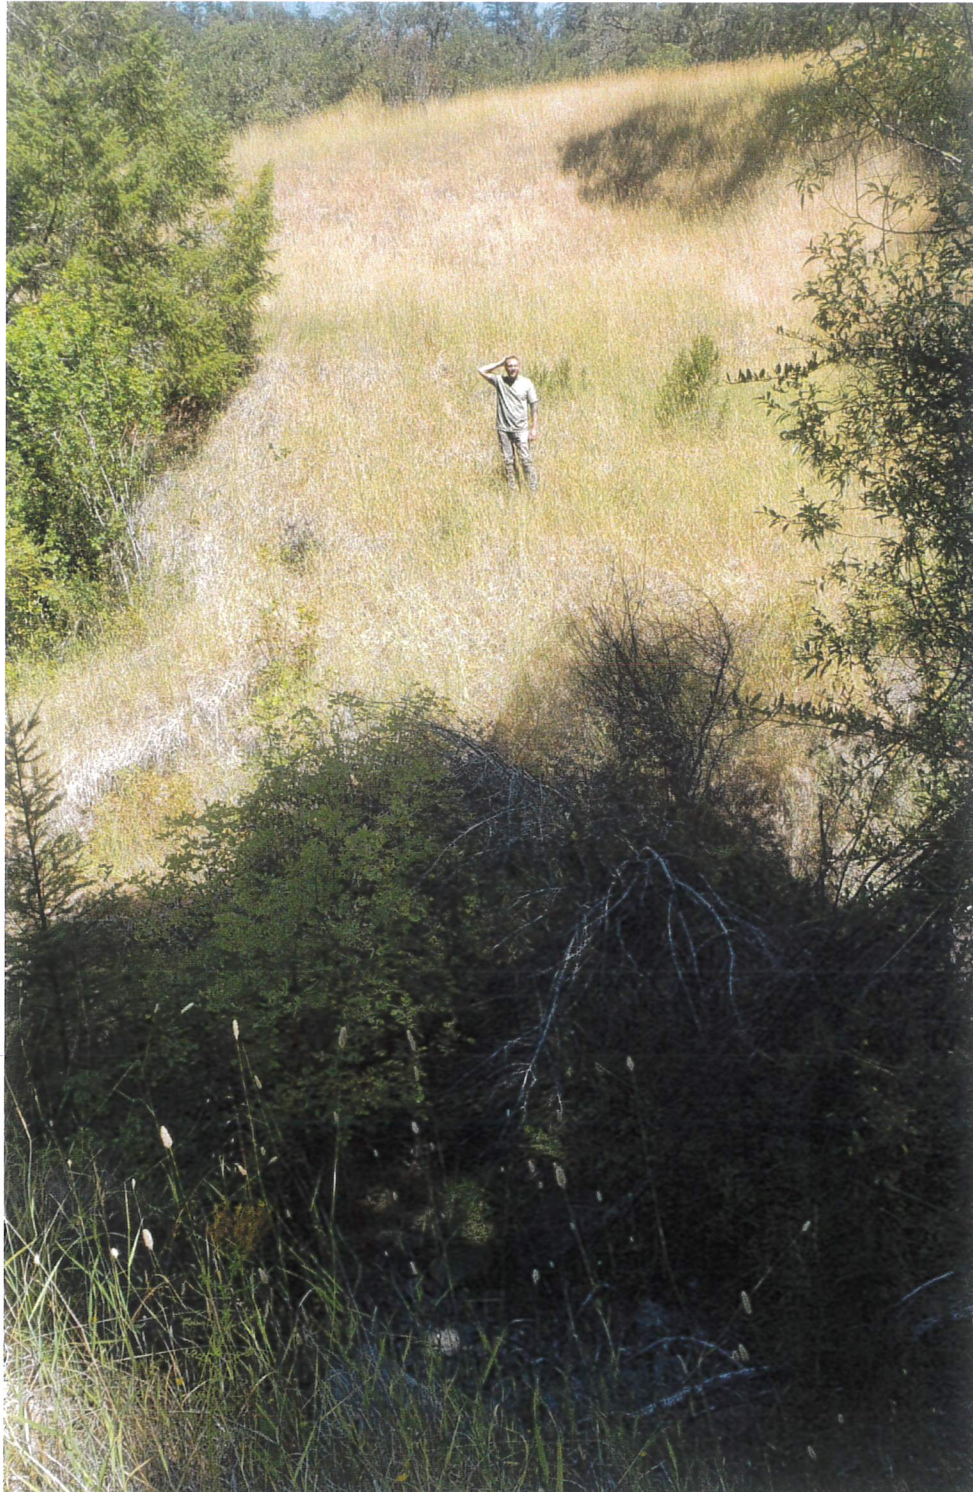
Photograph of the either removed or failed watercourse crossing at Site 70 looking north.

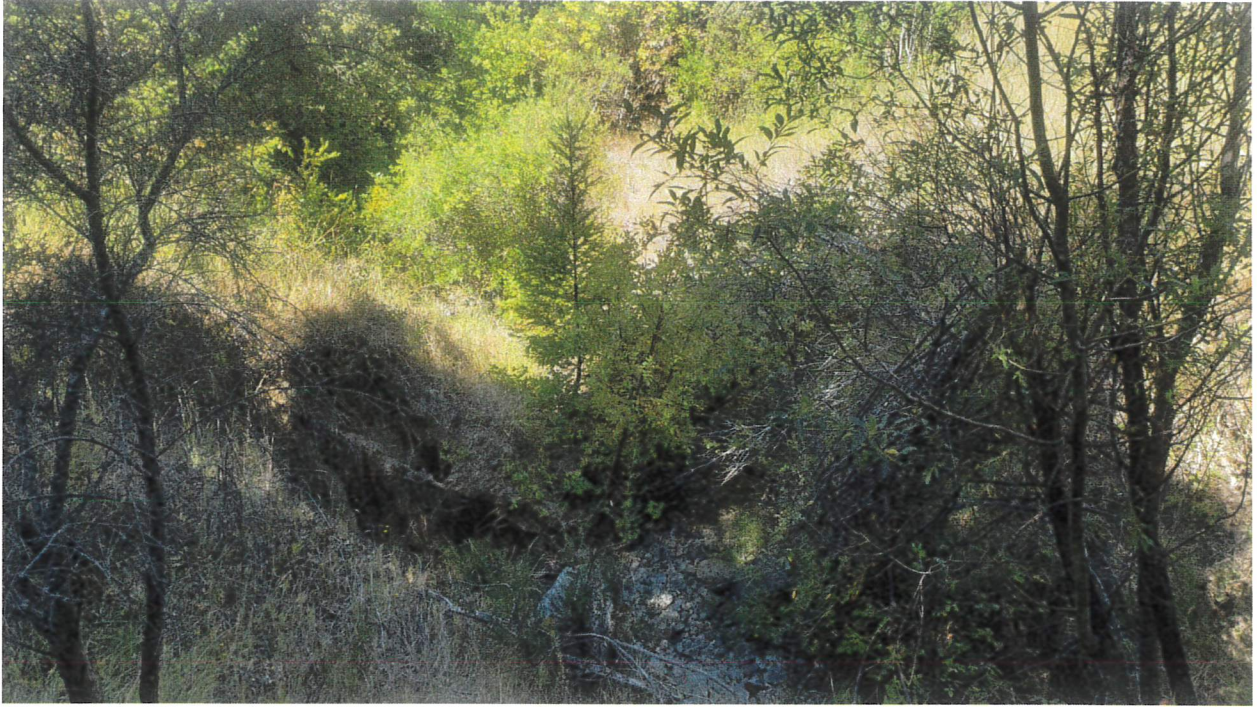
Photograph of the either removed or failed watercourse crossing at Site 70 looking west.

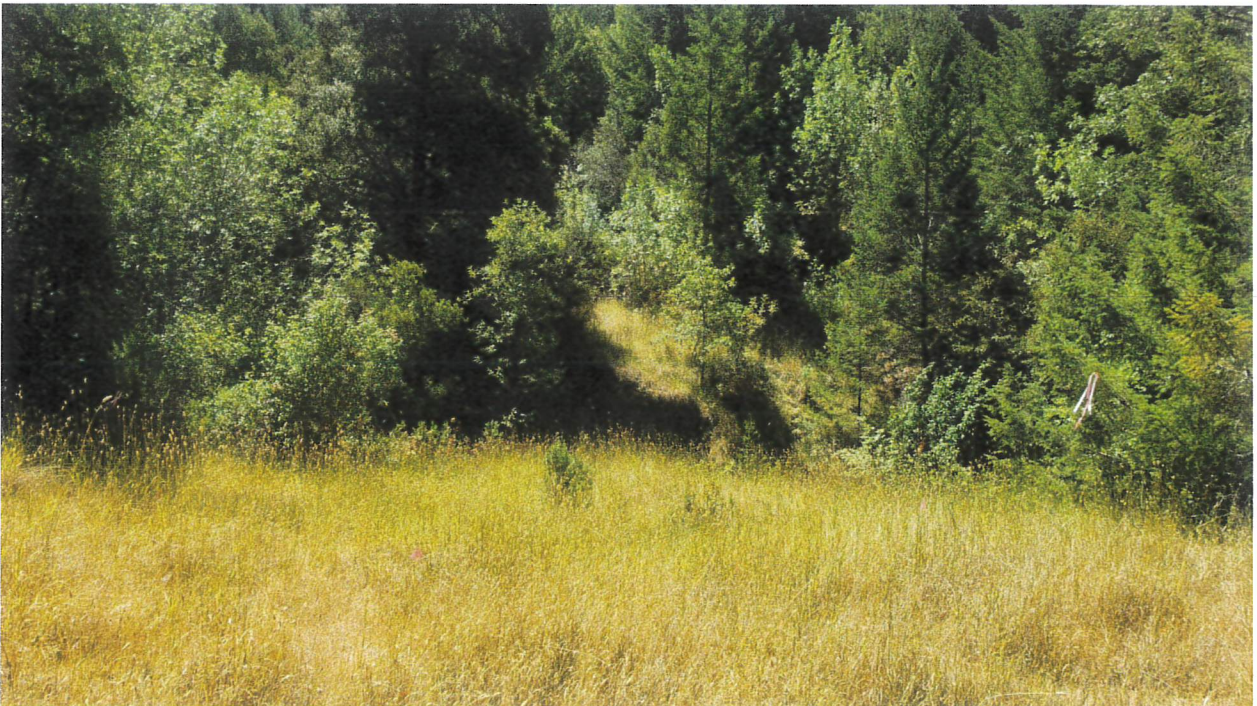
Photograph of the either removed or failed watercourse crossing at Site 70 looking south.

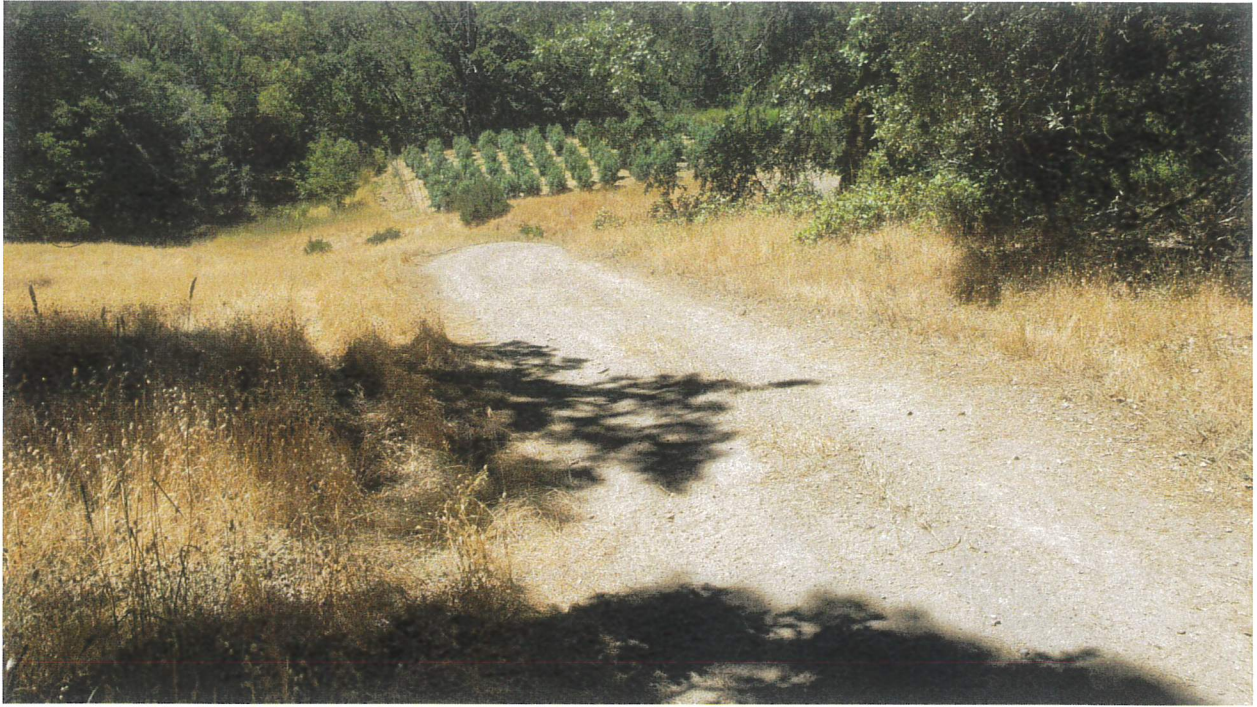
Photograph of the trail at Site 71 to be water barred and abandoned after the removal and relocation of Cultivation Area F.
