Tree Inventory and Evaluation Report

For: SE Corner of Sunset Blvd. & Vine Street

Prepared by: **Arborgate Consulting, Inc.**
Greg Applegate, RCA #365
1131 Lucinda Way
Tustin, CA 92780
714/731-6240

Date: **November 30, 2020**

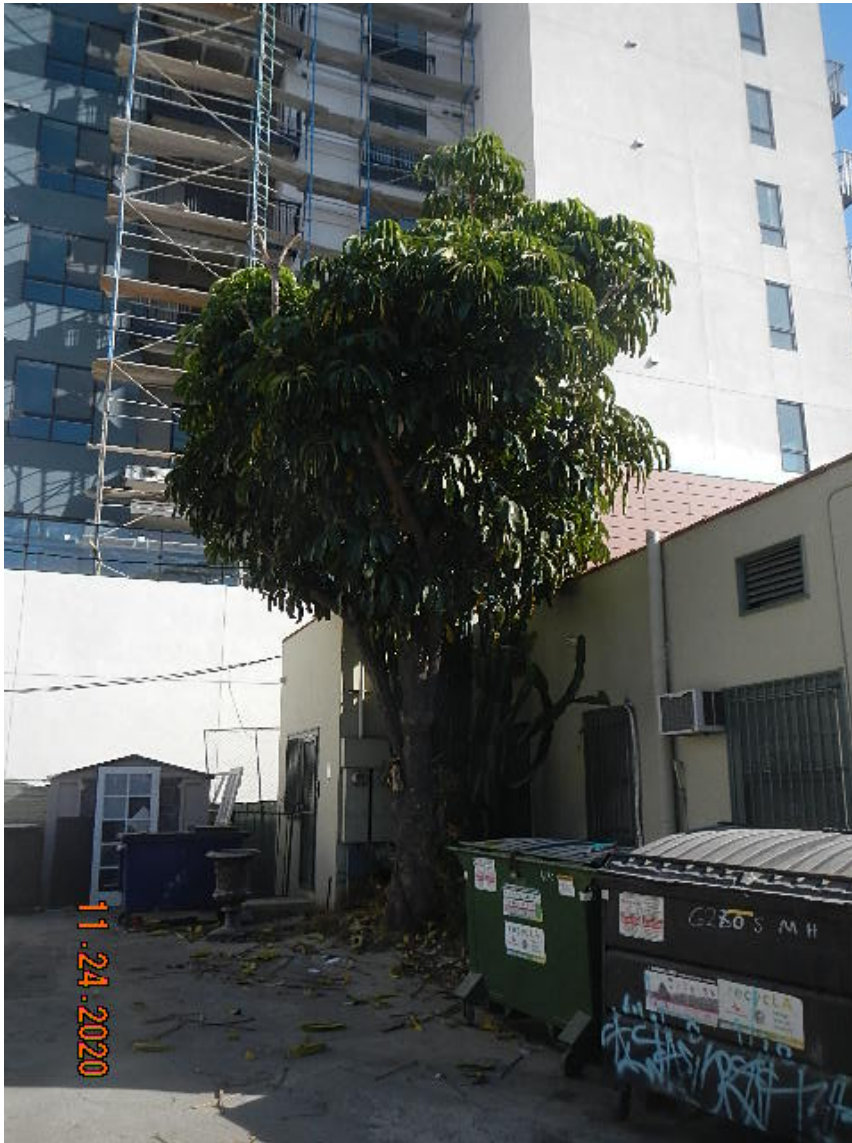
#1 Octopus tree behind the psychic reader & advisor.

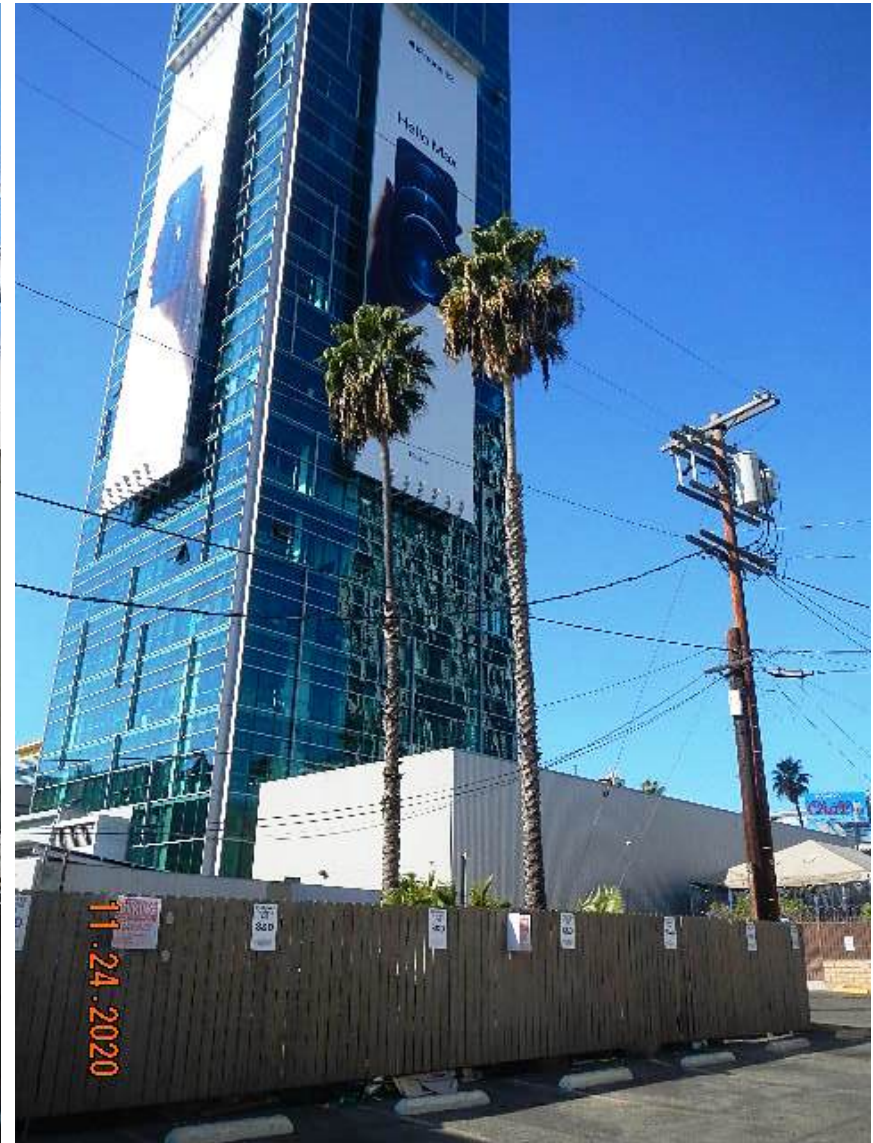
#2 & 3 Mexican fan palms are in the center of the site.

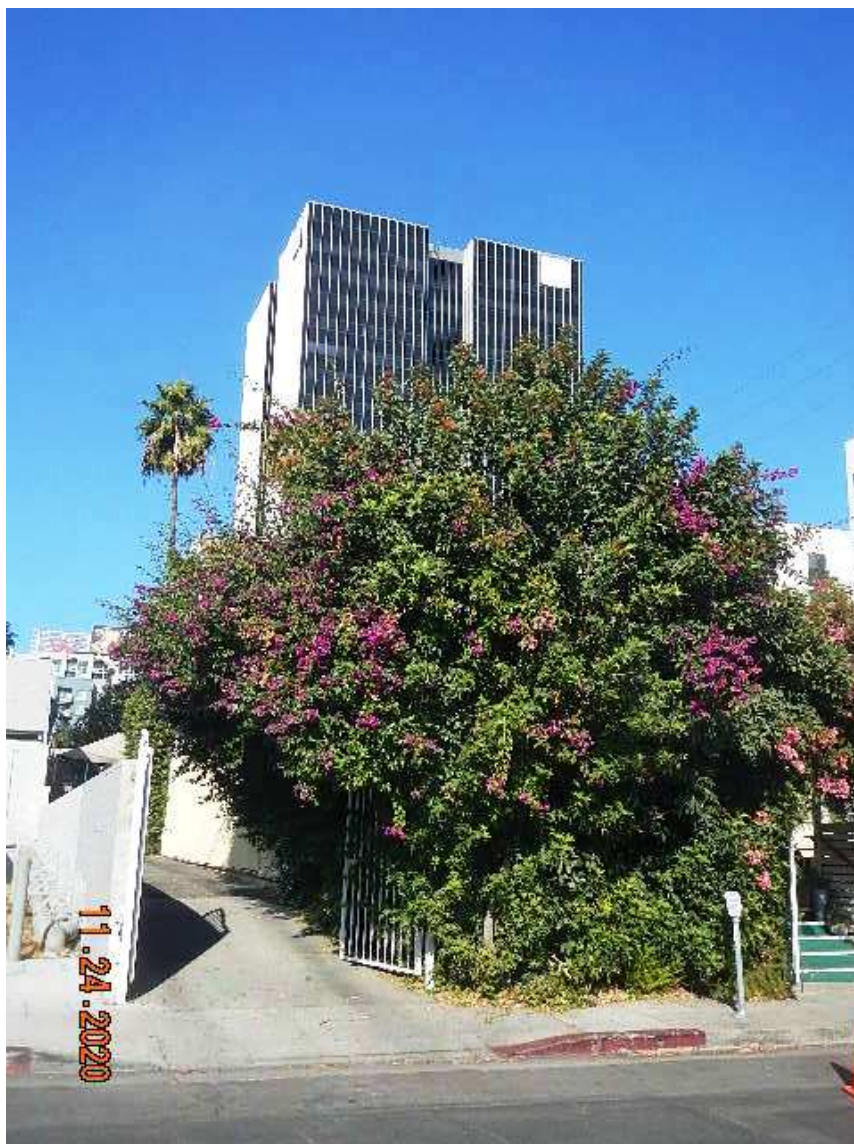
#4 Brazil pepper is covered in the bougainvillea.

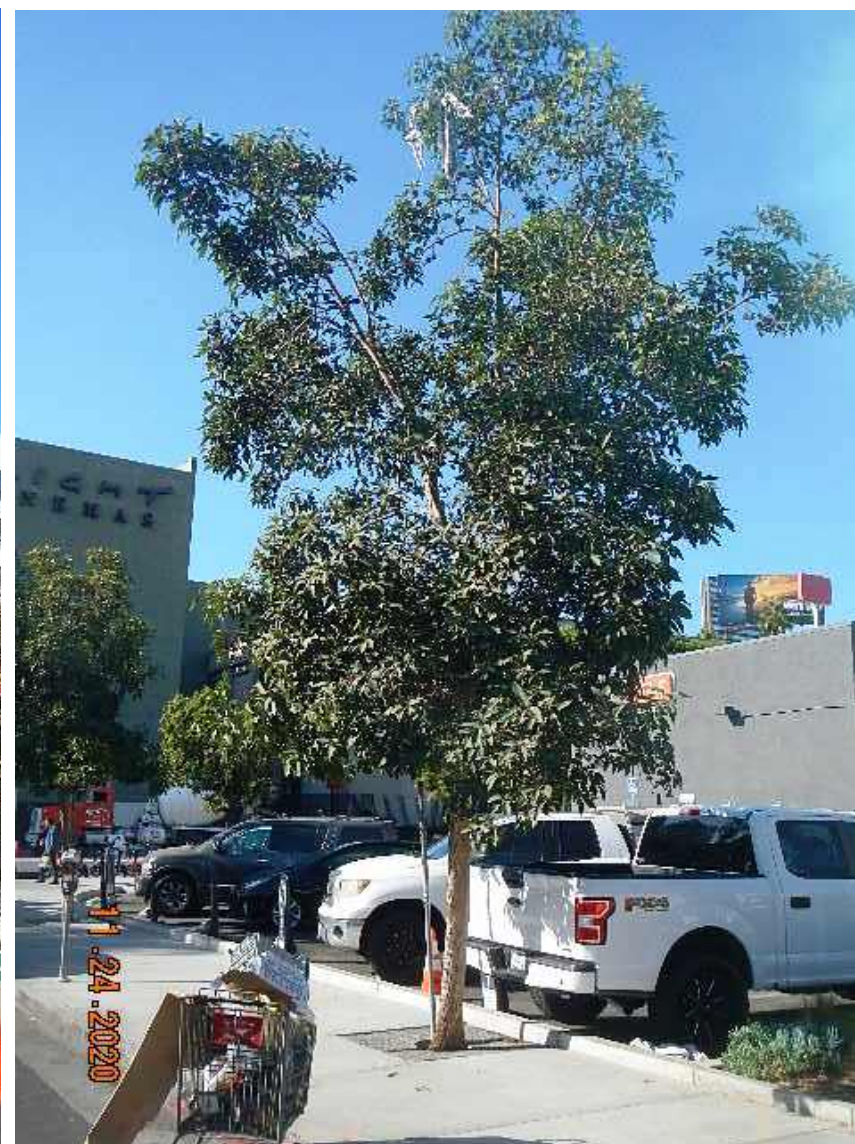
The leaning of the two Brisbane box, though partly caused by wind, could have been prevented or reduced by better staking. It is too late to straighten them now. This is a species that can get quite large and will outgrow the small sidewalk cutouts. Another species that used to have the same generic name (*Tristania*) now called *Tristaniopsis laurina*, would have been a much better choice and lasted much longer.

#5 Brisbane box -note that it came loose from the stake.

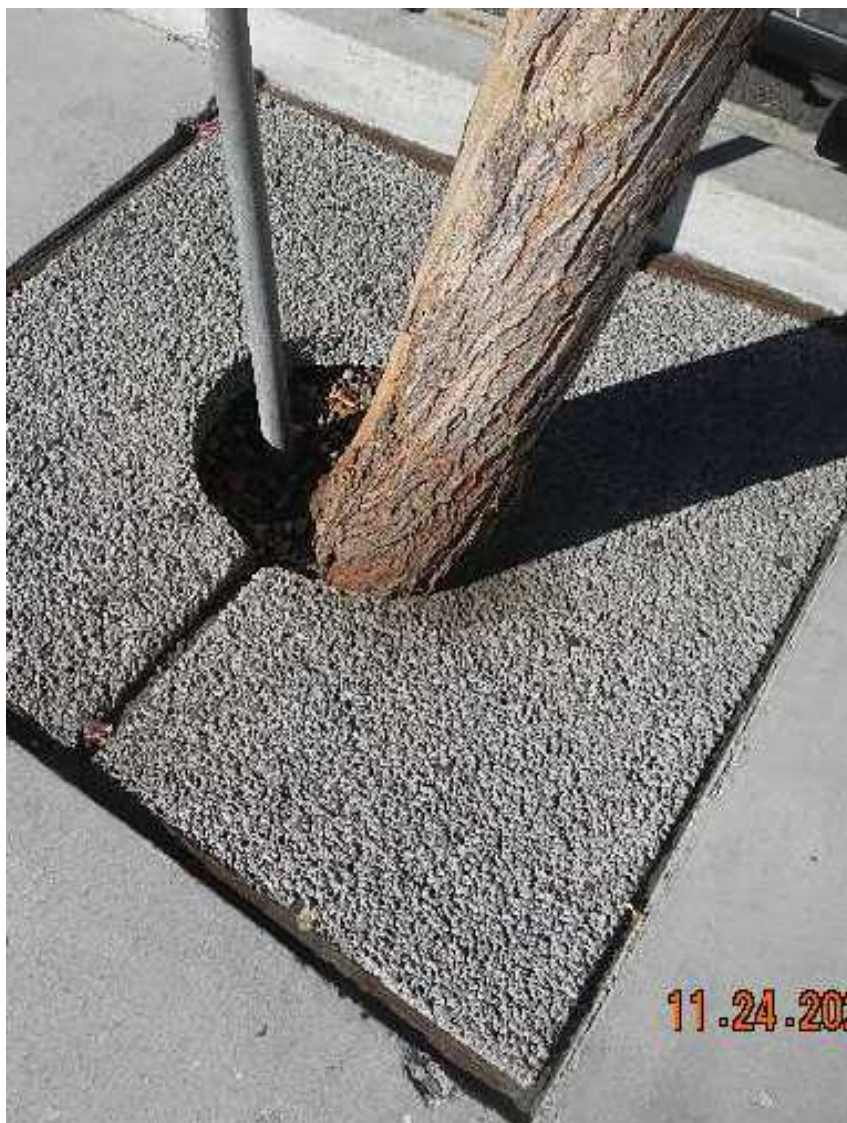
#5 Brisbane box's trunk leans against the collar.

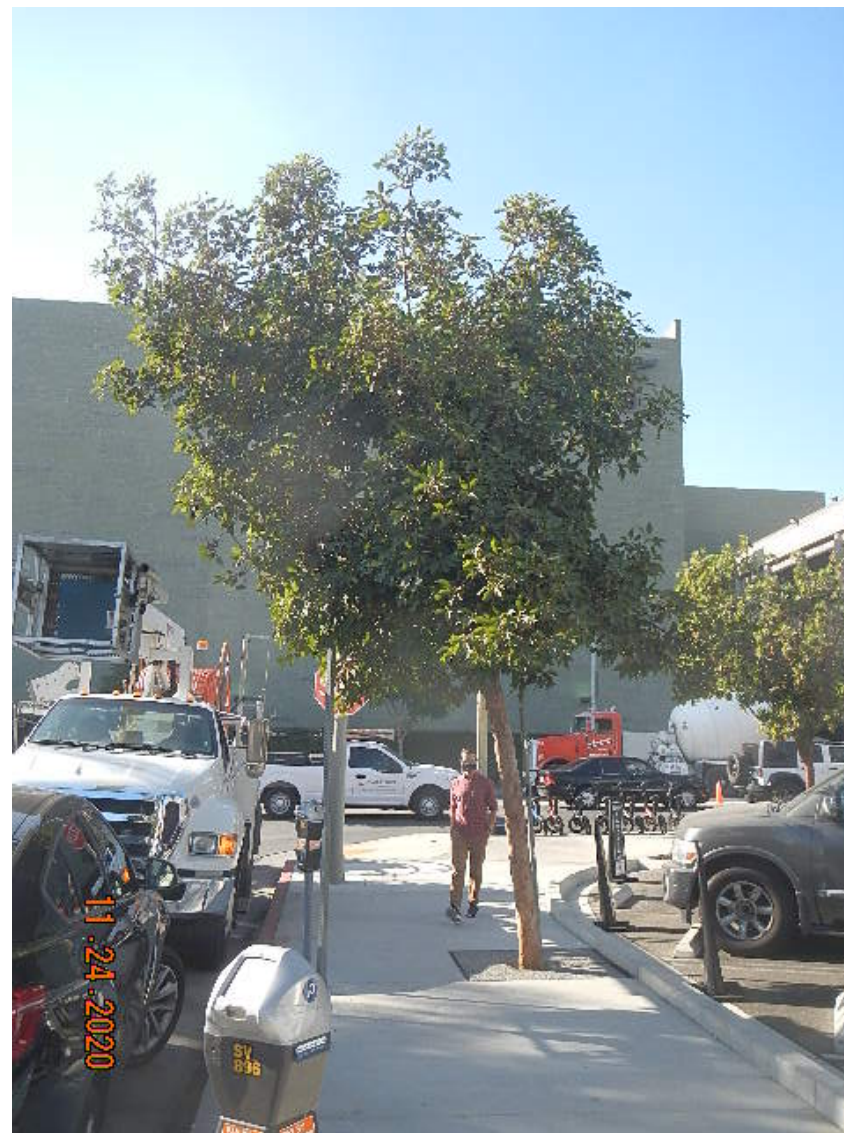
#6 Brisbane box also came loose from the stake.

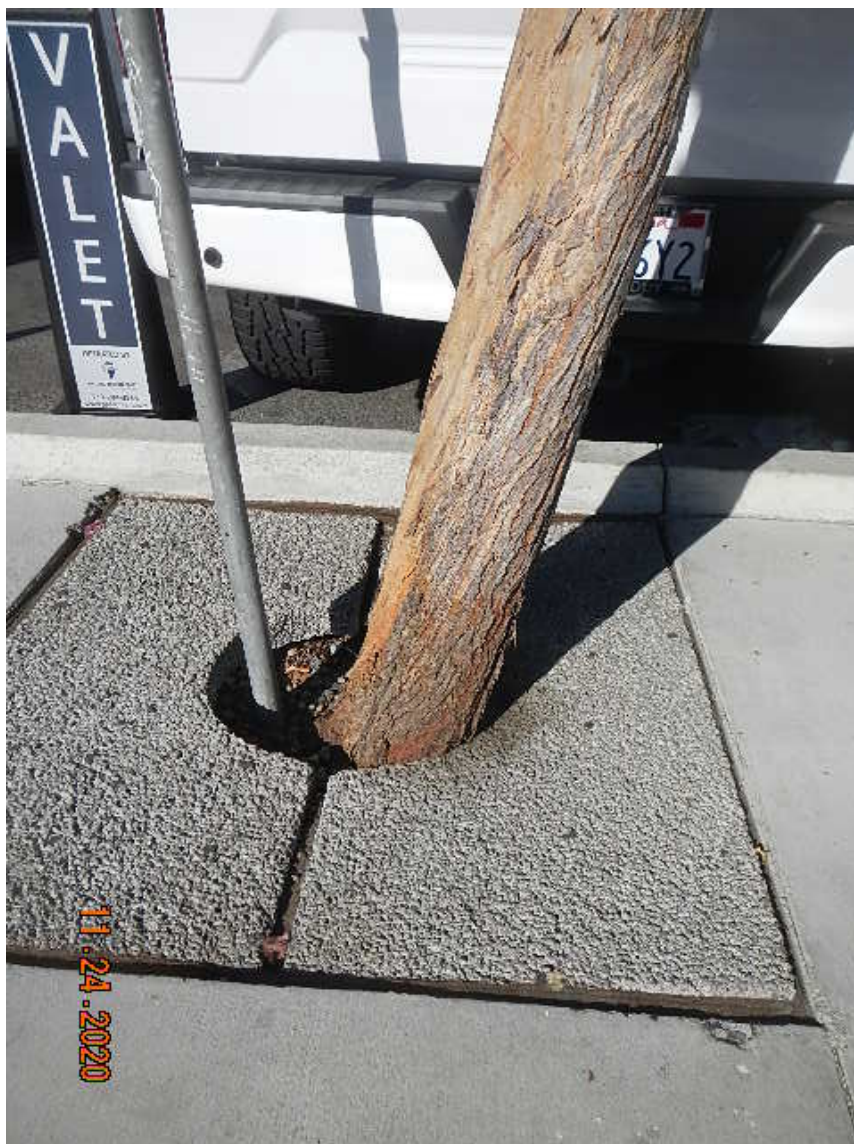
#6 Brisbane box's trunk leans against the collar.

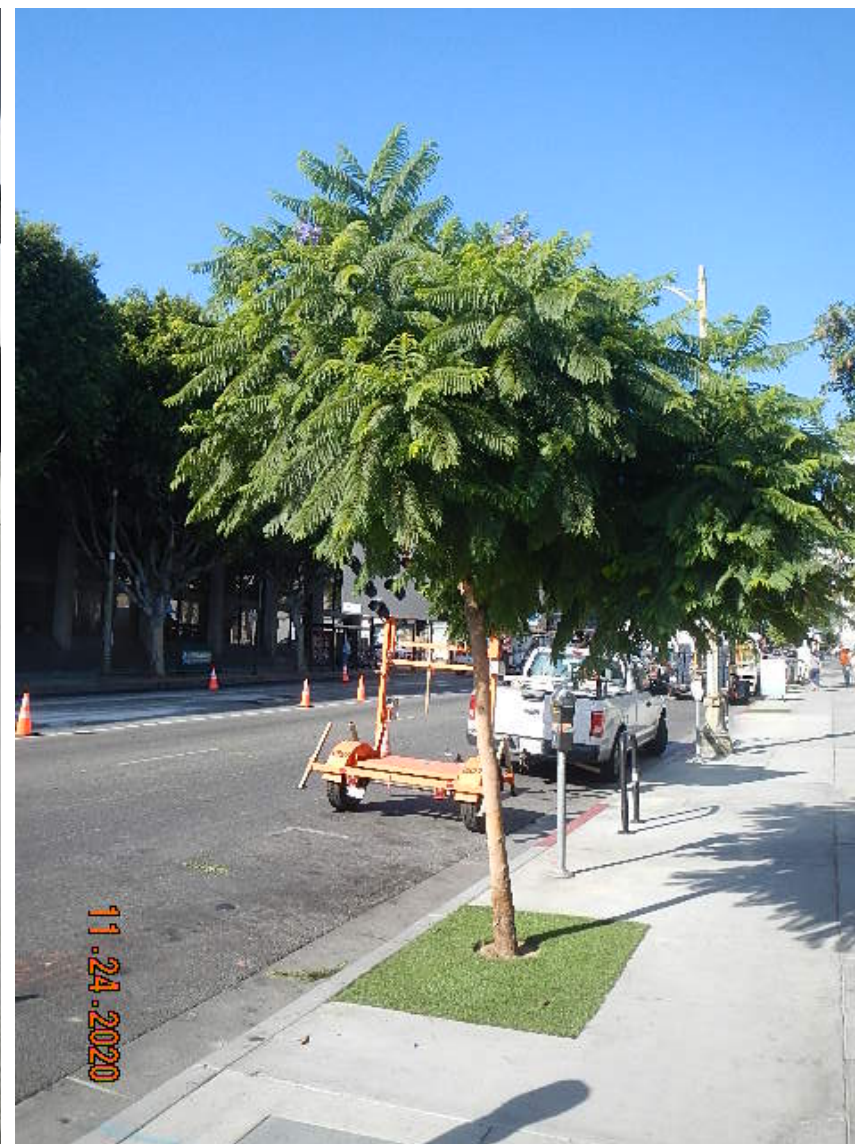
The street trees are in small tree wells totally surrounded by paving. The heavily compacted soil under the paving limits root growth to the area inside of the tree wells. This accounts for the reduced health of the trees, but not the palms. The new, smaller trees are not limited by this condition yet. Both of the Brisbane box are leaning significantly. The soil in the tree wells of the jacarandas was covered with artificial turf, which would limit aeration of the soil

#7 Jacaranda – note the artificial turf over the root zone.

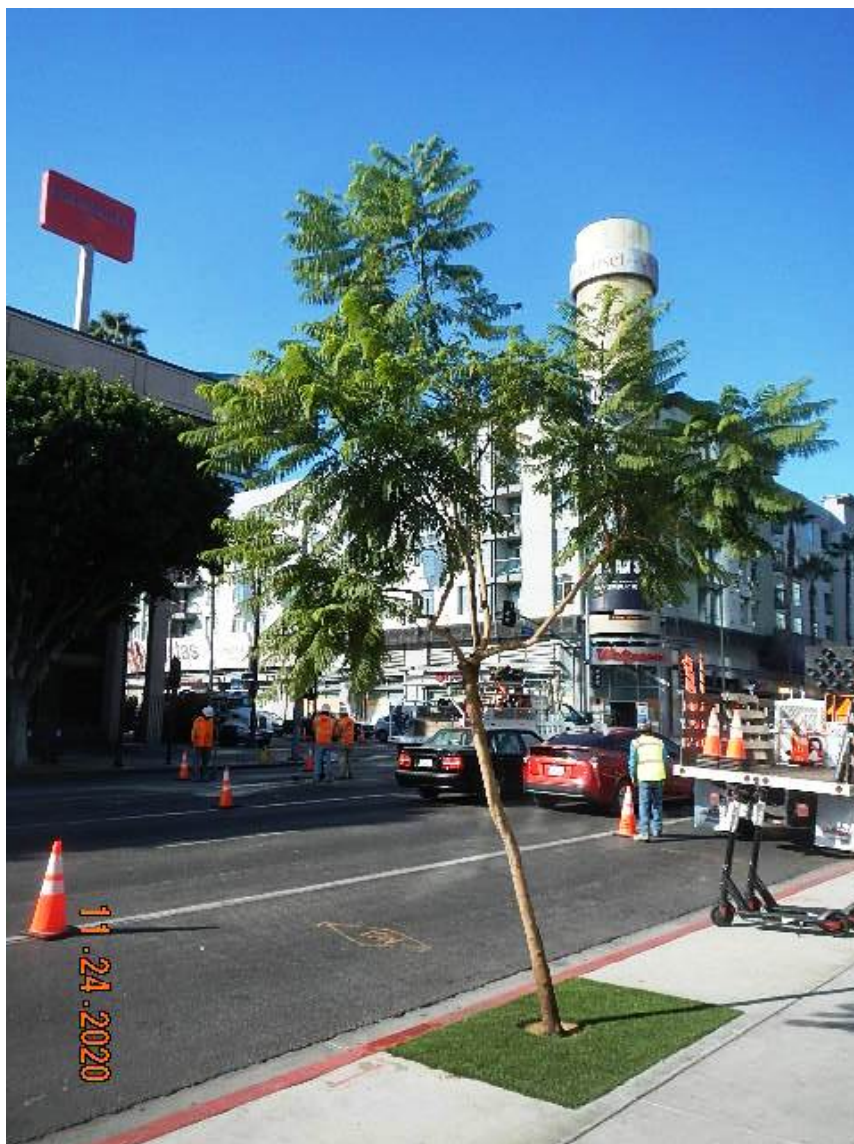
It is hard to find well trained jacarandas in the nurseries. Most are codominant to begin with. Early training, starting with subordinating the least vertical trunk(s) can help produce better street trees, with higher canopies and better clearance. Trees #7 has four equal sized primary limbs. It is not so old that it can't be trained this way, as could #8. Tree #8 has a moderate size trunk injury and has been lion-tailed. It might be better at this young age to just replace it.

#8 Jacaranda – note the four equal primary limbs

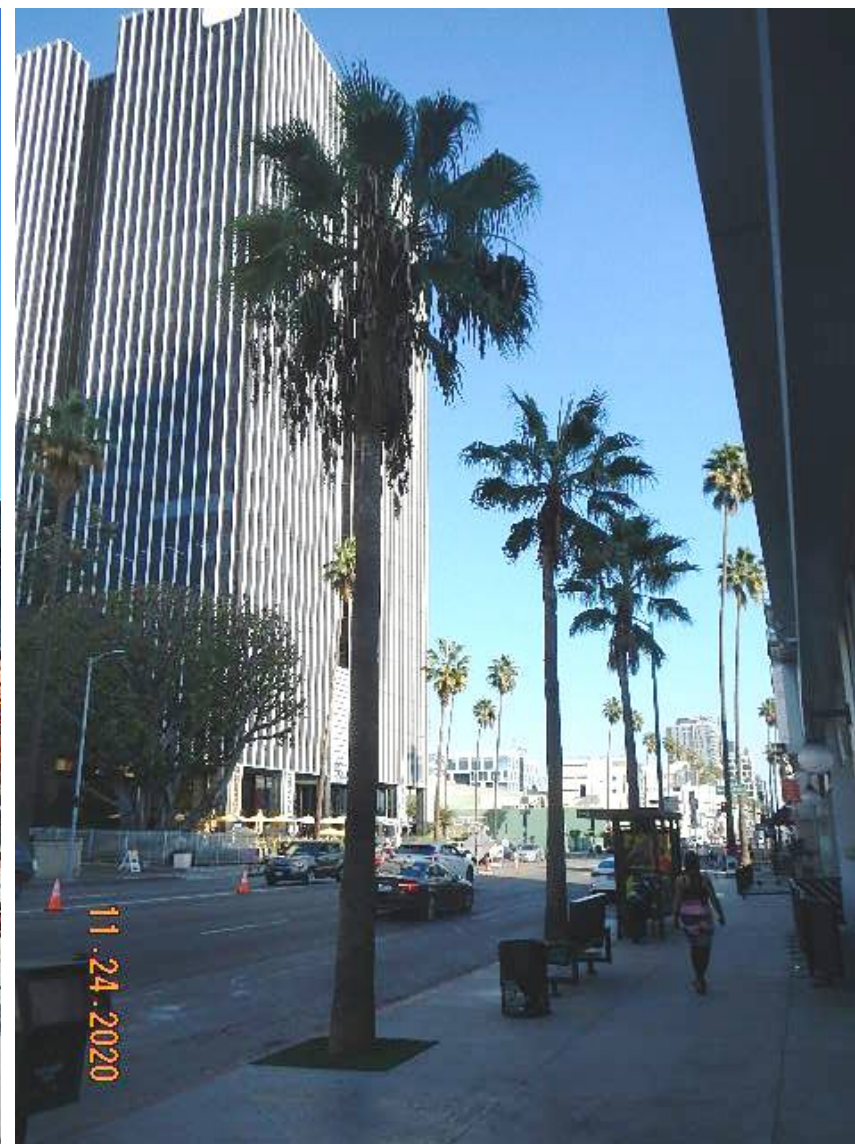
#9, 10 & 11 Mexican fan palms

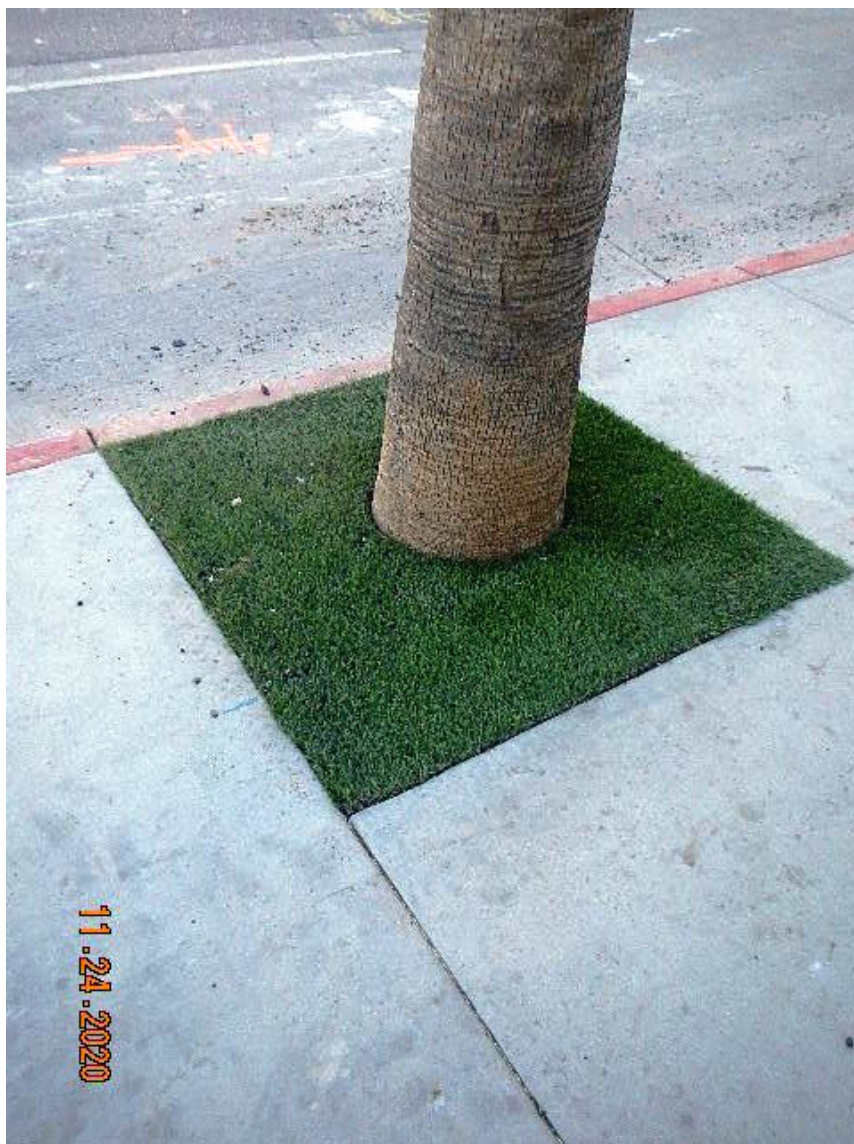
#9, 10 & 11 Mexican fan palms also have artificial turf below.

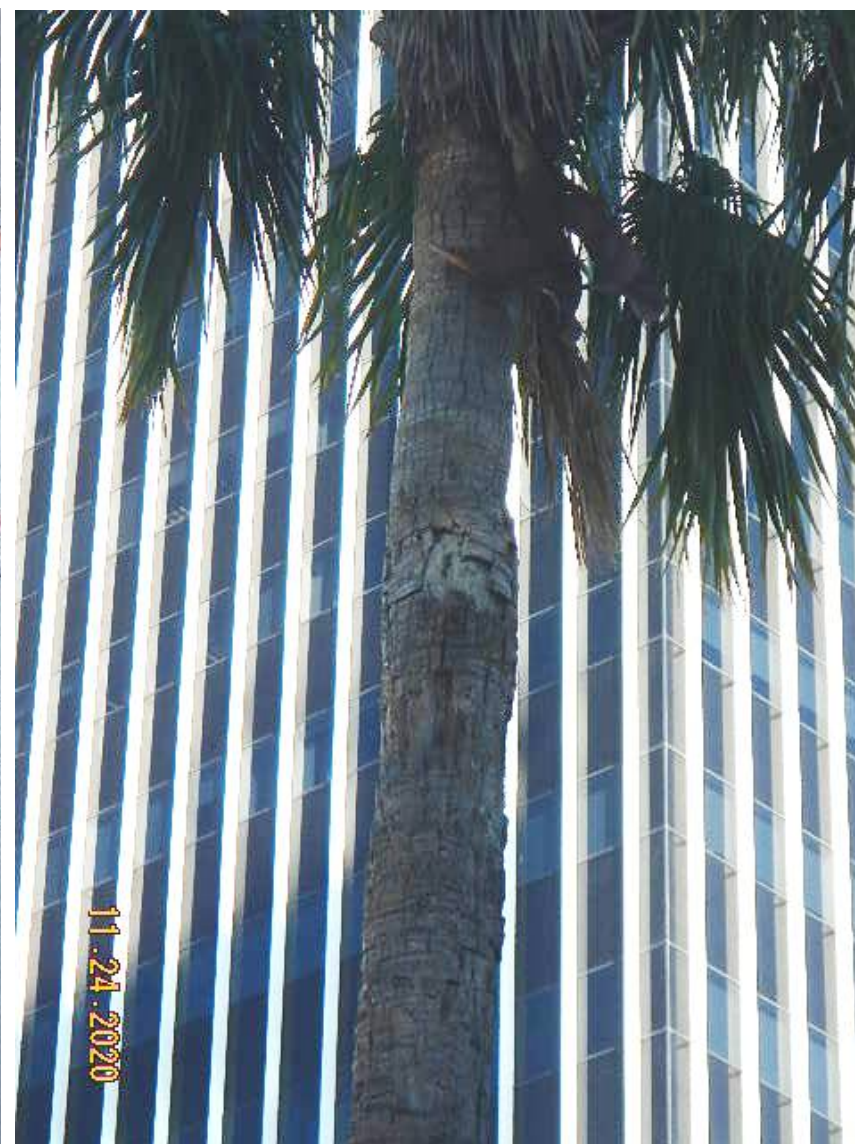
Any future planting of Mexican fan palms should have better quality control. The newer ones on Sunset will always have thinner damaged trunks. The trunk damage further up their trunks may be due to lack of necessary protection when they were delivered or how they were lifted. Lifting by a cable or chain will damage the trunk, and palm trunks do not heal.

Note the trunk damage on #9, 10 & 11 Mexican fan palms.

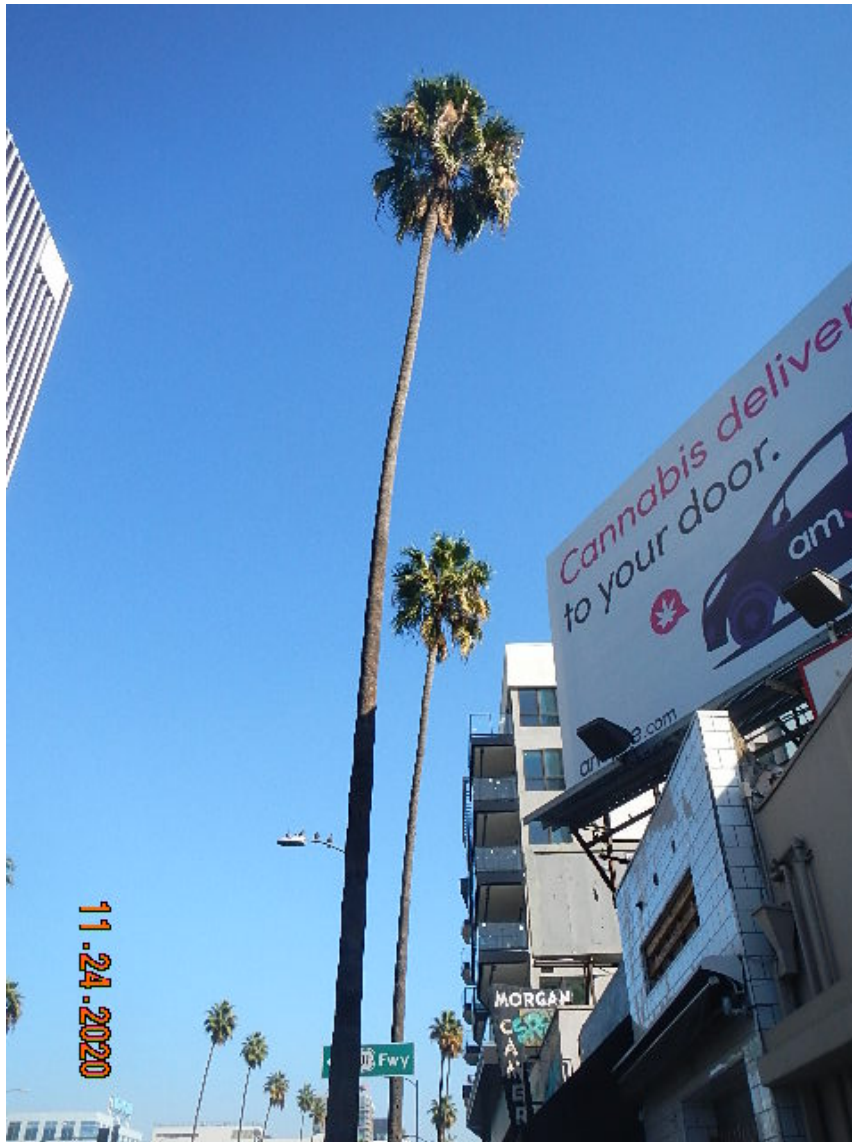
The three street trees along the Sunset portion are all Mexican fan palms, *Washingtonia robusta*. The ones in front of the tower apartments are newly planted, and only about 30 feet tall in trunk height. They also have much thinner trunks, possibly having been grown in a crowded nursery field. The two older Mexican fan palms, at 6260 and 6262 are more than twice as tall and old. Those two trunks are damaged by climbing spikes, but healthy.

#12 & 13 Mexican fan palms are much taller and have thicker trunks.

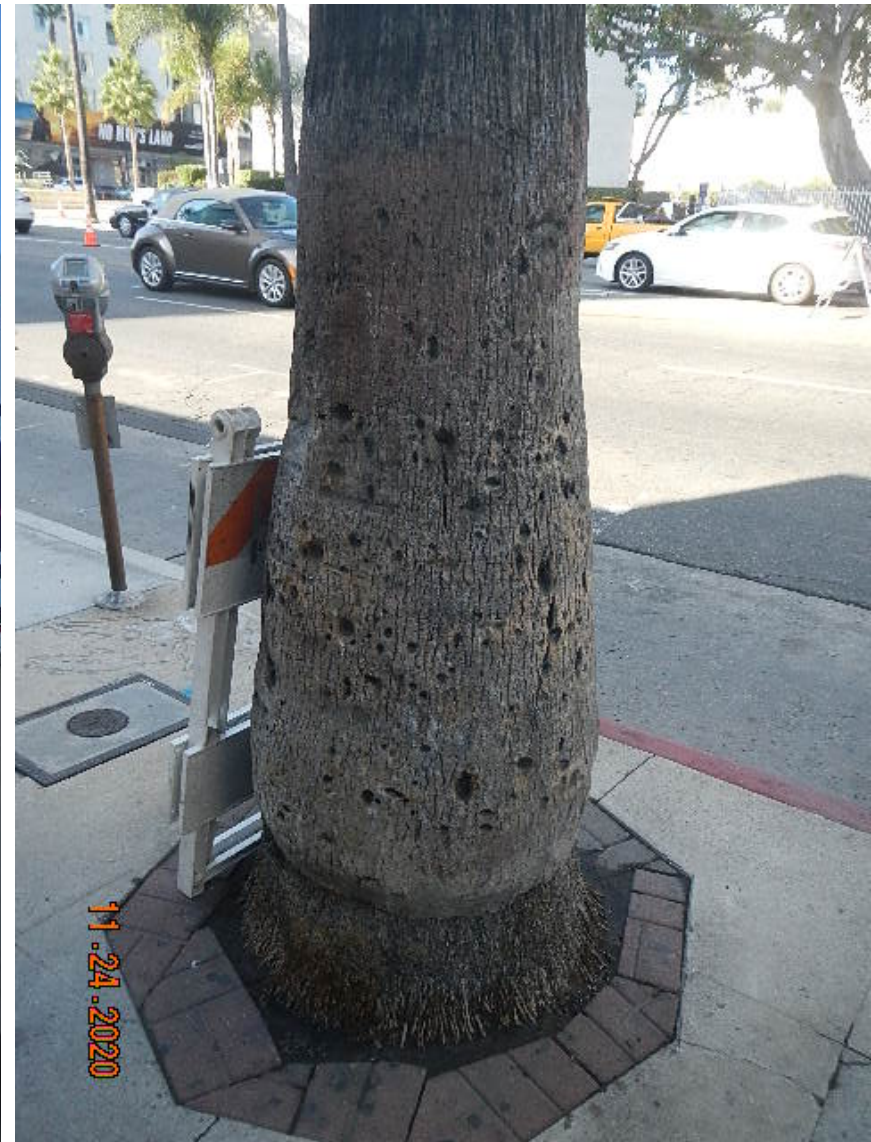
Note old gaff wounds do not “heal”.
