# Arborist Report

*Warehouse Facility  
16201 and 16251 Raymer Street  
Lake Balboa, California 91406*

*September 18, 2023*

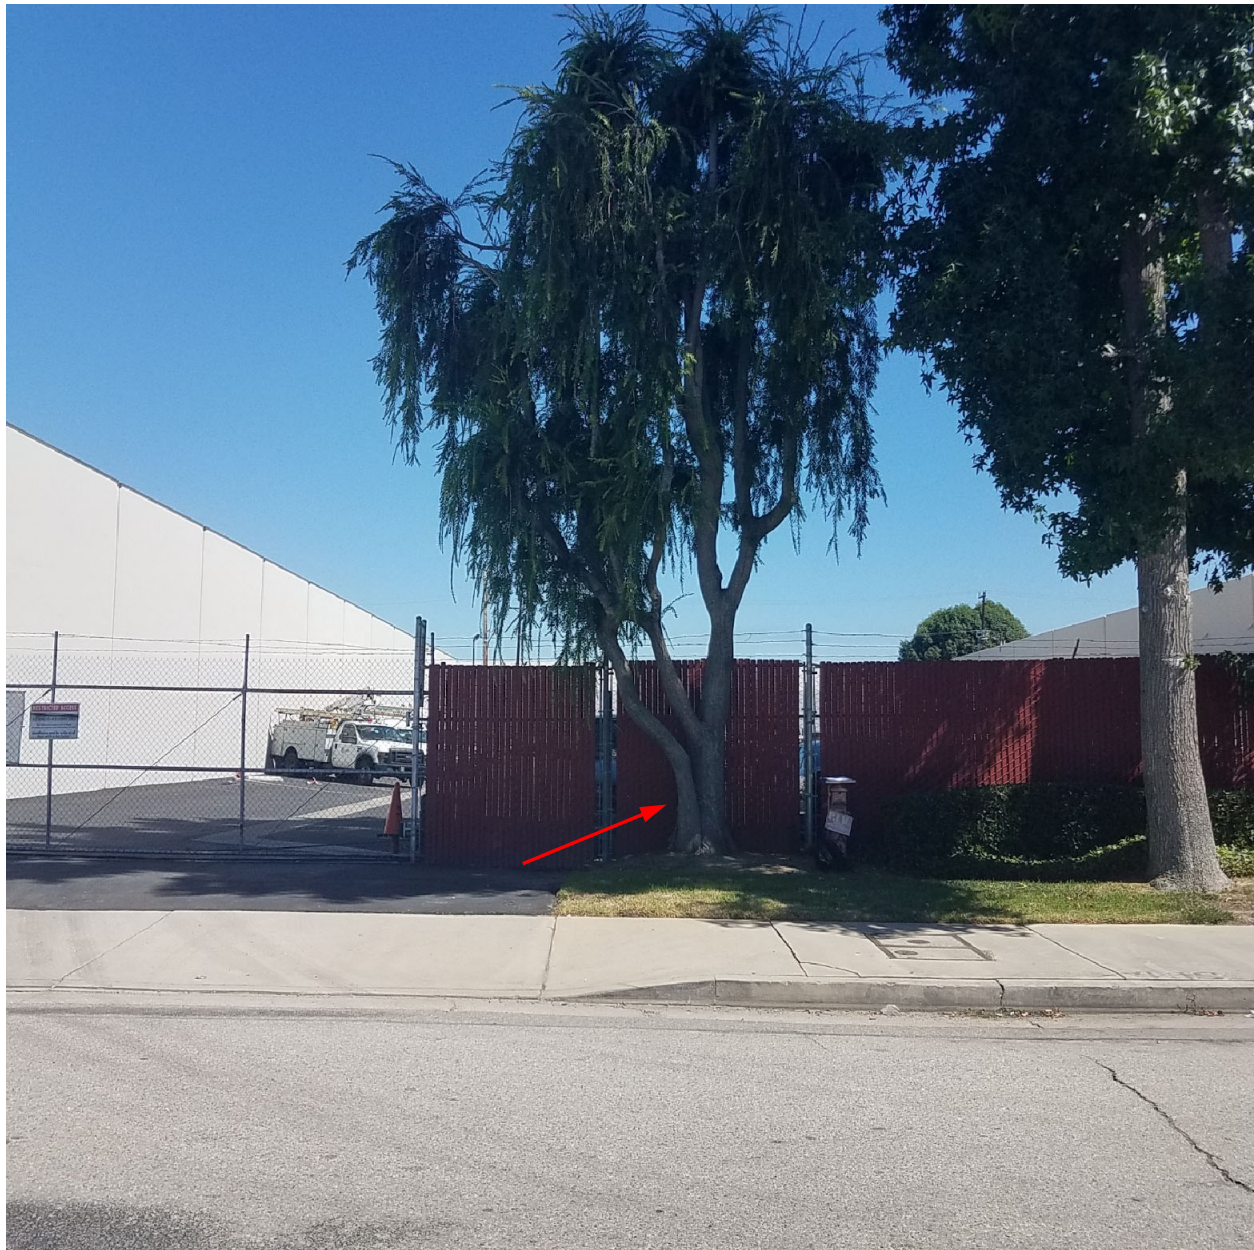
Tree #166 – This mature weeping bottlebrush tree (*Callistemon viminalis*) is located within the footprint of the westerly driveway and would therefore need to be removed to construct the project as proposed.

| Tree Number | Species | | dBH (inches) | Canopy (feet) | Height (feet) | Health | Appearance | Comments |
|---|---|---|---|---|---|---|---|---|
| 166 | <i>Callistemon viminalis</i> | weeping bottlebrush | 18 @ 4.0', 9 | 18 | 36 | B | B+ | topped; co-dominant trunks with included bark |

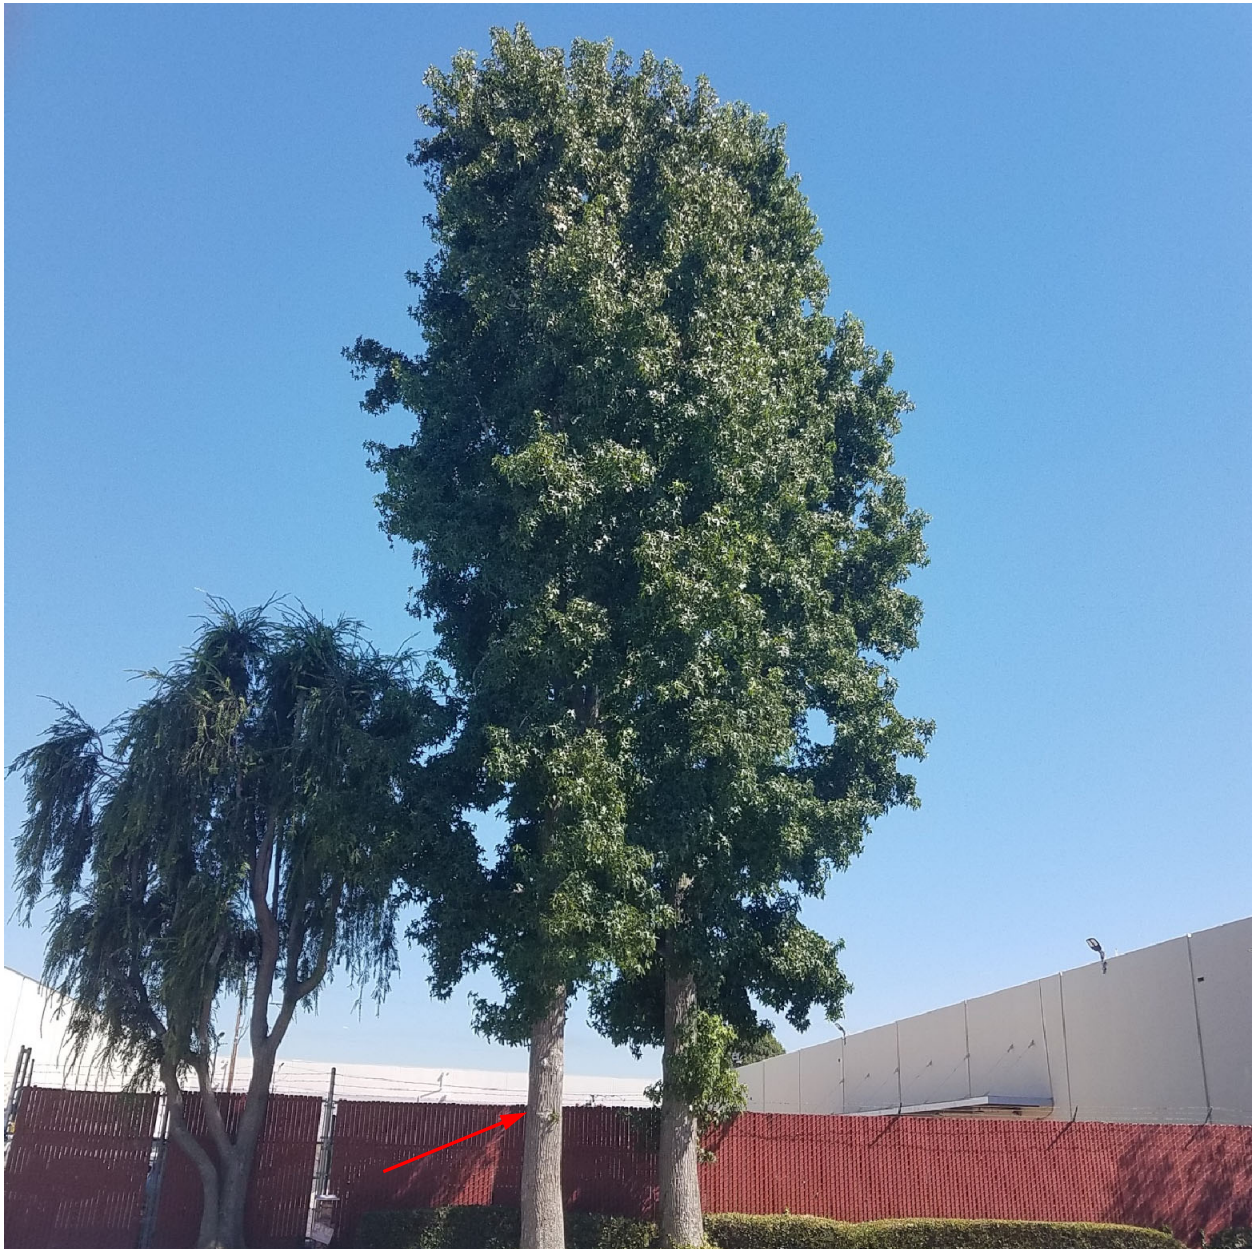
Tree #167 – This mature American sweetgum (*Liquidambar styraciflua*) is located 10 inches from the edge of the westerly driveway apron and would therefore need to be removed to construct the project as proposed.

| Tree Number | Species | | dBH (inches) | Canopy (feet) | Height (feet) | Health | Appearance | Comments |
|---|---|---|---|---|---|---|---|---|
| 167 | <i>Liquidambar styraciflua</i> | American sweetgum | 20 | 28 | 47 | B | B | heading cuts; co-dominant scaffolds |

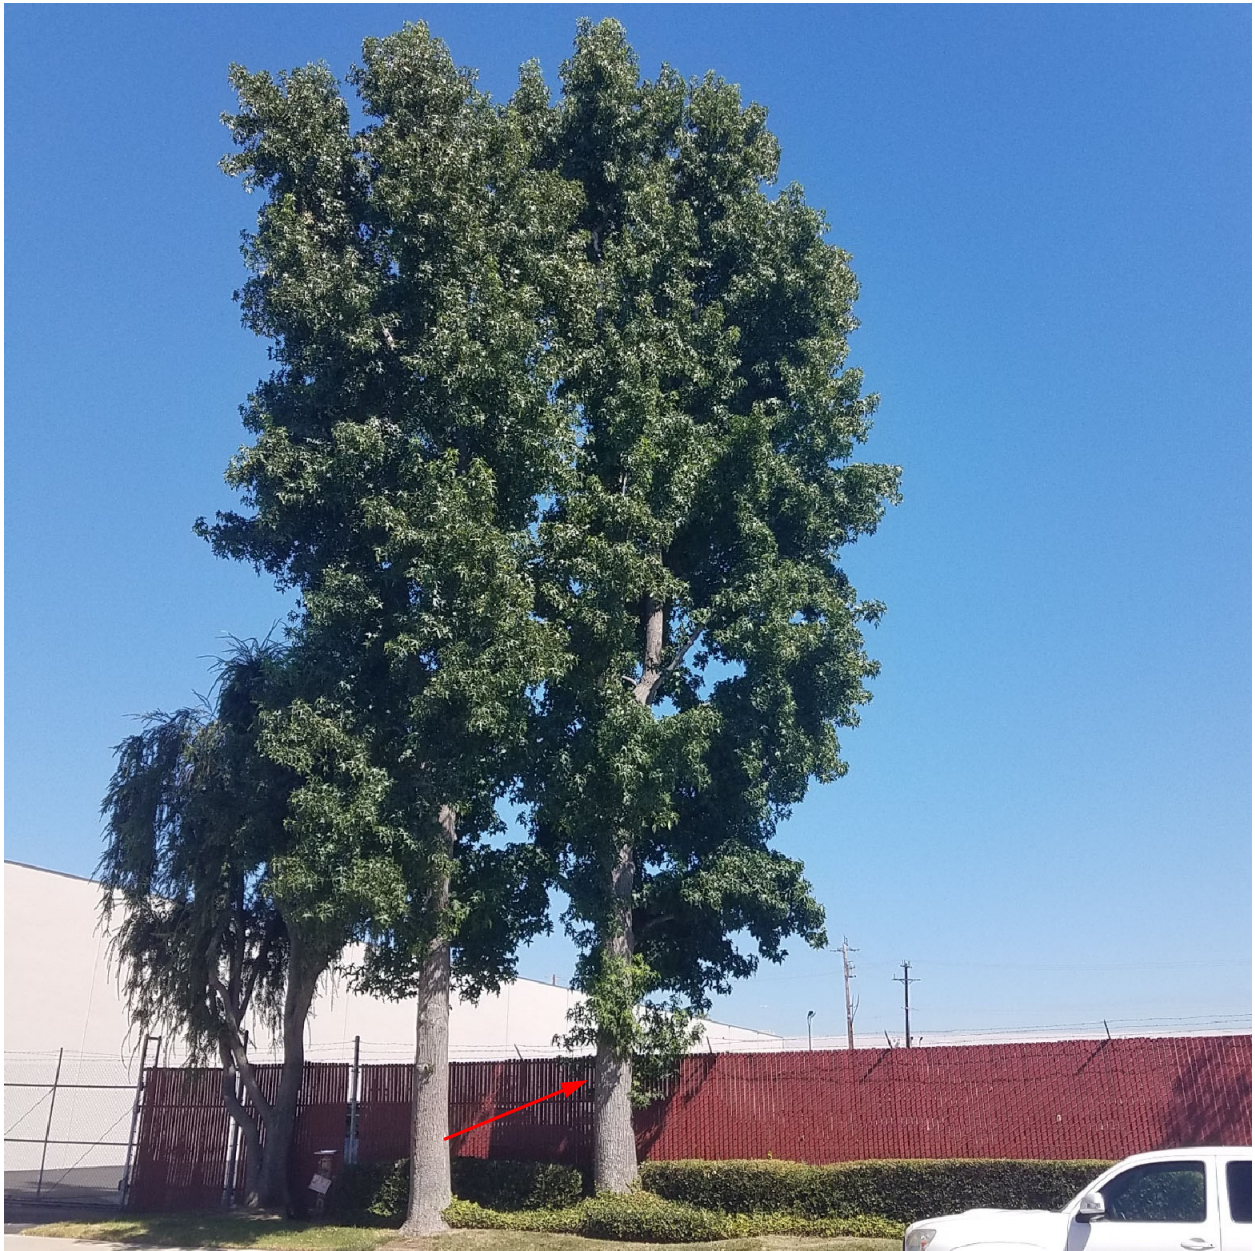
Tree #168 – This mature American sweetgum is located within the southwesterly corner of the site. The construction tolerance of American sweetgum is rated as ranging from poor to good therefore a more conservative low tolerance rating was utilized. A recommended TPZ for a mature American sweetgum of this size would be 27.5 feet.

Construction of the driveway apron for the proposed westerly driveway would occur within 9 feet of the trunk on the tree's southwesterly side. Over-excavation and re-compaction required to construct the new building would occur within 11.75 feet of the trunk on the northerly side of the tree. The tree would therefore need to be removed to construct the project as proposed.

| Tree Number | Species | | dBH (inches) | Canopy (feet) | Height (feet) | Health | Appearance | Comments |
|---|---|---|---|---|---|---|---|---|
| 168 | <i>Liquidambar styraciflua</i> | American sweetgum | 22 | 26 | 50 | B | B | heading cuts; co-dominant scaffolds |

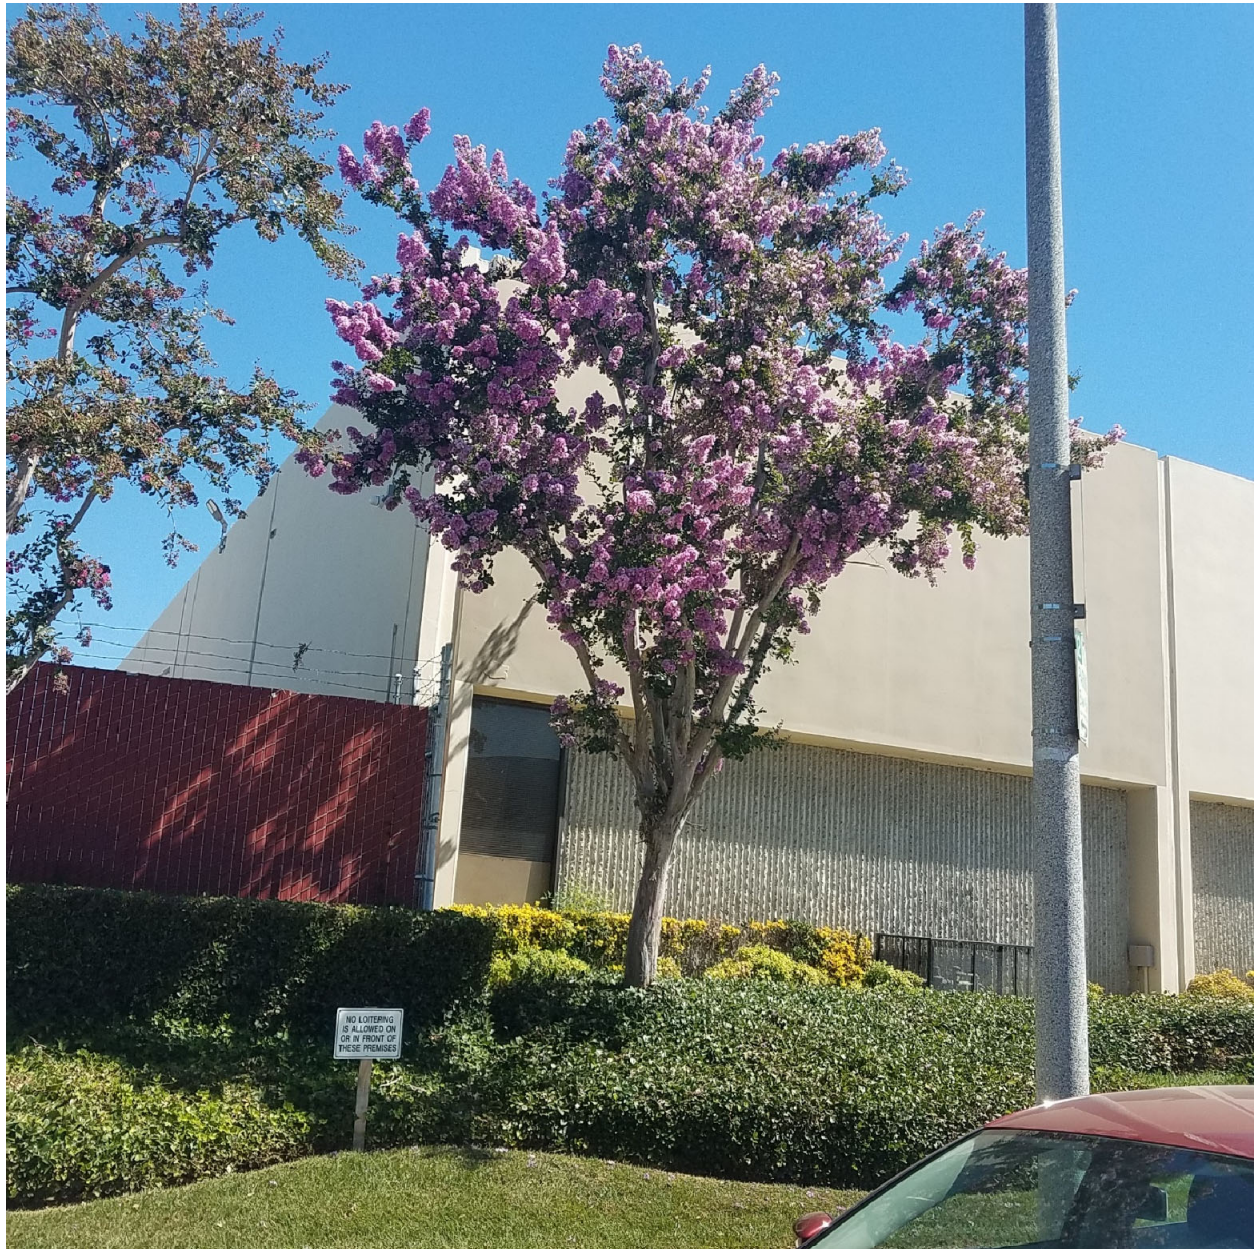
Tree #169 – This mature crape myrtle (*Lagerstroemia indica*) is located near the southwesterly corner of the site. The construction tolerance of crape myrtle is unavailable and therefore a more conservative low tolerance rating was utilized. A recommended TPZ for a mature crape myrtle of this size would be 11.25 feet.

Over-excavation and re-compaction required to construct the new building would occur within 7.67 feet of the trunk on the northerly side of the tree. The tree would therefore need to be removed to construct the project as proposed.

| Tree Number | Species | | dBH (inches) | Canopy (feet) | Height (feet) | Health | Appearance | Comments |
|---|---|---|---|---|---|---|---|---|
| 169 | <i>Lagerstroemia indica</i> | crape myrtle | 9 @ 3.5' | 20 | 27 | B- | B | multiple attachments; slightly sparse |

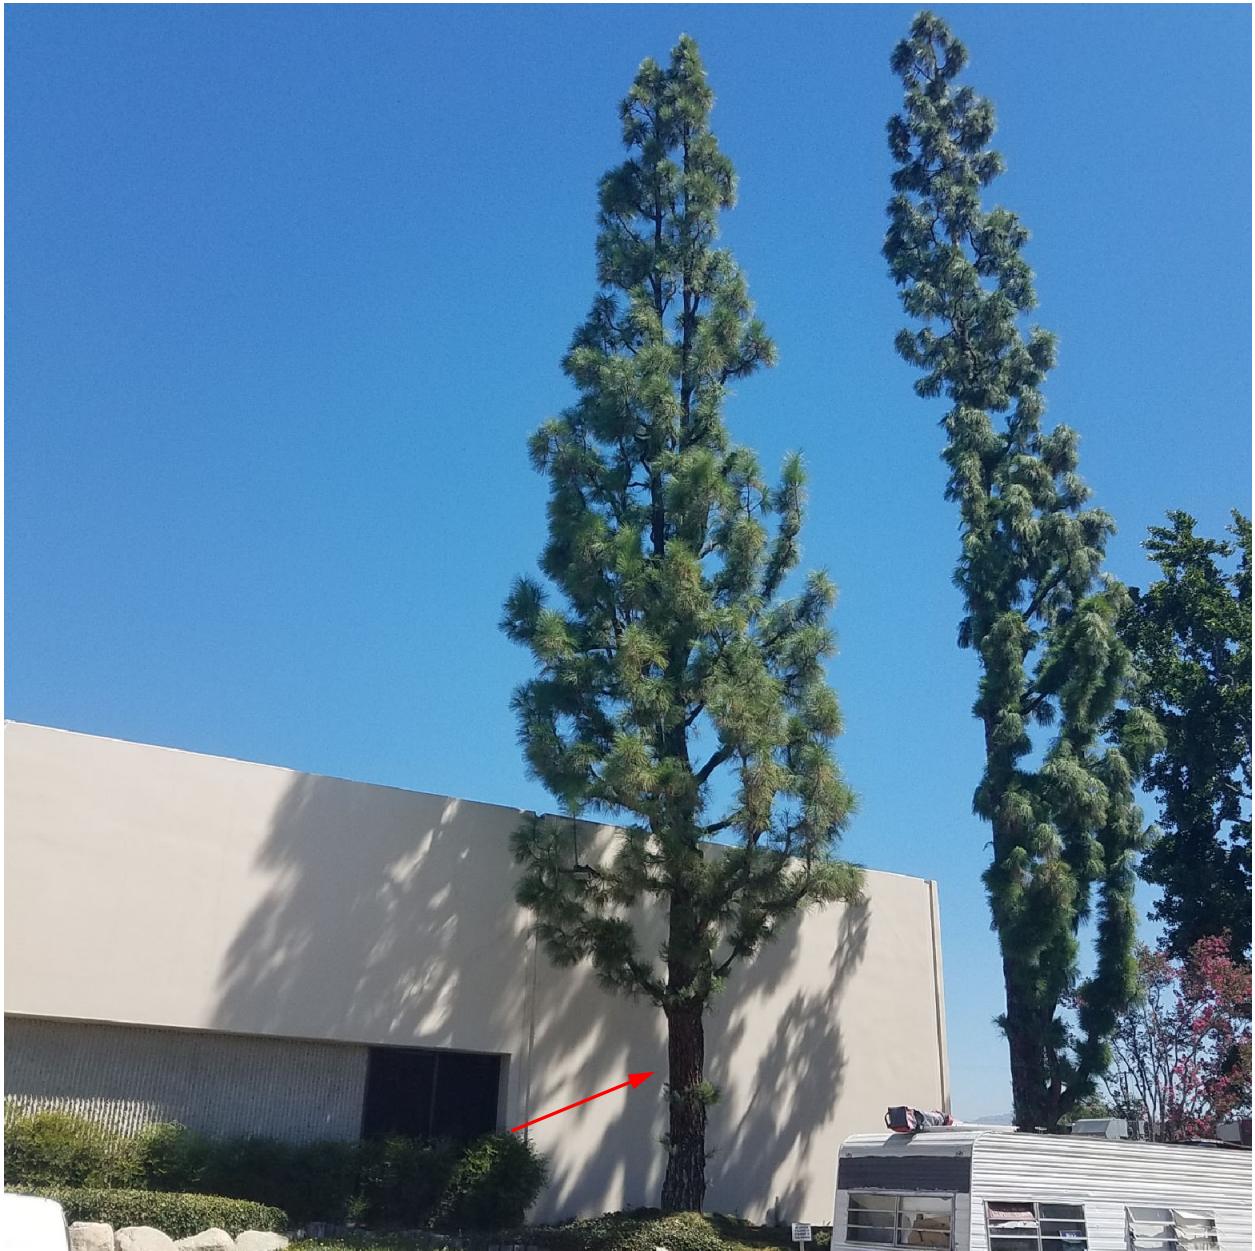
Tree #170

Trees #170, #172, #173 and #174 – This mature Canary Island pine (*Pinus canariensis*), American sweetgum and two crape myrtles, respectively, are located within the area of over-excavation and re-compaction required to construct the proposed building and would therefore need to be removed to construct the project as proposed.

| Tree Number | Species | | dBH (inches) | Canopy (feet) | Height (feet) | Health | Appearance | Comments |
|---|---|---|---|---|---|---|---|---|
| 170 | <i>Pinus canariensis</i> | Canary Island Pine | 26 | 26 | 60 | C- | C | over-pruned; epicormic sprouts |

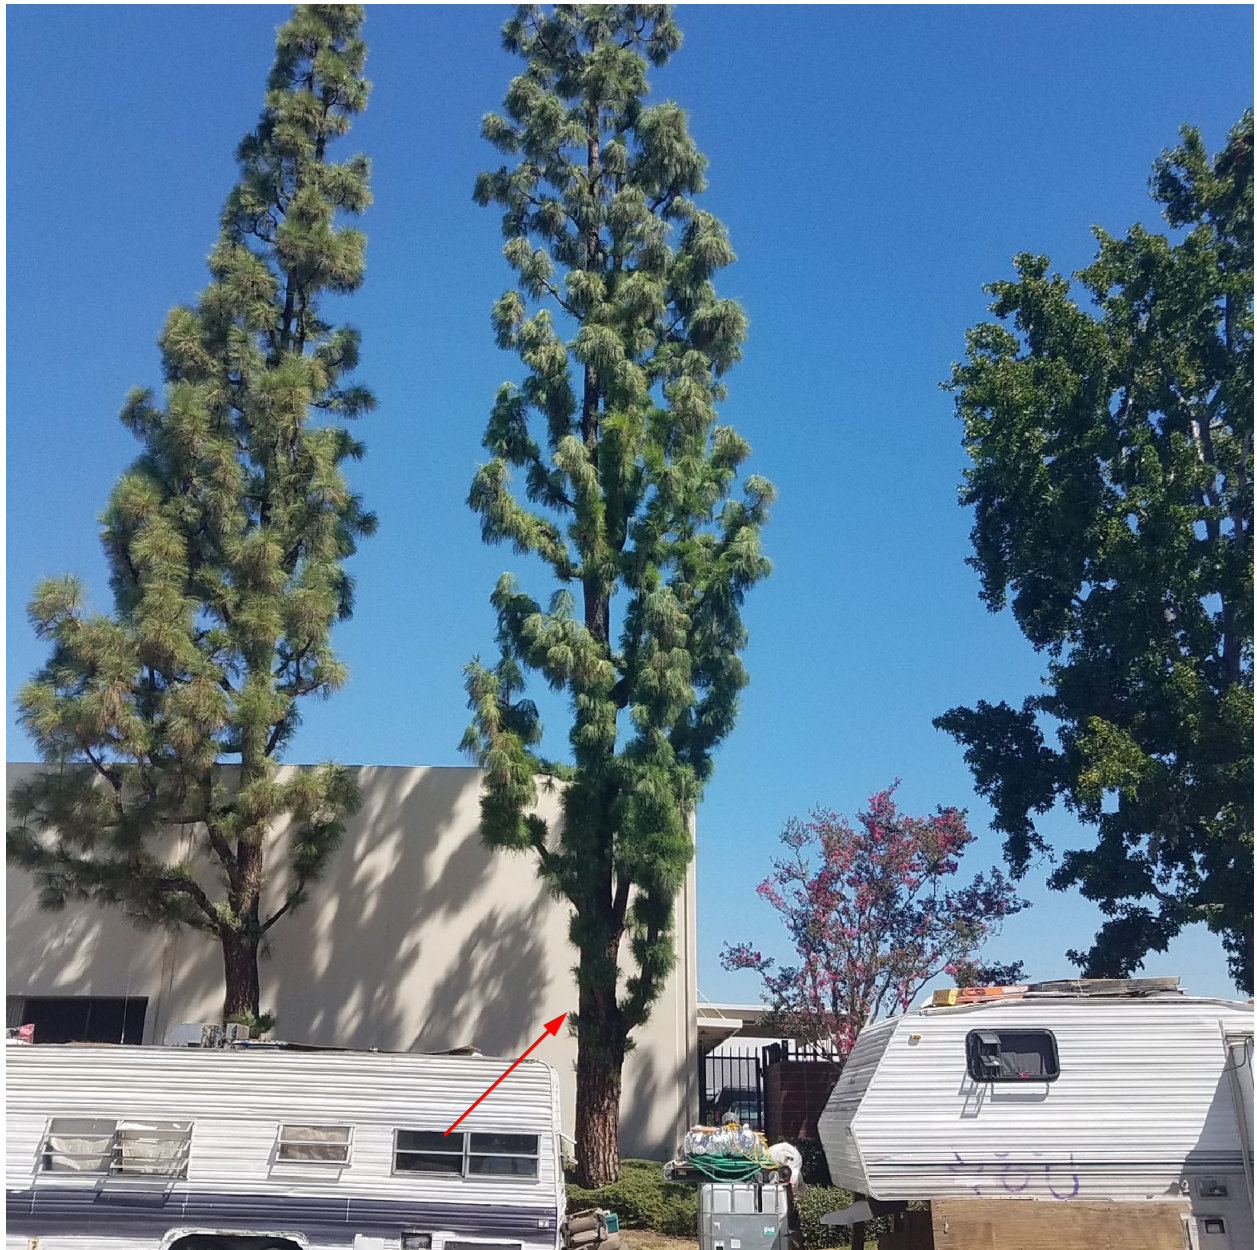
Tree #171 – This mature Canary Island pine is located 13 inches from the edge of over-excavation and re-compaction required to construct the building and would therefore need to be removed to construct the project as proposed.

| Tree Number | Species | | dBH (inches) | Canopy (feet) | Height (feet) | Health | Appearance | Comments |
|---|---|---|---|---|---|---|---|---|
| 171 | <i>Pinus canariensis</i> | Canary Island Pine | 24 | 20 | 70 | B | B- | over-pruned; epicormic sprouts |

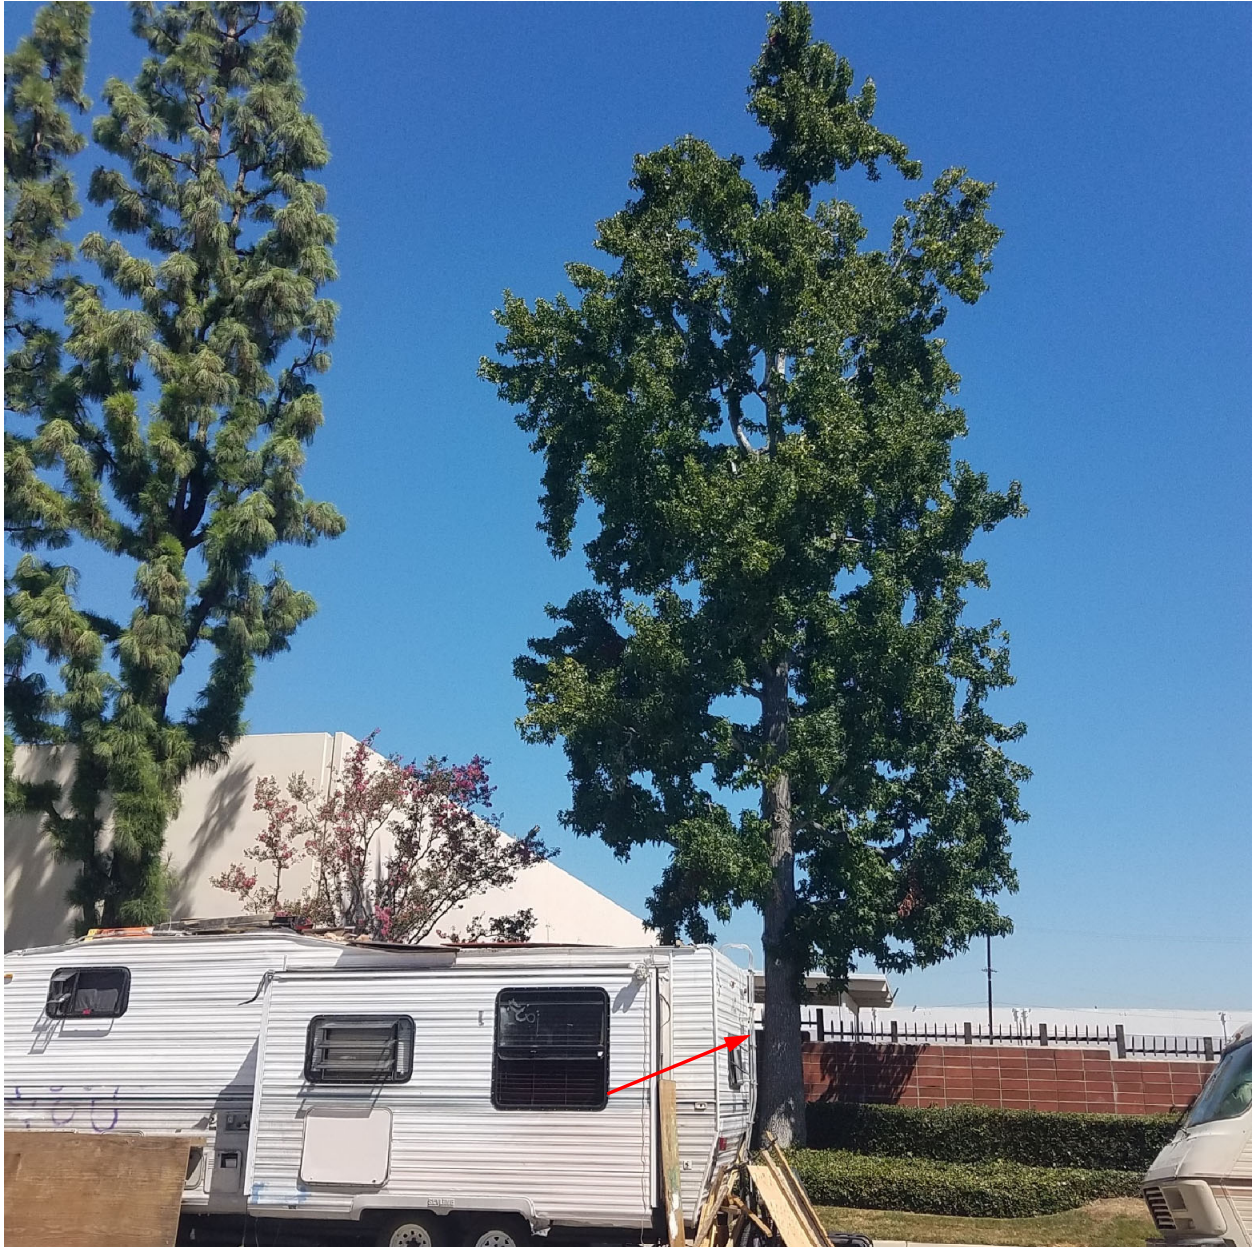
Tree #172

| Tree Number | Species | | dBH (inches) | Canopy (feet) | Height (feet) | Health | Appearance | Comments |
|---|---|---|---|---|---|---|---|---|
| 172 | <i>Liquidambar styraciflua</i> | American sweetgum | 25 | 27 | 54 | B- | B- | heading cuts; epicormic sprouts |

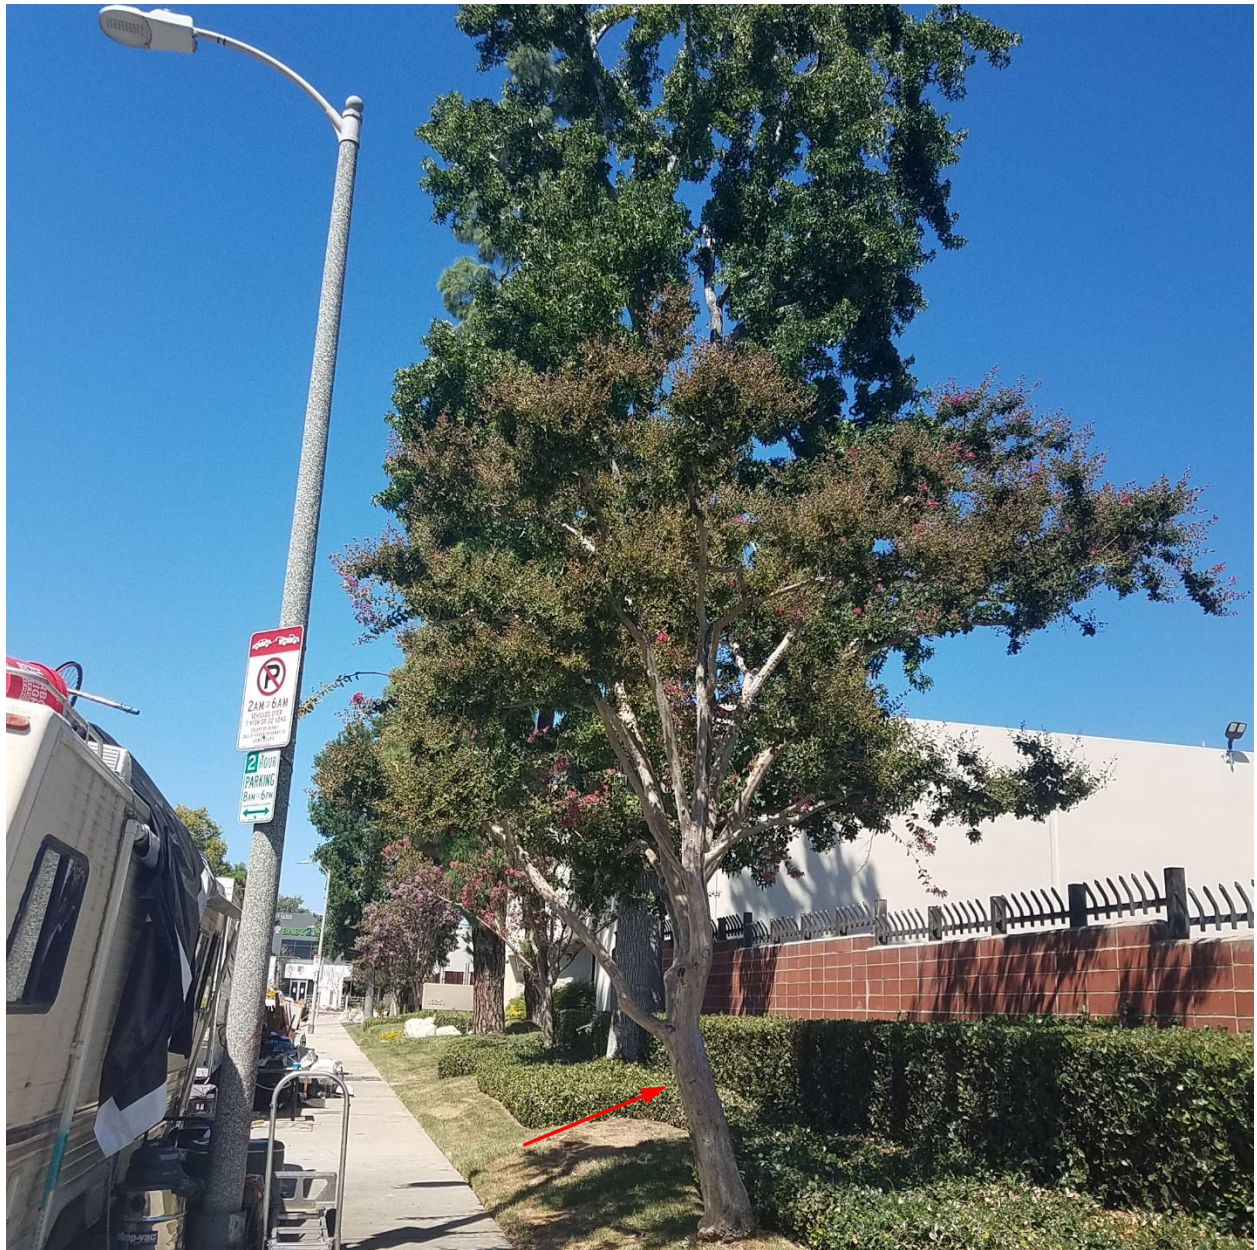
Tree #173

| Tree Number | Species | | dBH (inches) | Canopy (feet) | Height (feet) | Health | Appearance | Comments |
|---|---|---|---|---|---|---|---|---|
| 173 | <i>Lagerstroemia indica</i> | crape myrtle | 8 @ 3.5' | 18 | 22 | C | C | multiple attachments; slightly sparse |

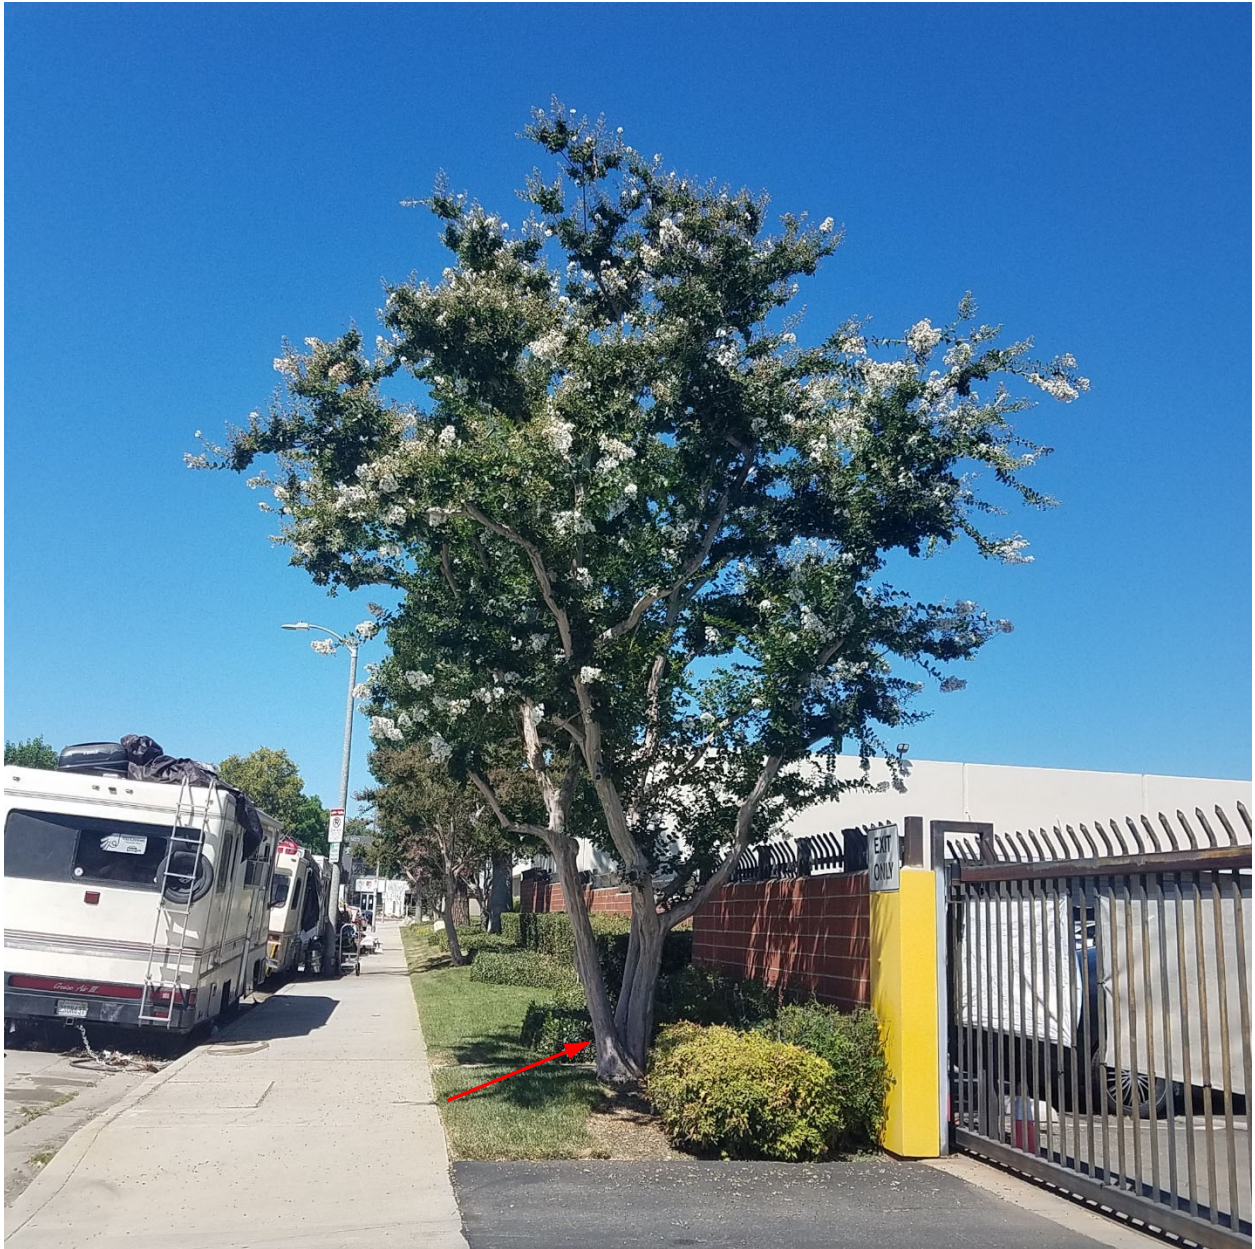
Tree #174

| Tree Number | Species | | dBH (inches) | Canopy (feet) | Height (feet) | Health | Appearance | Comments |
|---|---|---|---|---|---|---|---|---|
| 174 | <i>Lagerstroemia indica</i> | crape myrtle | 7, 7, 7 @ 4.0' | 27 | 25 | C | C | co-dominant trunks with included bark; epicormic sprouts |

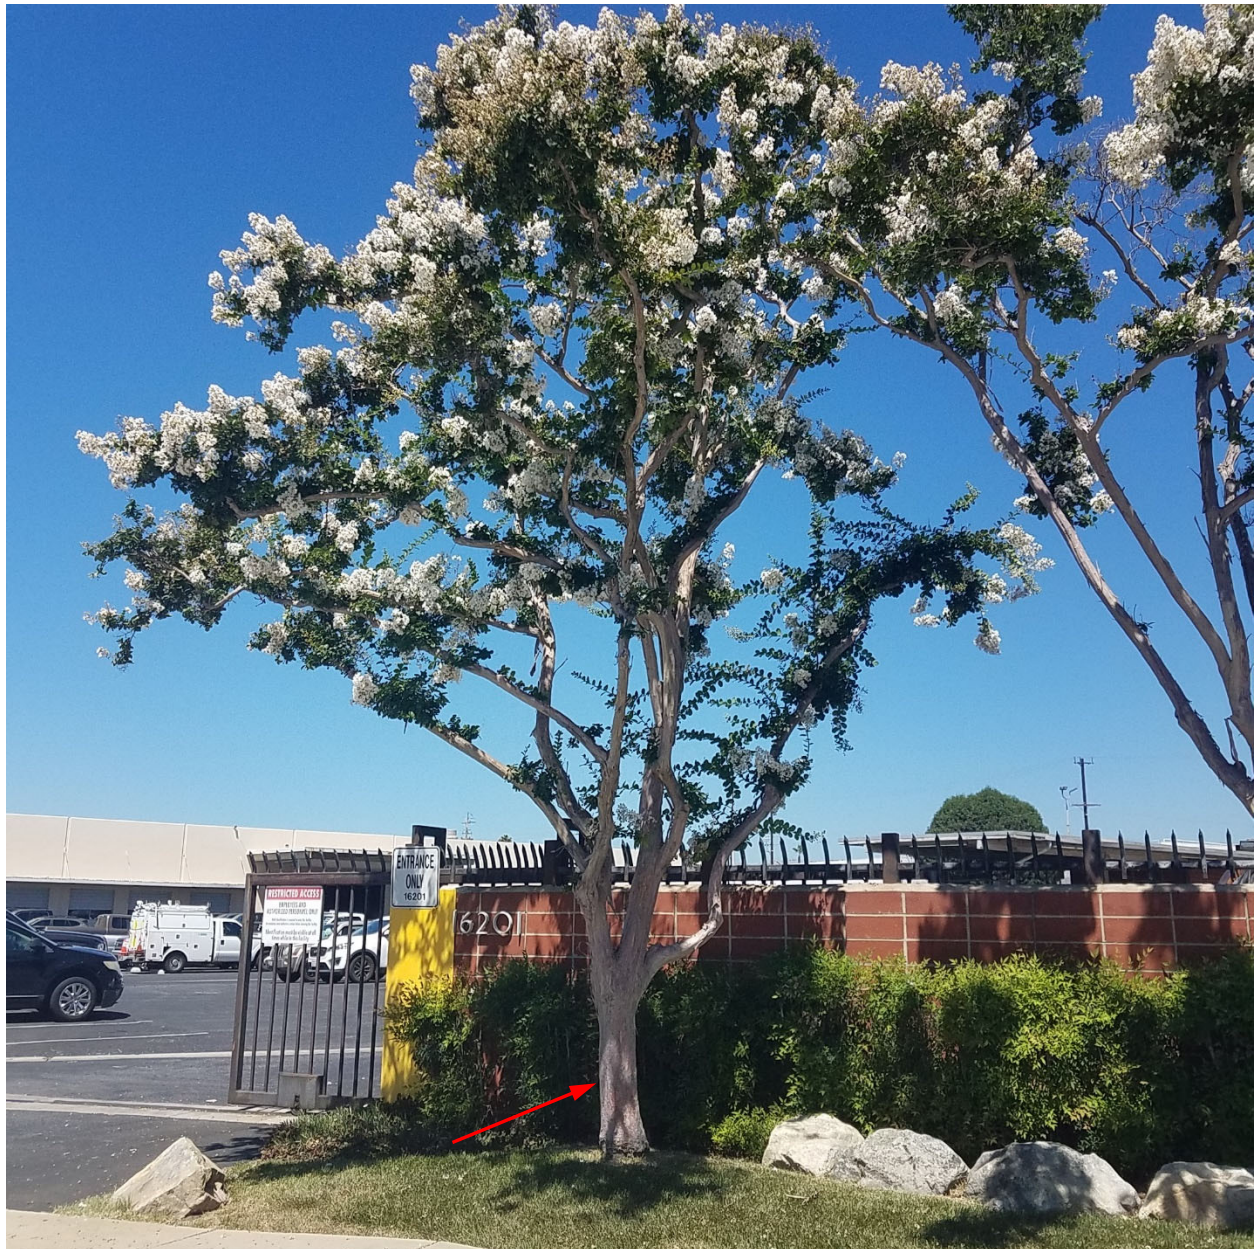
Tree #175 – This mature crape myrtle is located 24 inches from the edge of over-excavation and re-compaction required to construct the building and would therefore need to be removed to construct the project as proposed.

| Tree Number | Species | | dBH (inches) | Canopy (feet) | Height (feet) | Health | Appearance | Comments |
|---|---|---|---|---|---|---|---|---|
| 175 | <i>Lagerstroemia indica</i> | crape myrtle | 9 @ 3.5' | 21 | 23 | C | C | multiple attachments; epicormic sprouts; sparse |

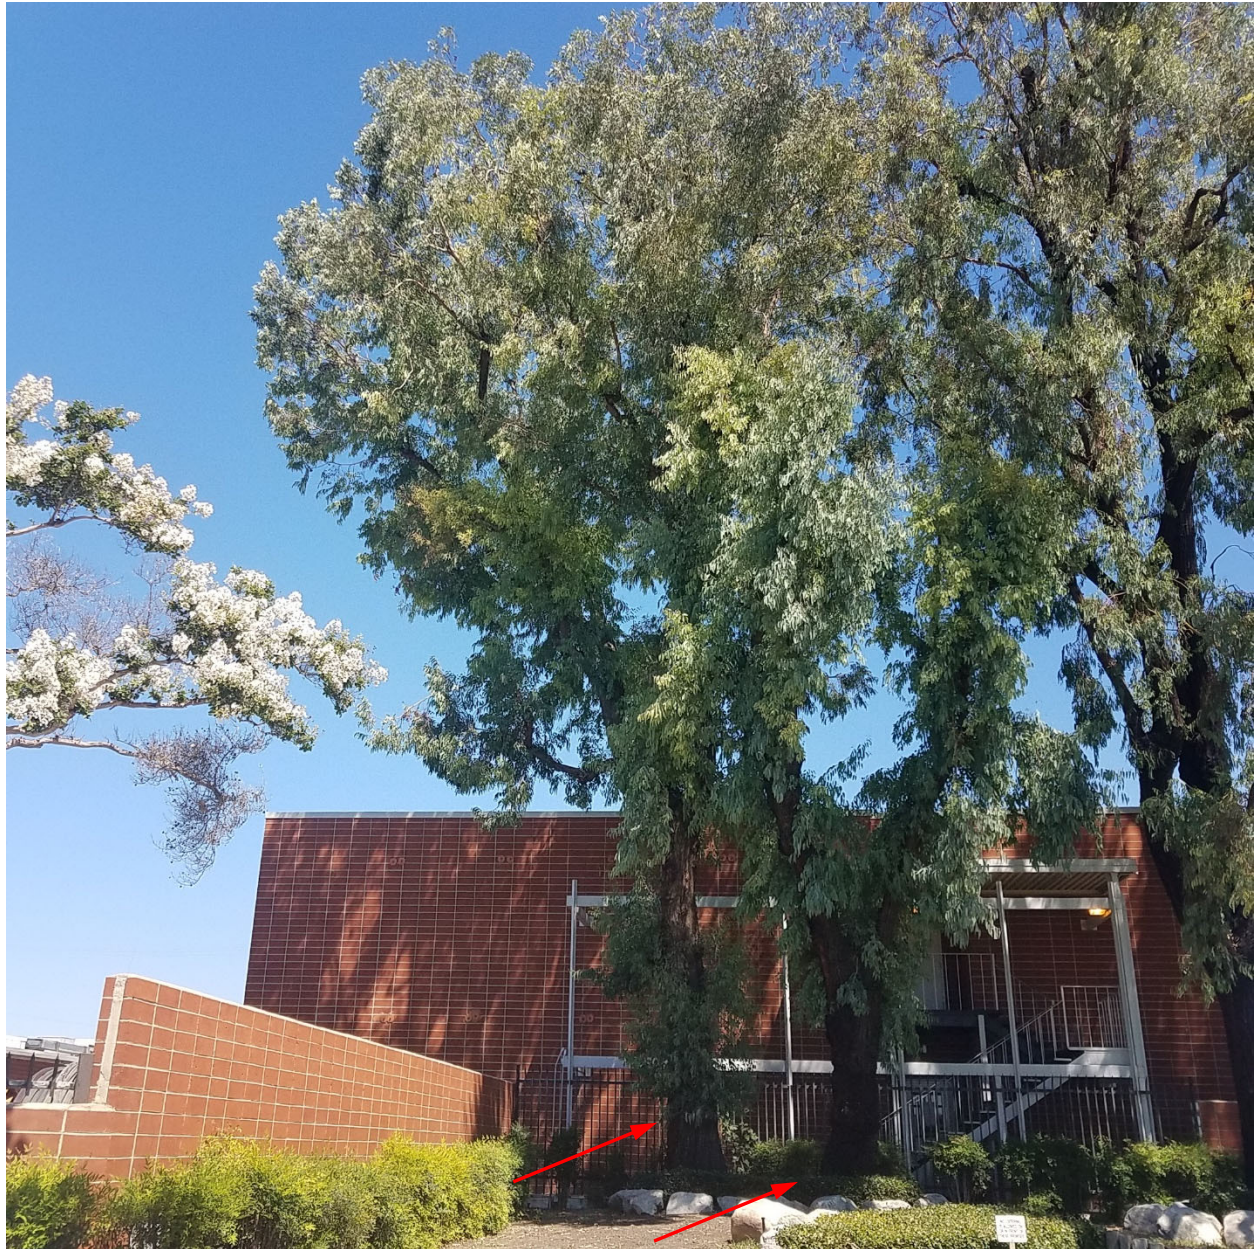
Trees #176 (left) and #177 (right)

Trees #176 and #177 – These two mature red ironbarks (*Eucalyptus sideroxylon*) are located within the footprint of the proposed building and would therefore need to be removed to construct the project as proposed.

| Tree Number | Species | | dBH (inches) | Canopy (feet) | Height (feet) | Health | Appearance | Comments |
|---|---|---|---|---|---|---|---|---|
| 176 | <i>Eucalyptus sideroxylon</i> | red ironbark | 33 @ 4.0' | 34 | 52 | C | C | sparse; epicormic sprouts |
| 177 | <i>Eucalyptus sideroxylon</i> | red ironbark | 32 @ 4.0' | 22 | 30 | C | C | suppressed; bow in trunk; co-dominant scaffolds; epicormic sprouts |

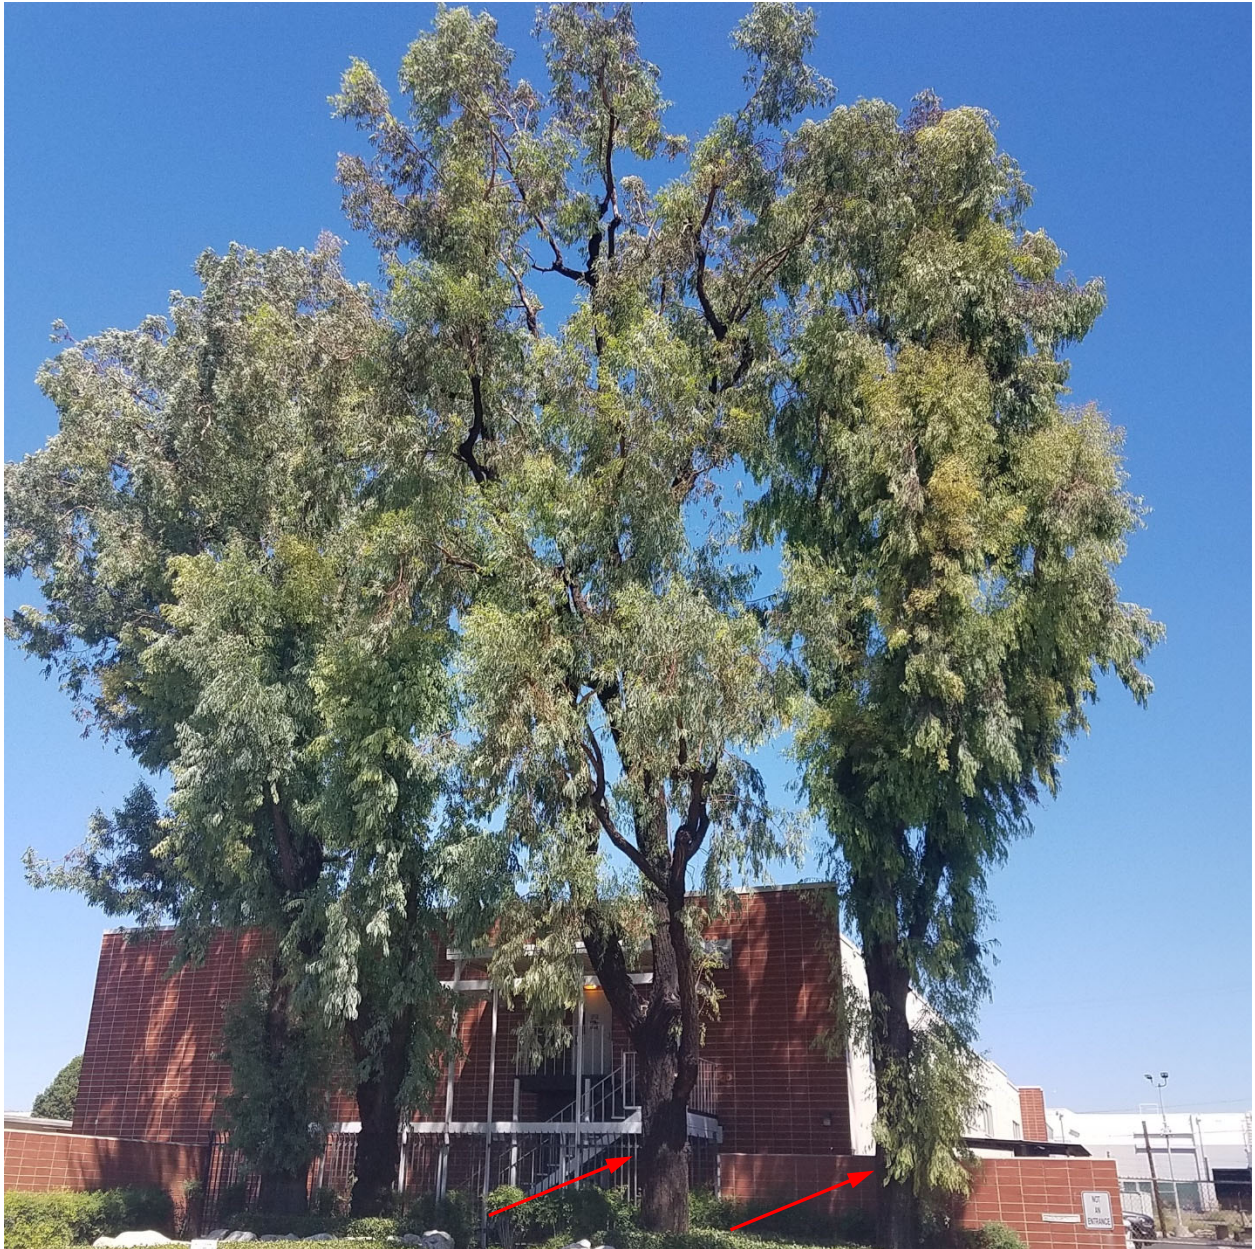
Trees #178 (left) and #179 (right)

Tree #178 – This mature red ironbark is located 10 inches from the edge of the new sidewalk on the easterly side of the building and 6.5 feet from the new driveway and would therefore need to be removed to construct the project as proposed.

Tree #179 – This mature red ironbark is located within the new entry drive and would therefore need to be removed to construct the project as proposed.

| Tree Number | Species | | dBH (inches) | Canopy (feet) | Height (feet) | Health | Appearance | Comments |
|---|---|---|---|---|---|---|---|---|
| 178 | <i>Eucalyptus sideroxylon</i> | red ironbark | 33 | 31 | 60 | C | C | minor amount of dead wood in canopy; heading cuts; sparse |
| 179 | <i>Eucalyptus sideroxylon</i> | red ironbark | 32 | 23 | 48 | C | C | co-dominant scaffolds |

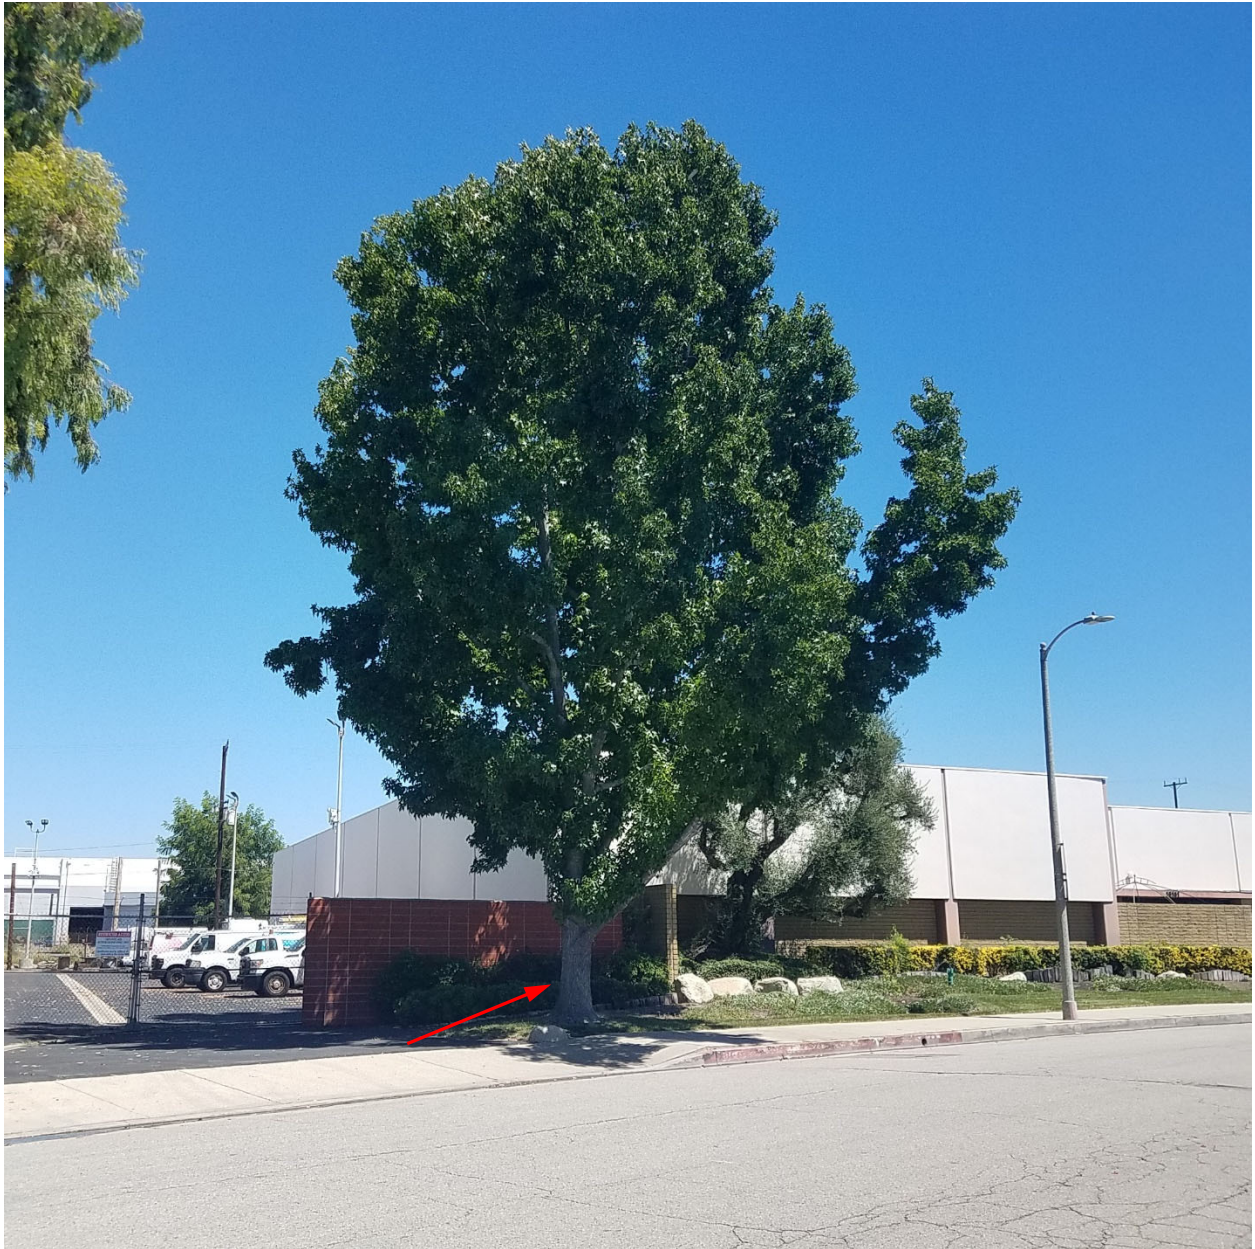
Tree #180 – This mature crape myrtle is located 10 inches from the edge of the easterly driveway apron and would therefore need to be removed to construct the project as proposed.

| Tree<br>Number | Species | | dBH<br>(inches) | Canopy<br>(feet) | Height<br>(feet) | Health | Appearance | Comments |
|---|---|---|---|---|---|---|---|---|
| 180 | <i>Liquidambar<br/>styraciflua</i> | American sweetgum | 21 @ 3.8' | 34 | 46 | B | B+ | heading cuts |
