California Tree and Landscape Consulting, Inc.

December 15, 2021 UPDATED February 3, 2022 Revised for Storm Damage June 7, 2023.

RE: 4134 Bannister Road, APN #242-0182-045-0000, County of Sacramento jurisdiction, California

PRELIMINARY ARBORIST REPORT & TREE INVENTORY

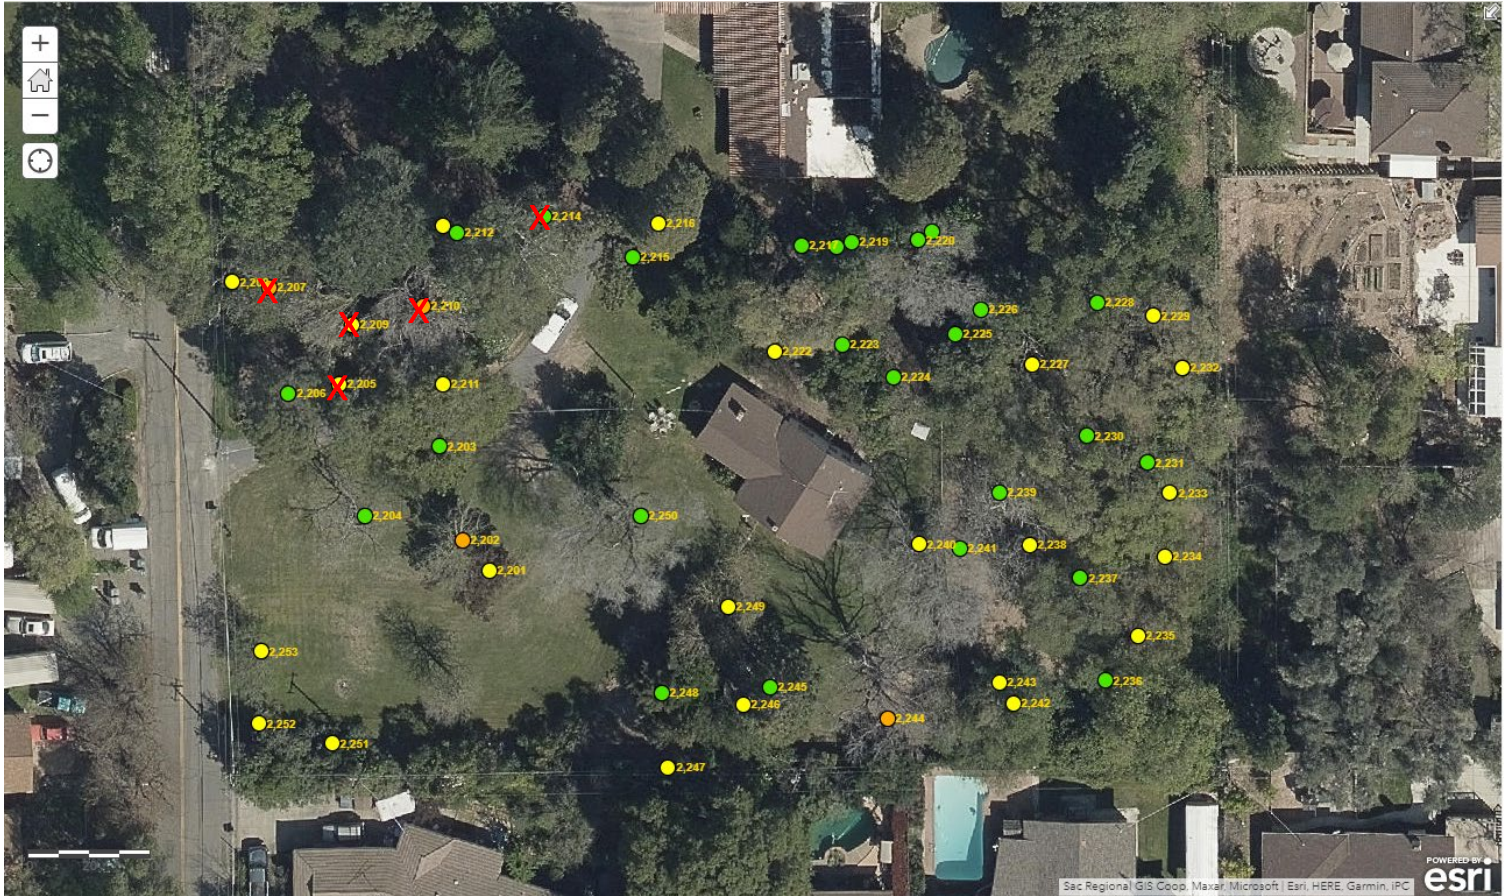
APPENDIX 1 – MAP OF THE PROPERTY SHOWING TREE LOCATION

X = Trees that failed in the 2023 Storms
