# Amazon San Jose Arborist Report

September  
2020

This report was prepared to evaluate all trees on the property, located throughout the project site at 1605 S 7th Street, San Jose California. The surveyed area is based on documents provided by the aforementioned client, including the site development plans.

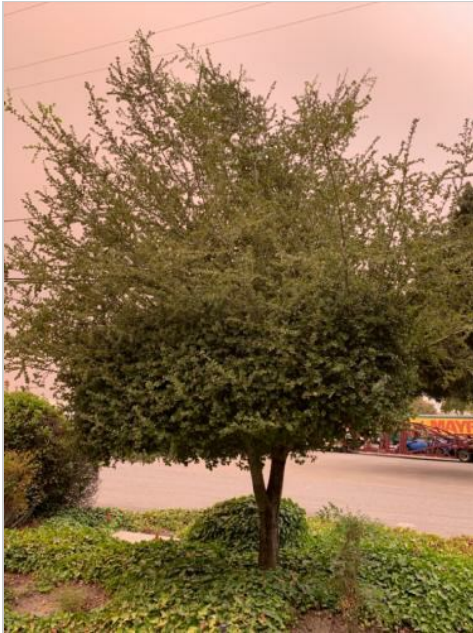
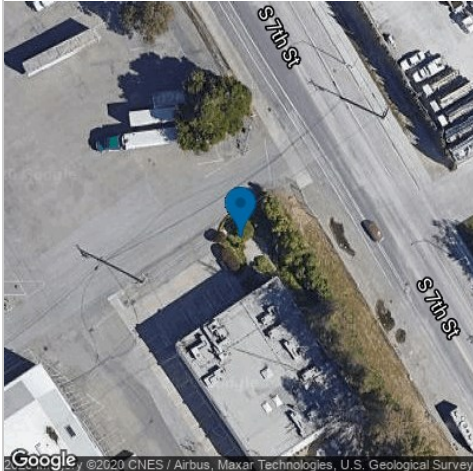
Oak, Coast Live ID# 1  
Oak, Coast Live  
Height: 1'-15' DBH: 8.5  
Health: 90% - Very Good

Canopy 10-15'  
Crown is spindly and dense

| ID | Species | Botanical Name | Height (ft) | DBH (in) | Health | Canopy (ft) | Recommendation |
|---|---|---|---|---|---|---|---|
| 1 | Oak, Coast Live | Quercus agrifolia | 1'-15' | 8.5 | 90% - Very Good | 10-15' | Construction Required Removal |

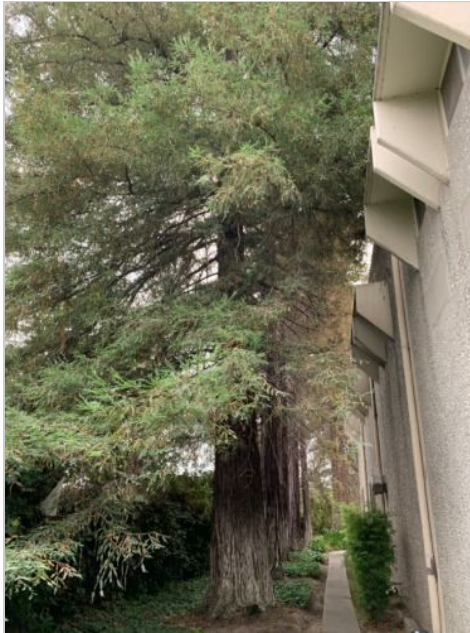
Redwood ID# 2  
Redwood  
Height: 46'-60' DBH: 38.5  
Health: 80% - Good

Canopy 20-25'  
Canopy is touching building

| ID | Species | Botanical Name | Height (ft) | DBH (in) | Health | Canopy (ft) | Recommendation |
|---|---|---|---|---|---|---|---|
| 2 | Redwood | Sequoia sempervirens | 46'-60' | 38.5 | 80% - Good | 20-25' | Construction Required Removal |

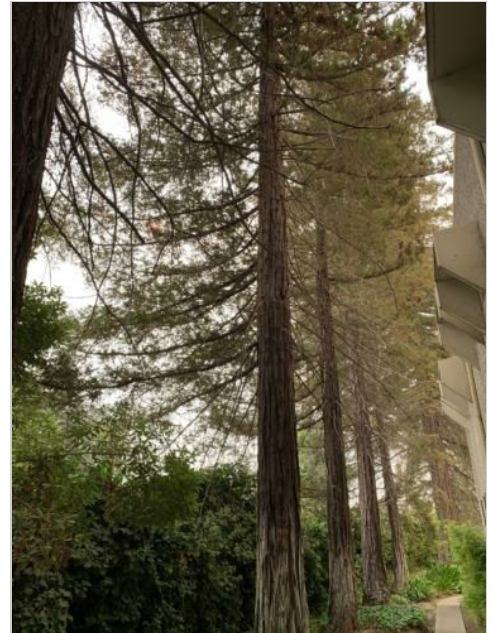
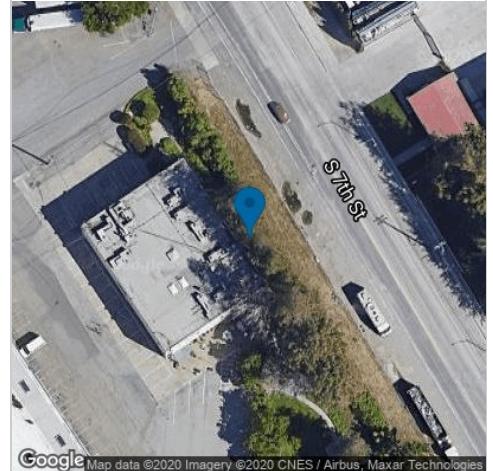
Redwood ID# 3  
Redwood  
Height: 46'-60' DBH: 24.5  
Health: 60% - Fair

Canopy 10-15'  
Canopy is close to building and has lots of deadwood

| ID | Species | Botanical Name | Height (ft) | DBH (in) | Health | Canopy (ft) | Recommendation |
|---|---|---|---|---|---|---|---|
| 3 | Redwood | Sequoia sempervirens | 46'-60' | 24.5 | 60% - Fair | 10-15' | Construction Required Removal |

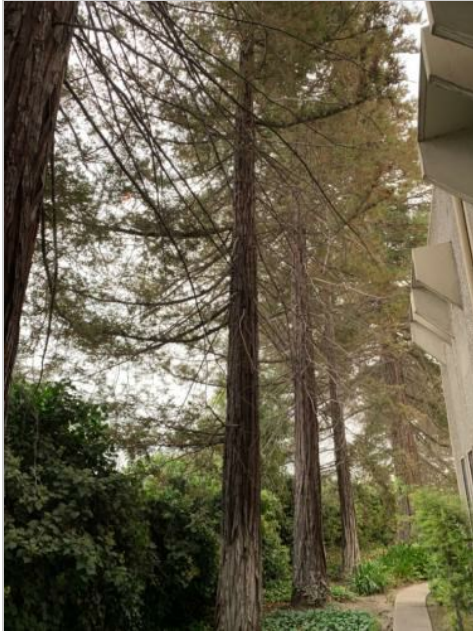
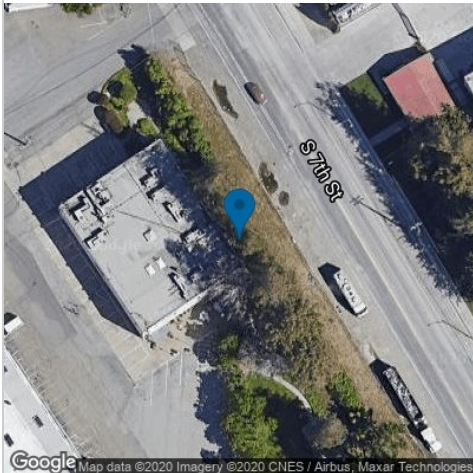
Redwood ID# 4  
Redwood  
Height: 46'-60' DBH: 20.5  
Health: 60% - Fair

Canopy 10-15'  
Canopy has lots of deadwood and is touching building

| ID | Species | Botanical Name | Height (ft) | DBH (in) | Health | Canopy (ft) | Recommendation |
|---|---|---|---|---|---|---|---|
| 4 | Redwood | Sequoia sempervirens | 46'-60' | 20.5 | 60% - Fair | 10-15' | Construction Required Removal |

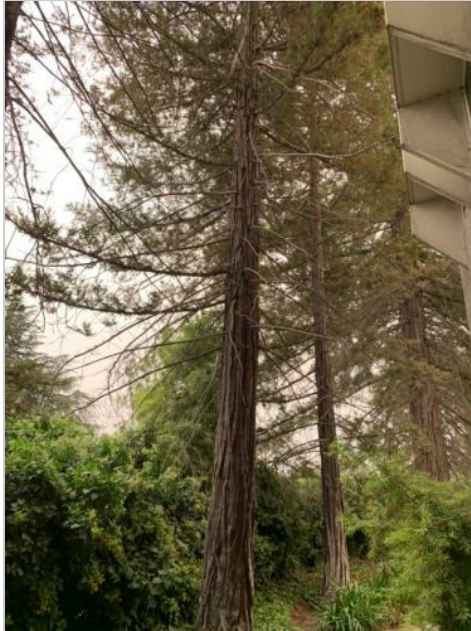
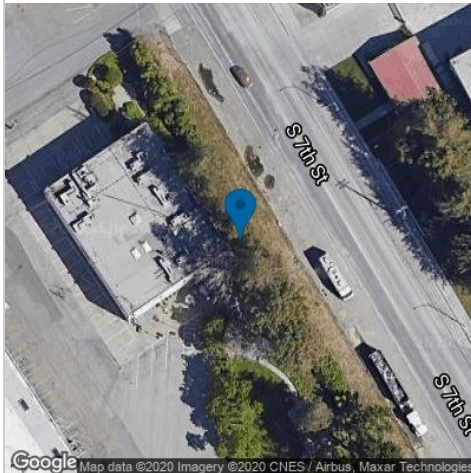
Redwood ID# 5  
Redwood  
Height: 46'-60' DBH: 24  
Health: 60% - Fair

Canopy 10-15'  
Canopy has a lot of deadwood

| ID | Species | Botanical Name | Height (ft) | DBH (in) | Health | Canopy (ft) | Recommendation |
|---|---|---|---|---|---|---|---|
| 5 | Redwood | Sequoia sempervirens | 46'-60' | 24 | 60% - Fair | 10-15' | Construction Required Removal |

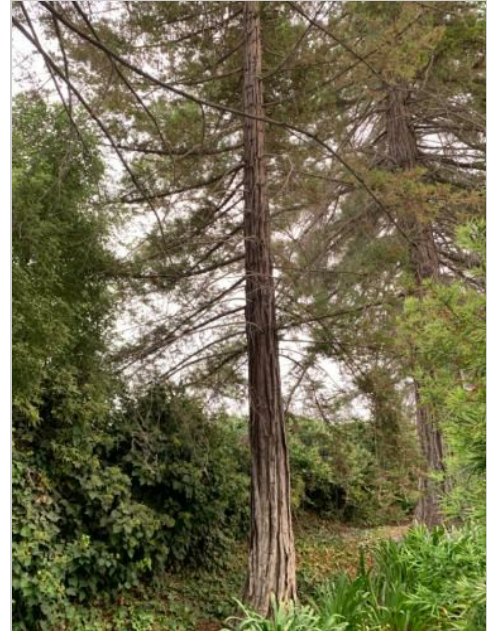
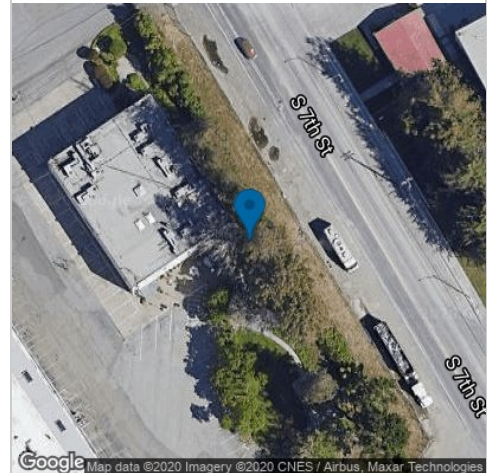
Redwood ID# 6  
Redwood  
Height: 31'-45' DBH: 17  
Health: 60% - Fair

Canopy 5-10'  
Canopy has lots of deadwood present

| ID | Species | Botanical Name | Height (ft) | DBH (in) | Health | Canopy (ft) | Recommendation |
|---|---|---|---|---|---|---|---|
| 6 | Redwood | Sequoia sempervirens | 31'-45' | 17 | 60% - Fair | 5-10' | Construction Required Removal |

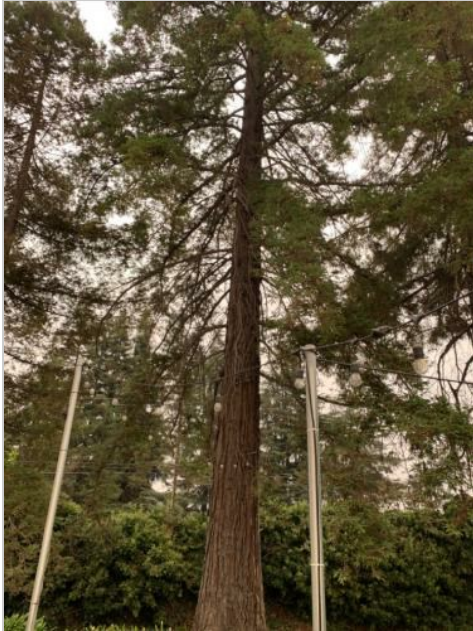
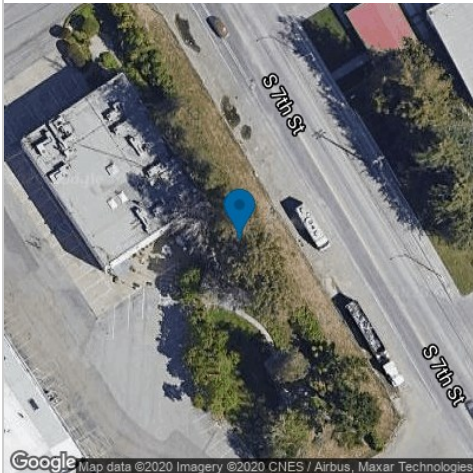
Redwood ID# 7  
Redwood  
Height: 46'-60' DBH: 41.5  
Health: 80% - Good

Canopy 20-25'  
Deadwood and heavy limbs present

| ID | Species | Botanical Name | Height (ft) | DBH (in) | Health | Canopy (ft) | Recommendation |
|---|---|---|---|---|---|---|---|
| 7 | Redwood | Sequoia sempervirens | 46'-60' | 41.5 | 80% - Good | 20-25' | Construction Required Removal |

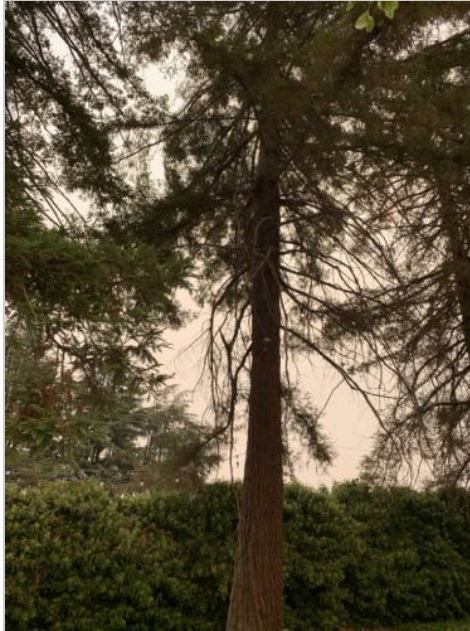
Redwood ID# 8  
Redwood  
Height: 46'-60' DBH: 31  
Health: 80% - Good

Canopy 15-20'  
Deadwood present

| ID | Species | Botanical Name | Height (ft) | DBH (in) | Health | Canopy (ft) | Recommendation |
|---|---|---|---|---|---|---|---|
| 8 | Redwood | Sequoia sempervirens | 46'-60' | 31 | 80% - Good | 15-20' | Construction Required Removal |

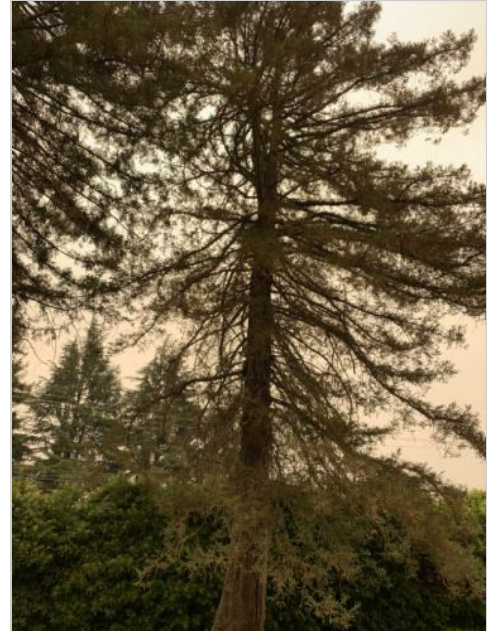
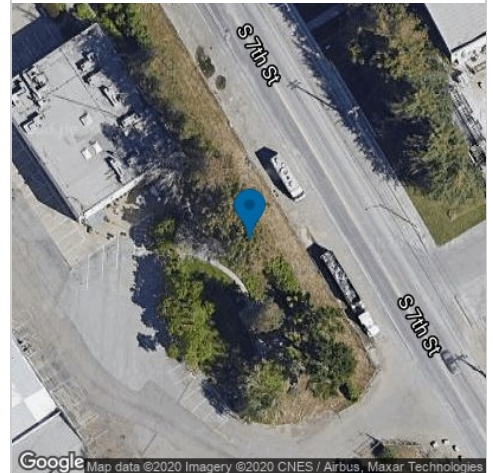
Redwood ID# 9  
Redwood  
Height: 46'-60' DBH: 30.5  
Health: 80% - Good

Canopy 15-20'  
Codominant leaders present

| ID | Species | Botanical Name | Height (ft) | DBH (in) | Health | Canopy (ft) | Recommendation |
|---|---|---|---|---|---|---|---|
| 9 | Redwood | Sequoia sempervirens | 46'-60' | 30.5 | 80% - Good | 15-20' | Construction Required Removal |

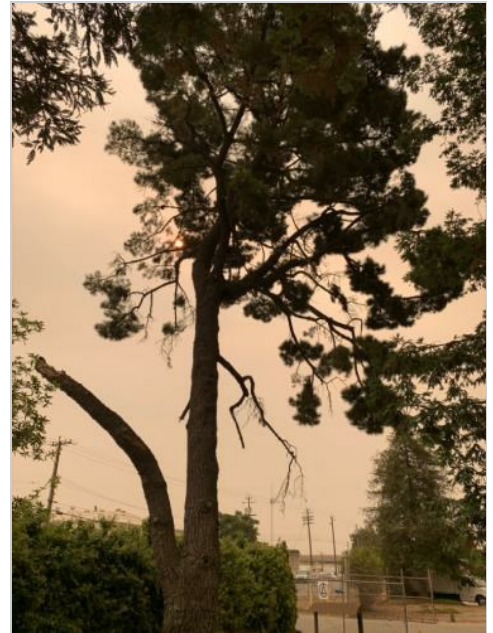
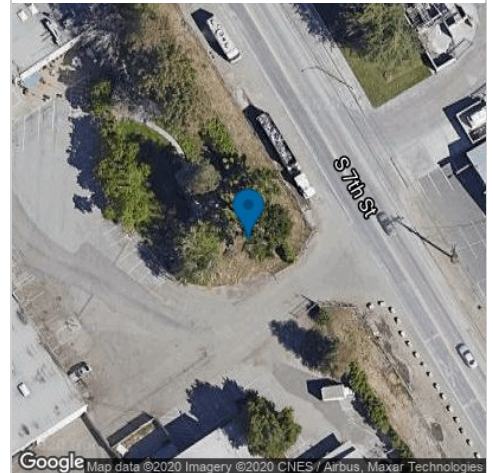
Pine, Monterey ID# 12  
Pine, Monterey  
Height: 46'-60' DBH: 39  
Health: 60% - Fair

Canopy 25-30'  
Rad limb present and canopy is off balance with heavy limbs

| ID | Species | Botanical Name | Height (ft) | DBH (in) | Health | Canopy (ft) | Recommendation |
|---|---|---|---|---|---|---|---|
| 12 | Pine, Monterey | Pinus radiata | 46'-60' | 39 | 60% - Fair | 25-30' | Construction Required Removal |

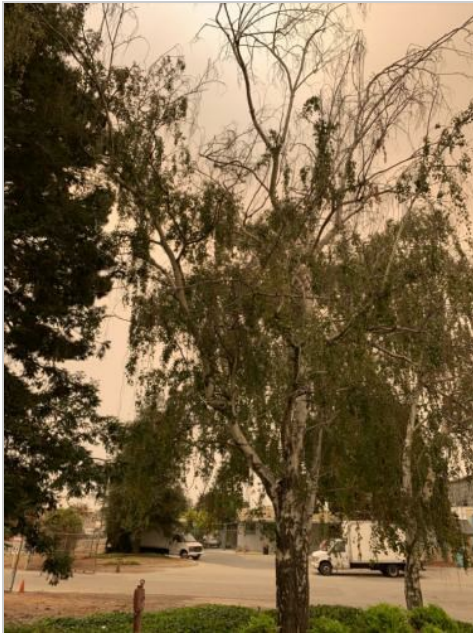
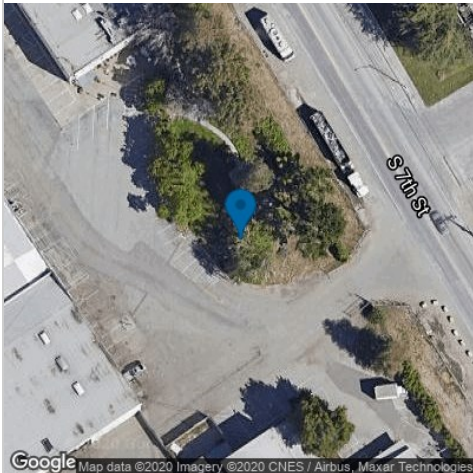
*Birch, European White* ID# 13  
*Birch, European White*  
 Height: 16'-30' DBH: 14.5  
 Health: 60% - Fair

Canopy 15-20'  
 Deadwood at top of canopy present

| ID | Species | Botanical Name | Height (ft) | DBH (in) | Health | Canopy (ft) | Recommendation |
|---|---|---|---|---|---|---|---|
| 13 | Birch, European White | Betula pendula | 16'-30' | 14.5 | 60% - Fair | 15-20' | Construction Required Removal |

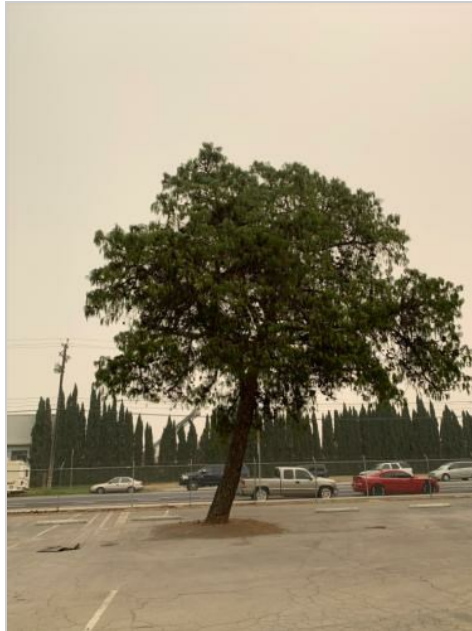
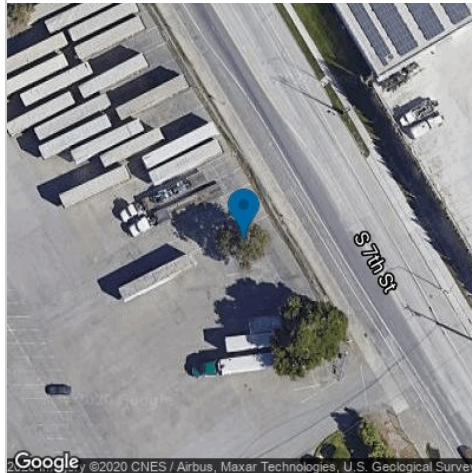
*Pine, Patula* ID# 17  
*Pine, Patula*  
Height: 31'-45' DBH: 22  
Health: 60% - Fair

Google  
©2020 CNES / Airbus, Maxar Technologies, U.S. Geological Survey  
Canopy 20-25'  
Sparse canopy with a lot of dead needles

| ID | Species | Botanical Name | Height (ft) | DBH (in) | Health | Canopy (ft) | Recommendation |
|---|---|---|---|---|---|---|---|
| 17 | Pine, Patula | Pinus patula | 31'-45' | 22 | 60% - Fair | 20-25' | Construction Required Removal |

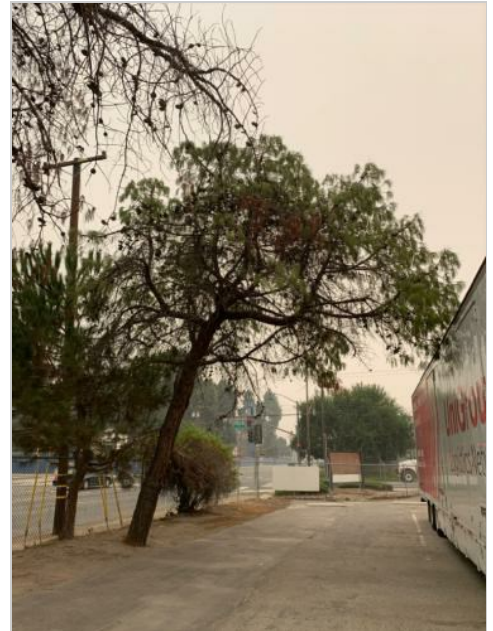
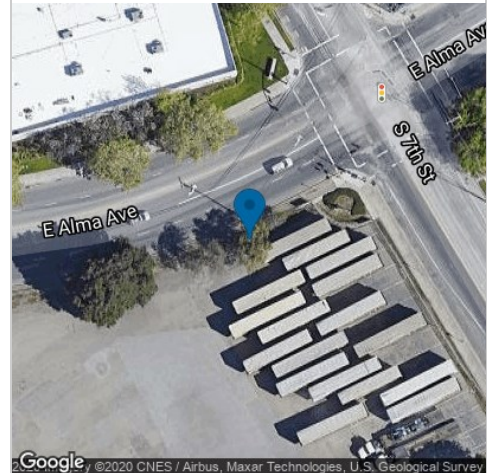
*Pine, Patula* ID# 18  
*Pine, Patula*  
Height: 16'-30' DBH: 17  
Health: 40% - Poor

Google  
©2020 CNES / Airbus, Maxar Technologies, U.S. Geological Survey  
Canopy 15-20  
Canopy sparse with lots of dead wood

| ID | Species | Botanical Name | Height (ft) | DBH (in) | Health | Canopy (ft) | Recommendation |
|---|---|---|---|---|---|---|---|
| 18 | Pine, Patula | Pinus patula | 16'-30' | 17 | 40% - Poor | 15-20' | Horticultural Based Removal |

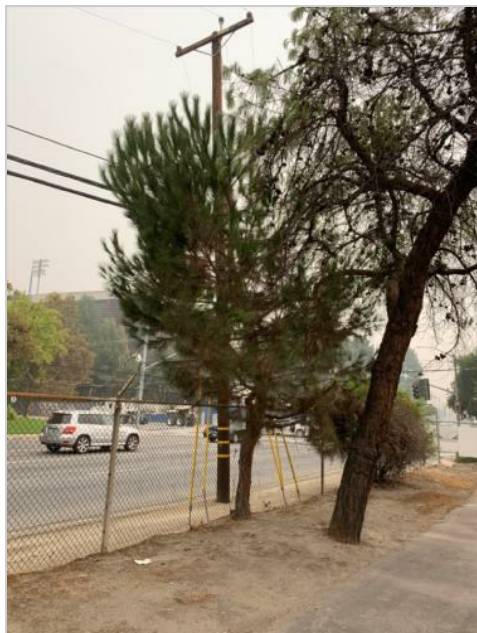
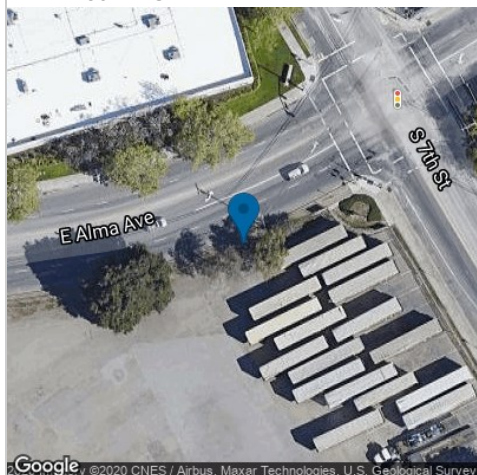
Pine, Patula ID# 19  
Pine, Patula  
Height: 16'-30' DBH: 9  
Health: 80% - Good

Canopy 5-10'  
Volunteer tree growing very close to fence

| ID | Species | Botanical Name | Height (ft) | DBH (in) | Health | Canopy (ft) | Recommendation |
|---|---|---|---|---|---|---|---|
| 19 | Pine, Patula | Pinus patula | 16'-30' | 9 | 80% - Good | 5-10' | Horticultural Based Removal |

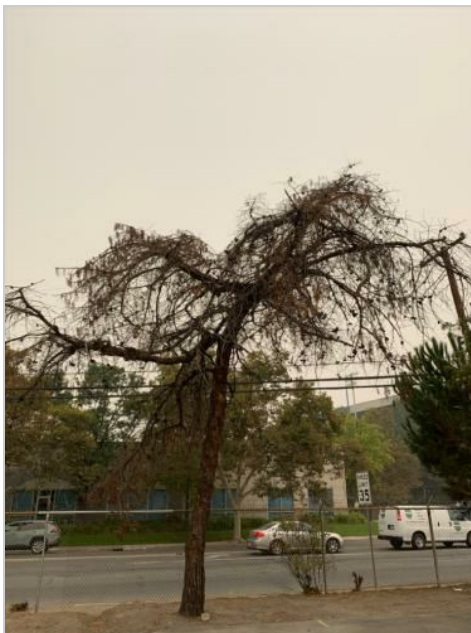
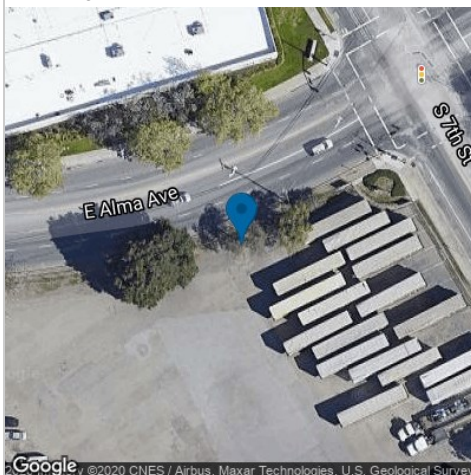
Pine, Patula ID# 20  
Pine, Patula  
Height: 16'-30' DBH: 15.5  
Health: 0% - Dead

Canopy 10-15'  
Tree is dead

| ID | Species | Botanical Name | Height (ft) | DBH (in) | Health | Canopy (ft) | Recommendation |
|---|---|---|---|---|---|---|---|
| 20 | Pine, Patula | Pinus patula | 16'-30' | 15.5 | 0% - Dead | 10-15' | Horticultural Based Removal |

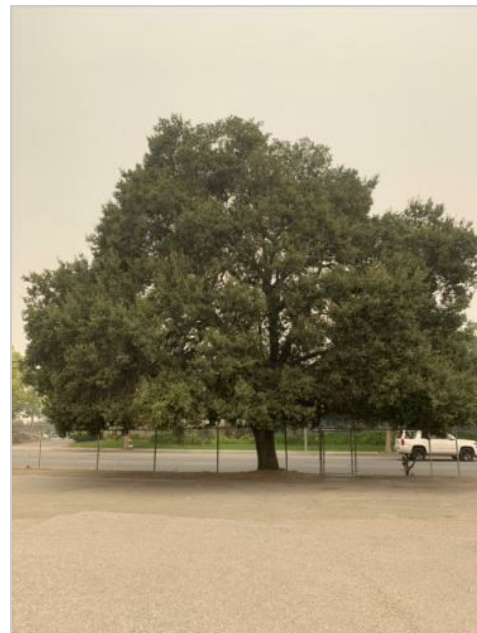
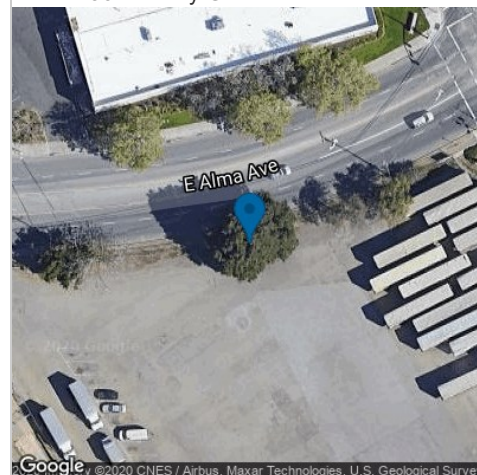
Oak, Coast Live ID# 21  
Oak, Coast Live  
Height: 31'-45' DBH: 35.5  
Health: 90% - Very Good

Canopy 35-40'  
Canopy is dense, heavy, and low to the ground

| ID | Species | Botanical Name | Height (ft) | DBH (in) | Health | Canopy (ft) | Recommendation |
|---|---|---|---|---|---|---|---|
| 21 | Oak, Coast Live | Quercus agrifolia | 31'-45' | 35.5 | 90% - Very Good | 35-40' | Preserve |

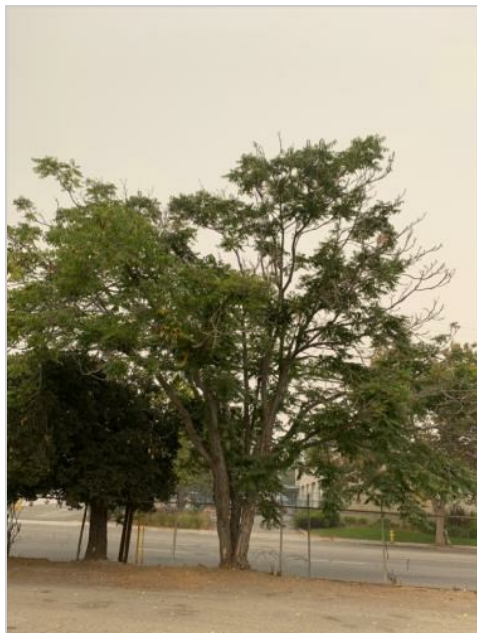
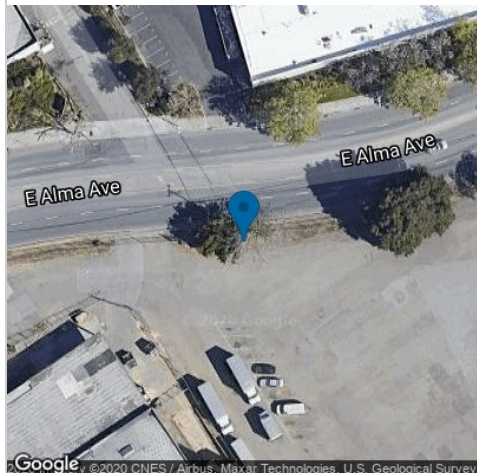
Walnut, California Black ID# 22  
Walnut, California Black  
Height: 16'-30' DBH: 7.5  
Health: 40% - Poor

Canopy 20-25'  
Bark is peeling and deadwood throughout canopy. Tree is in decline

| ID | Species | Botanical Name | Height (ft) | DBH (in) | Health | Canopy (ft) | Recommendation |
|---|---|---|---|---|---|---|---|
| 22 | Walnut, California Black | Juglans californica | 16'-30' | 7.5 | 40% - Poor | 20-25' | Horticultural Based Removal |

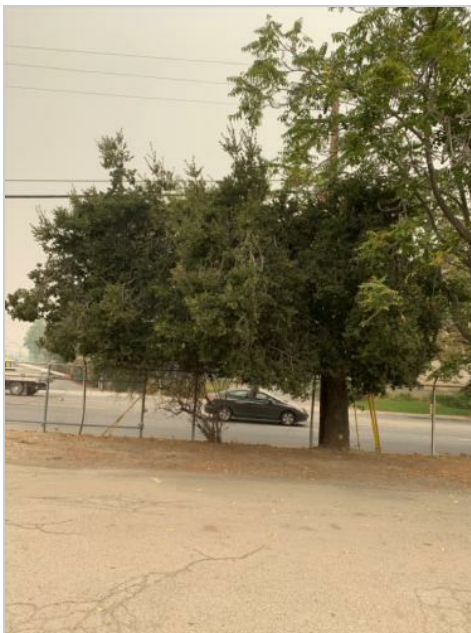
Oak, Coast Live ID# 23  
Oak, Coast Live  
Height: 1'-15' DBH: 18.5  
Health: 60% - Fair

Canopy 15-20'  
Canopy was topped due to line clearance, structure is poor

| ID | Species | Botanical Name | Height (ft) | DBH (in) | Health | Canopy (ft) | Recommendation |
|---|---|---|---|---|---|---|---|
| 23 | Oak, Coast Live | Quercus agrifolia | 1'-15' | 18.5 | 60% - Fair | 15-20' | Preserve |

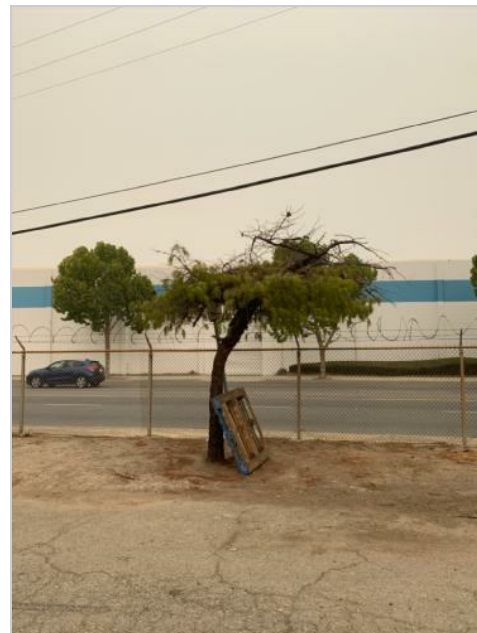
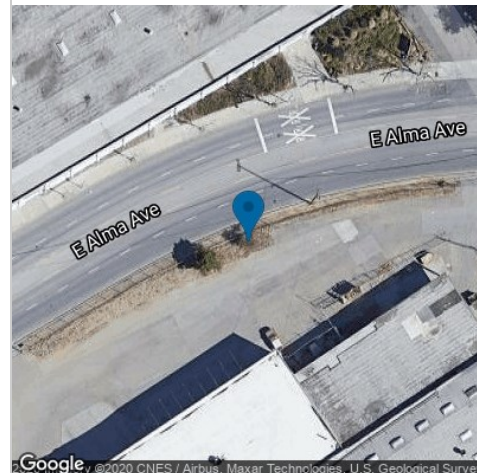
Pine, Patula ID# 24  
Pine, Patula  
Height: 1'-15'  
Health: 40% - Poor

Canopy 5-10'  
Top of canopy is dead

| ID | Species | Botanical Name | Height (ft) | DBH (in) | Health | Canopy (ft) | Recommendation |
|---|---|---|---|---|---|---|---|
| 24 | Pine, Patula | Pinus patula | 1'-15' | 8.5 | 40% - Poor | 5-10' | Horticultural Based Removal |

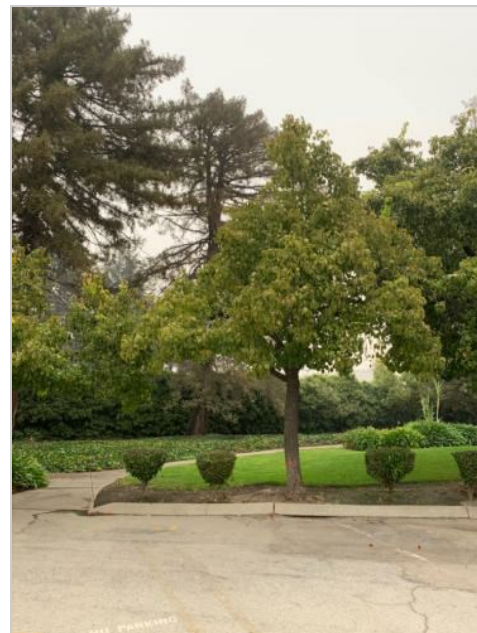
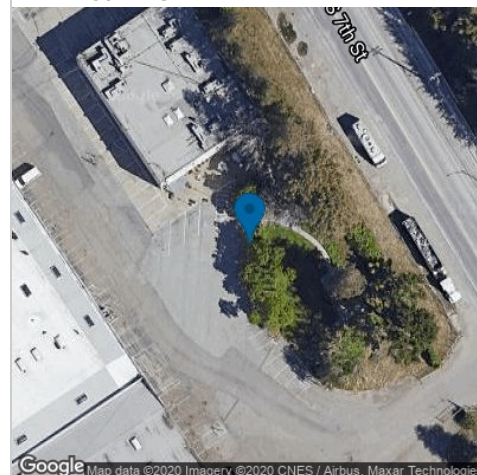
*Pear, Evergreen* ID# 27  
*Pear, Evergreen*  
Height: 16'-30' DBH: 10  
Health: 80% - Good

Canopy 5-10'  
Canopy is dense and was topped for line clearance

| ID | Species | Botanical Name | Height (ft) | DBH (in) | Health | Canopy (ft) | Recommendation |
|---|---|---|---|---|---|---|---|
| 27 | Pear, Evergreen | Pyrus kawakamii | 16'-30' | 10 | 80% - Good | 5- 10' | Construction Required Removal |

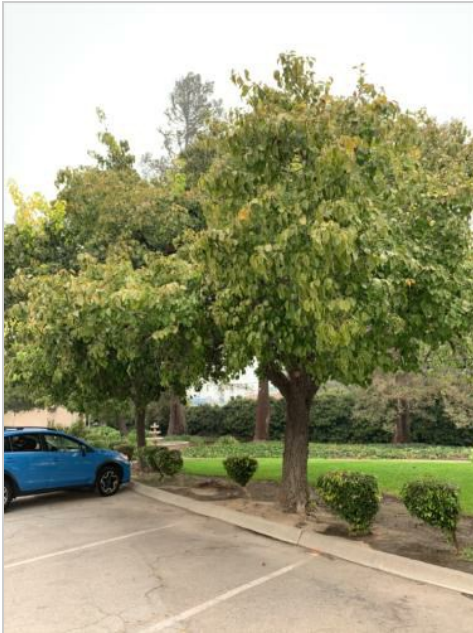
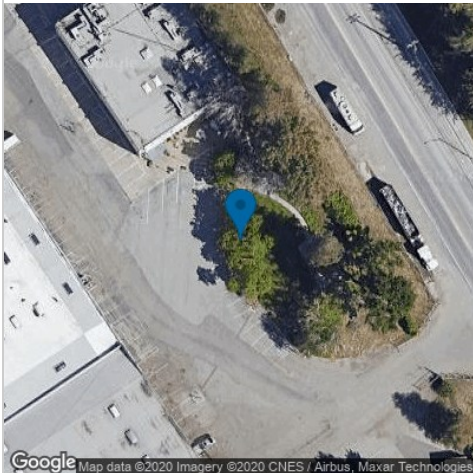
*Pear, Evergreen* ID# 28  
*Pear, Evergreen*  
Height: 16'-30' DBH: 17  
Health: 80% - Good

Canopy 15-20'  
Canopy has some deadwood but is overall healthy

| ID | Species | Botanical Name | Height (ft) | DBH (in) | Health | Canopy (ft) | Recommendation |
|---|---|---|---|---|---|---|---|
| 28 | Pear, Evergreen | Pyrus kawakamii | 16'-30' | 17 | 80% - Good | 15-20' | Construction Required Removal |

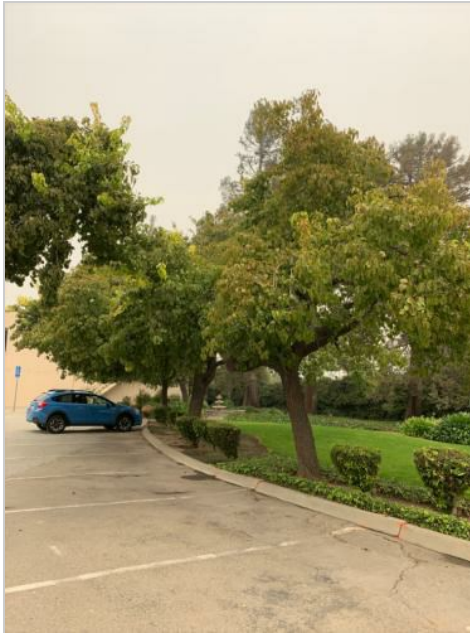
*Pear, Evergreen* ID# 29  
*Pear, Evergreen*  
Height: 16'-30' DBH: 13.5  
Health: 80% - Good

Canopy 15-20'  
Heavy limbs present

| ID | Species | Botanical Name | Height (ft) | DBH (in) | Health | Canopy (ft) | Recommendation |
|---|---|---|---|---|---|---|---|
| 29 | Pear, Evergreen | Pyrus kawakamii | 16'-30' | 13.5 | 80% - Good | 15-20' | Construction Required Removal |

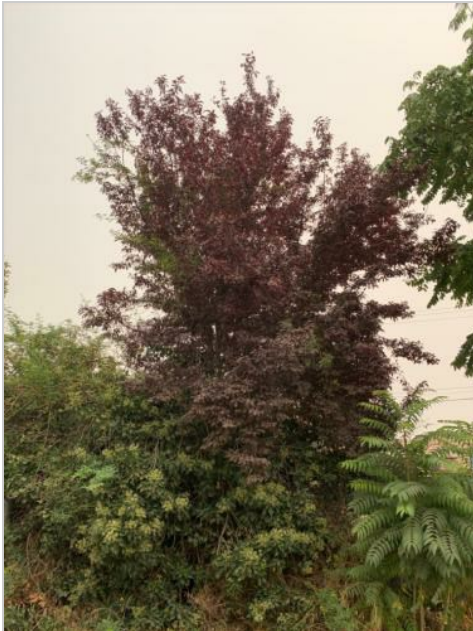
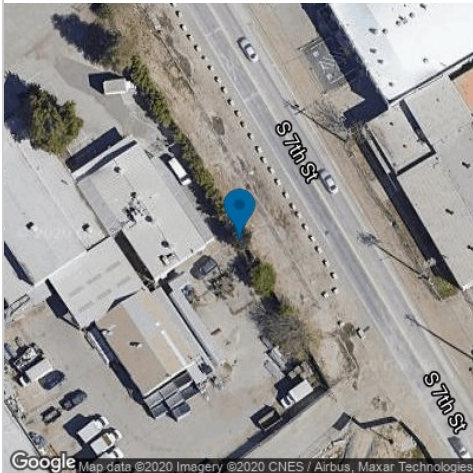
Plum, Purple Leaf ID# 31  
Plum, Purple Leaf  
Height: 16'-30' DBH: 8  
Health: 40% - Poor

Canopy 5-10'  
Tree is growing in shrubbery

| ID | Species | Botanical Name | Height (ft) | DBH (in) | Health | Canopy (ft) | Recommendation |
|---|---|---|---|---|---|---|---|
| 31 | Plum, Purple Leaf | Prunus cerasifera | 16'-30' | 8 | 40% - Poor | 5-10' | Construction Required Removal |

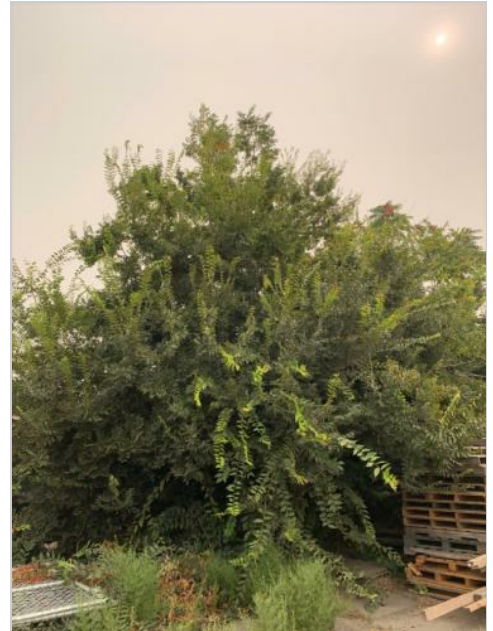
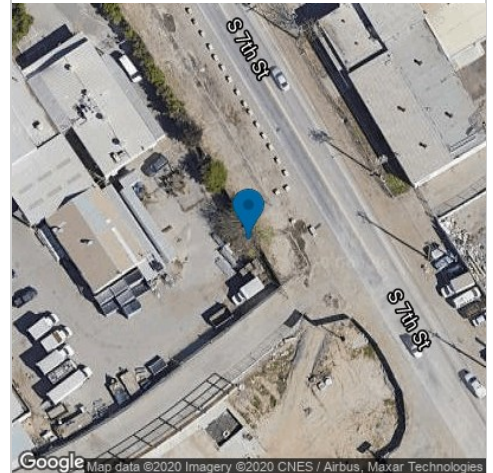
Hackberry ID# 33  
Hackberry

Canopy 25-30'  
Canopy is extremely overgrown

| ID | Species | Botanical Name | Height (ft) | DBH (in) | Health | Canopy (ft) | Recommendation |
|---|---|---|---|---|---|---|---|
| 33 | Hackberry | Celtis occidentalis | 16'-30' | 24.5 | 40% - Poor | 25-30' | Construction Required Removal |

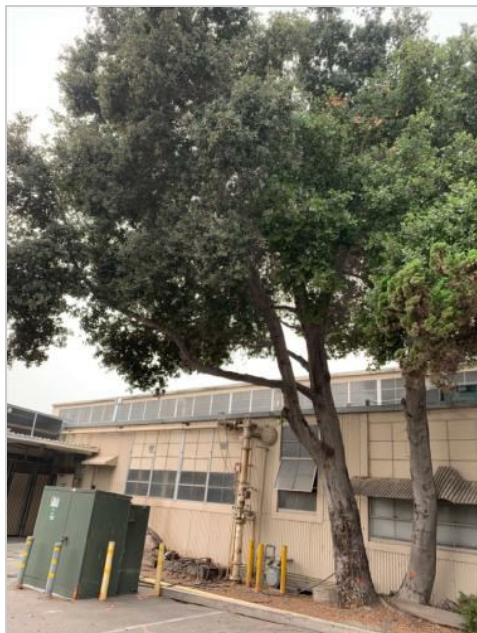
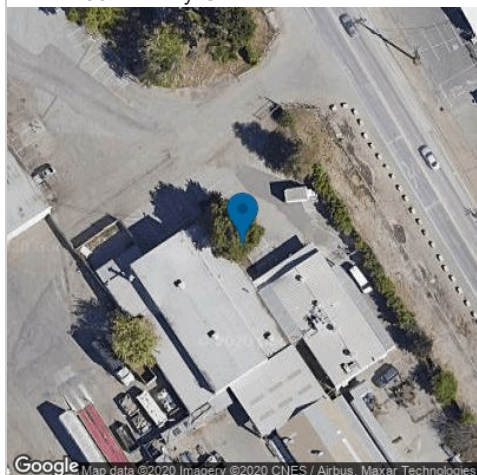
Oak, Coast Live ID# 34  
Oak, Coast Live  
Height: 31'-45' DBH: 23  
Health: 90% - Very Good

Canopy 20-25'  
Tree is healthy and has good structure but is very close to building

| ID | Species | Botanical Name | Height (ft) | DBH (in) | Health | Canopy (ft) | Recommendation |
|---|---|---|---|---|---|---|---|
| 34 | Oak, Coast Live | Quercus agrifolia | 31'-45' | 23 | 90% - Very Good | 20-25' | Construction Required Removal |

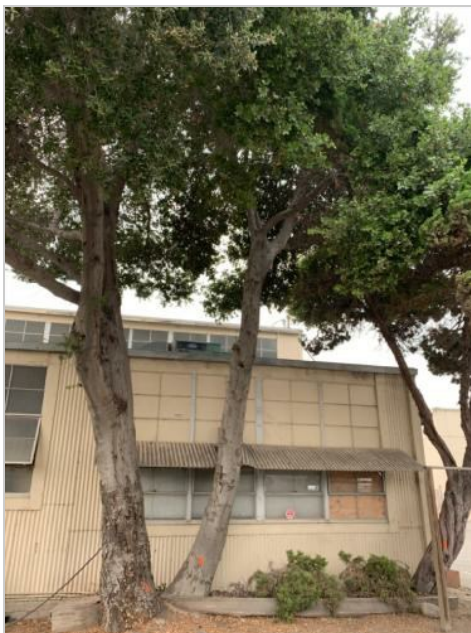
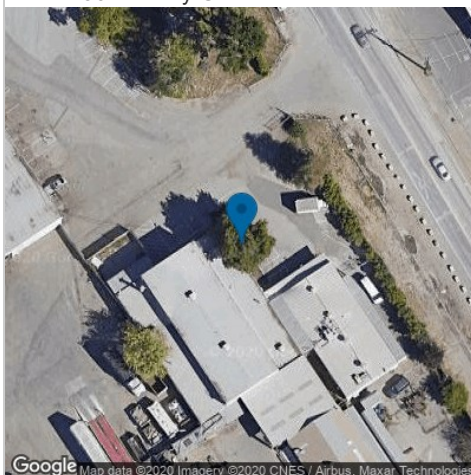
Oak, Coast Live ID# 35  
Oak, Coast Live  
Height: 16'-30' DBH: 16  
Health: 90% - Very Good

Canopy 10-15'  
Canopy is off balance and very close to building

| ID | Species | Botanical Name | Height (ft) | DBH (in) | Health | Canopy (ft) | Recommendation |
|---|---|---|---|---|---|---|---|
| 35 | Oak, Coast Live | Quercus agrifolia | 16'-30' | 16 | 90% - Very Good | 10-15' | Construction Required Removal |

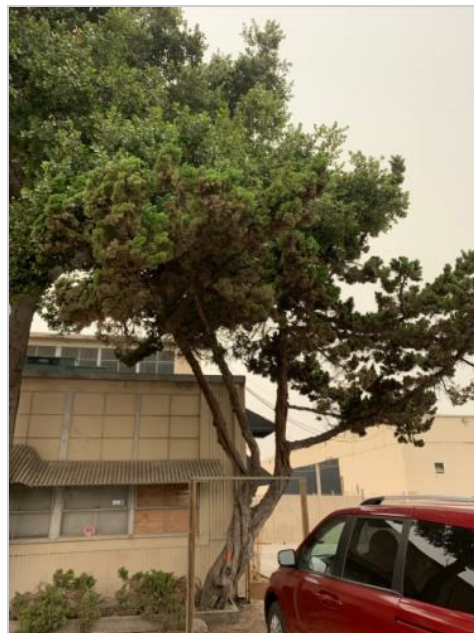
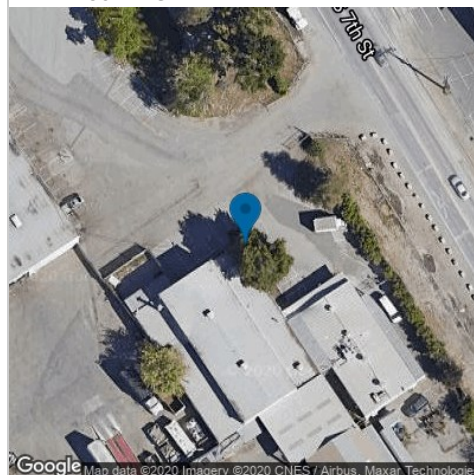
Juniper, Hollywood ID# 36  
Juniper, Hollywood  
Height: 16'-30' DBH: 16.5  
Health: 80% - Good

Canopy 10-15'  
Canopy is healthy and growing very close to building

| ID | Species | Botanical Name | Height (ft) | DBH (in) | Health | Canopy (ft) | Recommendation |
|---|---|---|---|---|---|---|---|
| 36 | Juniper, Hollywood | Juniperus chinensis | 16'-30' | 16.5 | 80% - Good | 10-15' | Construction Required Removal |
