OAK TREE REPORT

Calabasas Kia

Date: March 31, 2023

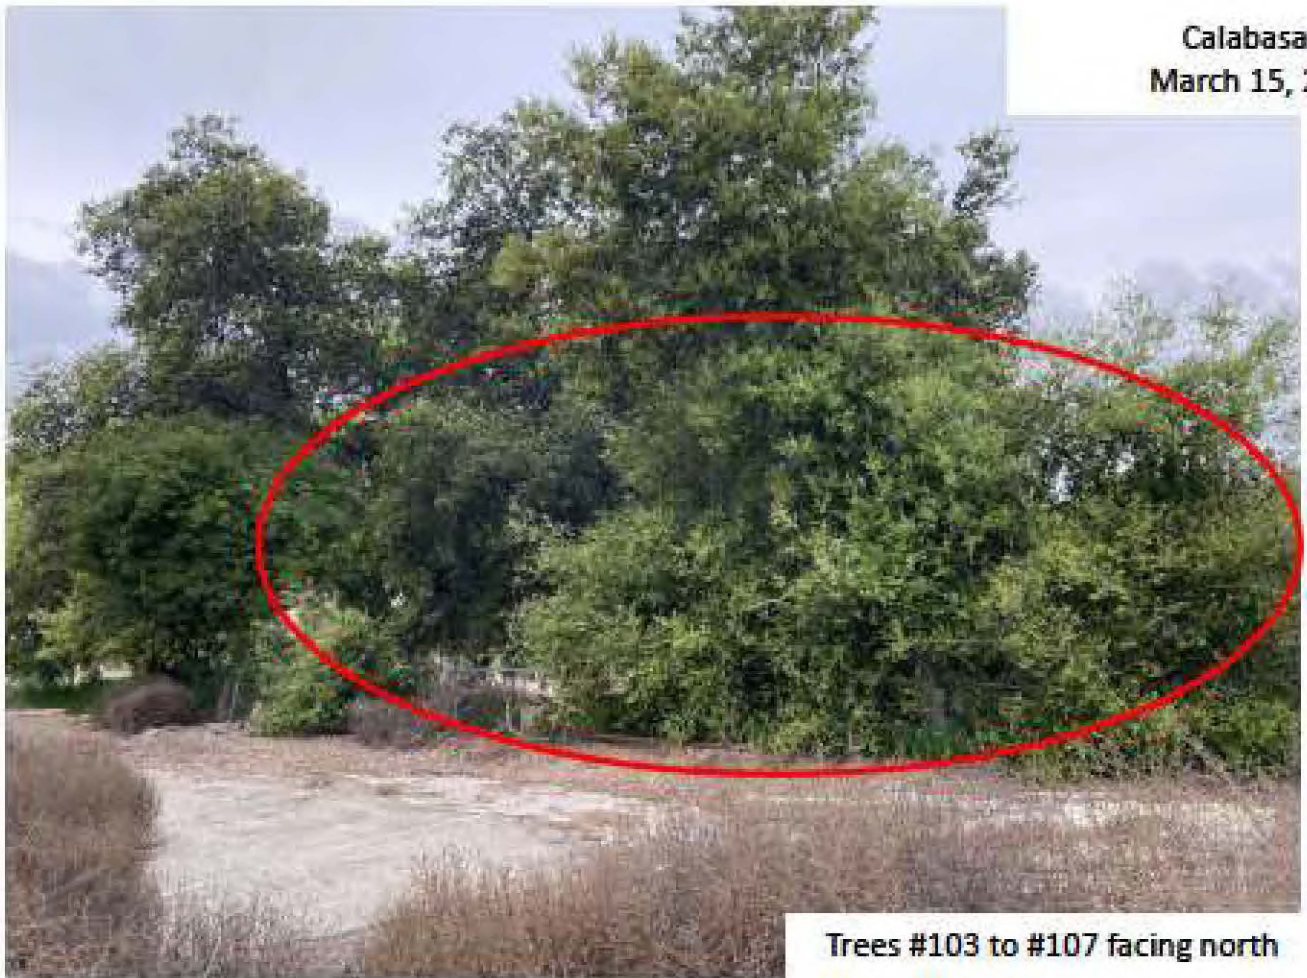
Trees #103 to #107 facing north

Oak trees #103, #104, #105, #106, and #107 – 5 young oak trees are located along the property line and an existing retaining wall. All the trees are 10 feet from the proposed 3-foot retaining wall. Excavation for the retaining will be no closer than 5 feet from the trunks encroaching roughly 10 to 15 percent of the PZs. These trees will be preserved and protected.

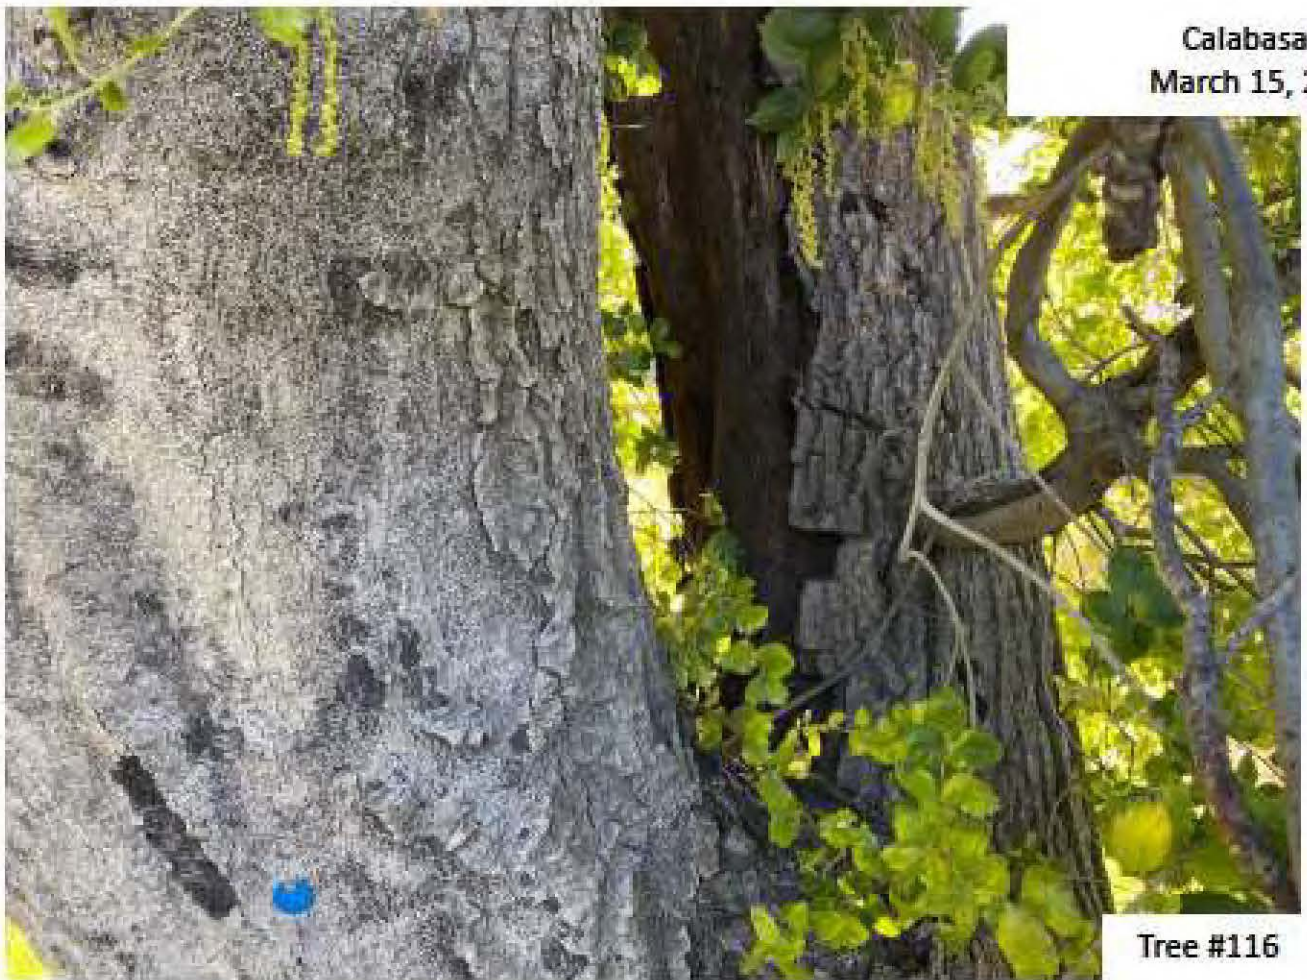
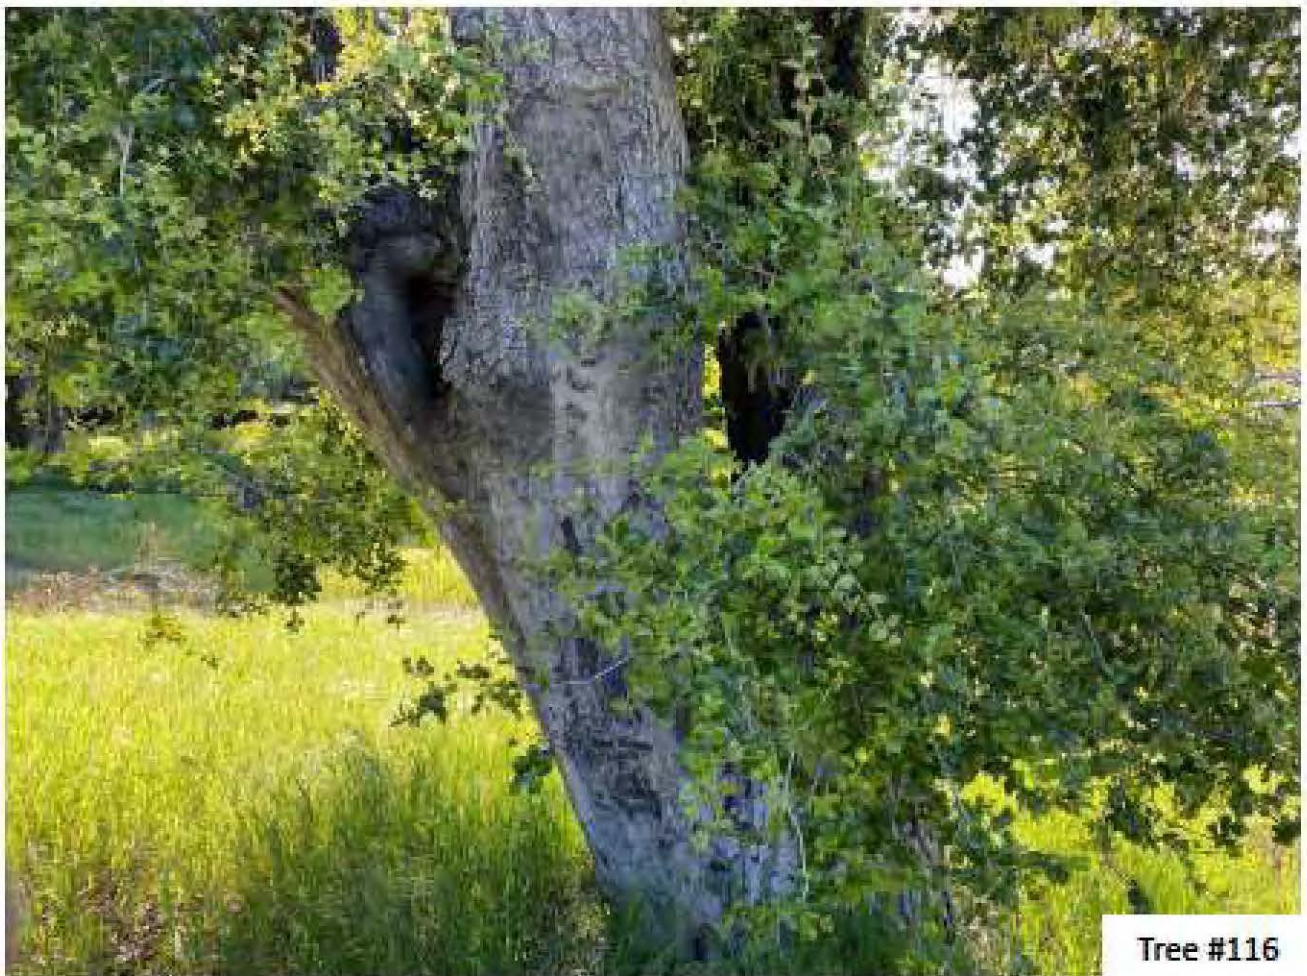
Tree #116

Oak tree #116 – This tree will be encroached by grading for a parking lot, a debris basin, and an access road to the debris basin. Roughly half of the PZ area will be encroached by grading. Part of the access road is an existing length of a paved road within the PZ. This will be a potentially harmful encroachment due to the removal of existing roots although there will be no encroachment closer than 25 feet from the trunk. This tree is declining structurally and should be evaluated later to determine whether drastic pruning should be done to make it safer. I recommend fencing this tree permanently to restrict access to it or remove it if, with further assessment, it is determined likely to fail and strike a target. This tree should be preserved and protected. No pruning required.

encroachment if it handled properly. Of the 21 oak trees proposed to be encroached by the project, only 2, #116 and #149 will be encroached so extensively that the damage may harm the trees. It is fortunate that the 2023 rains have made the existing trees healthier. Maintaining this good health, in particular, maintaining good soil moisture, will allow the trees to tolerate the encroachments as they recover.

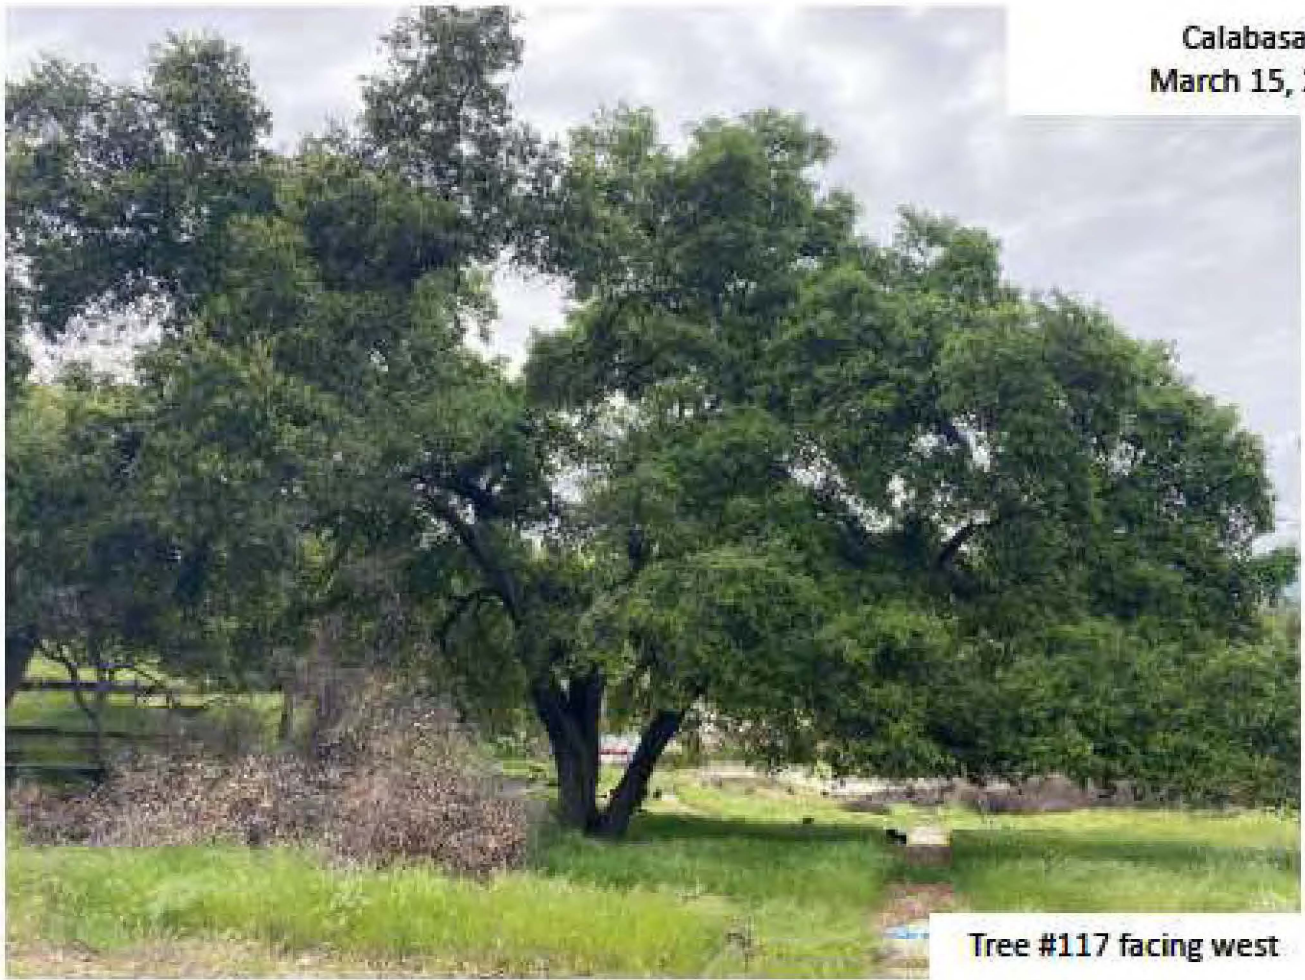
Tree #117 facing west

Oak tree #117 – This tree will be encroached by grading for a parking lot and a manufactured slope. Roughly 25 percent of the PZ area will be encroached by grading. This will be a potentially harmful encroachment due to the removal of existing roots although there will be no encroachment closer than 16 feet from the trunk. This is a healthy tree and the manufactured slope will be a significant encroachment but only on the north side of the tree. This tree should be preserved and protected. No pruning required.

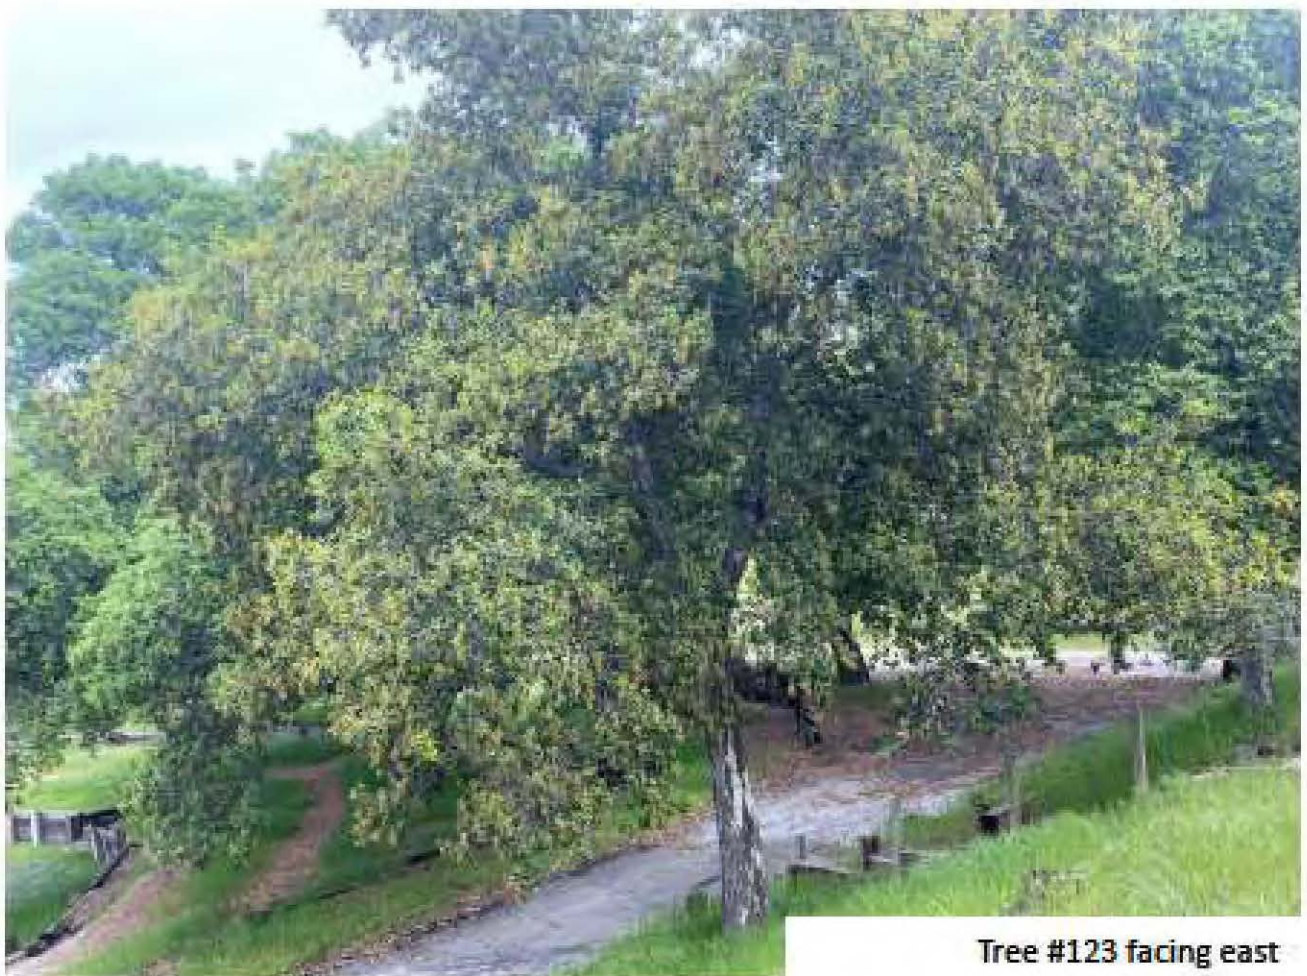
Tree #123 facing east

Oak tree #123 – This tree will be encroached by the manufactured slope to grade the parking lot, impacting 30 percent of the PZ. The v-ditch at the limit of grading will be no closer than 5 feet from the trunk. This will be a significant encroachment that can be managed. This tree will be protected and preserved, and no pruning will be needed.

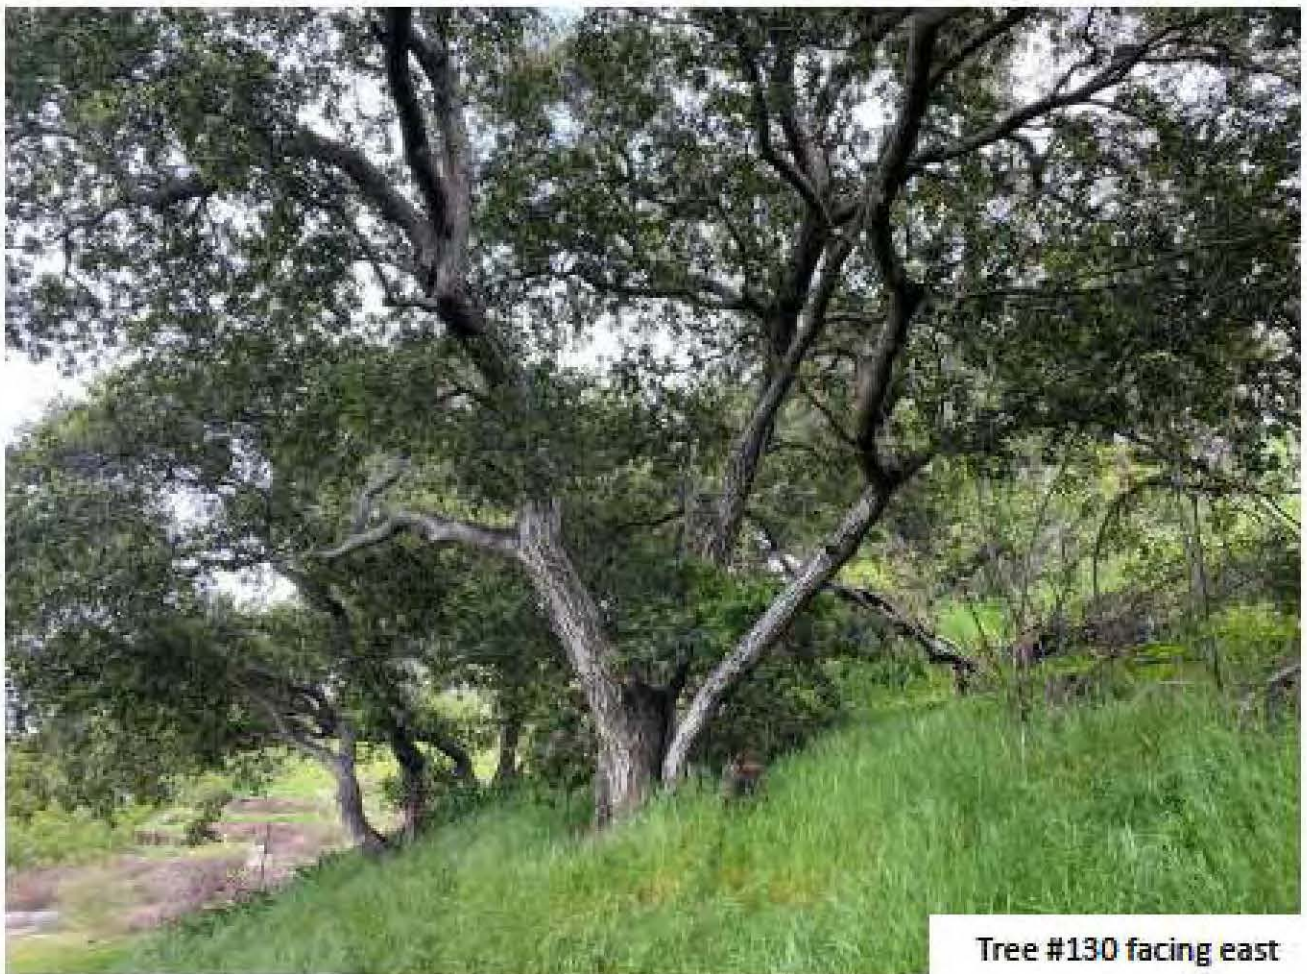
Tree #130 facing east

Oak trees #124, #125, #126, #127, #130, and #131 – These trees are all located on the north side of the grove that occupies the slope that arises from the more level area that will be developed. These 6 oak trees, 4 of which are heritage trees, will be encroached by the manufactured slope needed to create the building pad and parking lot below it. The v-ditch will be the closest encroachment.

- #124 – encroaches 35 percent of the PZ, no closer than 17 feet from the trunk.
- #125 – encroaches 21 percent of the PZ, no closer than 17 feet from the trunk.
- #126 – encroaches 30 percent of the PZ, no closer than 17 feet from the trunk.
- #127 – encroaches 25 percent of the PZ, no closer than 18 feet from the trunk.
- #130 – encroaches 12 percent of the PZ, no closer than 28 feet from the trunk.
- #131 – encroaches 5 percent of the PZ, no closer than 39 feet from the trunk.

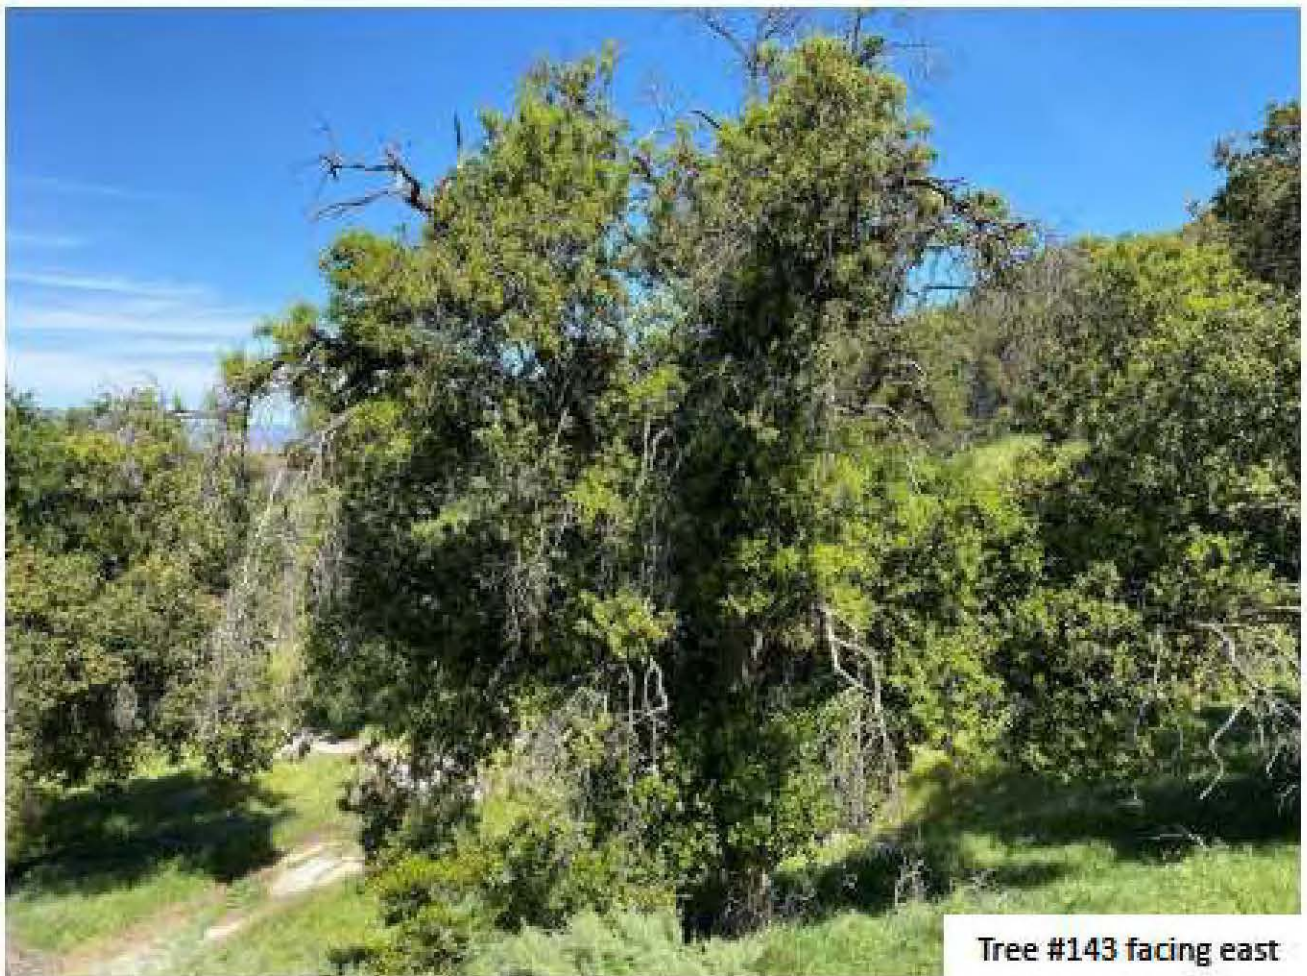
Tree #143 facing east

Oak tree #143 – This tree will be encroached by a drainage channel that begins near this tree, 34 feet from the trunk and encroaching 4 percent of the PZ.

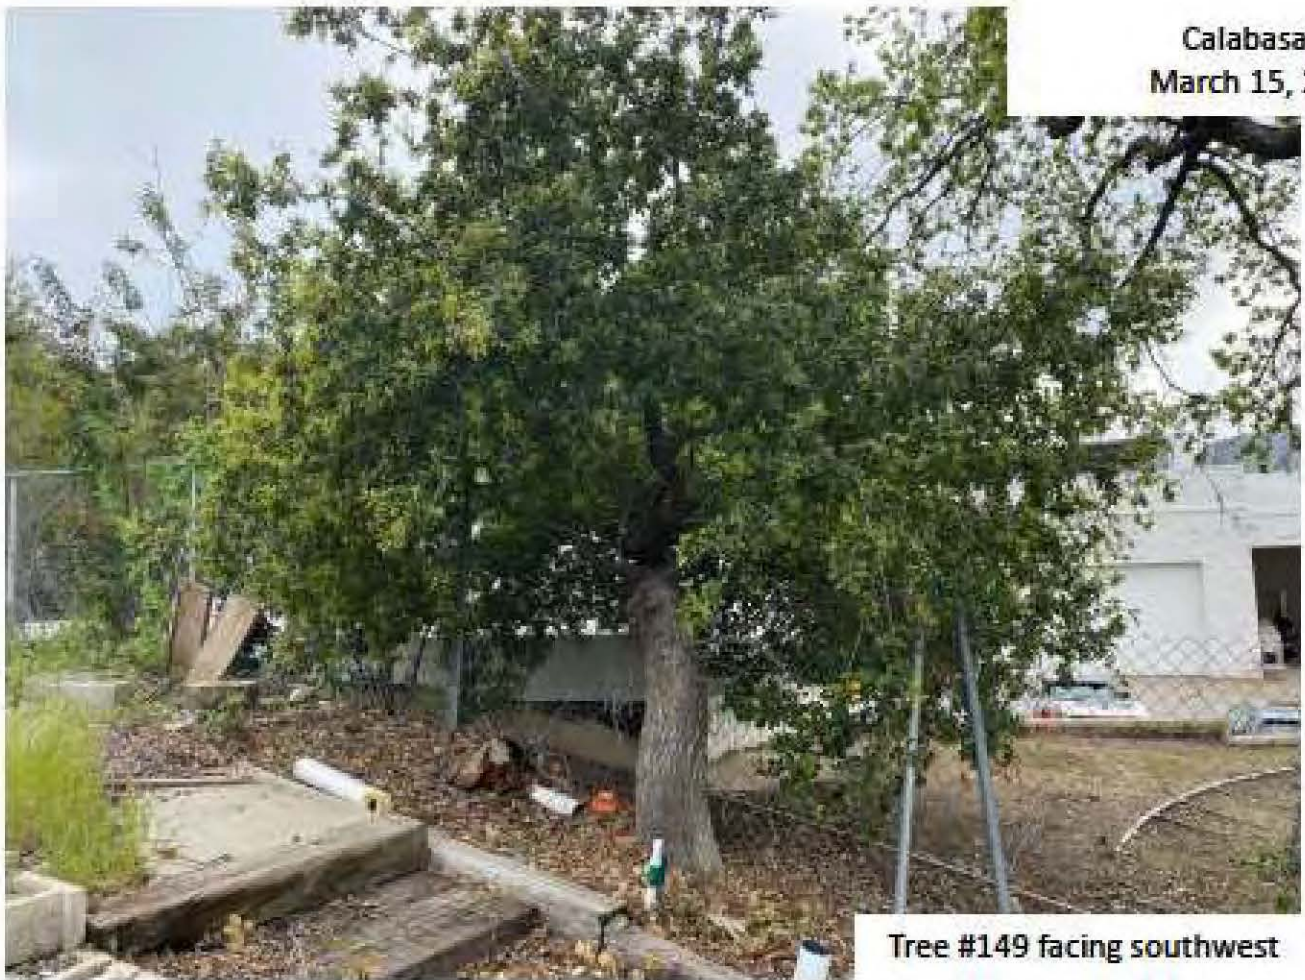
Tree #149 facing southwest

Oak tree #149 – This tree will be encroached by a 4-foot retaining wall, 5 feet from the trunk. This is a severe encroachment that will jeopardize the health of this tree, impacting 50 percent PZ. The drain line shown on the plan will be aligned away from the trunk.

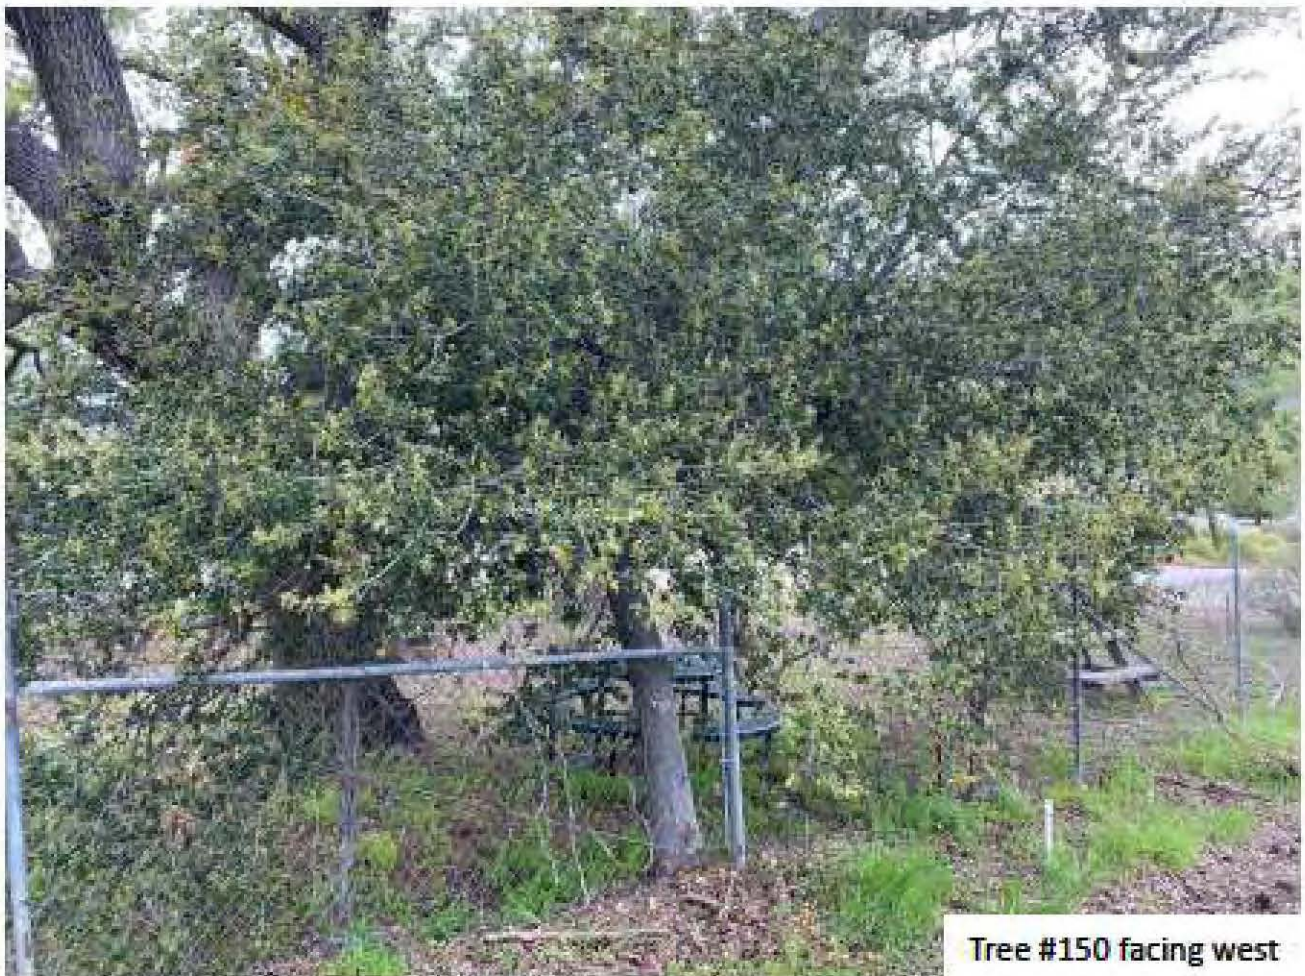
Tree #150 facing west

Oak tree #150 – This tree is located on the west property line, 2 feet from a proposed 6-foot retaining wall. The excavation for the wall will require the removal of this tree.
