February 24, 2020

Subject: Landslide Hazard Evaluation, Chappellet Vineyard
APN's 032-010-076 and 032-010-094

Subject: Response to comments on Chappellet Vineyards Landslide Hazard Evaluation associated with #P20-00271-ECPA Sage Canyon Road: APNs 032-560-022 and -033

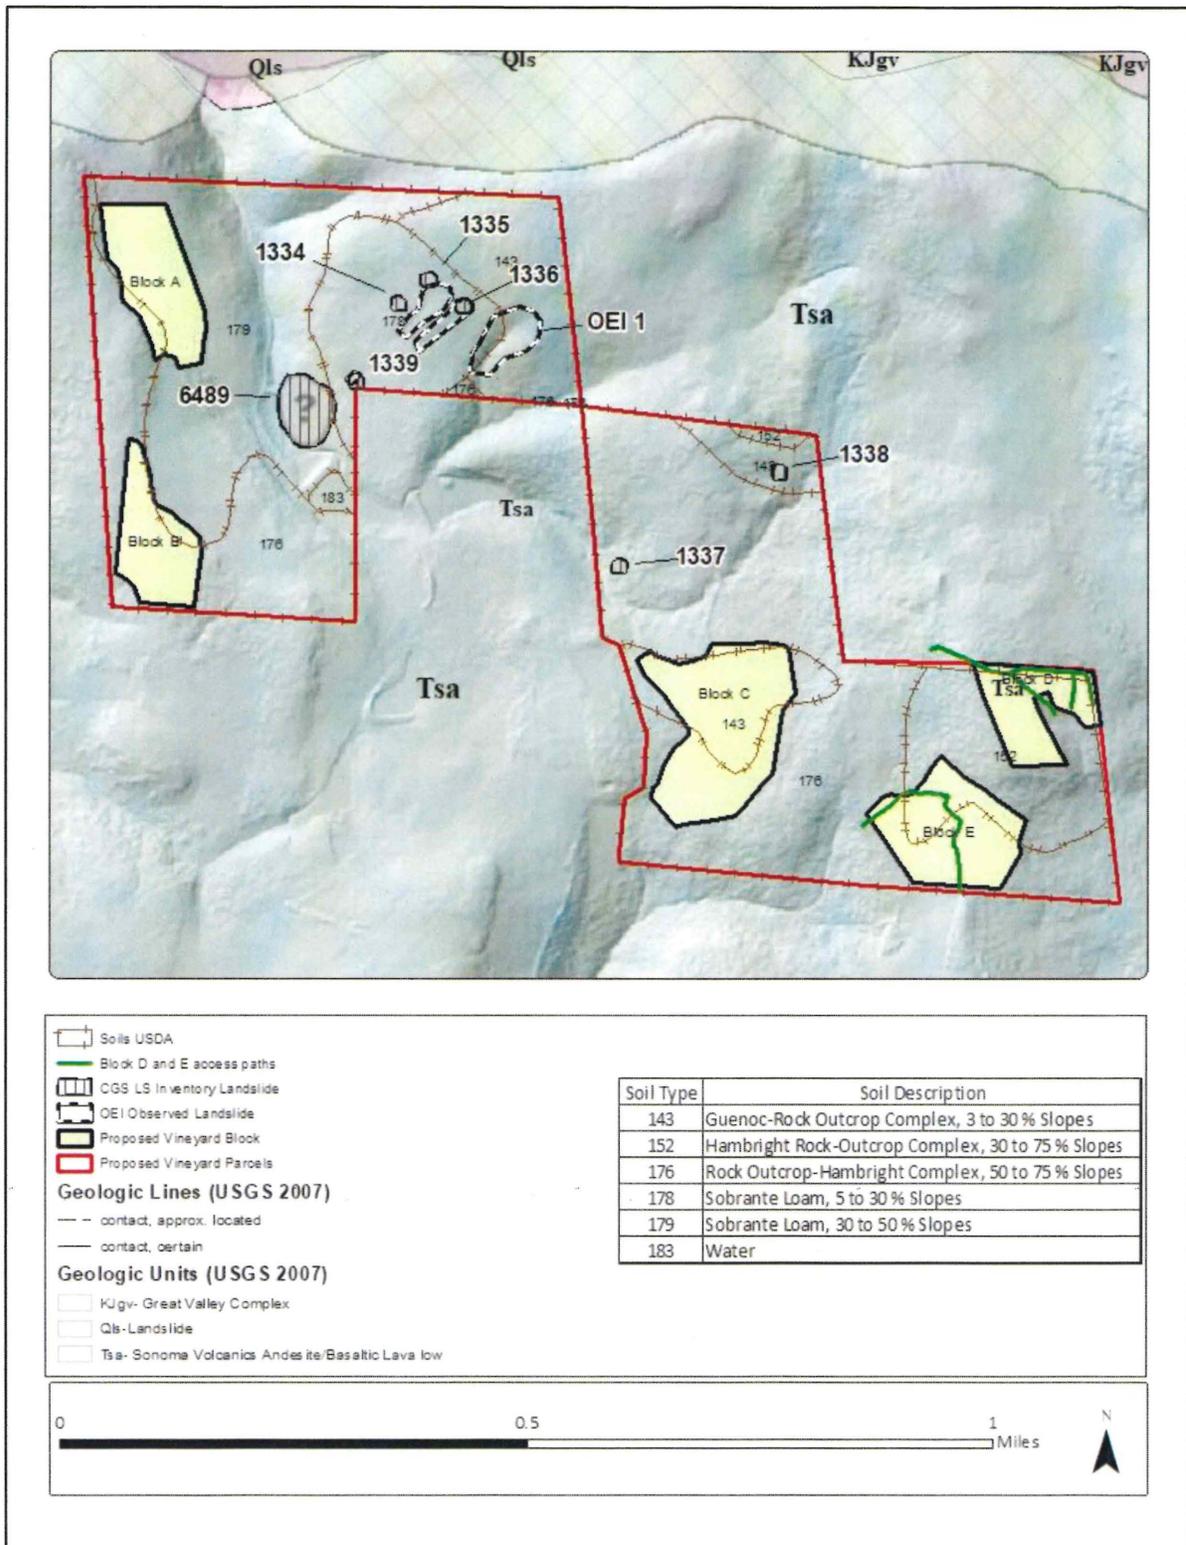
Napa County GIS Parcel Reports indicate that landslides are present on both of the project parcels. A regional landslide mapping effort by the California Geological Survey called the California Landslide Inventory (CGS, 2019) has compiled several mapping efforts across the state. In the vicinity of the project parcels landslides identified in the Yountville 7.5 Minute Quadrangle using aerial photos by Dwyer, Noguchi and O'Rourke of the US Geological Survey (USGS, 1976) show several landslides on the project parcels (Figure 3, Table 1). On the northern parcel four questionable debris flows (questionable is defined as "50% confident it is a landslide" by the USGS study) are mapped along with one feature identified as a questionable landslide of undefined type. On the southern parcel a questionable rockslide and a questionable debris flow are mapped (Figure 3). None of the mapped slides are located near the proposed vineyard areas or access roads.

Figure 3: Distribution of USDA Soil types, Geology (Graymer, 2007) and Landslides on the project parcels, CGS California Landslide Inventory Landslides shown are from Dwyer, Noguchi and O'Rourke (USGS 1976)

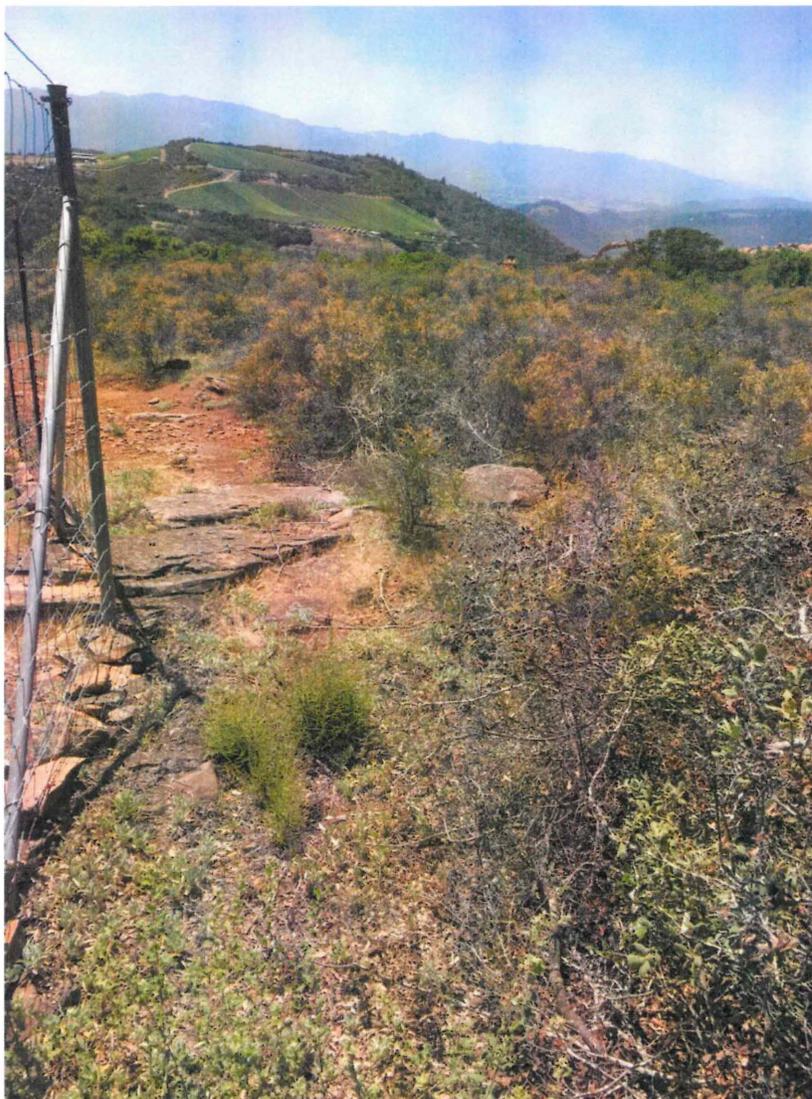
Photo 1 View of exposed bedrock in proposed vineyard Block B, view to the west.

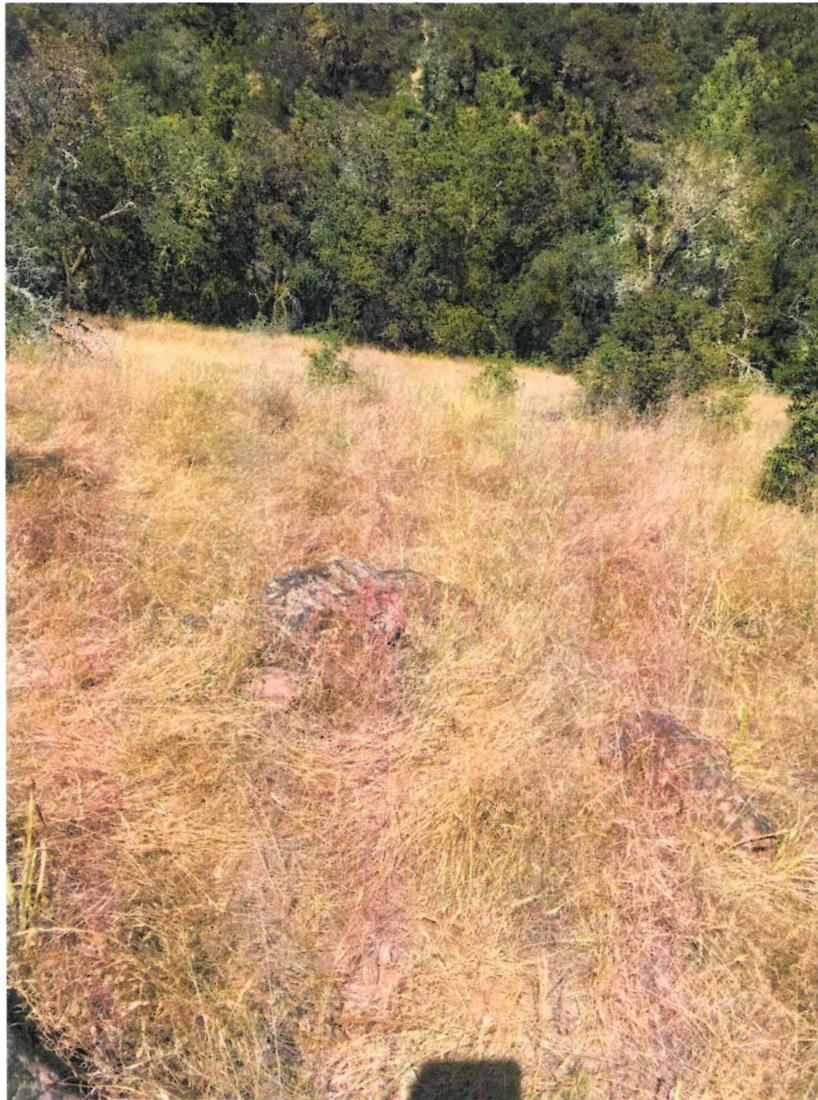
Photo 2. View of typical ground conditions with boulders and cobbles exposed on slope adjacent to Block A; view is to the east.

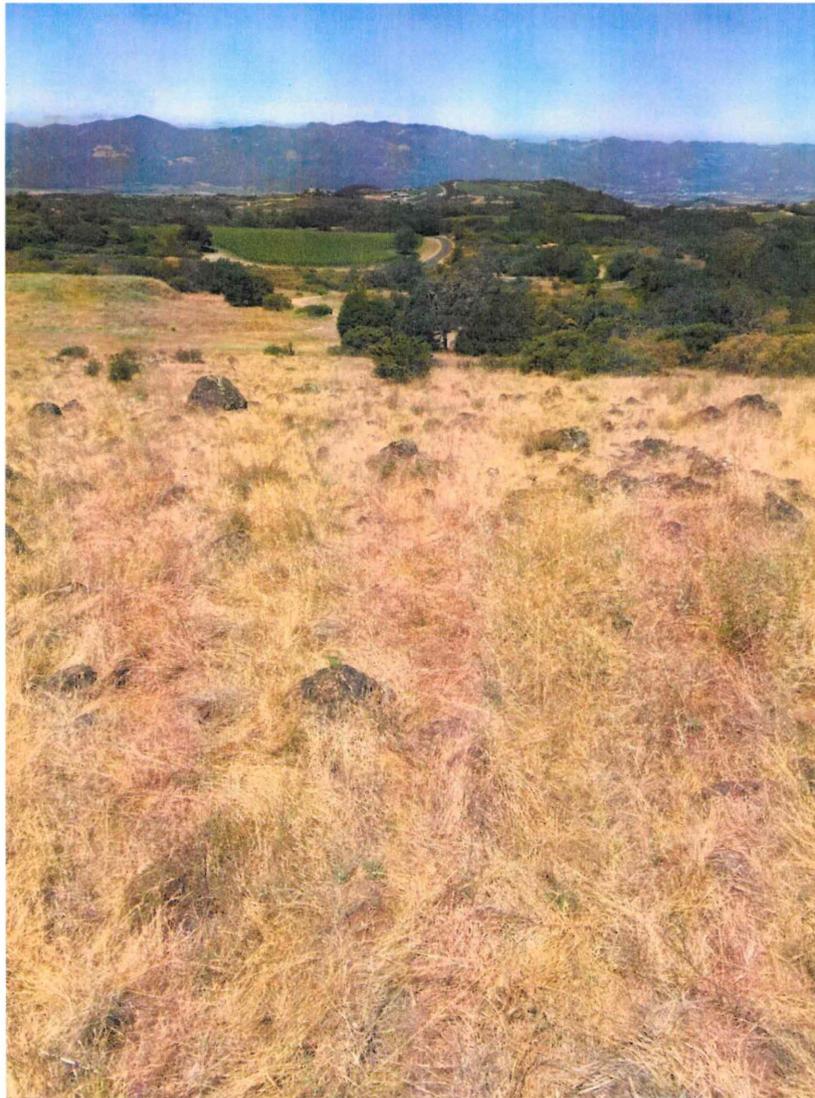
Photo 3 . View of typical ground conditions in proposed vineyard Block C, view to the west.

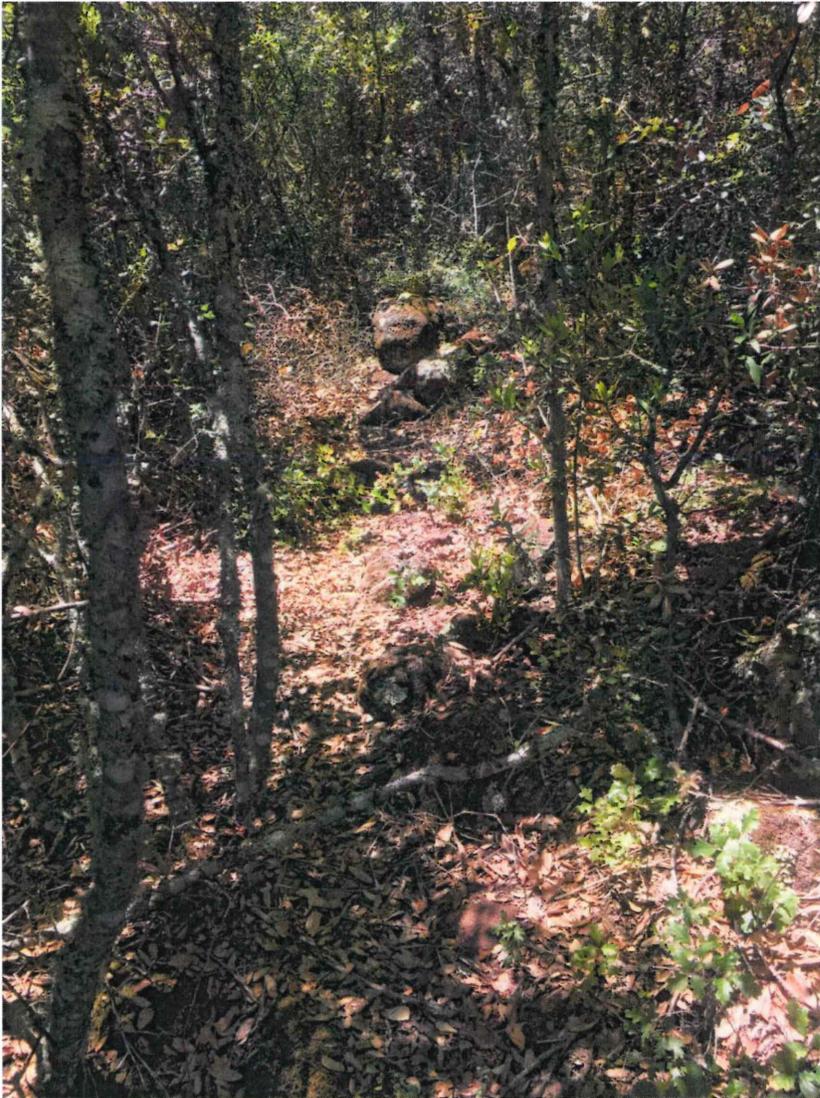
Photo 4. View of surface conditions in Block D

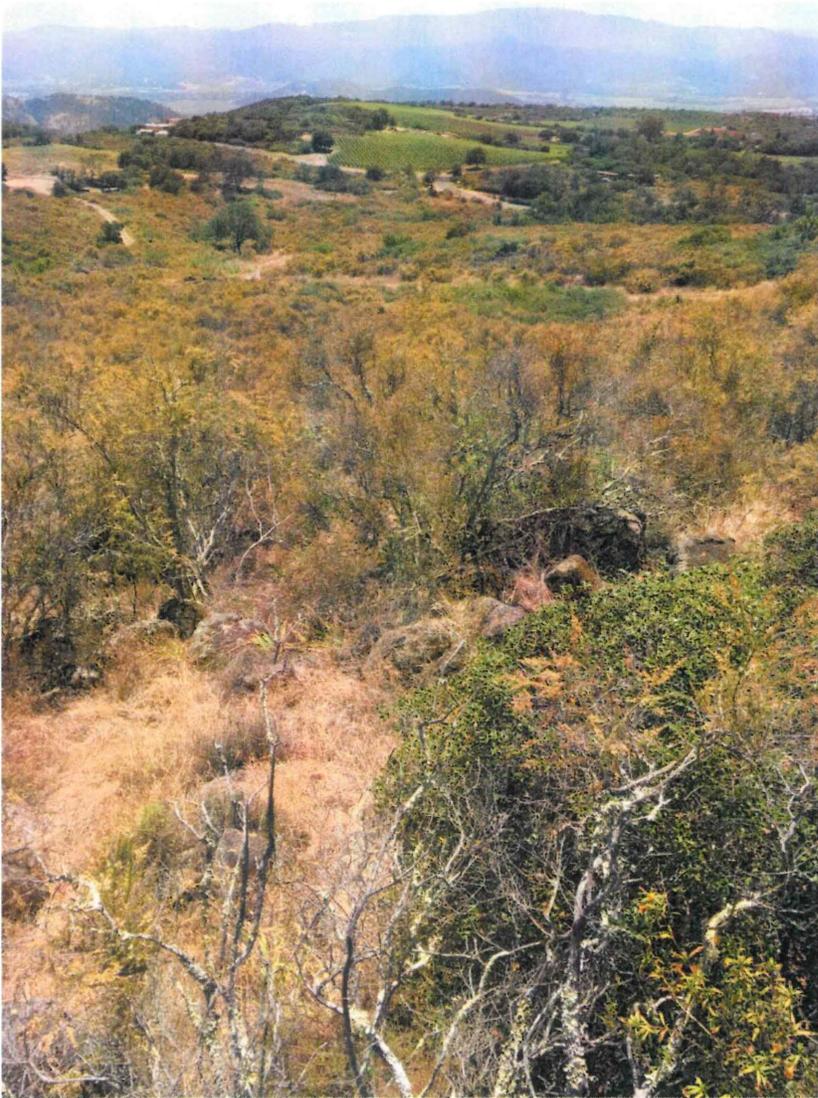
Photo 5. View of surface conditions in proposed vineyard Block E.

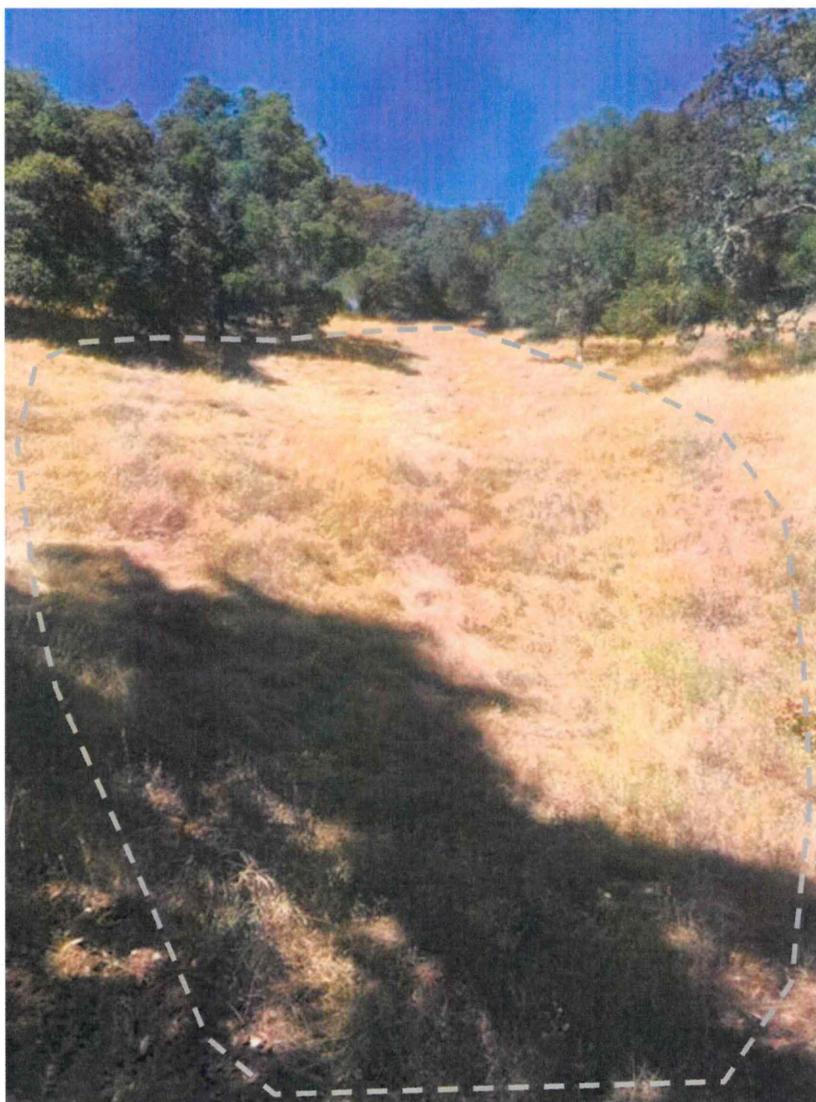
Photo 6. View up-hill to northeast of Probable Historic Debris slide OEI 1. Dashed line shows approximate extent.

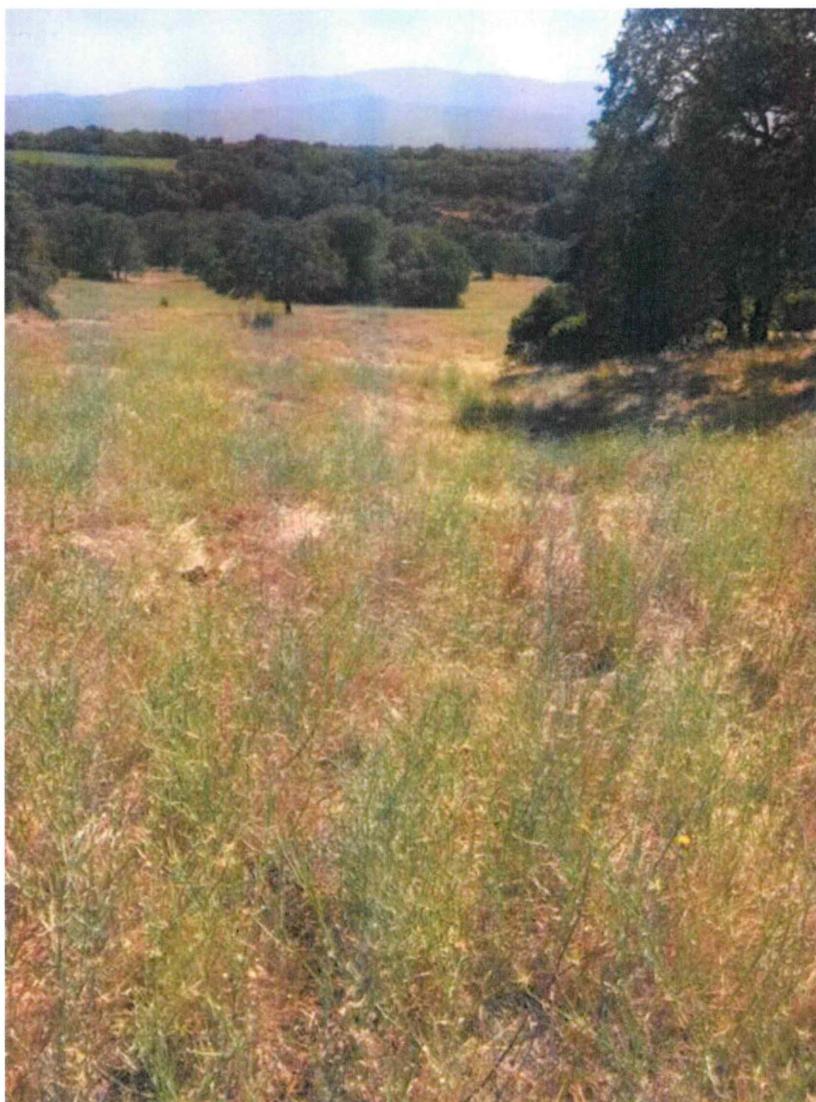
In the northern project parcel I visited all five mapped landslides and assessed their classification, activity and stability. The extents of landslides 1334, 1335, 1336 and 1339 were adjusted as shown by the black and white dashed polygons in Figure 1. Landslides 1334 and 1335 appear to be offset to the northwest slightly and are part of a single feature; 1339 was smaller than the USGS mapped extent. The extent of landslide 6489 was not changed, and a previously unmapped probable historic debris slide landslide (OEI 1) was observed. None of the landslides observed were active or present a hazard to the project or project infrastructure. In the southern project parcel at the locations of the two mapped landslides both sites had exposed bedrock, boulders and cobbles; however, no evidence of active or historic slope movement was observed.

Photo 7. View from top to southwest of historic debris slide 1336. Subtle grassy swale extends down hill.

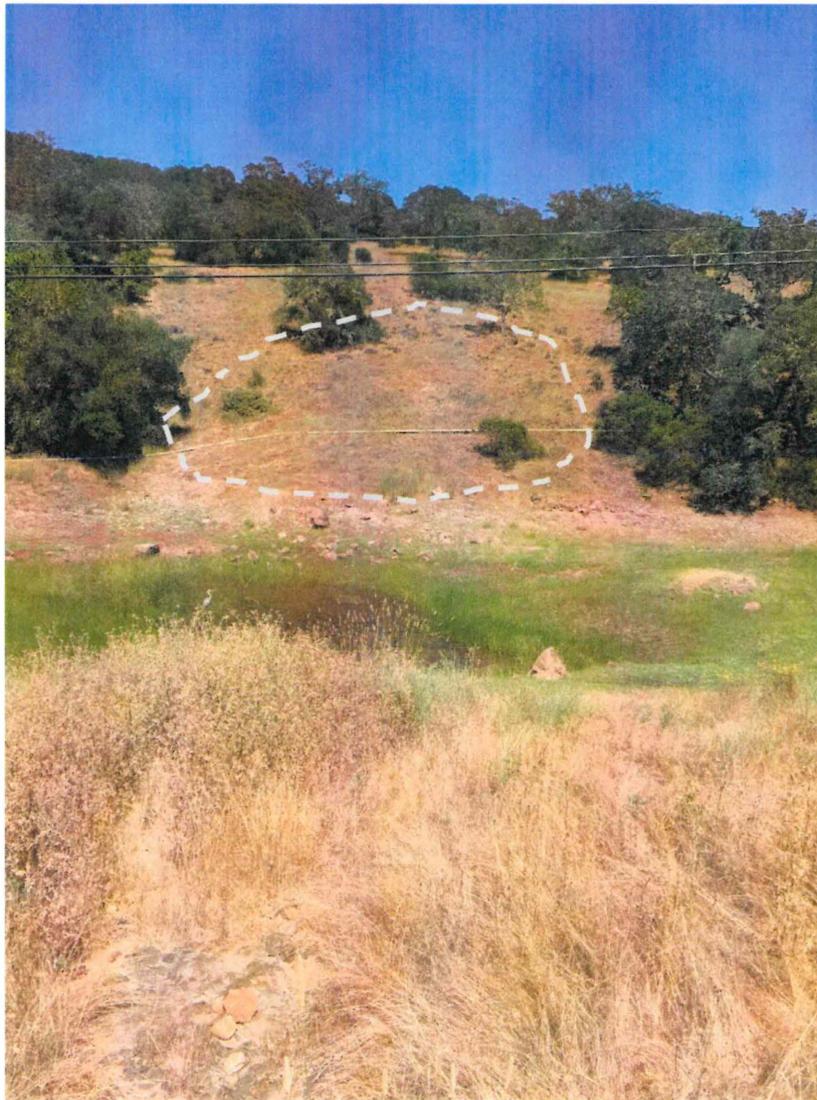
Photo 7. View of Probable historic debris slide/slump 6489 with small pond in foreground. Approximate extent indicated by dashed white line.
