## **LEAD-BASED PAINT INSPECTION**

**1433 CRESTFIELD DRIVE  
DUARTE, CALIFORNIA 91010**

**APRIL 24, 2024**

RE: Lead-based paint inspection at 1433 Crestfield Drive, Duarte, California 91010

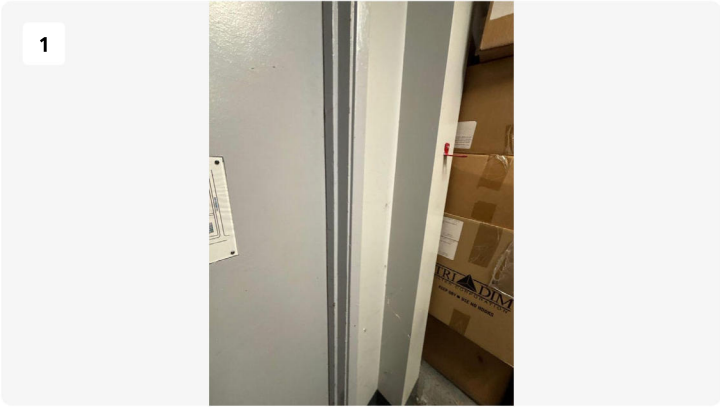
Building H staff lounge positive door frame

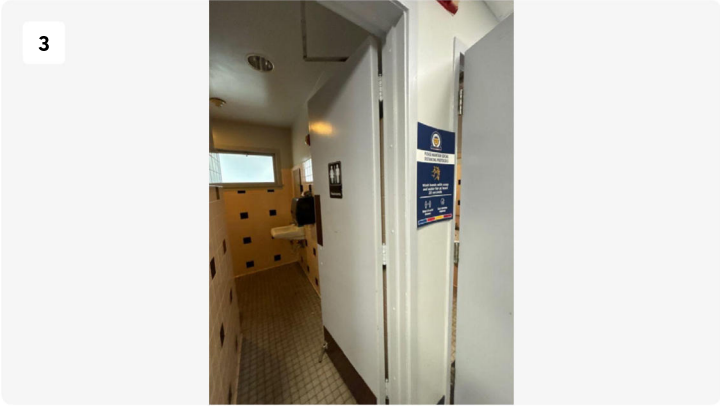
Building H staff lounge restroom 2 positive door frame

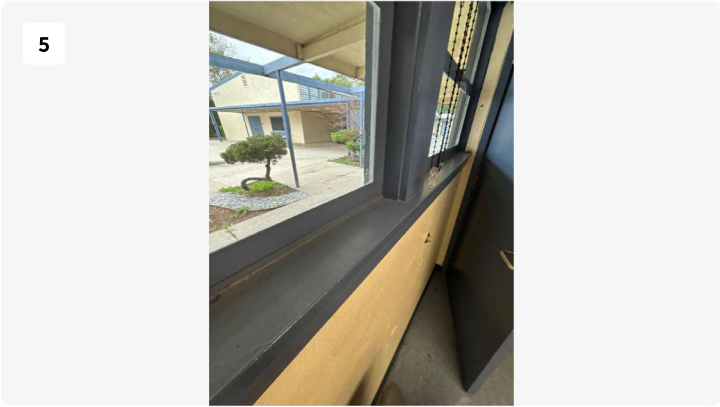
Building H nurse positive window frame

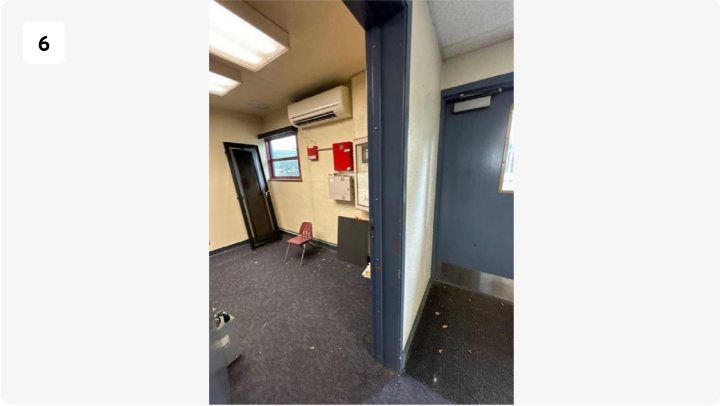
Building H electrical room positive door frame

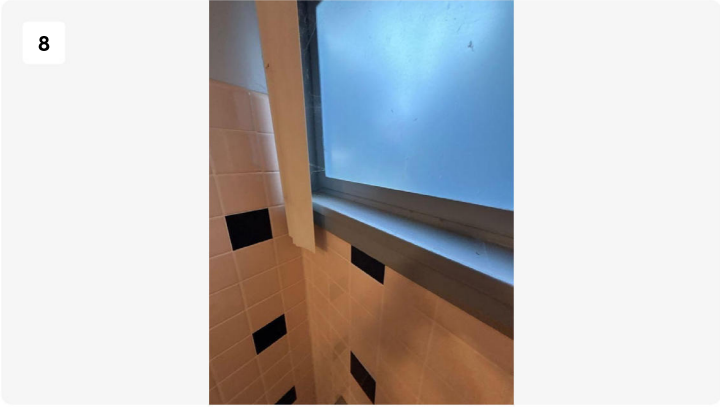
Building H office 2 restroom positive window frame

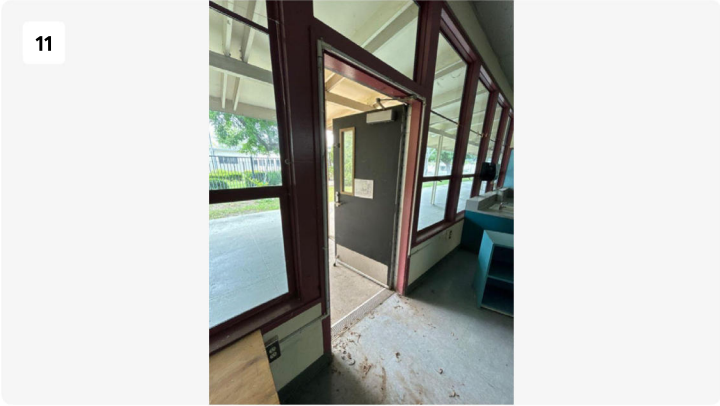
Building I room 3 positive door frame, window frame, lower wall

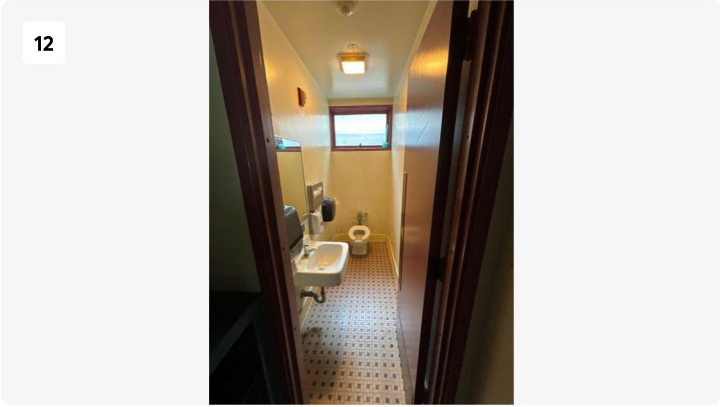
Building I room 3 restroom positive door frame, ceramic baseboard, window frame

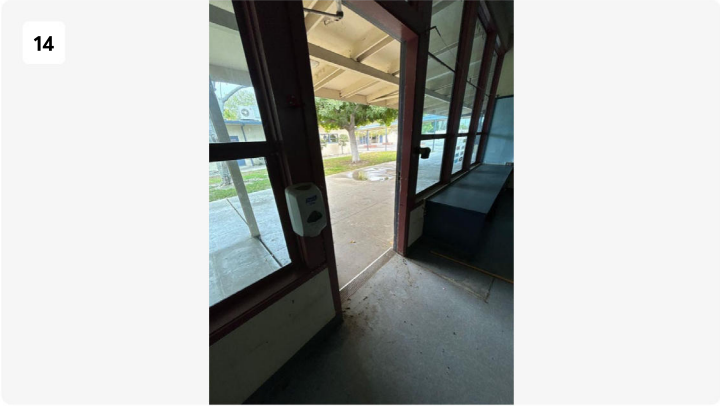
Building I room 4 positive door frame, window frame, lower wall

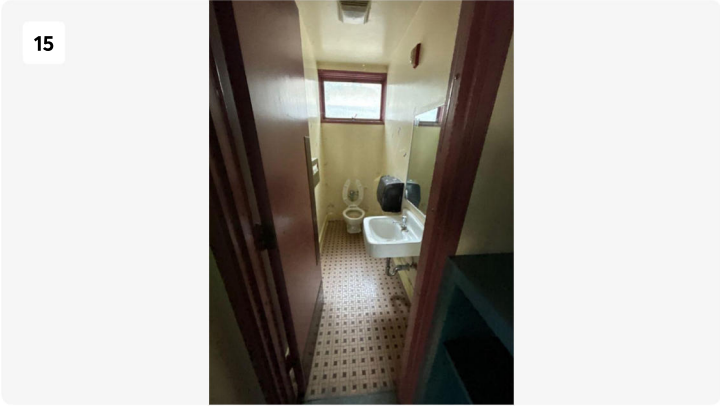
Building I room 4 restroom positive door frame, ceramic baseboard, window frame

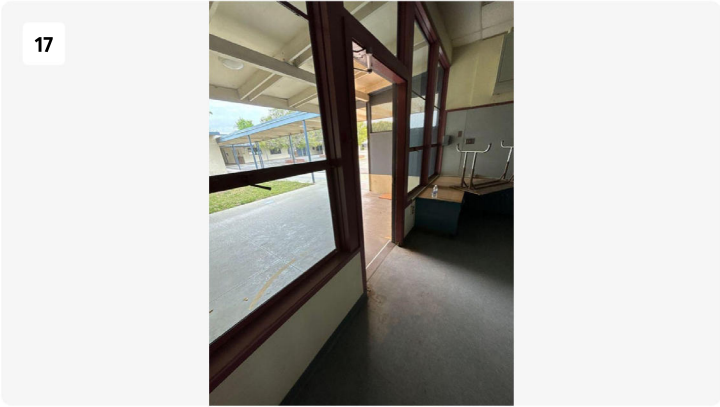
Building I room 5 positive door frame, window frame, lower wall

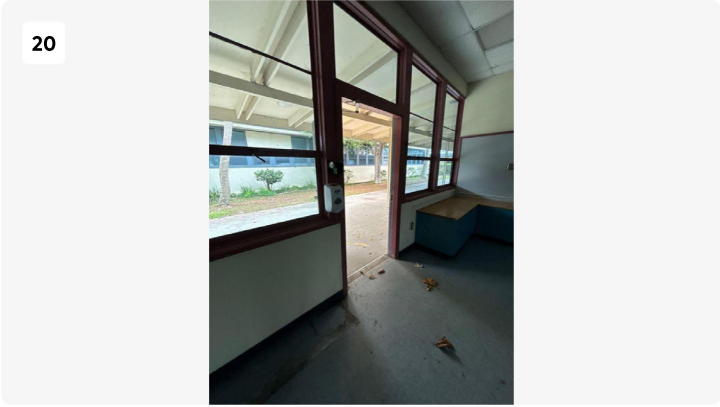
Building J room 8 positive door frame, window frame, lower wall

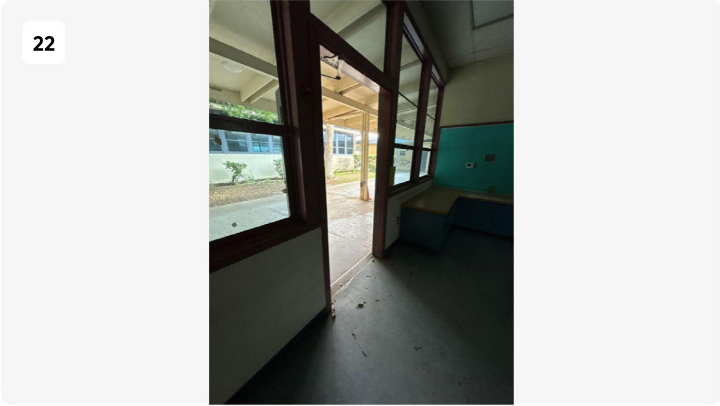
Building J room 9 positive door frame, window frame, lower wall

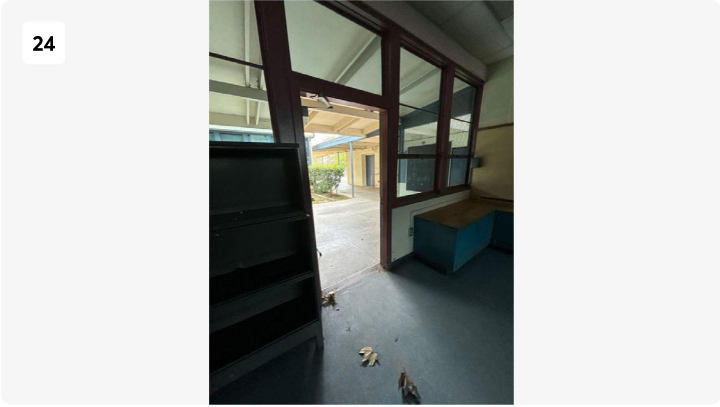
Building J room 10 positive door frame, window frame, lower wall

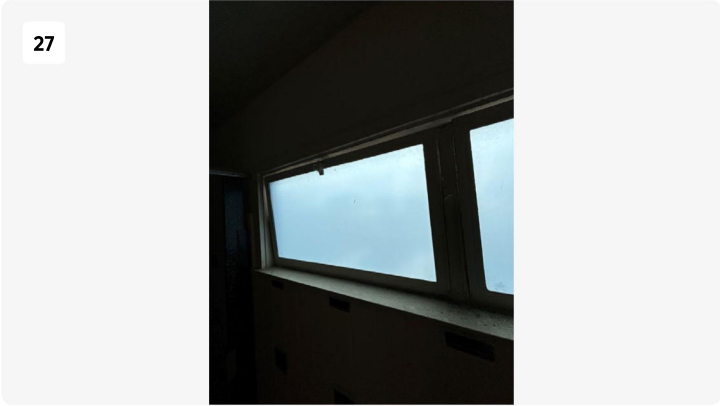
Lower grade restrooms girls restroom positive window frame

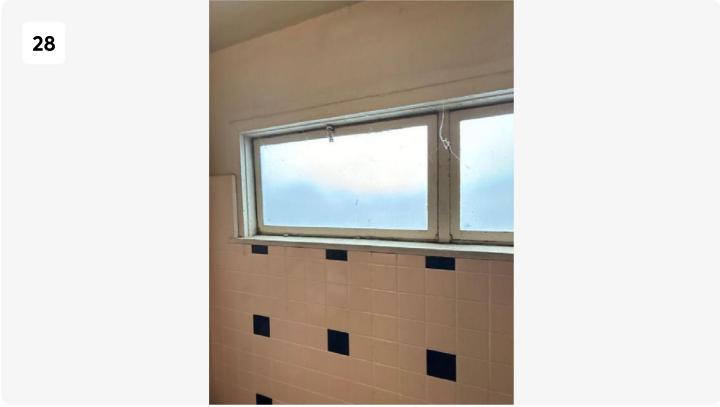
Lower grade restrooms boys restroom positive window frame

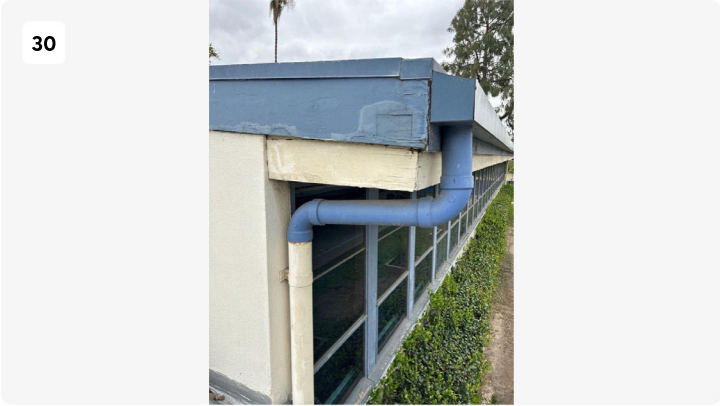
Building B positive down spout, window frames, rafter tails, fascia

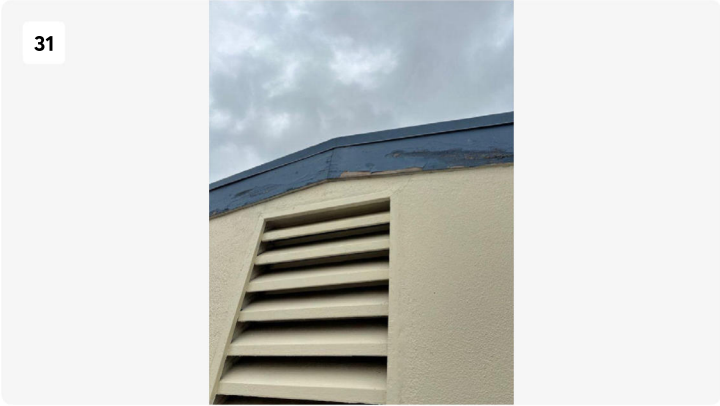
Building F positive louvers, fascia

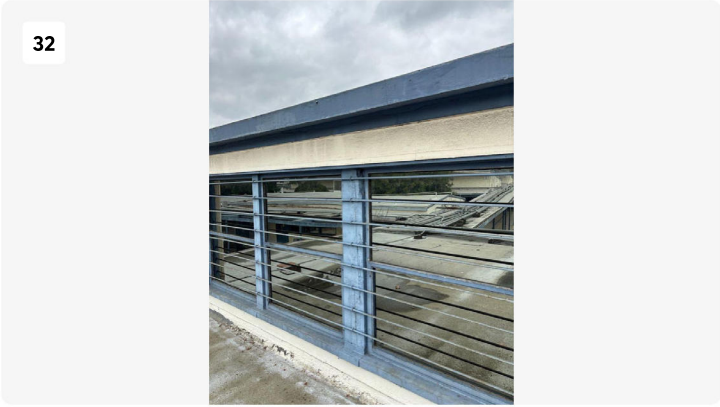
Building F positive window frame, window sash, gutter

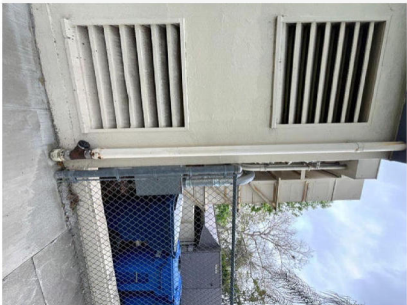
33

Building F positive down spout

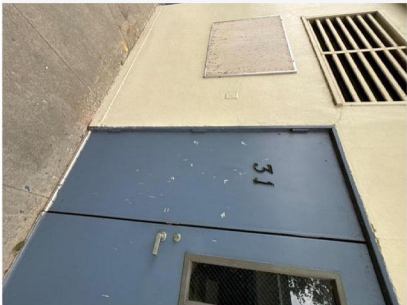
34

Building F positive door frame

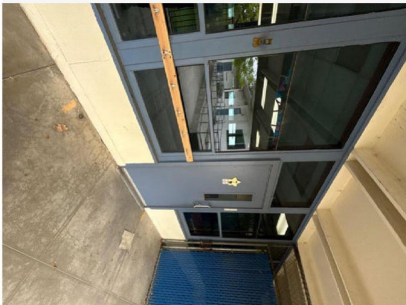
35

Building G positive window frame, door frame

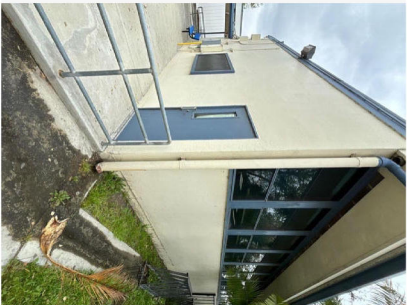
36

Building G positive down spout

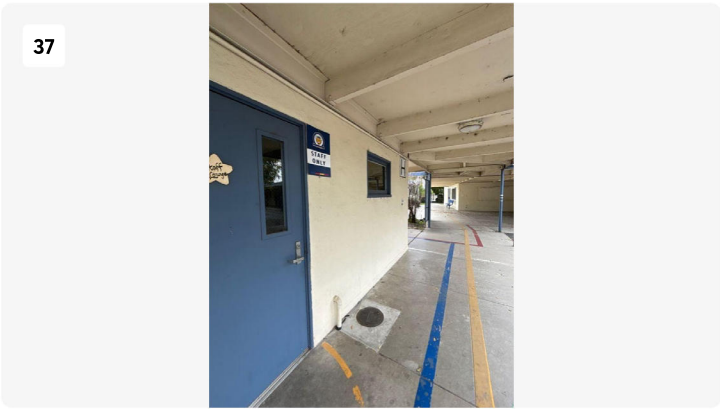
Building H positive window frame, door frame

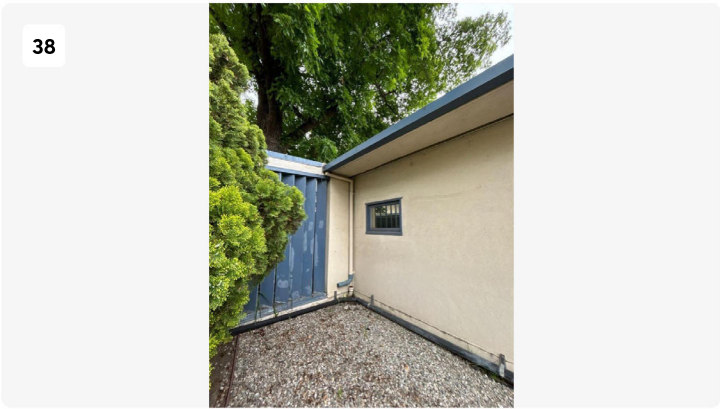
Building H positive gutter, downspout

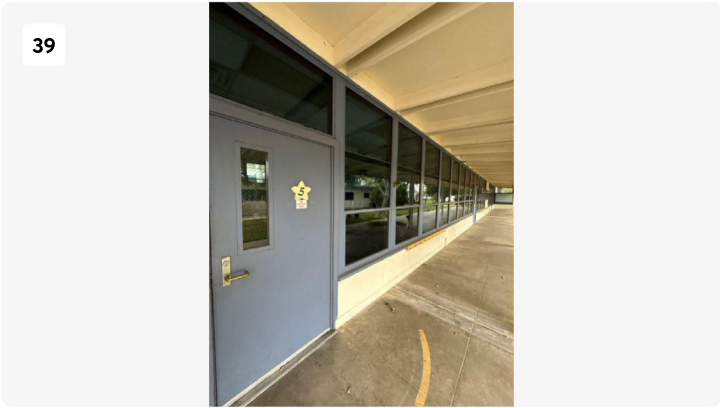
Building I positive window frame, door frame

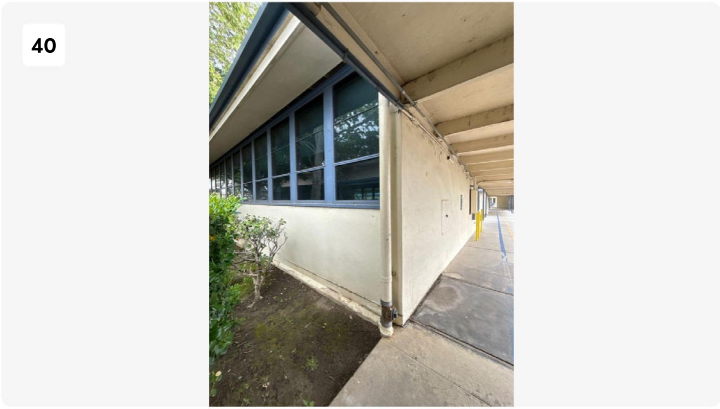
Building I positive downspout

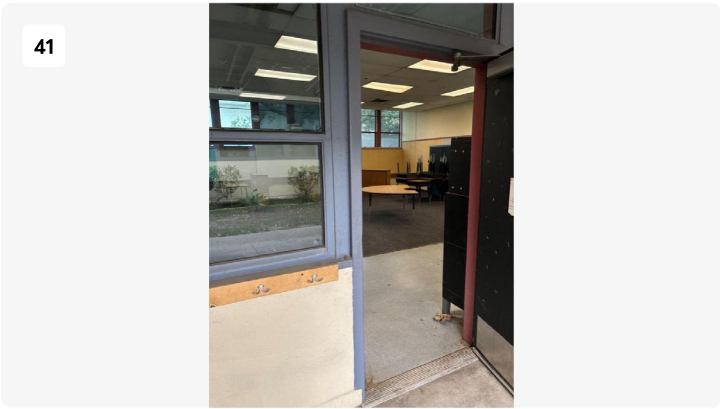
Building J positive window frame, door frame

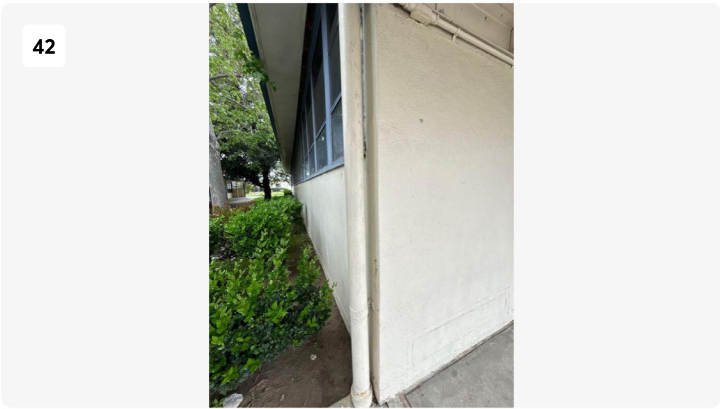
Building J positive downspout

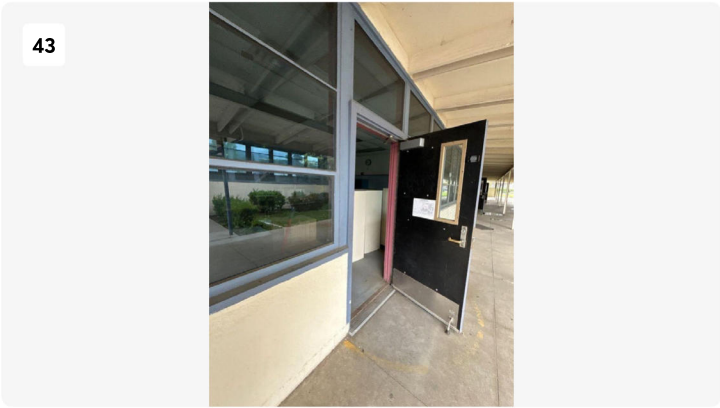
Building I positive window frame, door frame

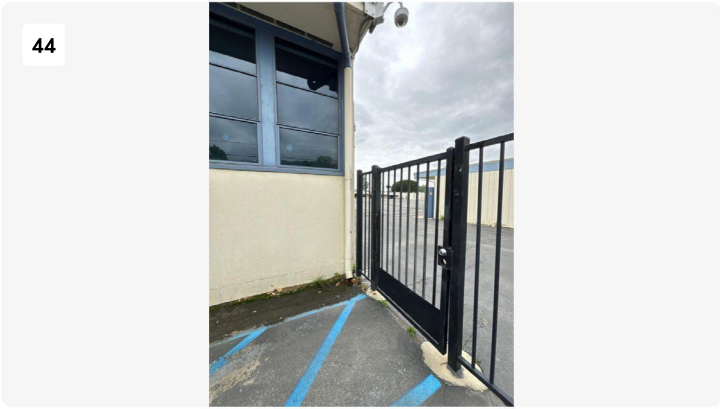
Building L positive downspout

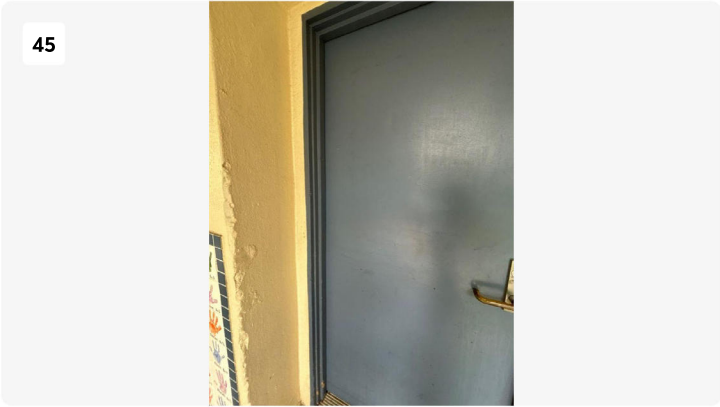
Building D positive door frame

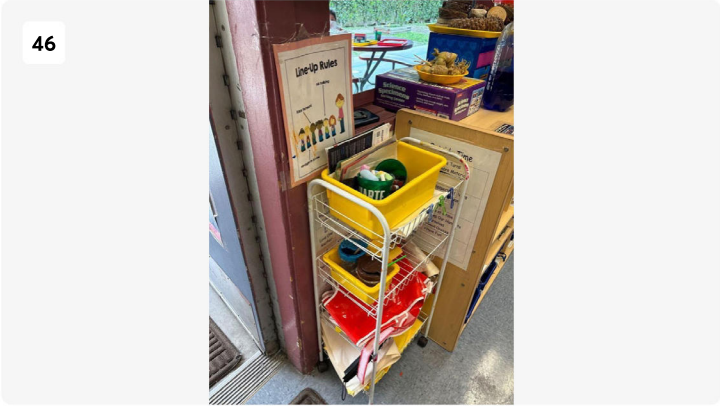
Building A room 5 positive door frame, window frame

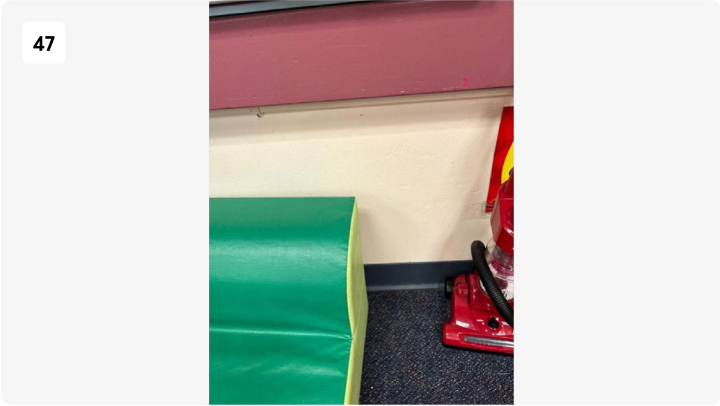
Building A room 5 positive lower wall

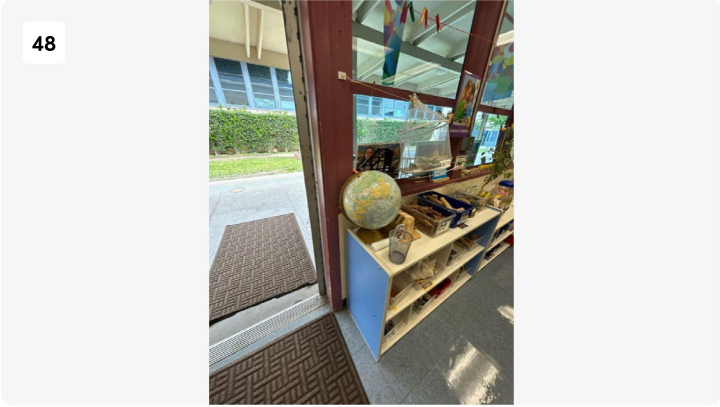
Building A room 4 positive door frame, window frame, lower wall
