**Tree Inventory, Assessment,  
and  
Protection Report**

**3315 Sierra Road  
San Jose, CA 95132**

**Robson Homes, LLC**

**February 17, 2023  
Revised January 16, 2025**

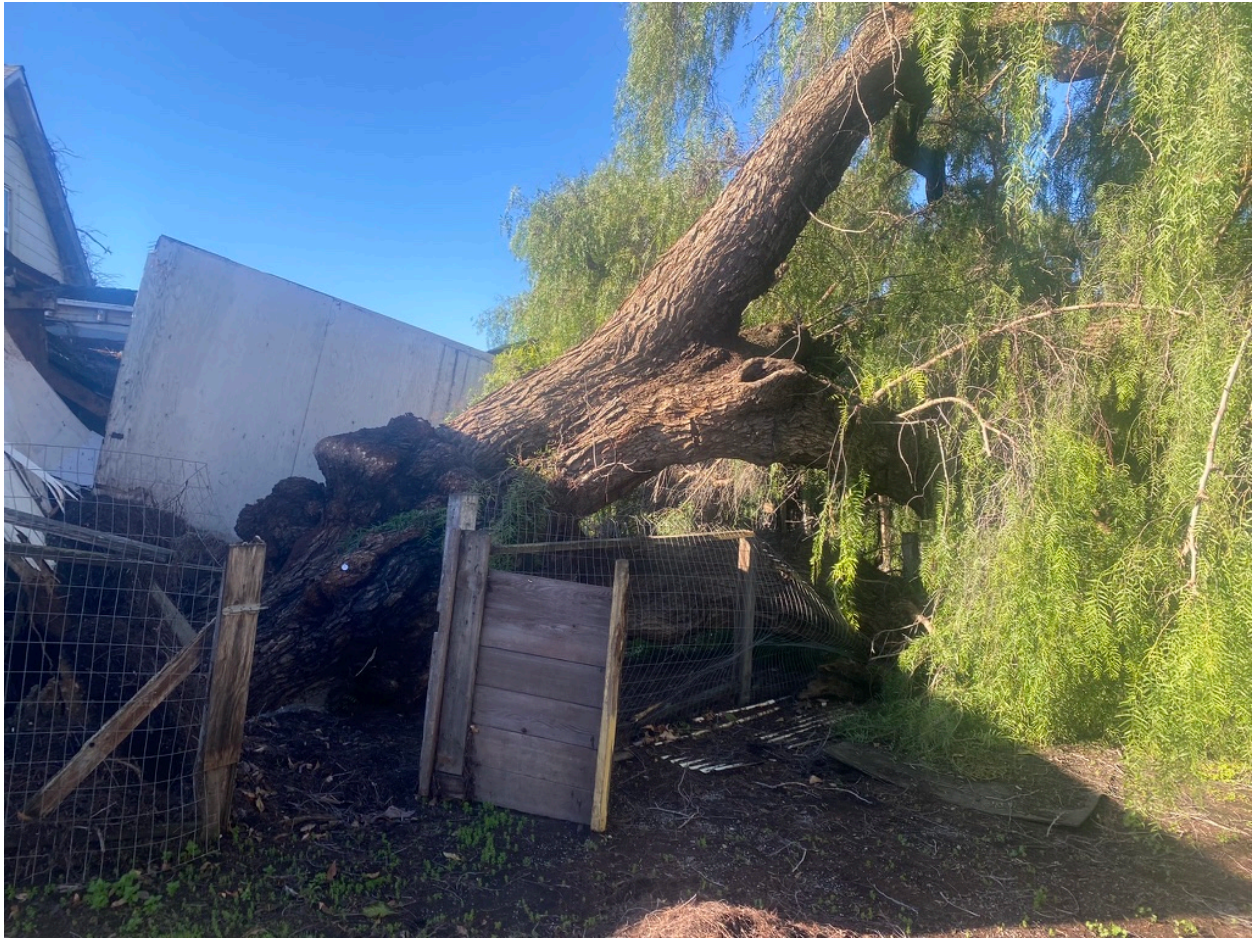
### C1: Failed Pepper #654

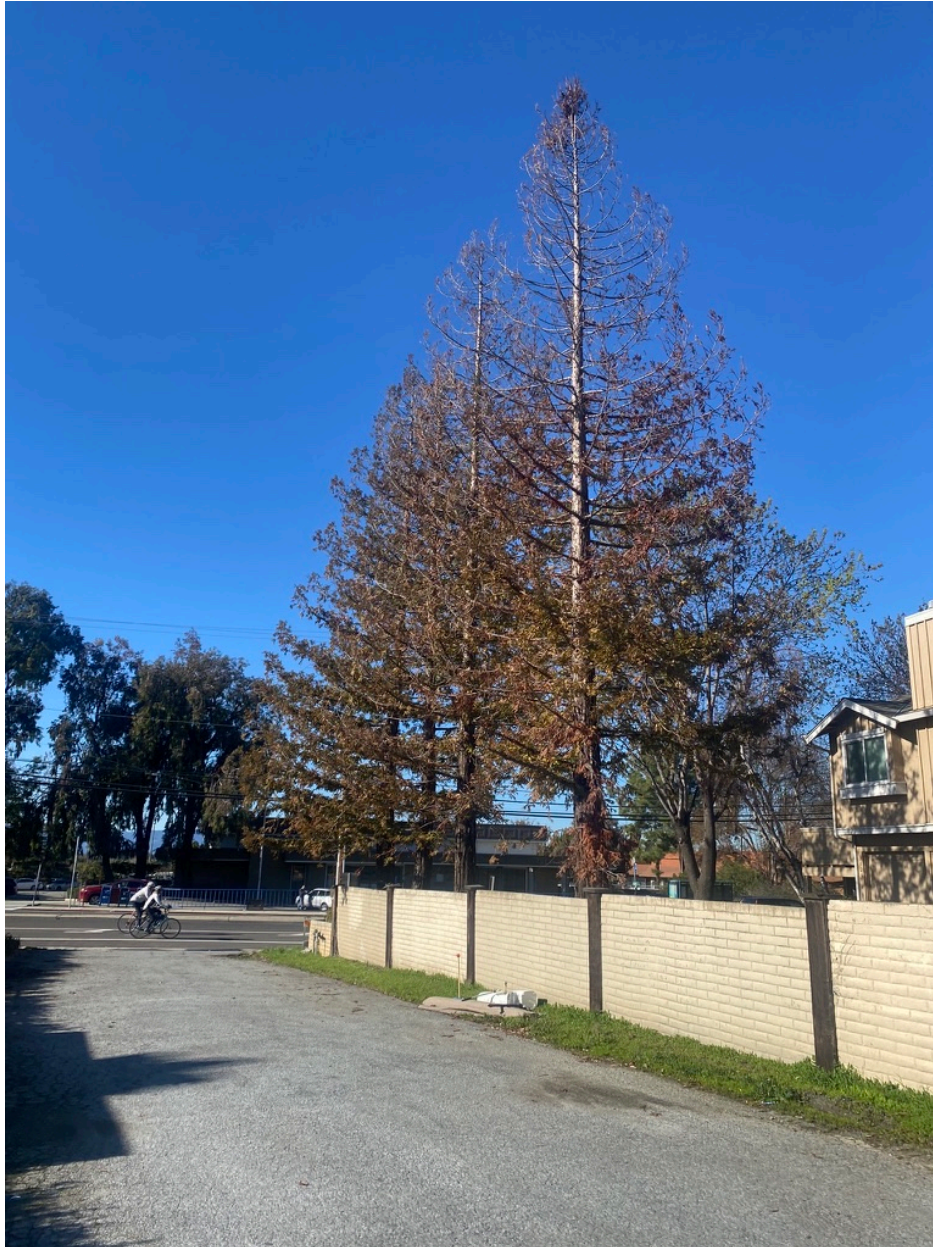
| Tree Species | I.D. # | Trunk Diameter | Trunk Circumference | Overall Condition | Suitability | Expected Impact | Status |
|---|---|---|---|---|---|---|---|
| coast redwood<br>( <i>Sequoia sempervirens</i> ) | 632 | 19 | 60 | Very poor | N/A | Moderate<br>-high | Ordinance<br>Size |

## C2: Declining Redwoods #630-#633 on adjacent site

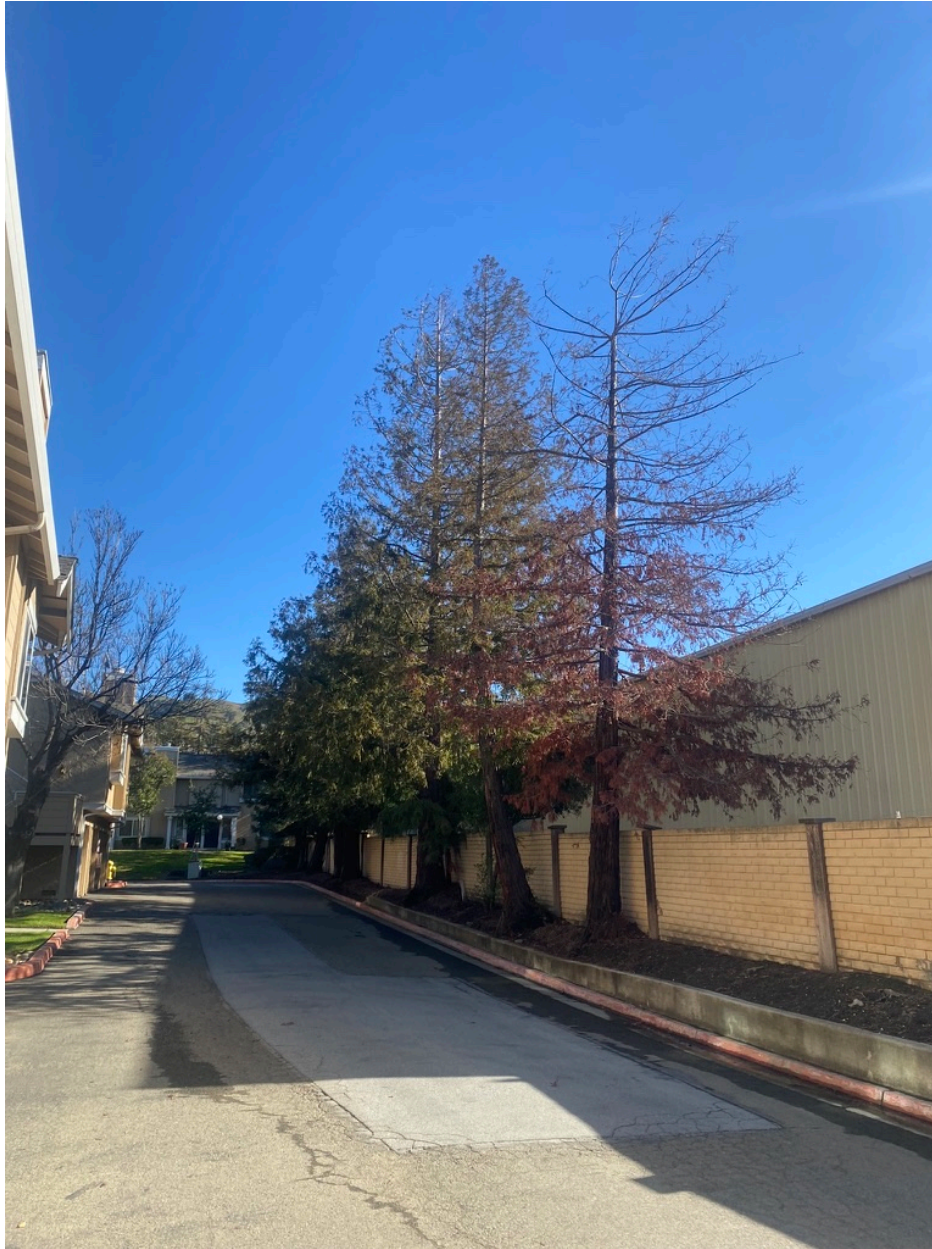
Tree protection will be required primarily for the adjacent coast redwoods within the Ivalynn Circle area. Many of these trees are growing along the neighbor fence in a small strip with no discernible root area on the opposite side, and many are in poor condition. It may not be possible to obtain distances of 12 to 25 feet which would be a typical tree protection radius for these specimens. Some of these trees should be removed due to poor condition but are not under the control of the applicant.

### **C3: Redwoods #634 to #641 on adjacent site**

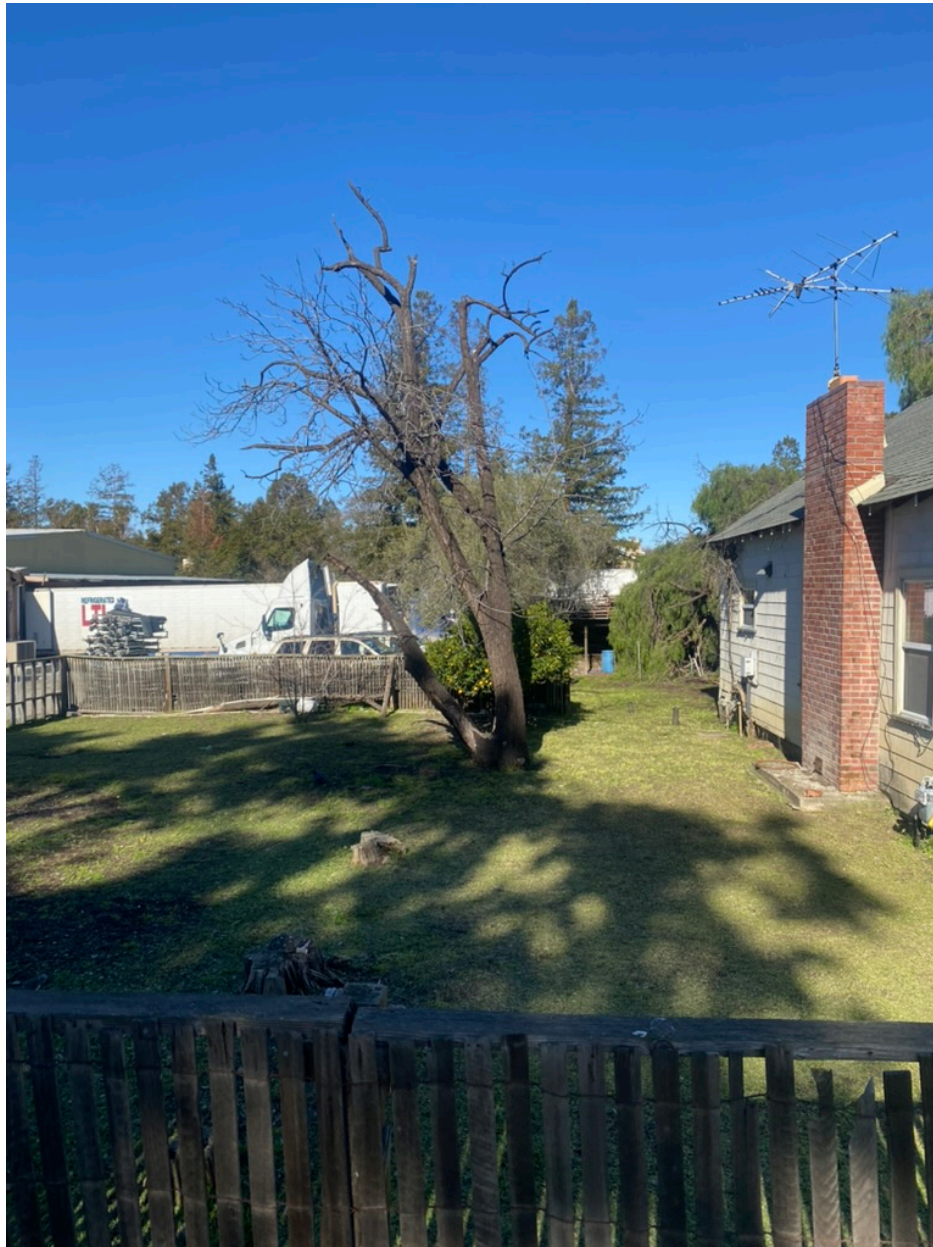
## C4: Black Walnut #666
