# GEOHAZARDS EVALUATION RESIDENTIAL DEVELOPMENT

## 3315 SIERRA ROAD SAN JOSE, CALIFORNIA

**JULY 10, 2024**  
**PROJECT PA22.1048.00**

**GEOHAZARDS EVALUATION  
PROPOSED RESIDENTIAL DEVELOPMENT  
3315 SIERRA ROAD  
SAN JOSE, CALIFORNIA**

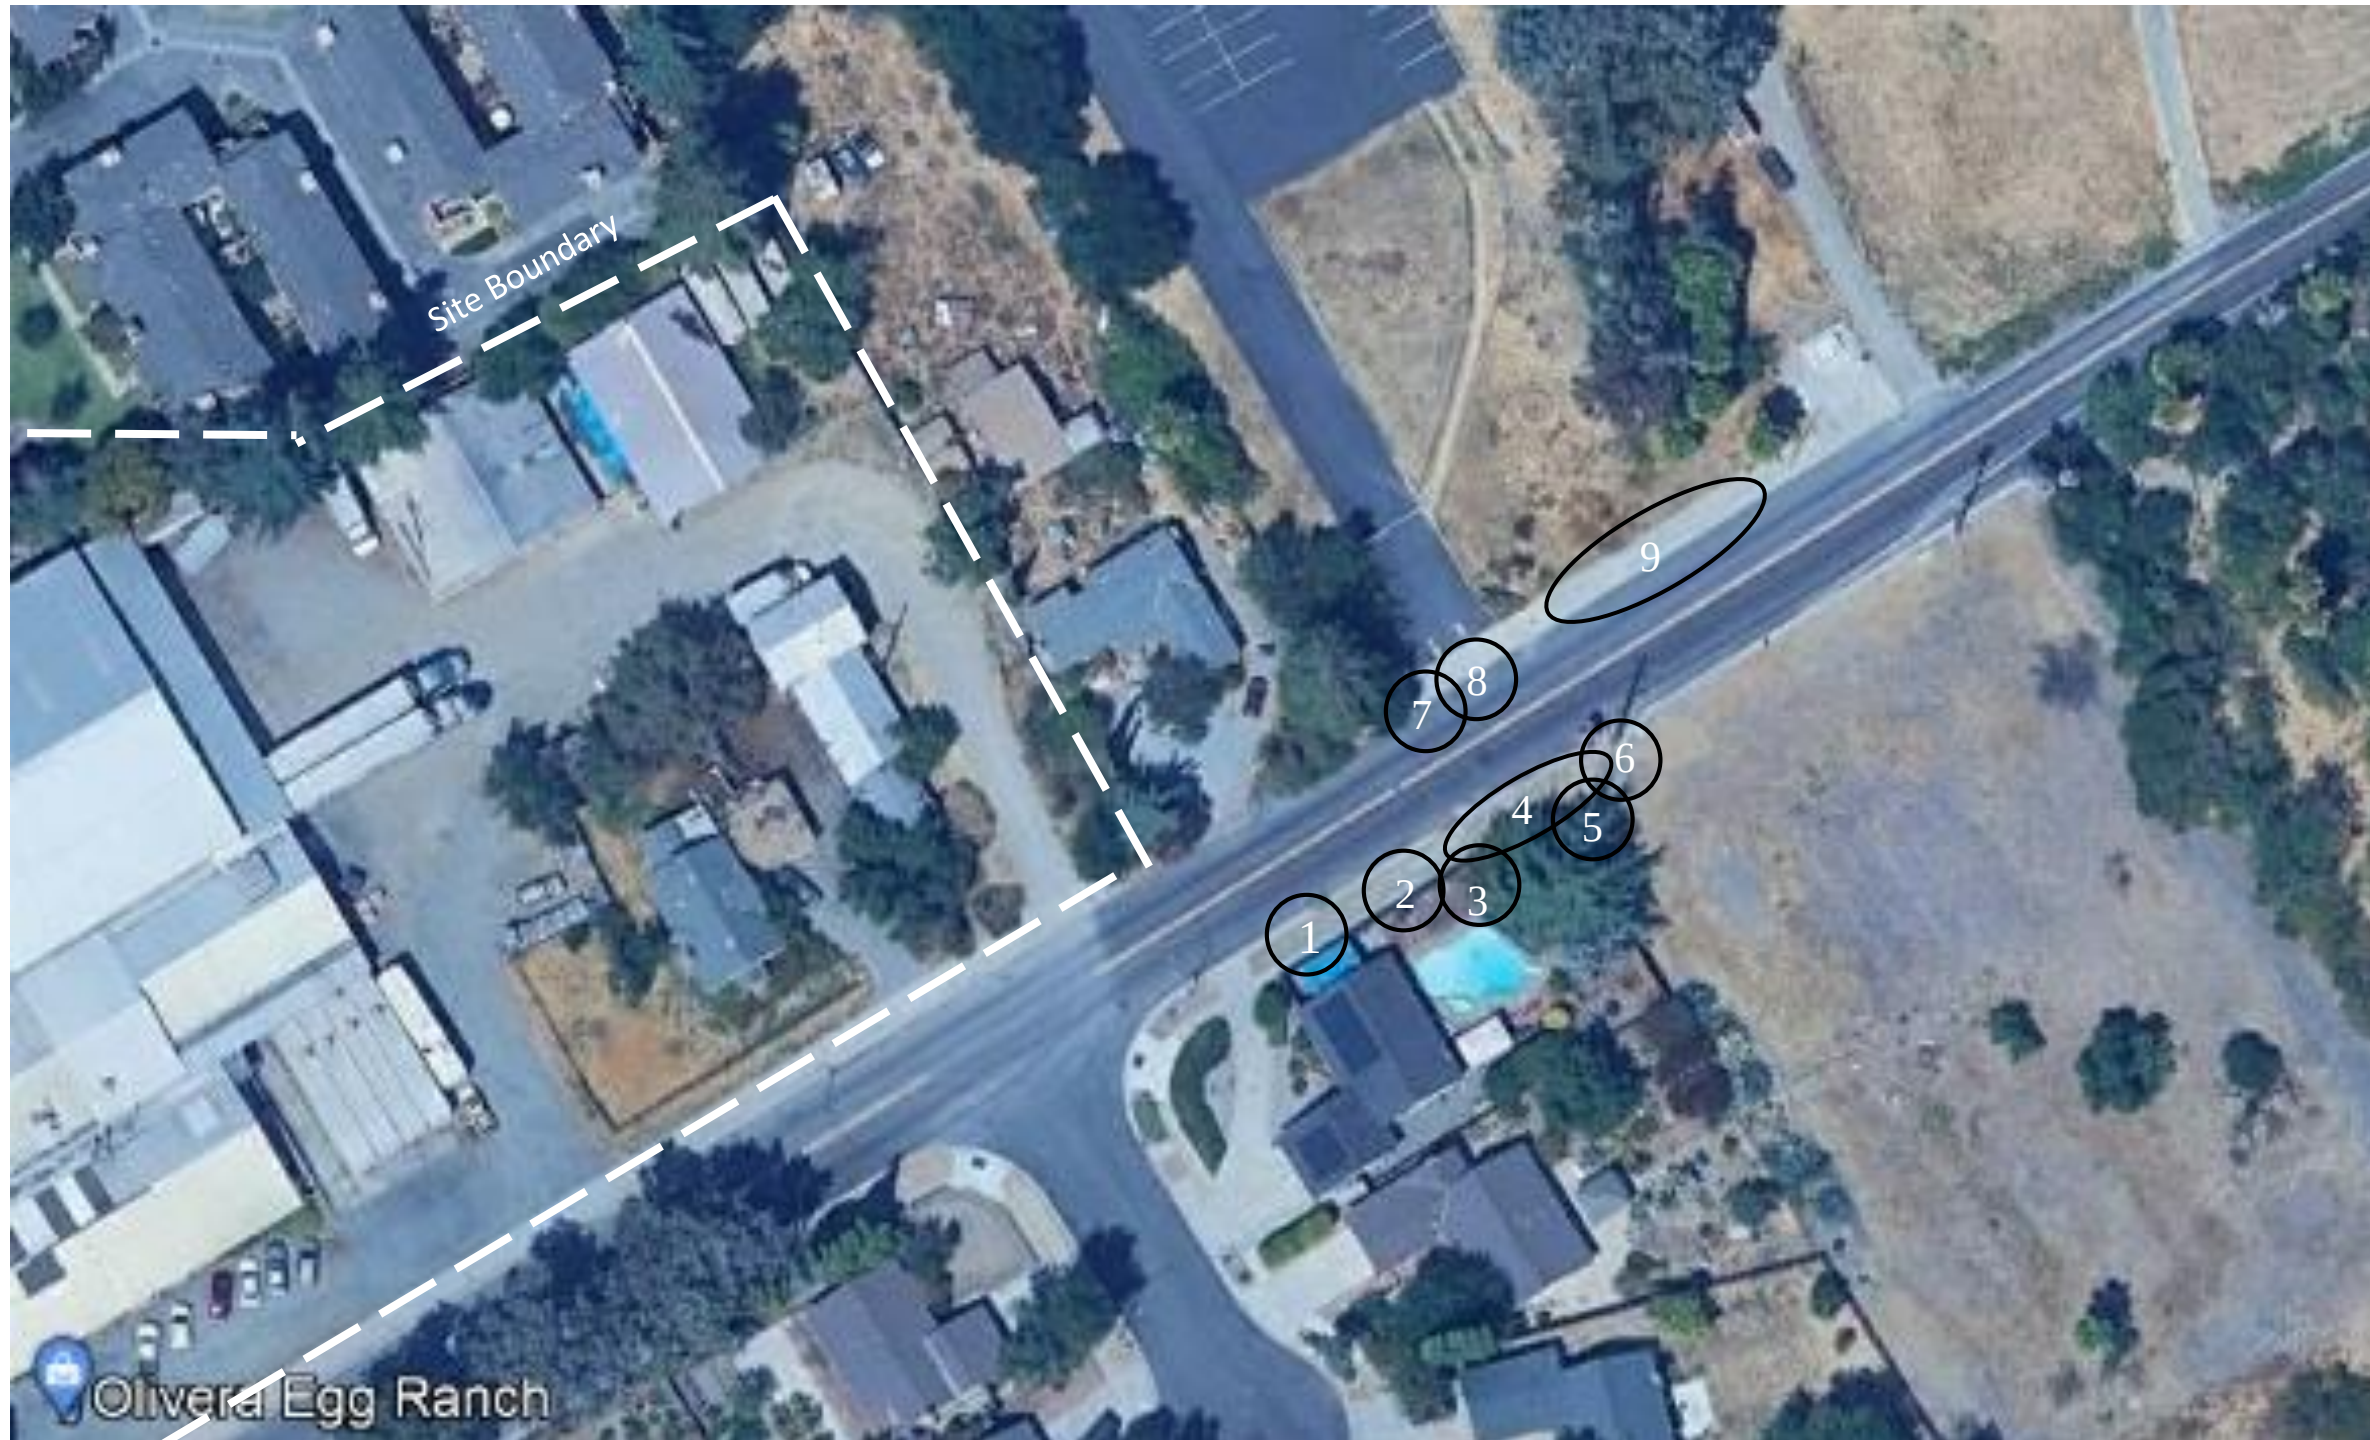
OBSERVED OFF-SITE SURFACE DISTRESS  
FEATURES  
3315 Sierra Road,  
San Jose, California

1. Cracked curb
2. Cracked and warped sidewalk
3. Tilted brick column
4. Multiple sidewalk cracks
5. Tilted brick column
6. Down-warped sidewalk
7. Buckled storm drain inlet
8. Distorted sidewalk slabs
9. Warped, depressed sidewalk
