LOS ANGELES RIVER PHASE IV BIKE PATH PROJECT

Park Tree Inventory Report

Prepared for
City of Los Angeles Department of Public Works
- Bureau of Engineering

February 2025

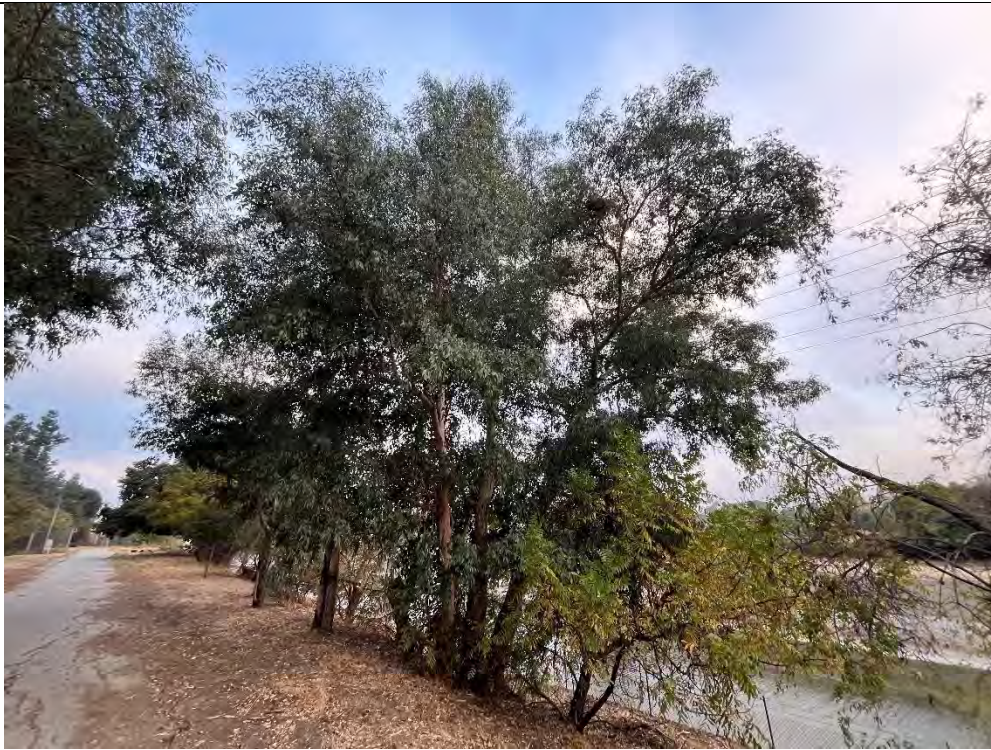
32	Pistache	<i>Pistacia chinensis</i>	3.0, 8.8	13	16	15	10	16	16	16	16	15	C	C	C	C	LA - RAP	Common	Encroached	
33	Blue Gum	<i>Eucalyptus globulus</i>	17.6, 18.1, 8.5, 5.1	45	20	18	16	18	22	26	26	30	C	C	C	C	LA - RAP	Common	Encroached	
34	Pistache	<i>Pistacia chinensis</i>	1.5, 1, 1, 1, 1	6	4	5	4	2	2	3	3	4	C	C	C	C	LA - RAP	Common	Not Impacted	
35	Mexican Elderberry	<i>Sambucus nigra</i>	9.4, 4.9, 7.8	9	6	8	8	6	2	8	6	6	D	D	D	D	LA - RAP	Ordinance	Encroached	Trunk decay. Topped.

Photo 33: View of Tree Number 33, facing northwest.

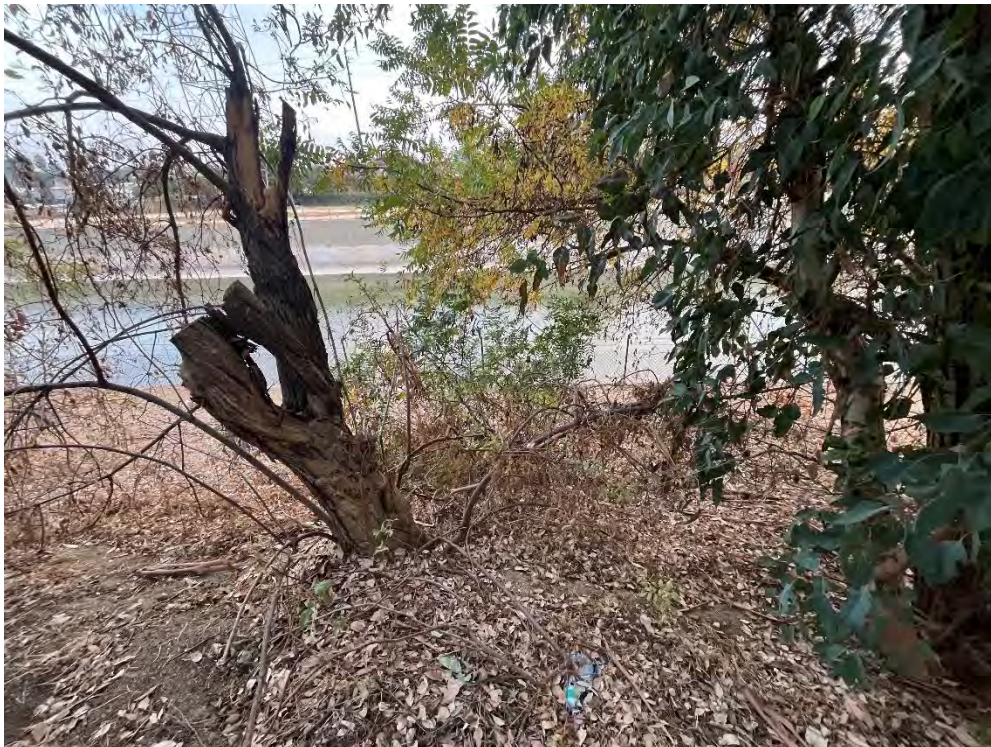
Photo 34: View of Tree Number 34, facing north.

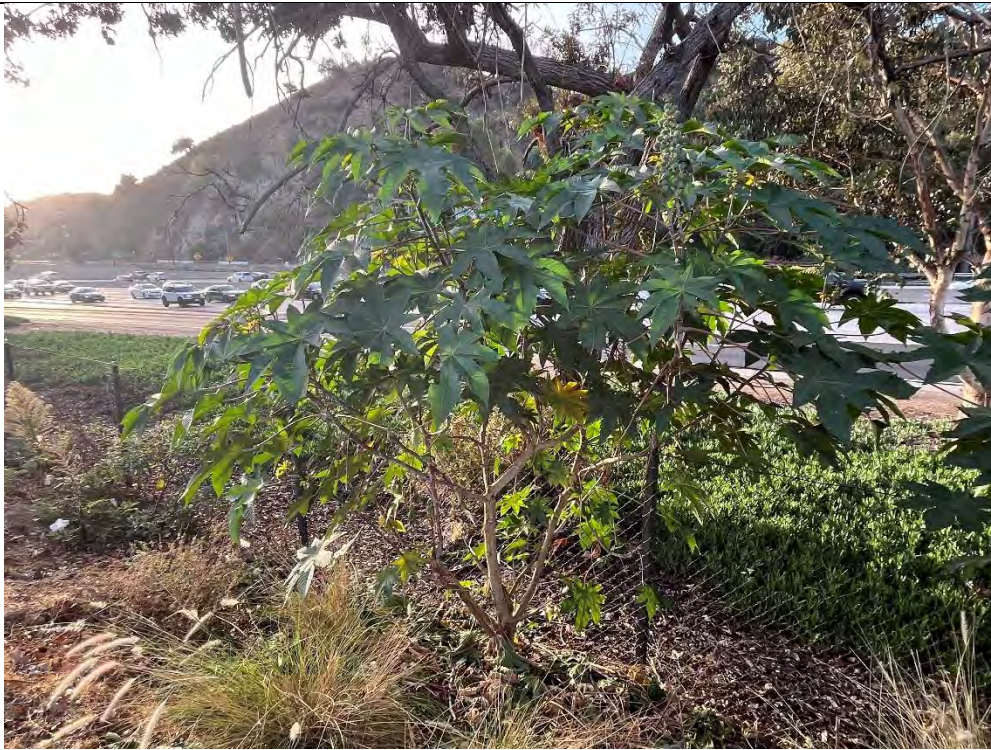
The majority of the assessment rating categories were rated Good to Fair. Four castor beans (Tree Nos. 125, 126, 127, and 129) were observed to be infested with invasive shothole borer (*Euwallacea* species). Castor beans are a known reproduction host for invasive shothole borer.

Photo 129: View of Tree Number 129, facing southeast.

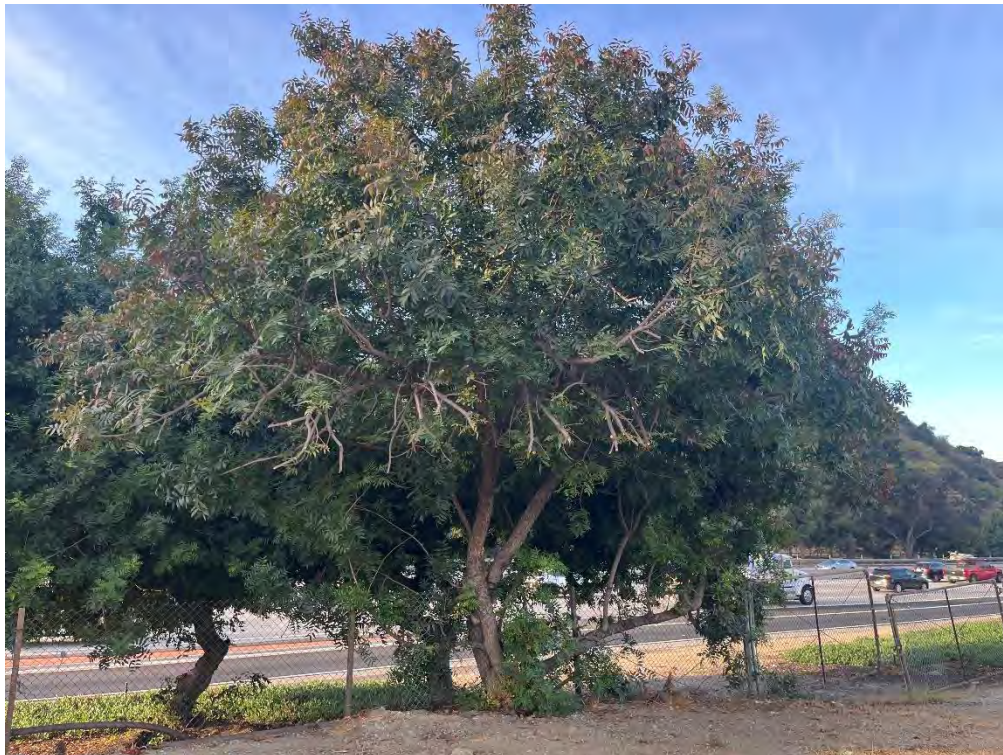
Photo 130: View of Tree Number 130, facing southwest.

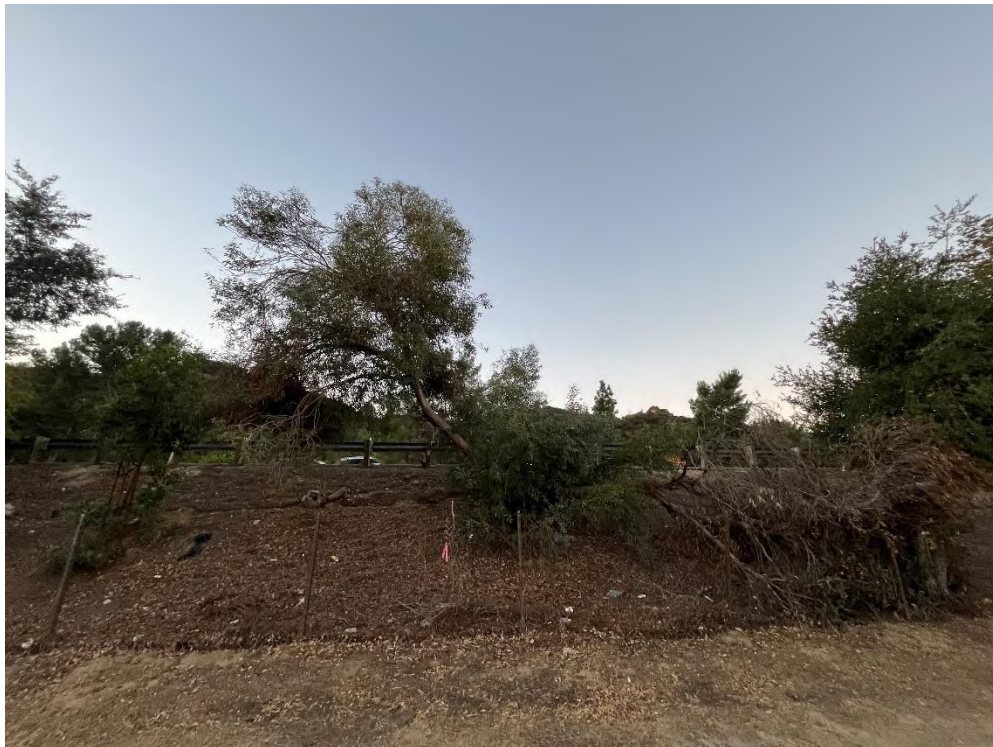
Photo 194: View of Tree Number 194, facing south.

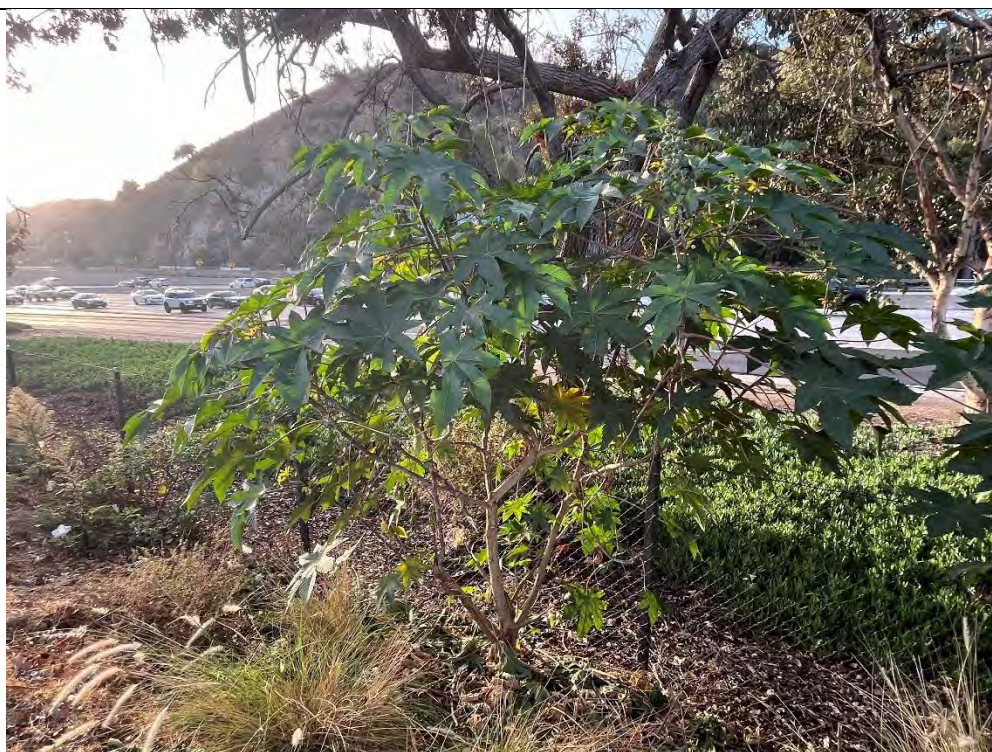
Photo 129: View of Tree Number 129, facing southeast.
