Pre-Demolition Hazardous Building Materials Survey
845 Santa Fe Drive
Encinitas, California
APN: 260-132-23-00

October 13, 2023 | Project No. 109721001

Subject: Pre-Demolition Hazardous Building Materials Survey
845 Santa Fe Drive
Encinitas, California 92024
San Diego County APN: 260-132-23-00

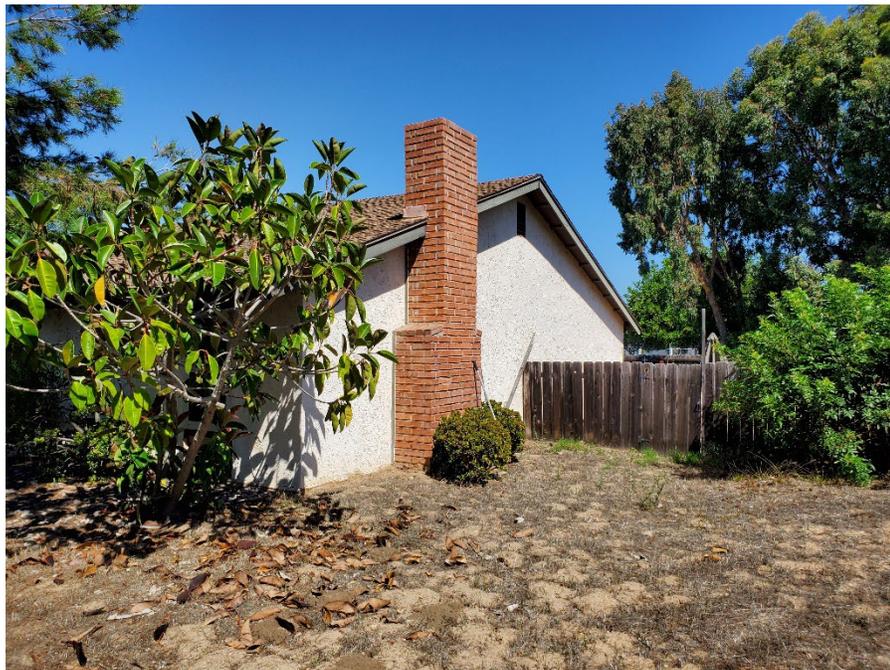
Photograph 2: View of the chimney at the Residence. Caulking at the brick-stucco joint was identified as ACM.

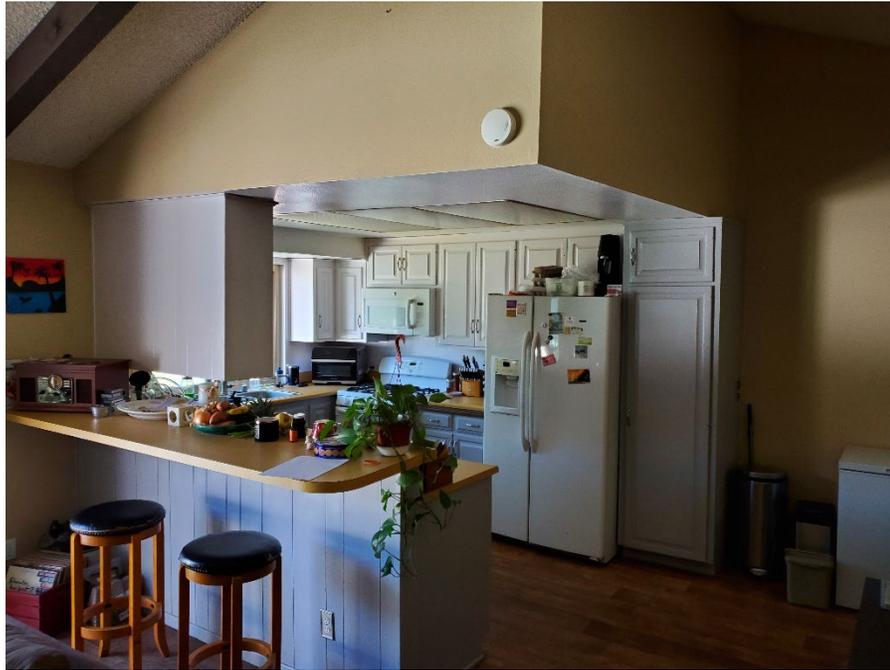
Photograph 3:

View of the Kitchen in the Residence. Typical spray-applied acoustic ceilings and drywall ceiling/walls are visible, which were identified as ACM and ACCM, respectively. The undercoating of the sink in the Kitchen was also identified as ACM.

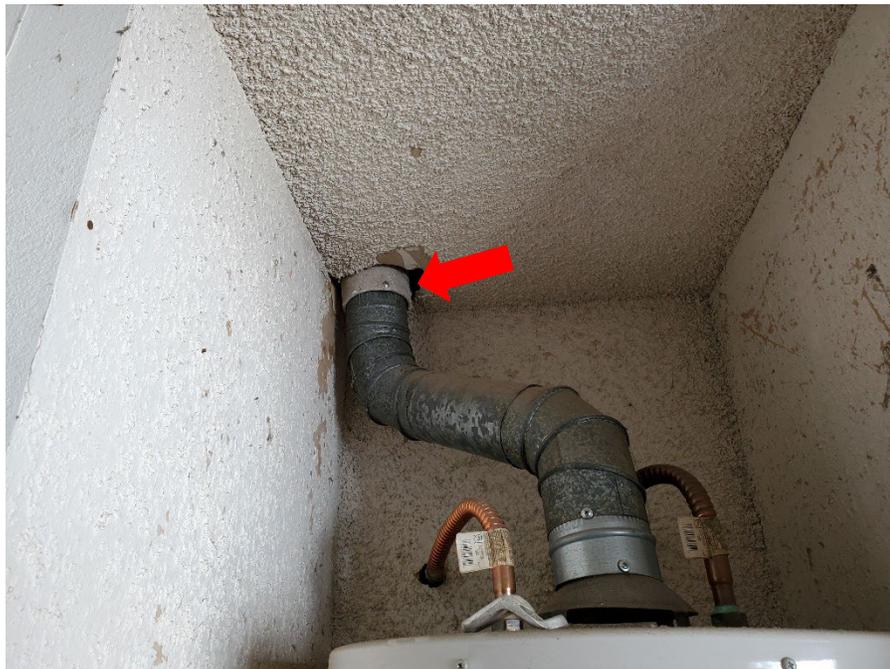
Photograph 4:

View of transite flue above water heater in the Garage of the Residence, which is assumed to be ACM (see marker).

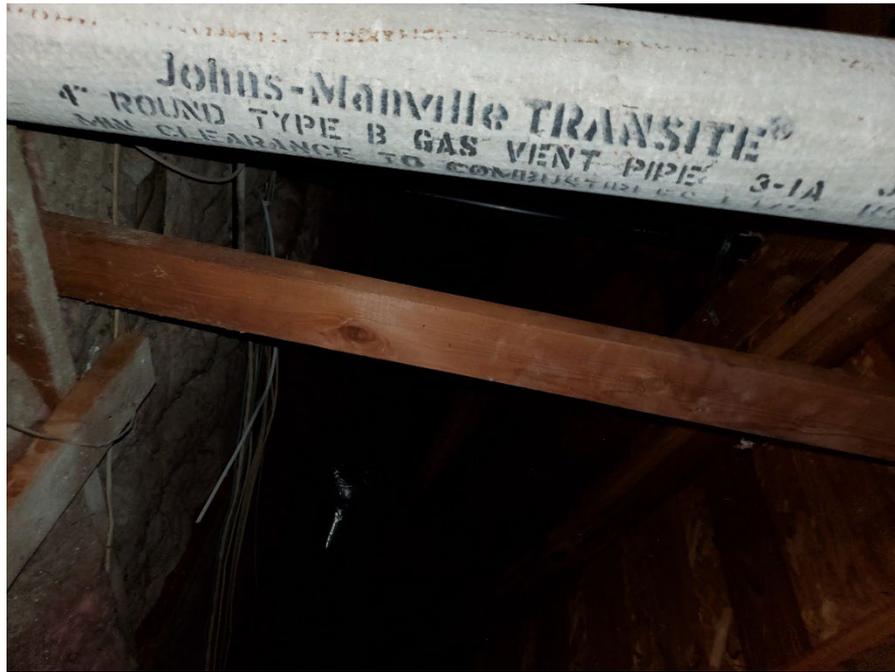
Photograph 5: View of transite flue from within the attic above the Garage of the Residence (photo rotated 90° clockwise).

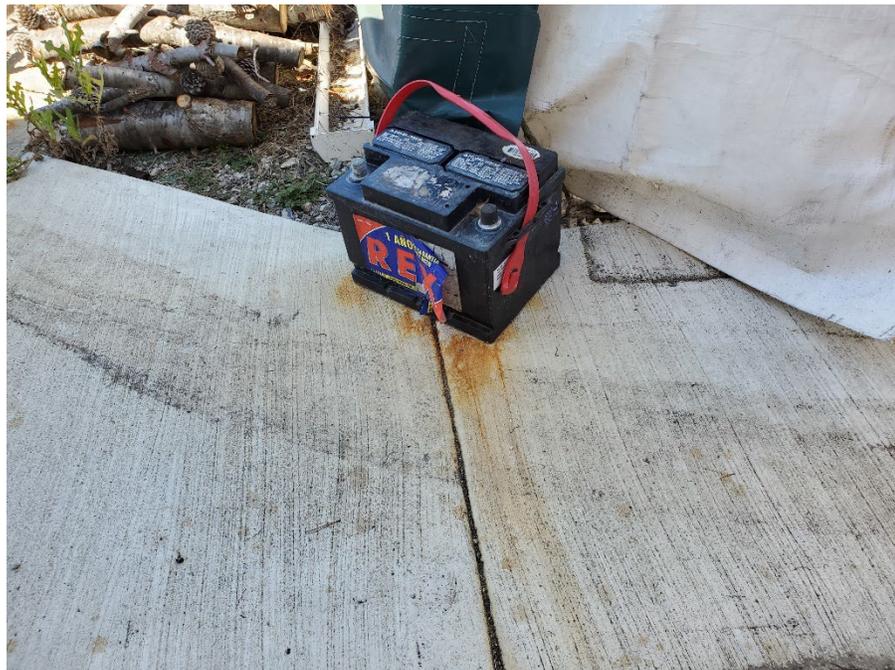
Photograph 6: View of lead-acid car battery located near the work canopy west of the Garage of the Residence. Vehicle maintenance equipment and fluids (e.g., fuels, oils) were also observed.

Prior to renovation and/or demolition activities that could potentially disturb these materials, building materials falling under the UWR and other potential hazardous building materials should be removed and properly recycled or disposed of by a licensed contractor in accordance with federal, state, and local regulations. **It is the contractor's responsibility to confirm miscellaneous hazardous building materials quantities and locations present prior to bid submittals and initiating renovation and/or demolition activities at the subject site.** The Contractor is also responsible for waste characterization for all materials removed from the site.

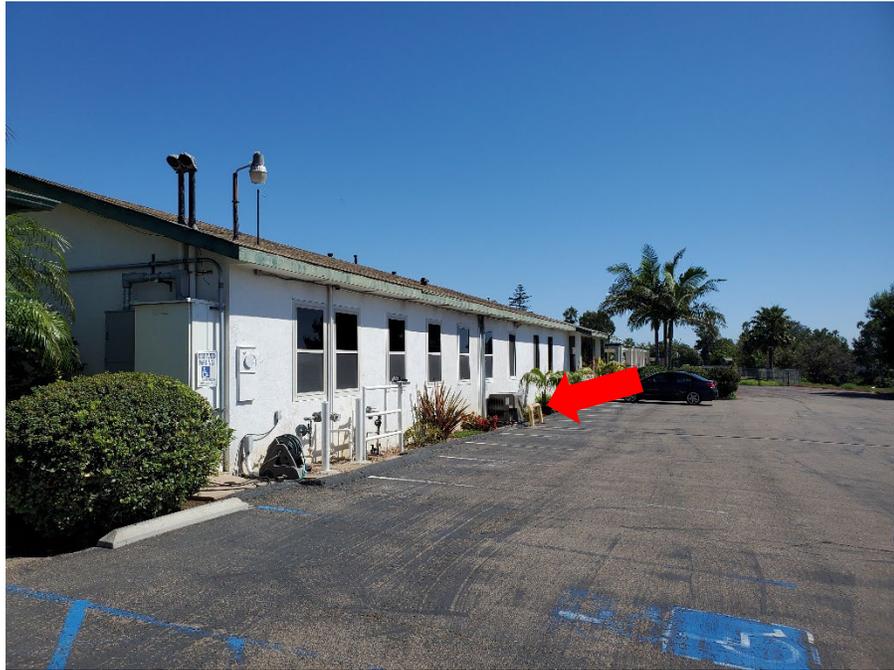
Photograph 9: View of bollard (see marker) located on the west side of the Office Building, near the AC unit of the Office Building, that was identified as LCS.

The identified LCS should not be disturbed by unauthorized personnel. Prior to building demolition activities, a licensed abatement contractor should remove the LCS in accordance with federal, state, and local regulations. **It is the contractor’s responsibility to confirm LCS locations and quantities prior to bid submittals and prior to initiating demolition activities at the subject site.** In addition, please note that LCS condition was based upon Ninyo & Moore’s visual

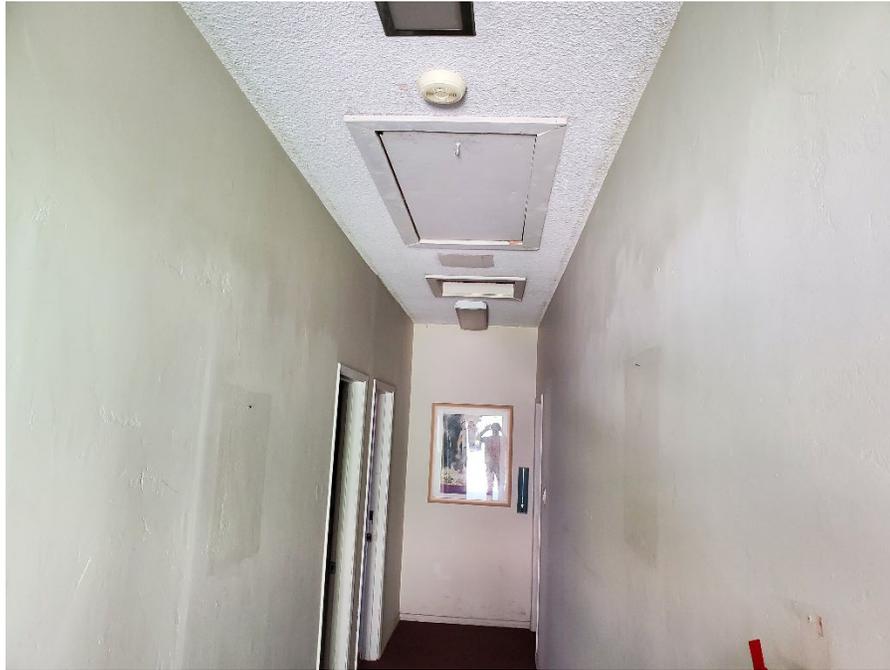
Photograph 11: View of North Hall of Office Building. The spray-applied ceiling and vinyl tile beneath carpeting from this area north were identified as ACM. The plaster walls were identified as ACCM.

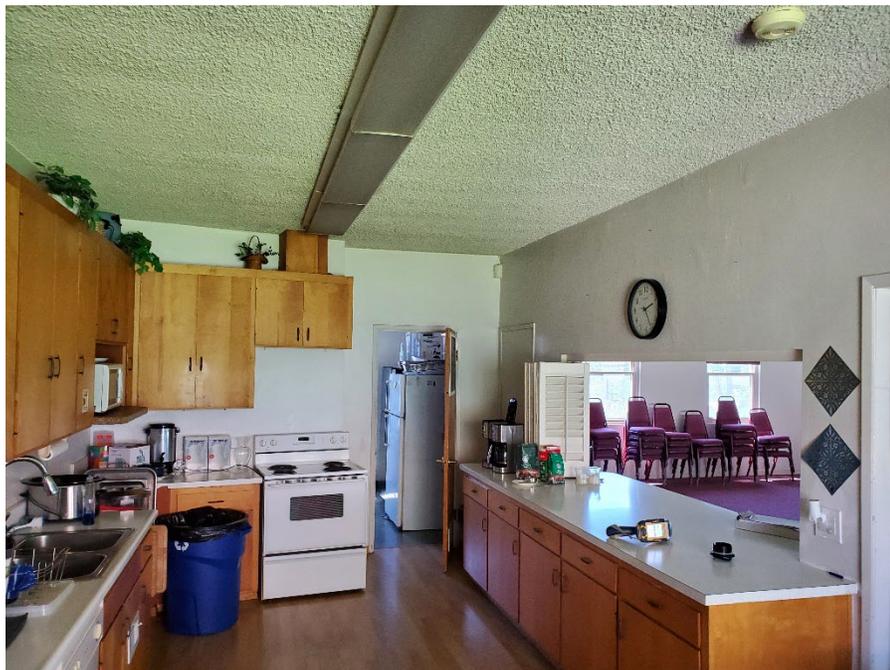
Photograph 12: View of the Kitchen of the Office Building. The sink undercoating was not sampled, but is assumed to be ACM.

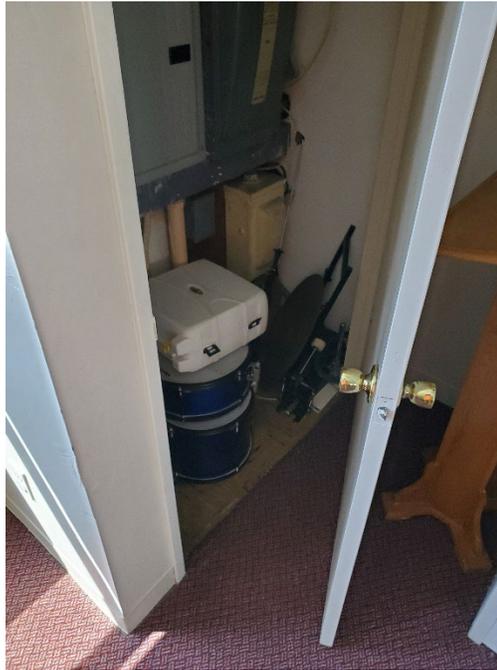
Photograph 15: View of exposed vinyl floor tile identified as ACM in the Communication Closet of the Community Hall. Tile extends beneath the carpet.

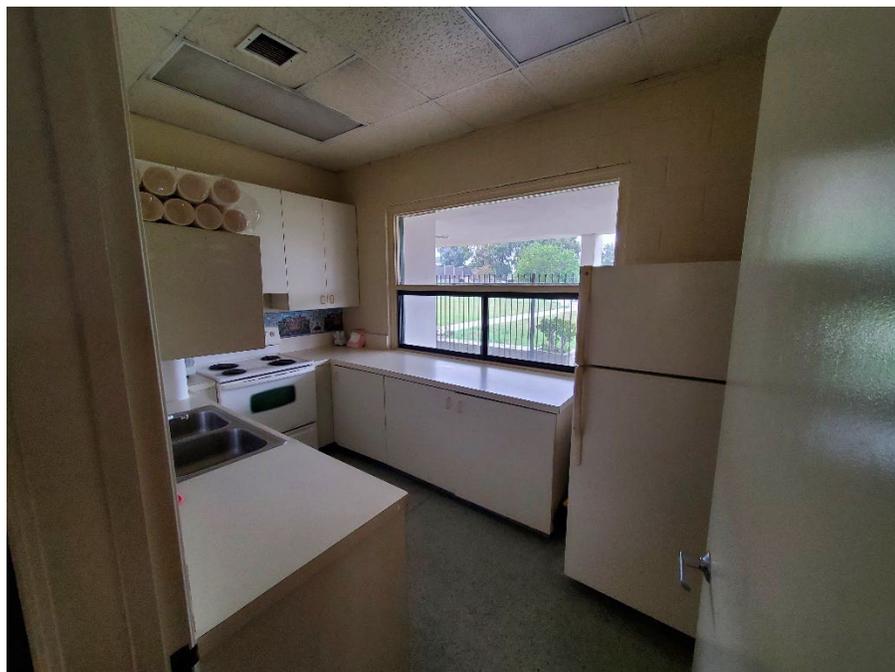
Photograph 18: View of the Kitchen in the Preschool Building. The undercoating of the sink visible on the left of the photo was identified as ACM.

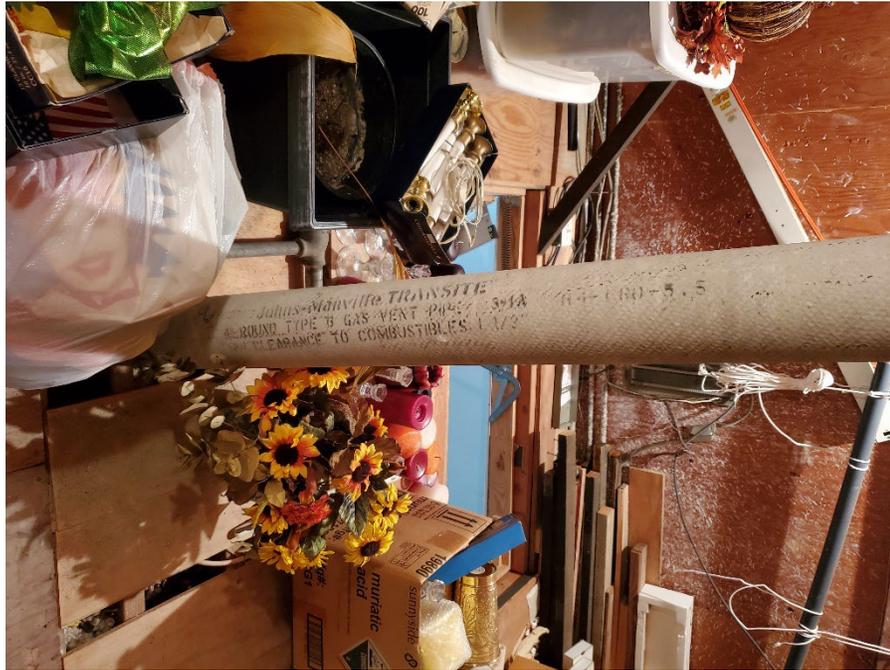
Photograph 21: View of transite flue in the attic above the Hall of the Church Building. Photos within the Church were limited due to time constraints (photo rotated 90° clockwise).

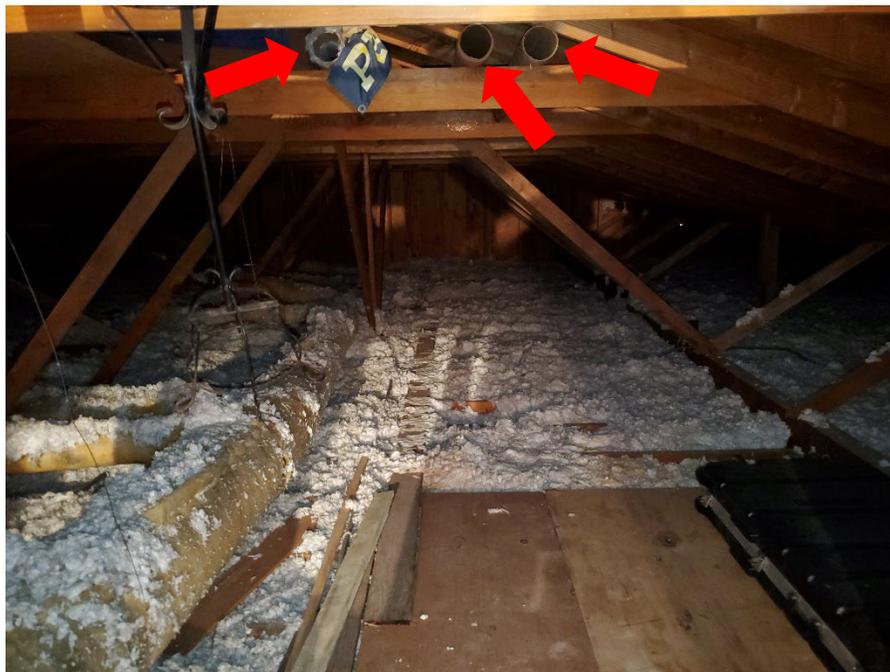
Photograph 22: View of potential additional transite flues (see markers) in the Church Building attic.
