Arborist Report
28th Street and Q Street
Rio Linda, Sacramento County

Report Date: July 2022

This Arborist Report documents the findings of an arborist survey conducted for the 28th Street and Q Street (Project) located within unincorporated Sacramento County, California (**Exhibits 1 and 2**). The survey was performed on June 2, 2022, by Bargas Environmental Consulting LLC (Bargas) Biologist and International Society of Arboriculture (ISA) Certified Arborist Krystal Pulsipher (WE-12181A). The purpose of the arborist survey was to identify species, location, and current condition of trees within the project area that may be subject to regulation and protection, and to provide tree care recommendations, if warranted. Additionally, trees located within the anticipated impact area (area of ground disturbance) are identified.

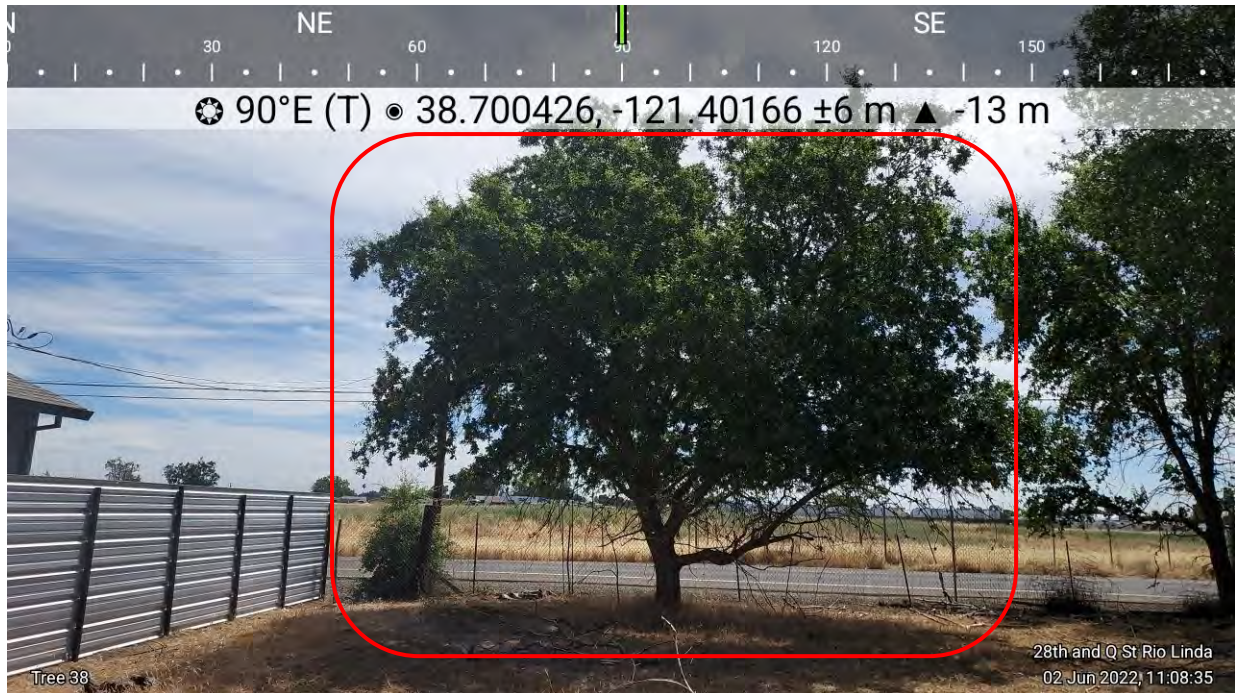
Tree #	Scientific Name	Common Name	DBH (inches)	Height (feet)	Protected Zone Radius (feet)	Condition	Comments	Recommendations
38	<i>Quercus lobata</i>	Valley Oak	16	30	20	Fair - Good	Tree health is good. Tree structure is poor. Rot at location of included bark of major limb crotch, bark damage on trunk (possibly from livestock), some dead branches low on tree, rot present in one limb.	Monitor tree condition in future to assess if major limbs should be pruned due to rot, or if tree removal may be necessary. Prune deadwood for health. Protect and preserve.
39	<i>Quercus lobata</i>	Valley Oak	8	30	10	Good	Tree health and structure are good. Some dead branches low on tree.	Prune deadwood for health. Protect and preserve.
40	<i>Quercus lobata</i>	Valley Oak	7.5	30	12	Fair - Good	Tree health is good. Tree structure is fair. Some dead branches low on tree.	Prune deadwood for health. Protect and preserve.

Photo 1. Tree #38, Valley Oak; dbh = 16 inches; condition = Fair-Good.

Tree #38, a Valley Oak, has some evidence of rot present in major limbs. It is recommended that the tree condition be monitored periodically by an arborist in the future to assess if major limbs should be pruned due to rot, or if complete tree removal may become necessary.

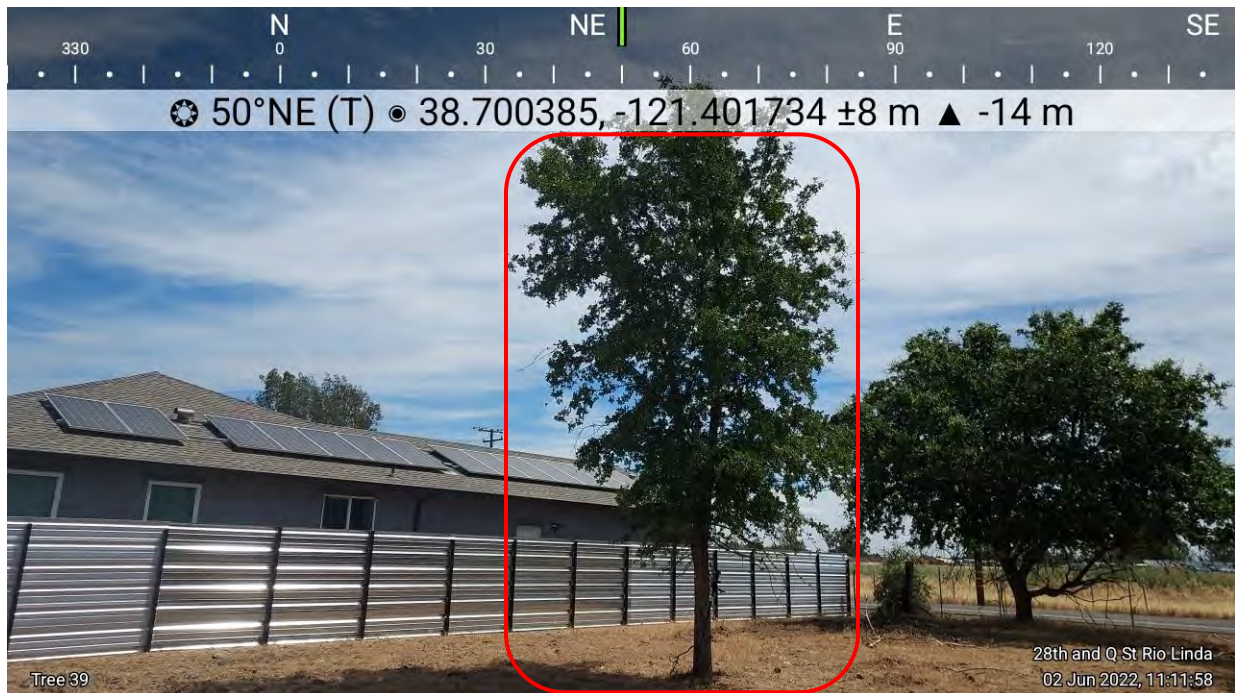
Photo 2. Tree #39, Valley Oak; dbh = 8 inches; condition = Good.

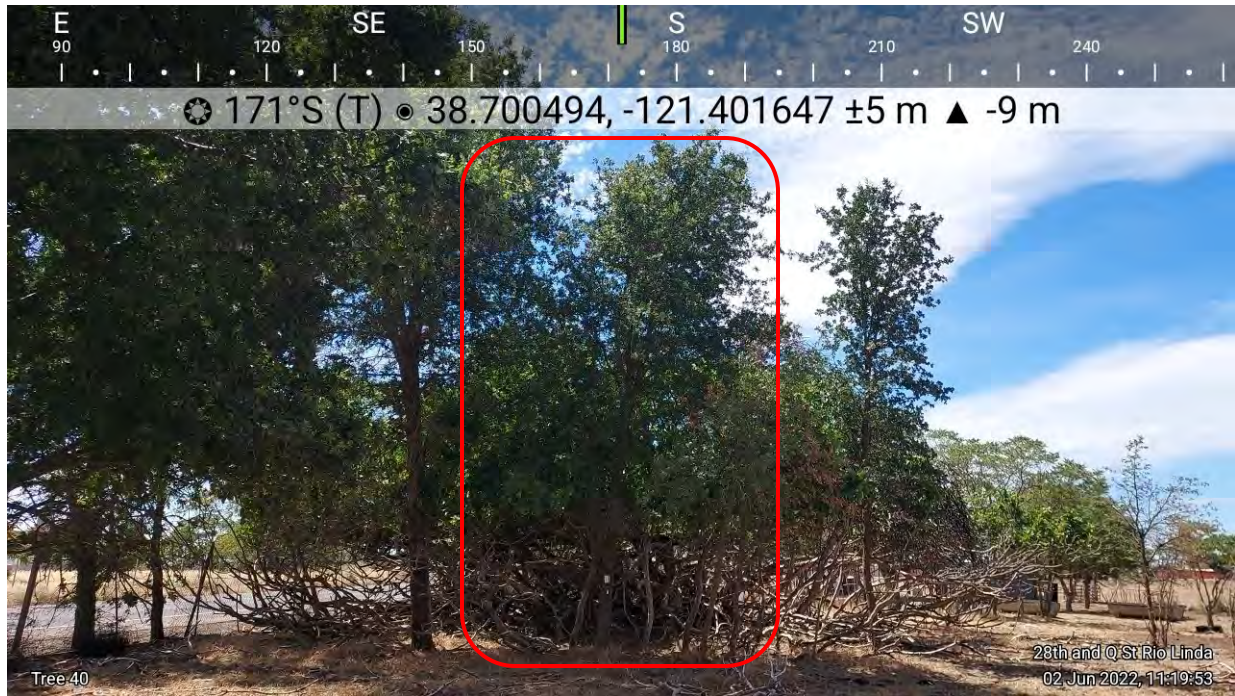
Photo 3. Tree #40, Valley Oak; dbh = 7.5 inches; condition = Fair-Good.

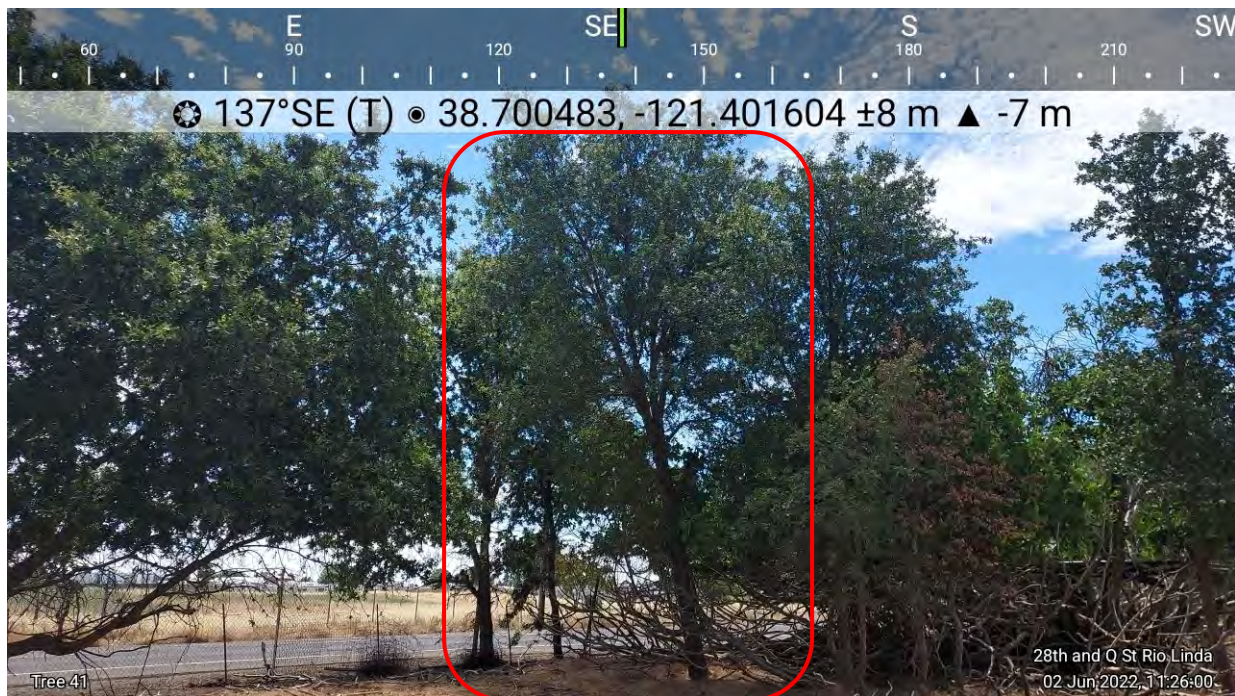
41	<i>Quercus lobata</i>	Valley Oak	11	37	15	Fair	Tree health and structure are fair. Rot at knots on trunk, many dead branches and lack of foliage on lower half of crown, slight lean, included bark on upper limb crotch.	Prune deadwood for health. Protect and preserve.
42	<i>Quercus lobata</i>	Valley Oak	11	30	15	Fair	Tree health and structure are fair. Embedded barbed wire fence, many dead branches and lack of foliage in lower half of crown, included bark at primary crotch.	Prune deadwood for health. Protect and preserve.
43	<i>Quercus lobata</i>	Valley Oak	5	30	6	Fair	Tree health is good. Tree structure is poor. Bark is coming off thick on trunk, possible insect boring (holes in bark, does not appear like sapsucker damage).	Protect and preserve.
44	<i>Quercus lobata</i>	Valley Oak	7	29	10	Fair - Good	Tree health and structure are fair. Some dead branches low on tree and lack of foliage in lower half of crown.	Prune deadwood for health. Protect and preserve.

Photo 4. Tree #41, Valley Oak; dbh = 11 inches; condition = Fair.

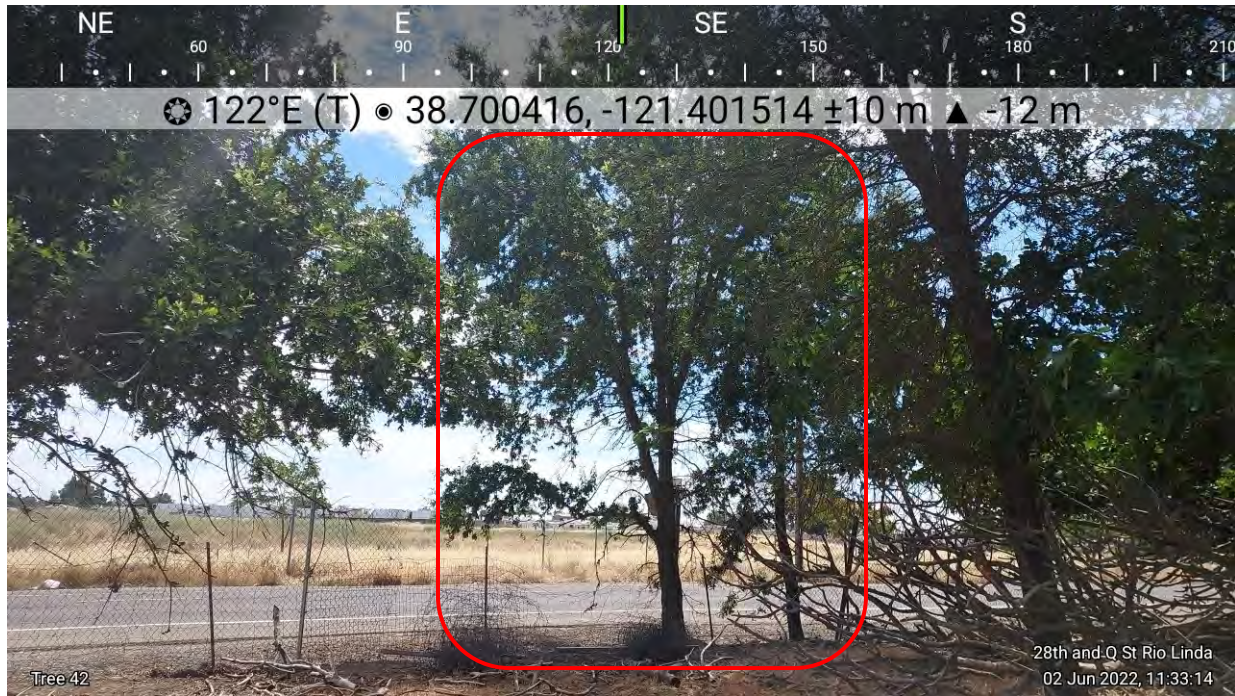
Photo 5. Tree # 42, Valley Oak; dbh = 11 inches; condition = Fair.

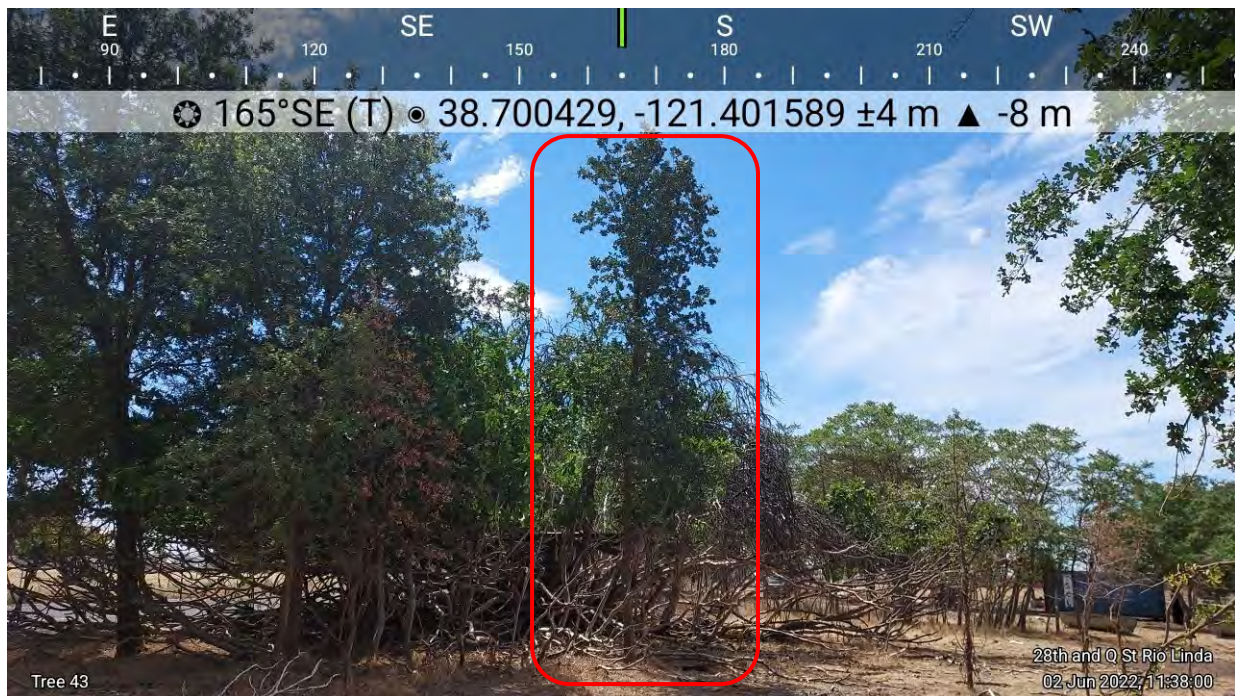
Photo 6. Tree #43, Valley Oak; dbh = 5 inches; condition = Fair.

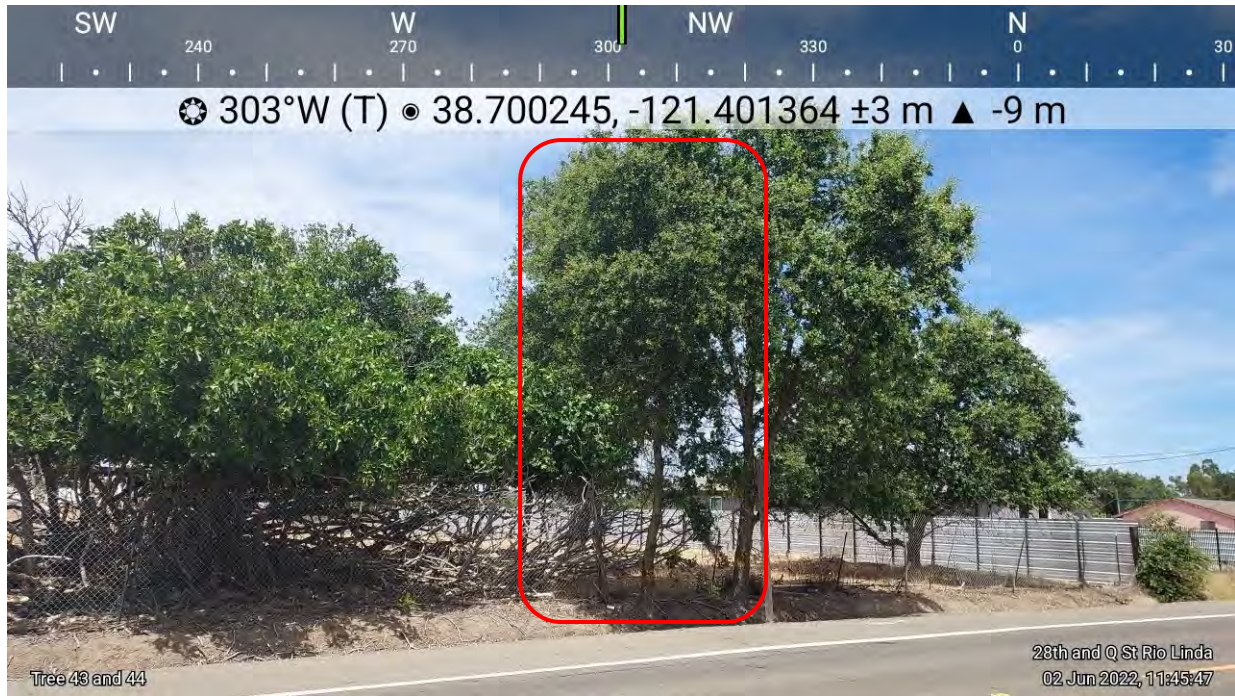
Photo 7. Tree #44, Valley Oak; dbh = 7 inches; condition = Fair-Good.

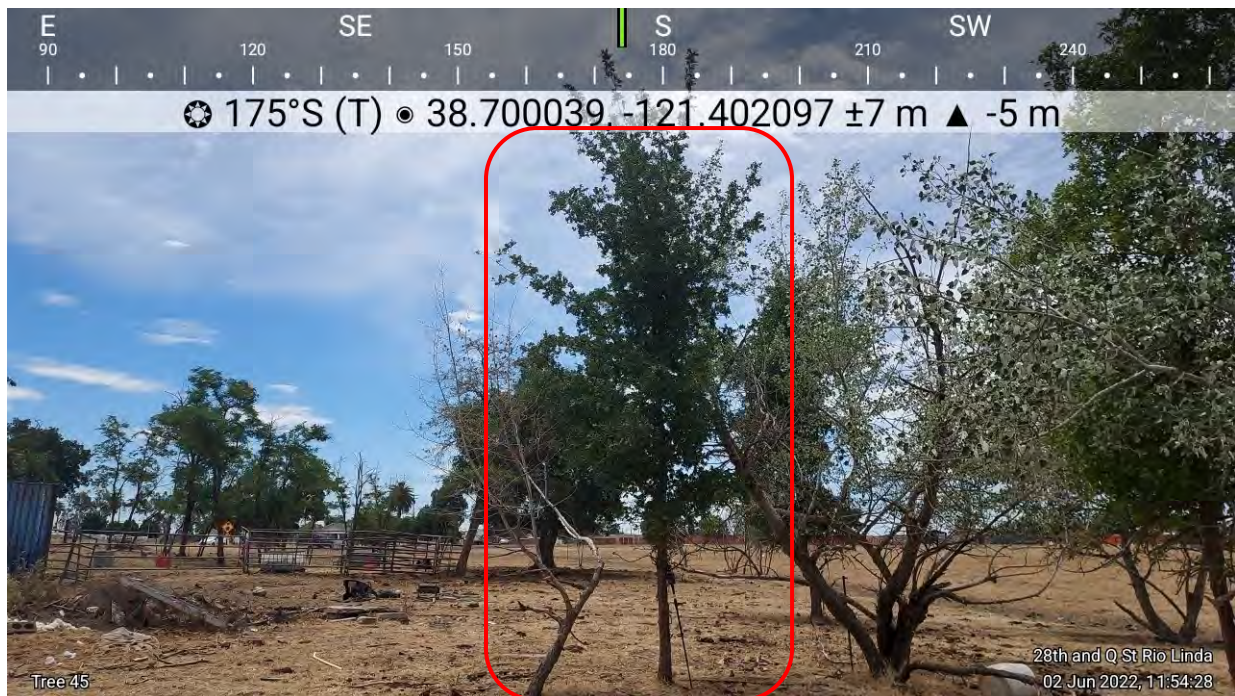
45	<i>Quercus lobata</i>	Valley Oak	4.5	20	8	Fair - Good	Tree health is good. Tree structure is fair. Some missing bark and bark damage (possibly from livestock), some dead branches low on tree.	Prune deadwood for health. Protect and preserve.
46	<i>Quercus lobata</i>	Valley Oak	7.5	22	7	Good	Tree health is good. Tree structure is fair. Some dead branches low on tree.	Prune deadwood for health. Protect and preserve.
47	<i>Quercus wislizeni</i>	Interior Live Oak	13	25	20	Good	Tree health is good. Tree structure is fair. Some dead branches low on tree, embedded wire fence in trunk.	Prune deadwood for health. Protect and preserve.
48	<i>Quercus lobata</i>	Valley Oak	19.5	50	30	Good	Tree health is good. Tree structure is fair. Some embedded wire fence at base of trunk, rot in a few small dead branches.	Prune deadwood for health. Protect and preserve.
49	<i>Quercus lobata</i>	Valley Oak	11	15	5	Good	Two leaders (6.5, 4.5 inches dbh), bark damage (possibly from livestock), some dead branches low on tree.	Prune deadwood for health. Protect and preserve.

Photo 8. Tree # 45, Valley Oak; dbh = 4.5 inches; condition = Fair-Good.

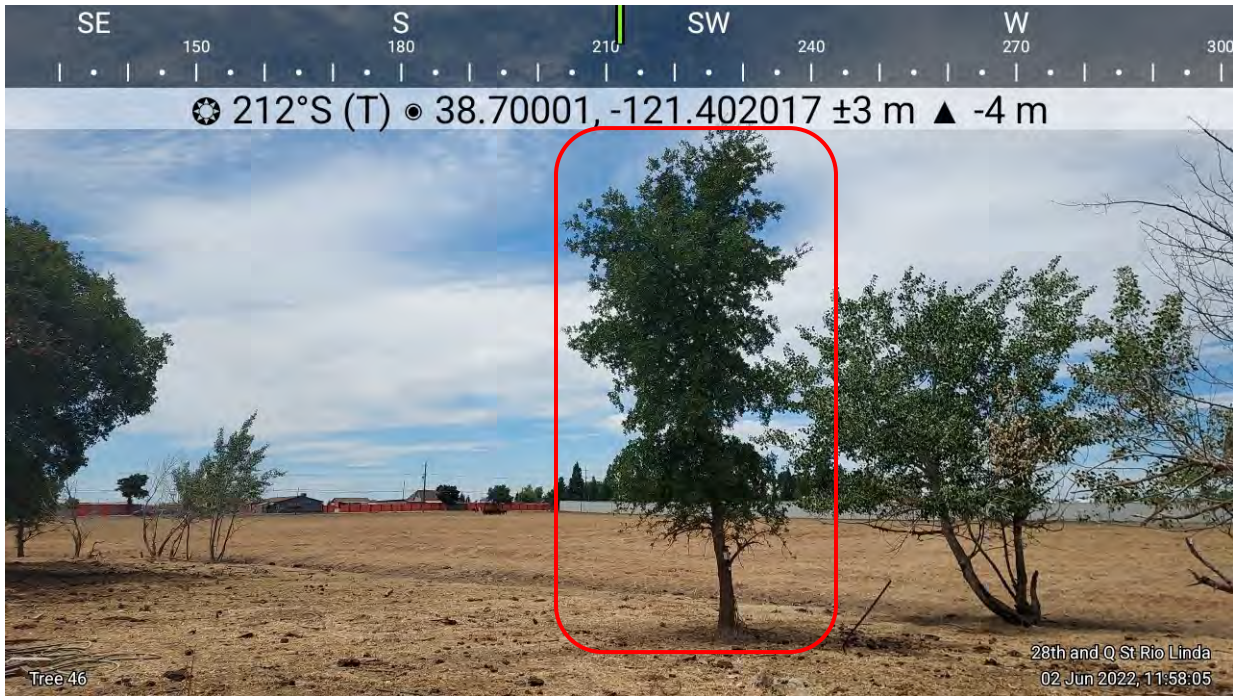
Photo 9. Tree #46, Valley Oak; dbh = 7.5 inches; condition = Good.

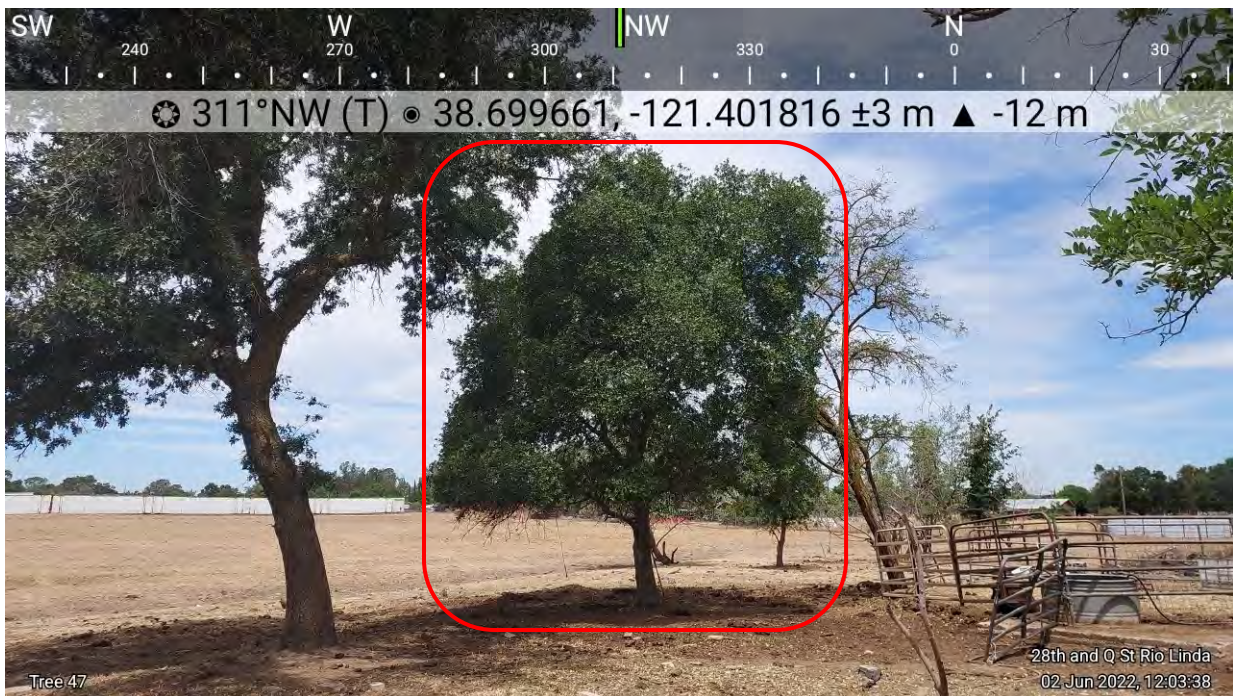
Photo 10. Tree # 47, Interior Live Oak; dbh = 13 inches; condition = Good.

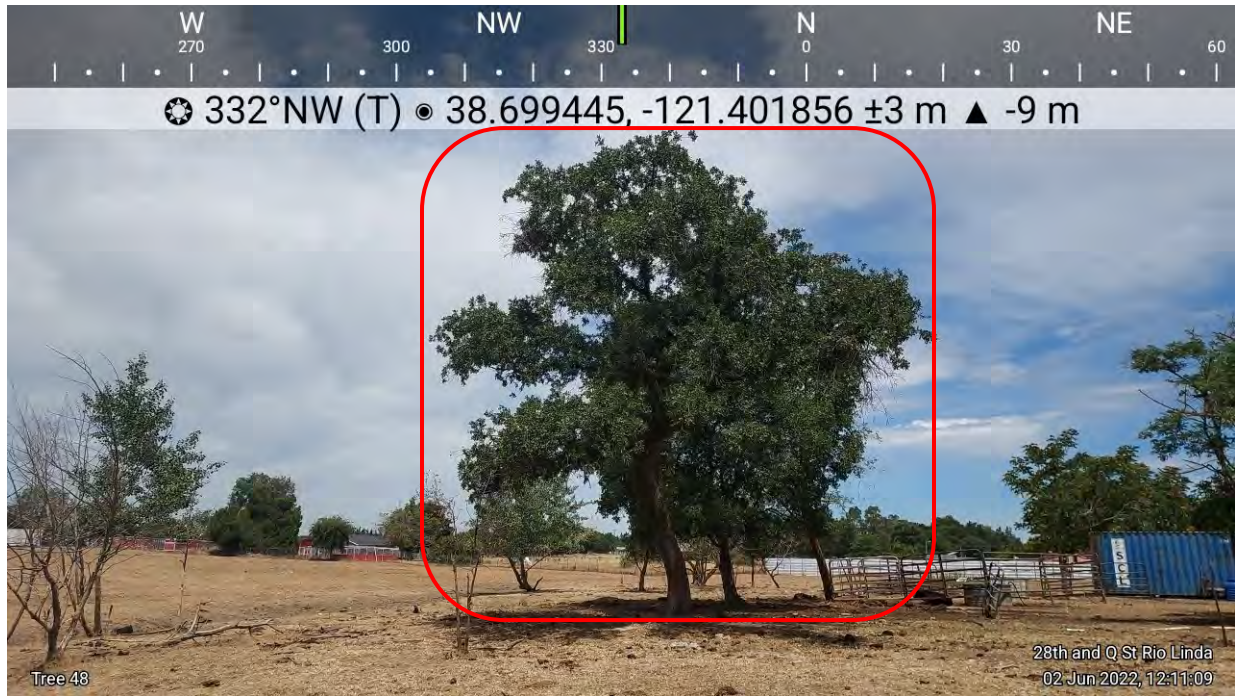
Photo 11. Tree #48, Valley Oak; dbh = 19.5 inches; condition = Good.

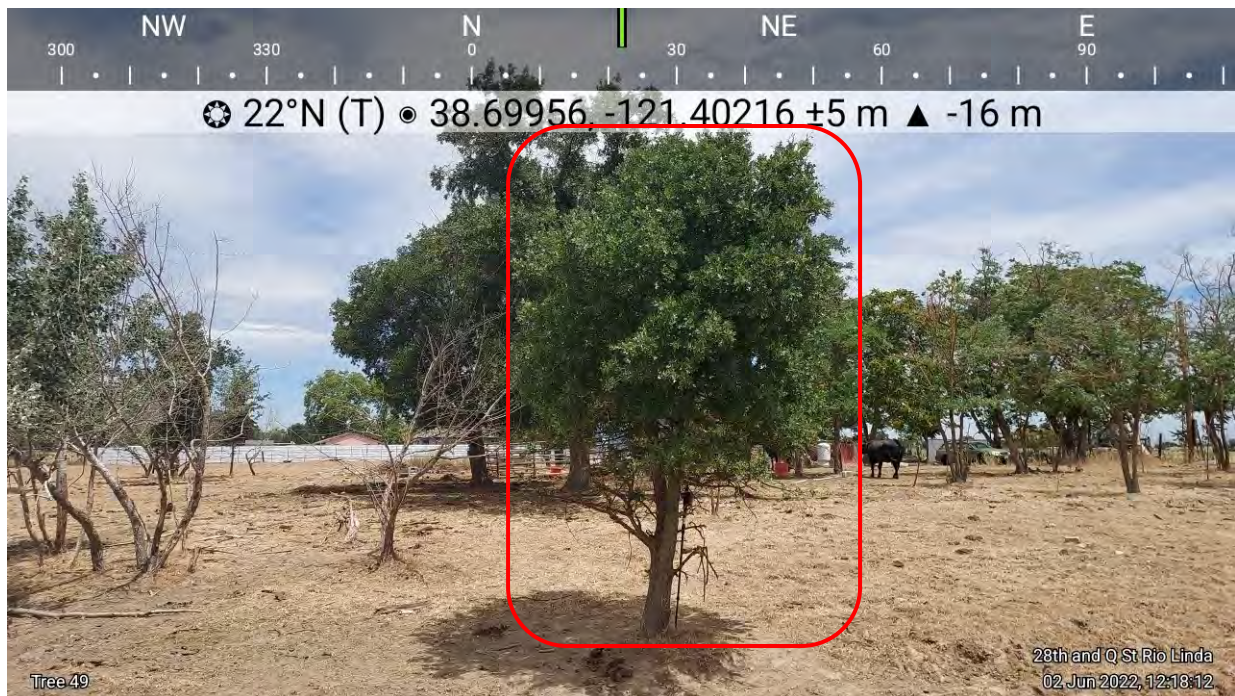
Photo 12. Tree #49, Valley Oak; dbh = 11 inches; condition = Good.

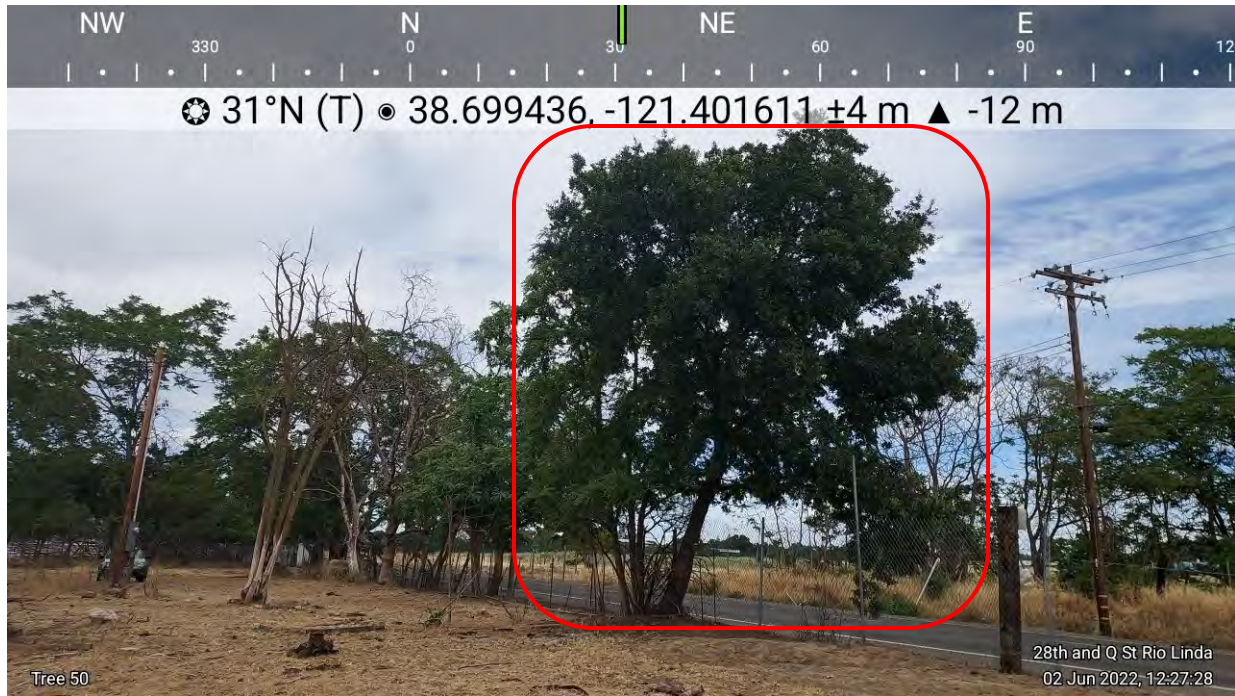
50	<i>Quercus lobata</i>	Valley Oak	16	35	20	Good	Tree health is good. Tree structure is fair. Embedded barbed wire fence, slight lean.	Protect and preserve.
51	<i>Quercus douglasii</i>	Blue Oak	14	25	15	Good	Tree health is good. Tree structure is fair. Included bark at primary crotch, some dead branches.	Prune deadwood for health. Protect and preserve.

Photo 13. Tree # 50, Valley Oak; dbh = 16 inches; condition = Good.

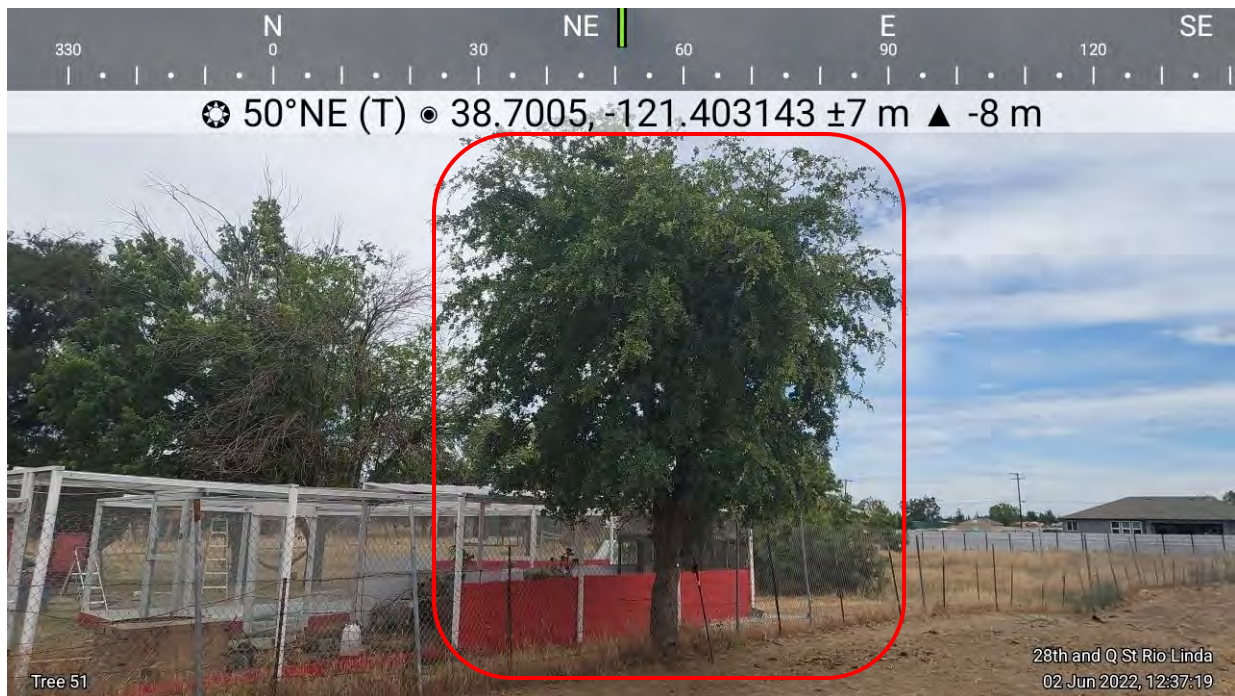
Photo 14. Tree # 51, Blue Oak; dbh = 14 inches; condition = Good.
