September 6, 2024

Subject: Tree Survey Report for the Lynwood City Park Stormwater Capture Project in the City of Lynwood, California

Tree Inventory - Lynwood City Park Stormwater Capture Project

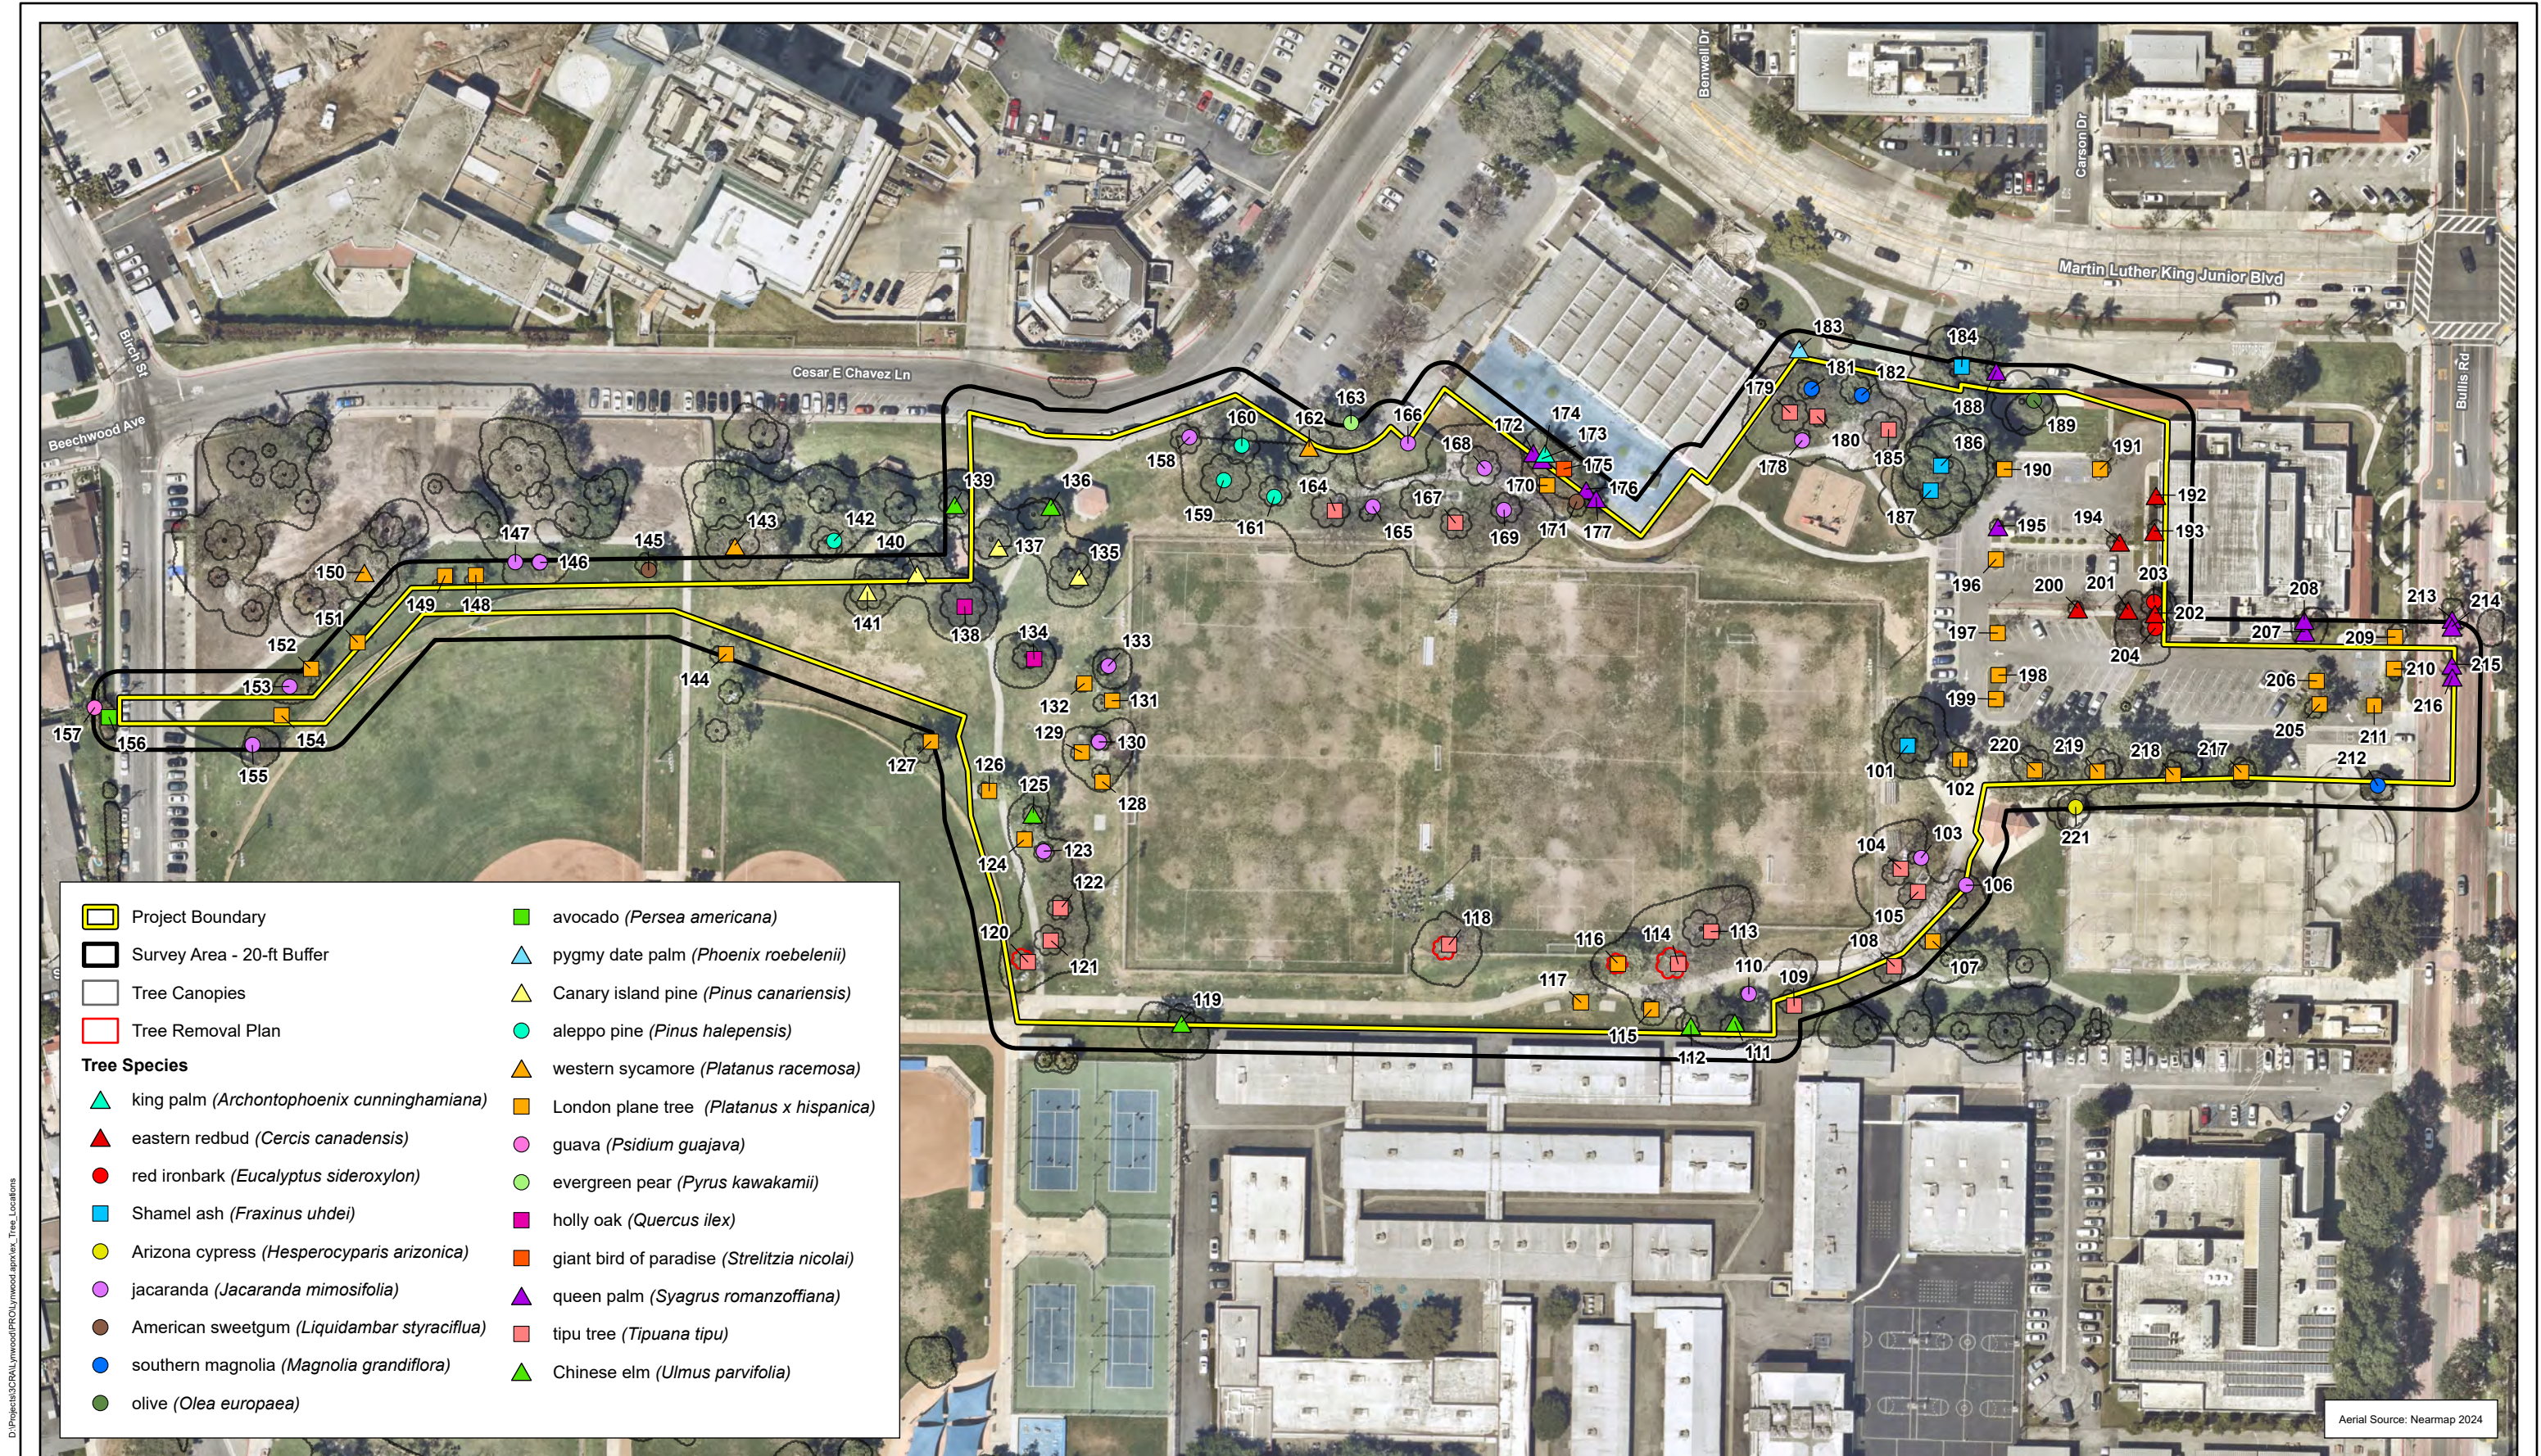
Exhibit 2

A summary of trees included in the survey and their regulated status is provided in Table 1. Locations are shown on Exhibit 2.

Construction activities are expected to require the removal of five trees, consisting of three tipu trees and two London plane trees. These trees are mature individuals that are poor candidates for relocation due to their size, except for one of the London plane trees which is a sapling, likely planted within the last several years. Though this tree is smaller, it exhibits significant canopy dieback and anthracnose which also makes it a poor candidate for relocation and it is better replaced by appropriately sized nursery stock. A summary of trees to be removed for Project implementation is provided in Table 2.
