# Tree Survey and Arborist Report

*for an approximate 8.3-acre Site*

*Located at 333 Garrison St. Oceanside, CA, within the County of San Diego*

*Report Date: March 27, 2024*

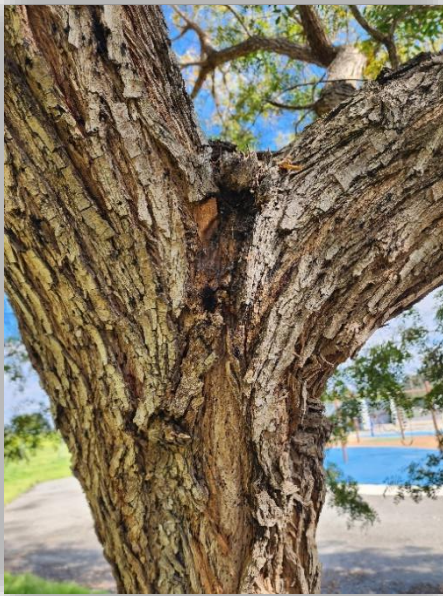
Plate 3. This is a view of a crotch with indication of decay (#599).

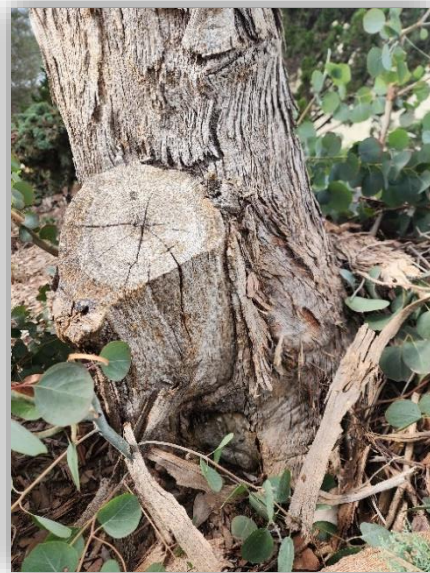
Plate 4. This is a view of a large canker at a former branch cut (#559).

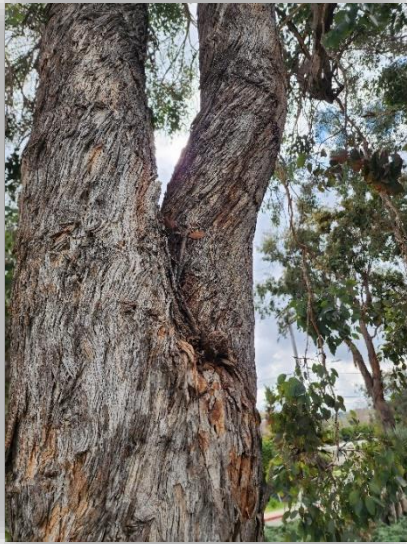
Plate 5. This is a view of a codominant stem with included bark (#559).

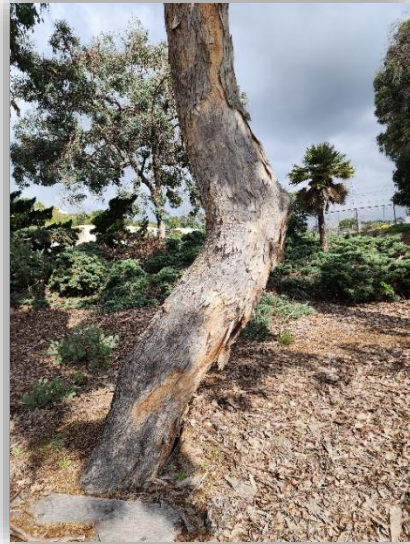
Plate 6. This is a view of a stem with irregular growth form affecting the balance of the overhead canopy mass (#564).

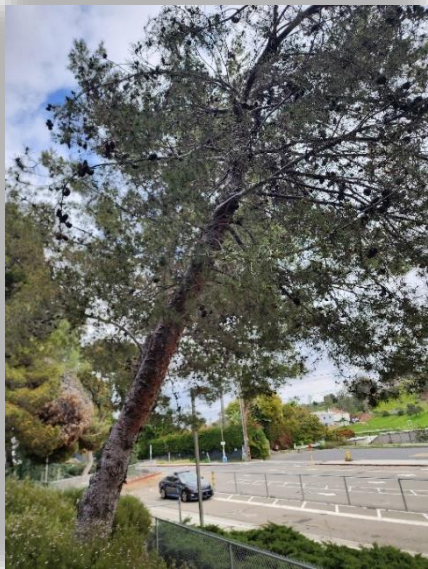
Plate 7. This is a view of a tree with an uncorrected lean (#572).

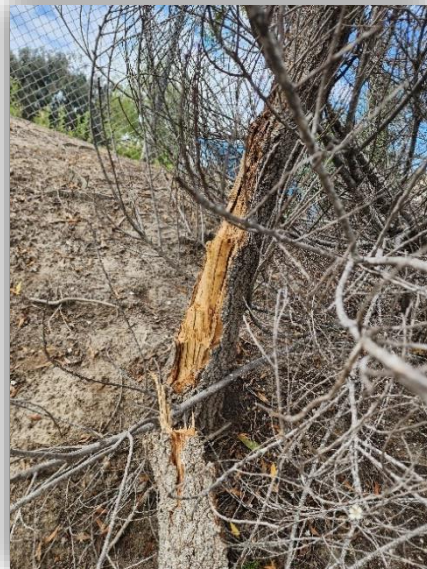
Plate 8. This is a view of a failed stem due to poor crotch development (#574).

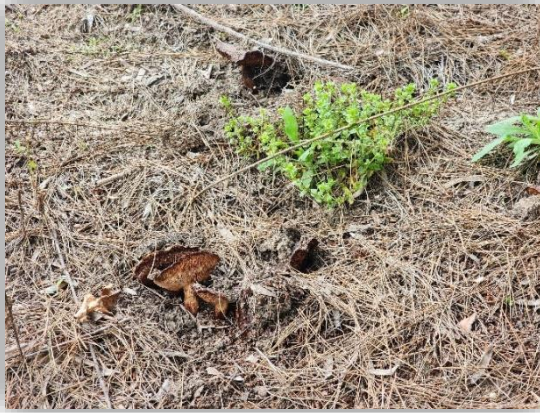
Plate 9. This is a view of fungal fruiting bodies within the root crown of a tree (near #575).

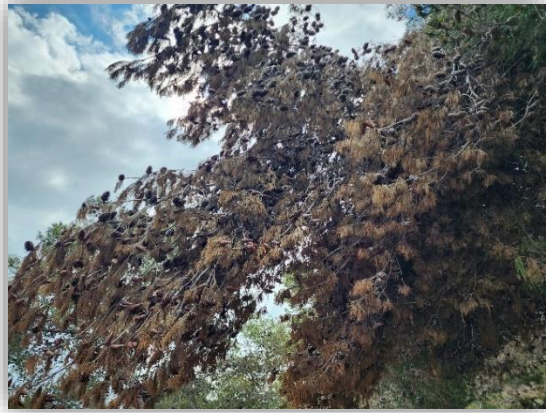
Plate 10. This is a view of a diseased limb within the crown of a tree (#578).

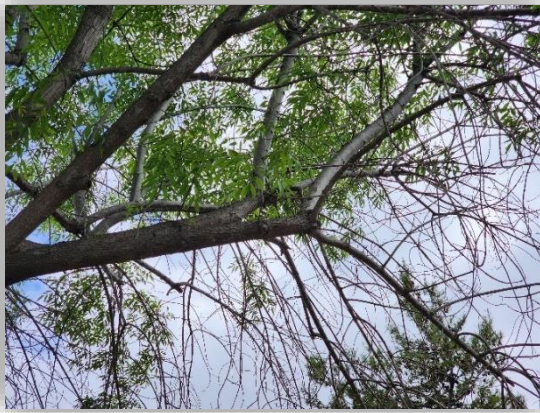
Plate 11. This is a view of a limb topped with resultant water sprouting (#579).

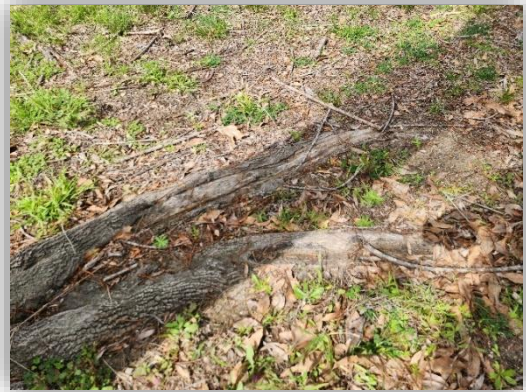
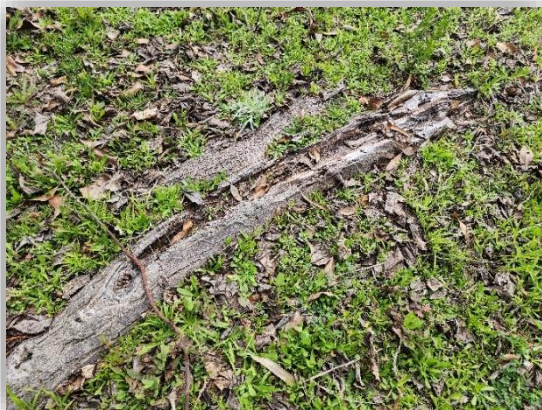
Plate 12. This is a view of a structural root with decay (#582).

Plate 13. This is another view of a structural root with decay (#582).

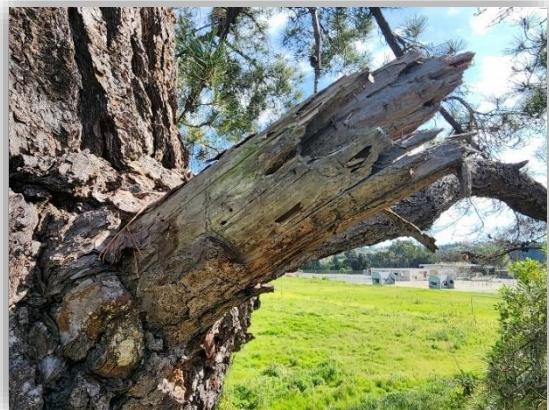
Plate 14. This is a view of a failed branch with indication of termites (#602).

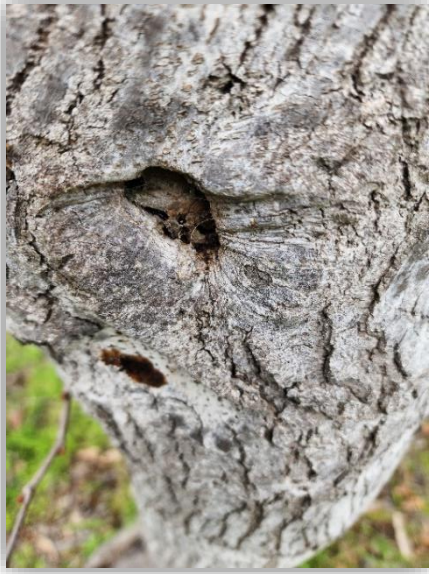
Plate 15. This is a view of an unclosed branch cut with indication of termites in the structural wood (#583).

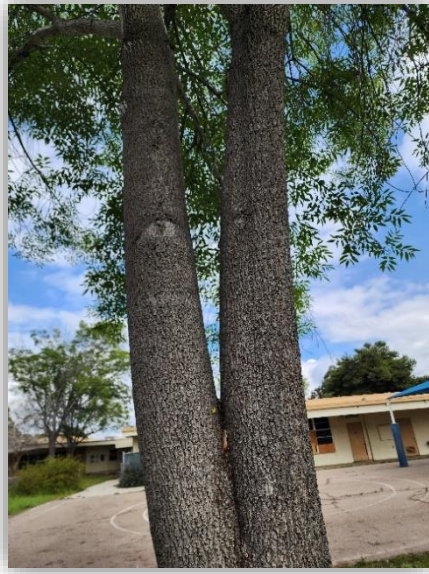
Plate 16. This is a view of codominant stems with included bark (#585).

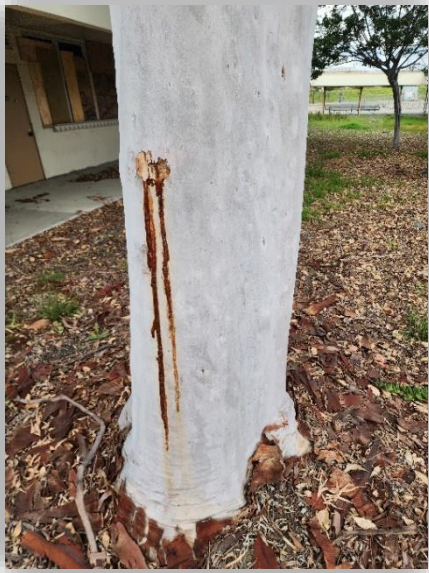
Plate 17. This is a view of mechanical bark damage resulting in exuding sap (#586).

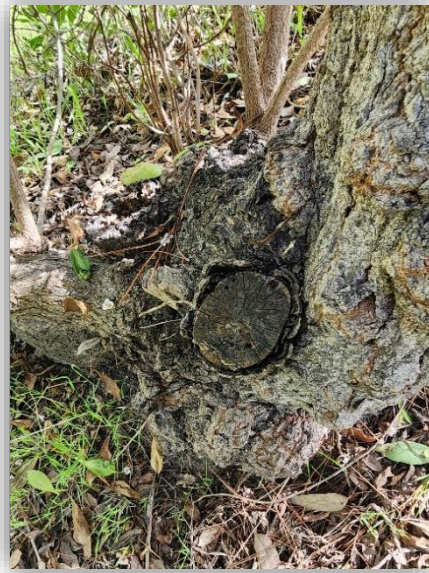
Plate 18. This is a view of an unclosed branch cut with adjacent tissue decay (#590).

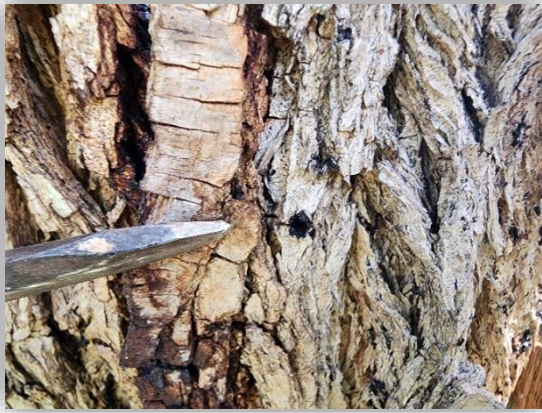
Plate 19. This is a view of a bore hole from a boring insect (#599).

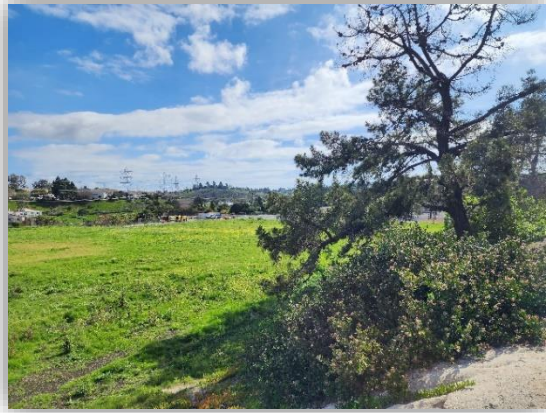
Plate 20. This is a view of a tree with retrenchment/dieback (#601).
