# Protected Tree Evaluation Report

**For: Carlton Way, Los Angeles**

Project Name Address: Carlton Apartments, 5416-5430 Carlton Way

Dated: 03/09/2024

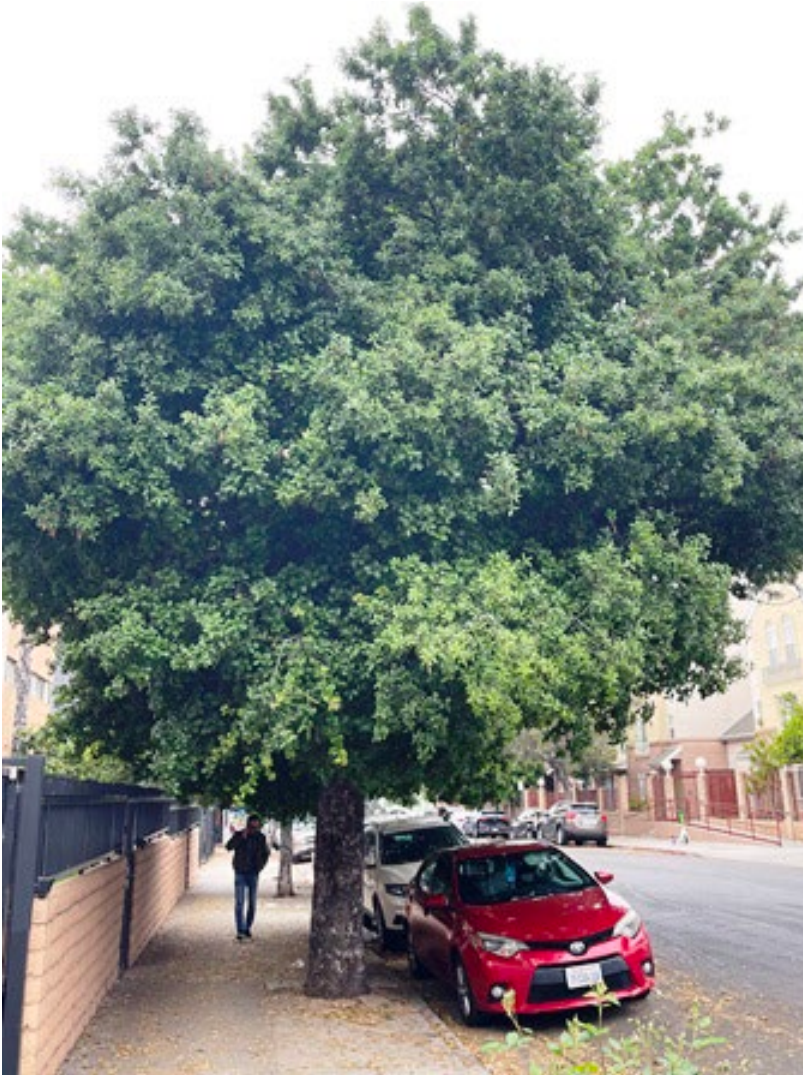
The apartments at 5430 Carlton Way will be demolished and replaced. The site has no trees, only the one large protected oak as a street tree. The tree has good health, but only fair structure. The trunk has a minor bow and has a codominant fork. The scaffold limbs are crowded together and the trunk stops there. The roots are lifting the sidewalk and the collar at the base is too small and is breaking up.

This tree cannot remain in place, due to demolition, construction and probably grading. Based on canopy and root size, it may have out-grown this space.

After getting a permit and removing the street tree, replace the street tree according to Urban Forestry instructions

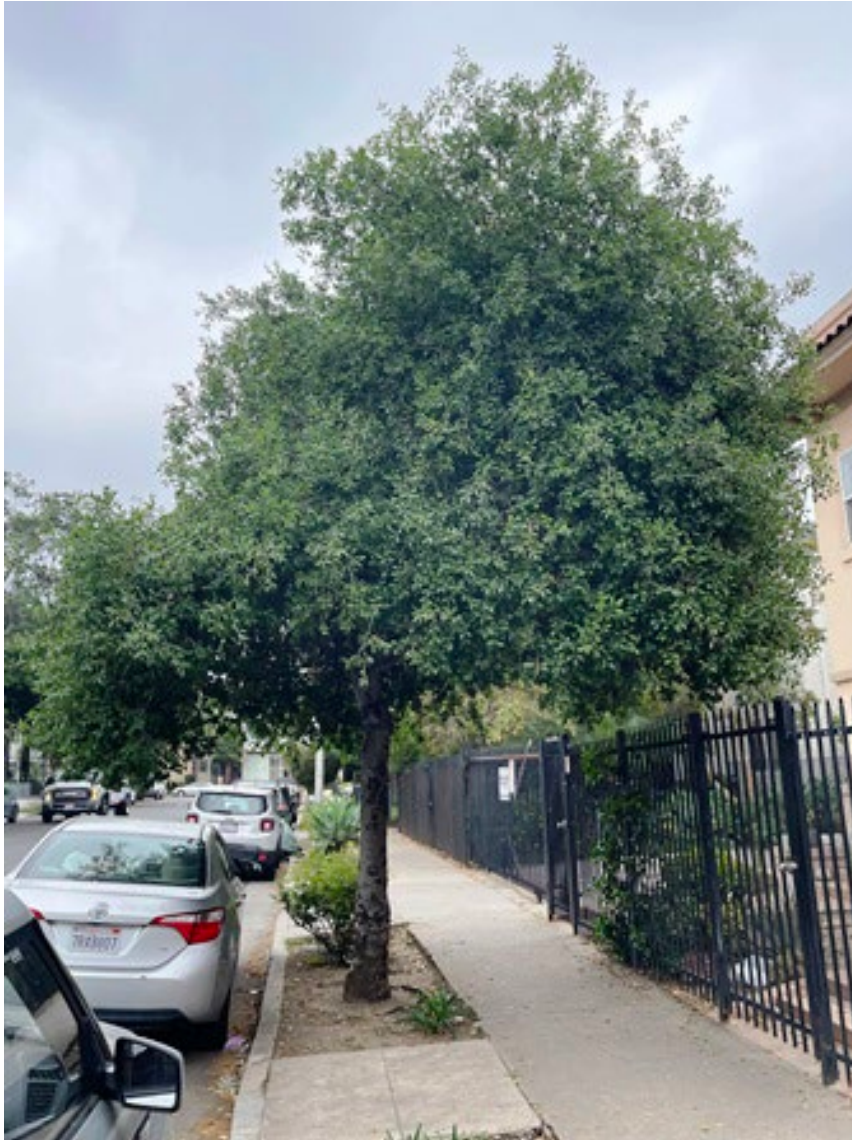
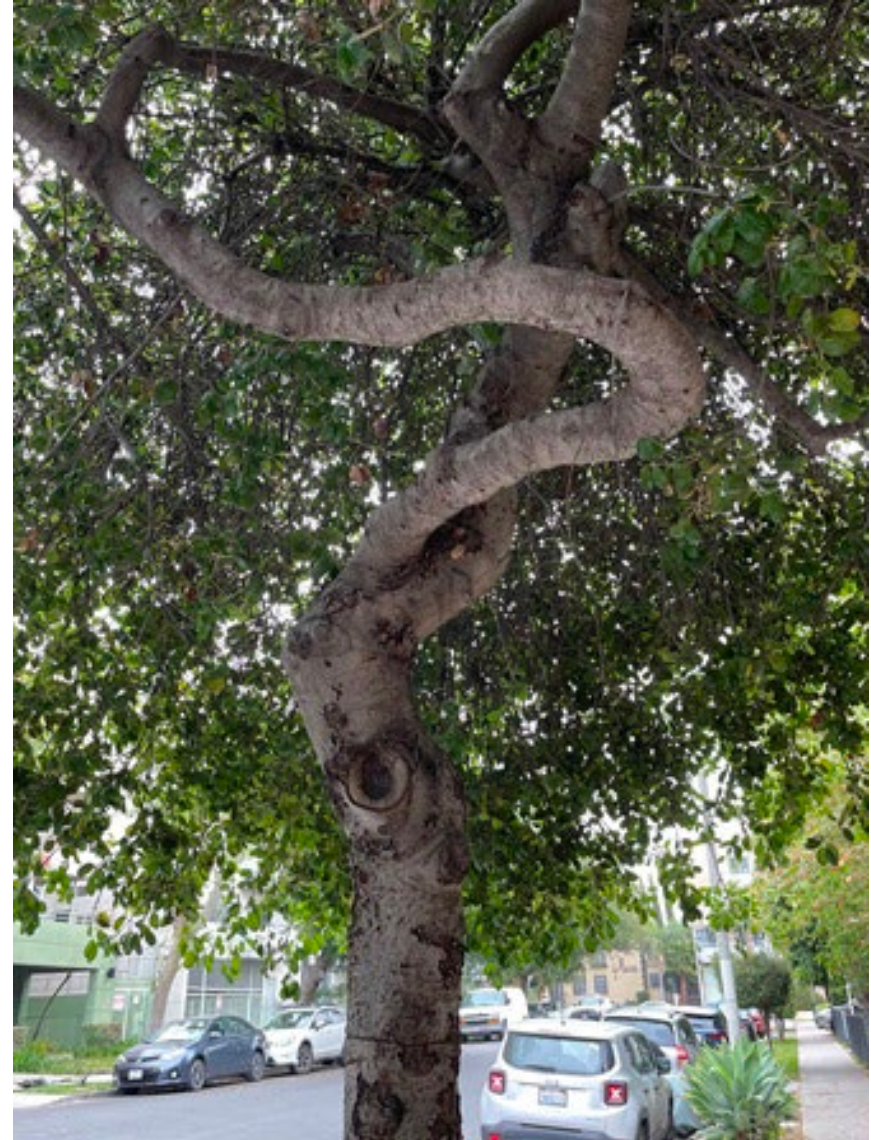
#3 Street tree – note lop-sided head

#3 Street tree – note dogleg trunk and dogleg limbs.

The existing apartment buildings and trees at 5424 Carlton Way will be demolished and replaced. The site has three trees, and one protected oak as a street tree. The street tree has good health, but only fair to poor structure. The trunk has a minor dogleg, a codominant fork and dogleg scaffold limbs. The scaffold limbs are crowded together and have included bark between them.

These trees cannot remain in place, due to demolition, construction and probably grading. Based on canopy size and necessary past pruning, the site trees should never been planted here, but now they all need to be removed.

After getting a removal permit and removing the street tree, replace the street tree according to Urban Forestry instructions.

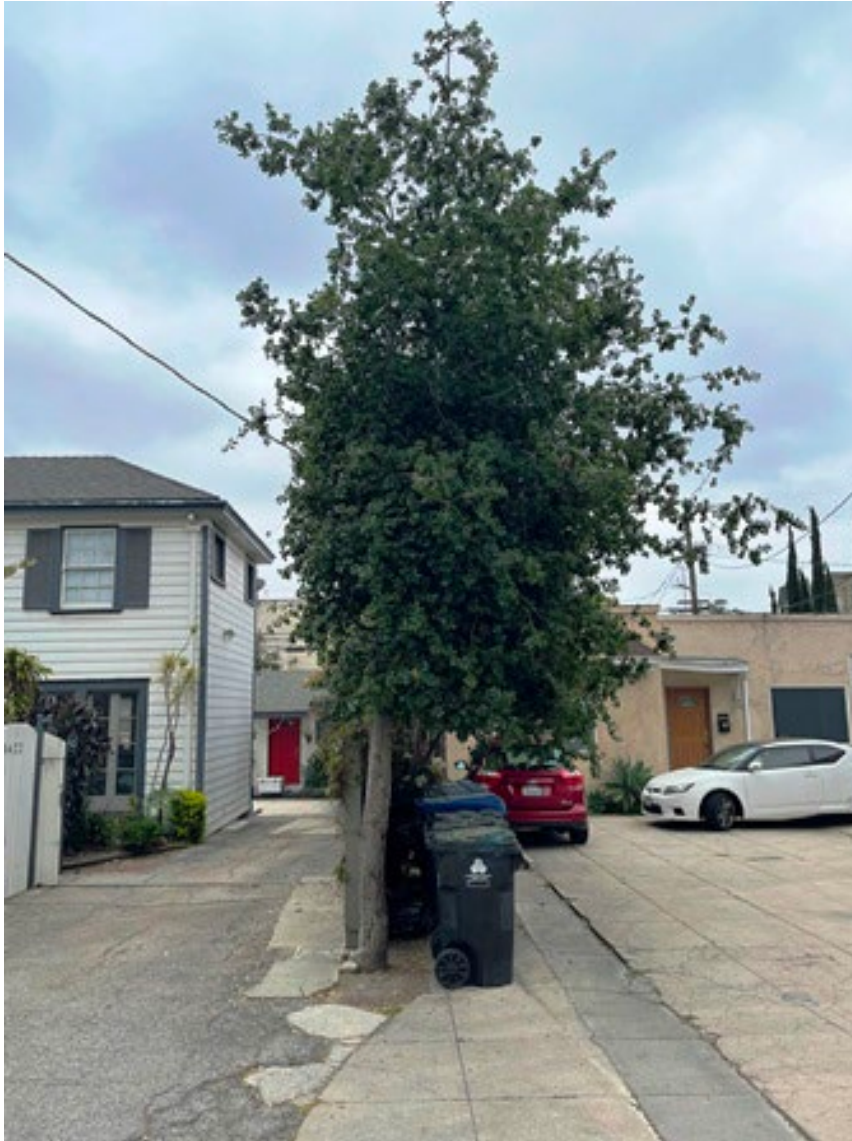
#6 Coast live oak – note narrow planting space.

There is one protected coast live oak (#6) on the site, in a narrow space. The canopy has been trimmed narrow for passing vehicles.

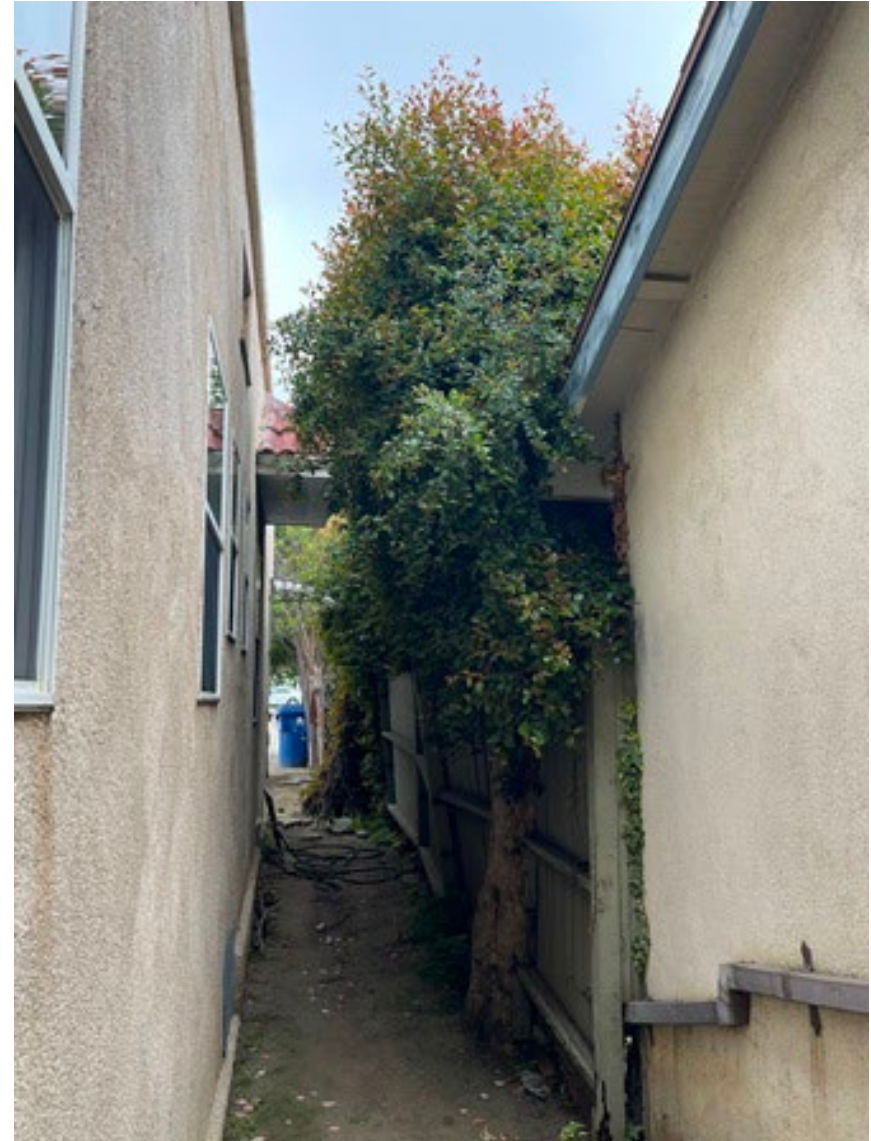
#7 Brush cherry – note topping for wires and narrow space.

In the same narrow planter for the oak there is a topped brush cherry (#7), also kept narrow headed.

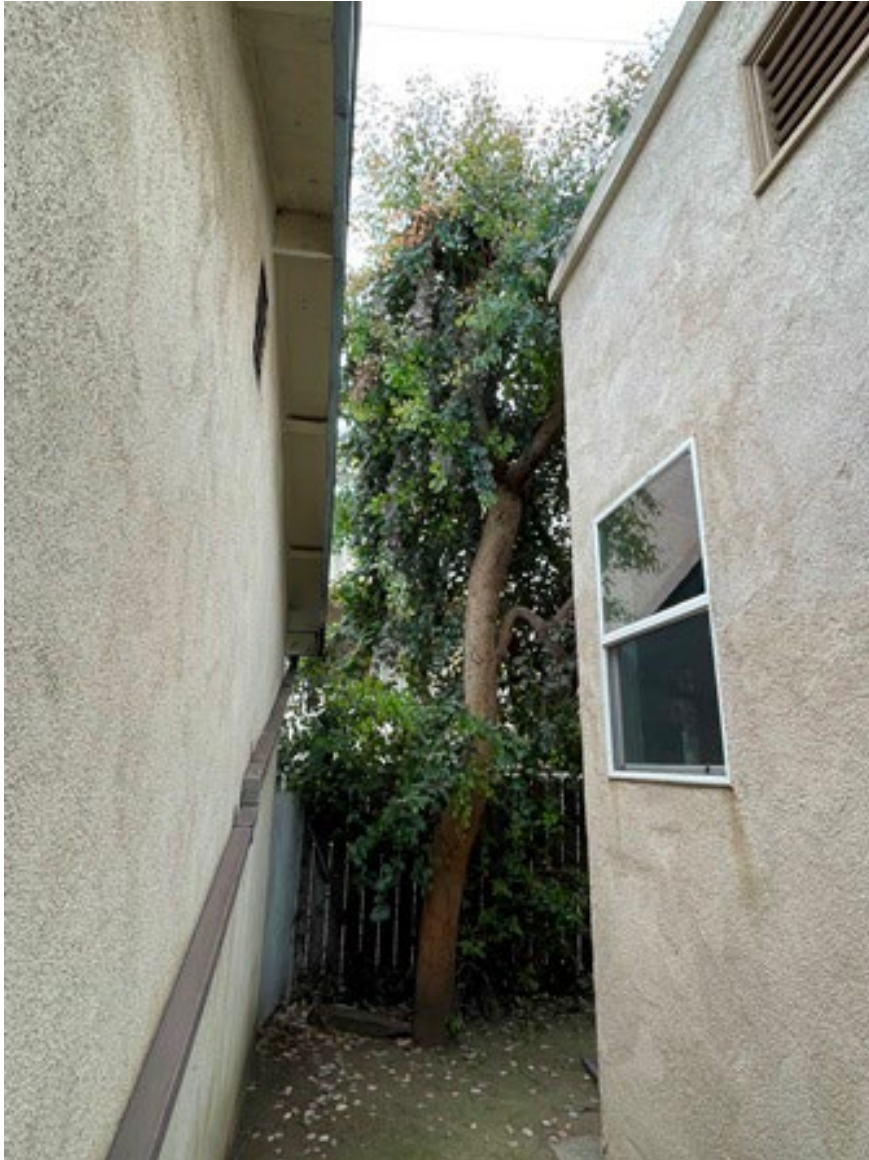
#8 Silver Mountain gum – note small space.

At the back edge of the property, there is a Silver Mountain gum (#8) that has received severe topping to keep it below the wires.

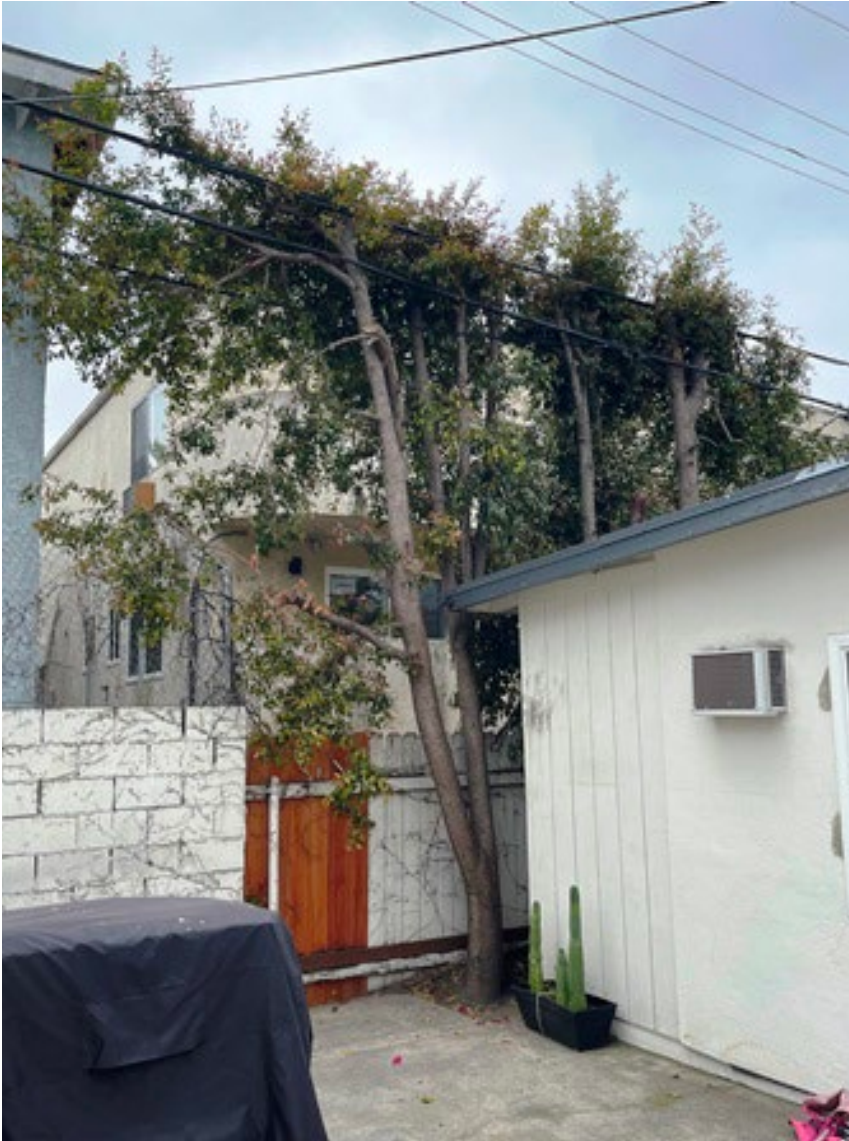
#9 Brush cherry in the narrow side planter

In the rear part of the site there are a few brush cherries, one (#9) is 8-inches at 2-feet up below the codominant fork. A second brush cherry is 13 inches at the base.

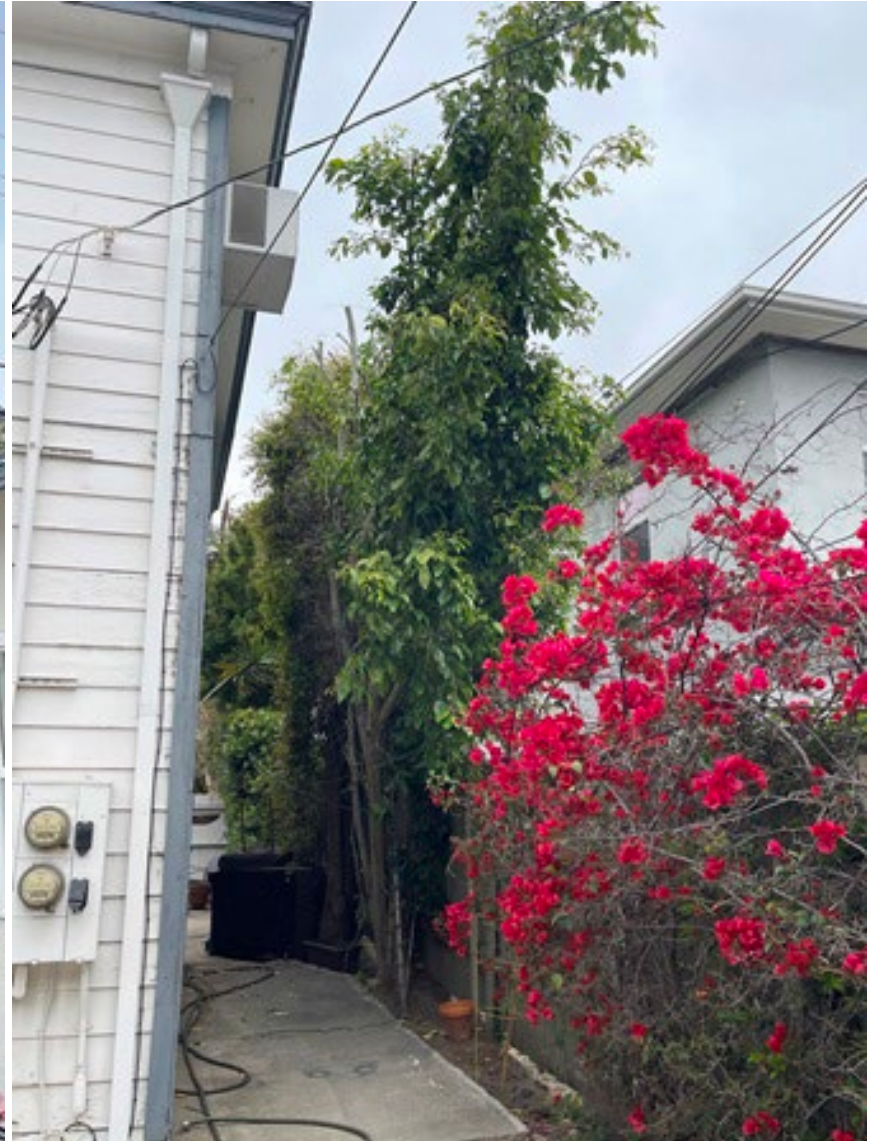
#10 Indian laurel in narrow planter.

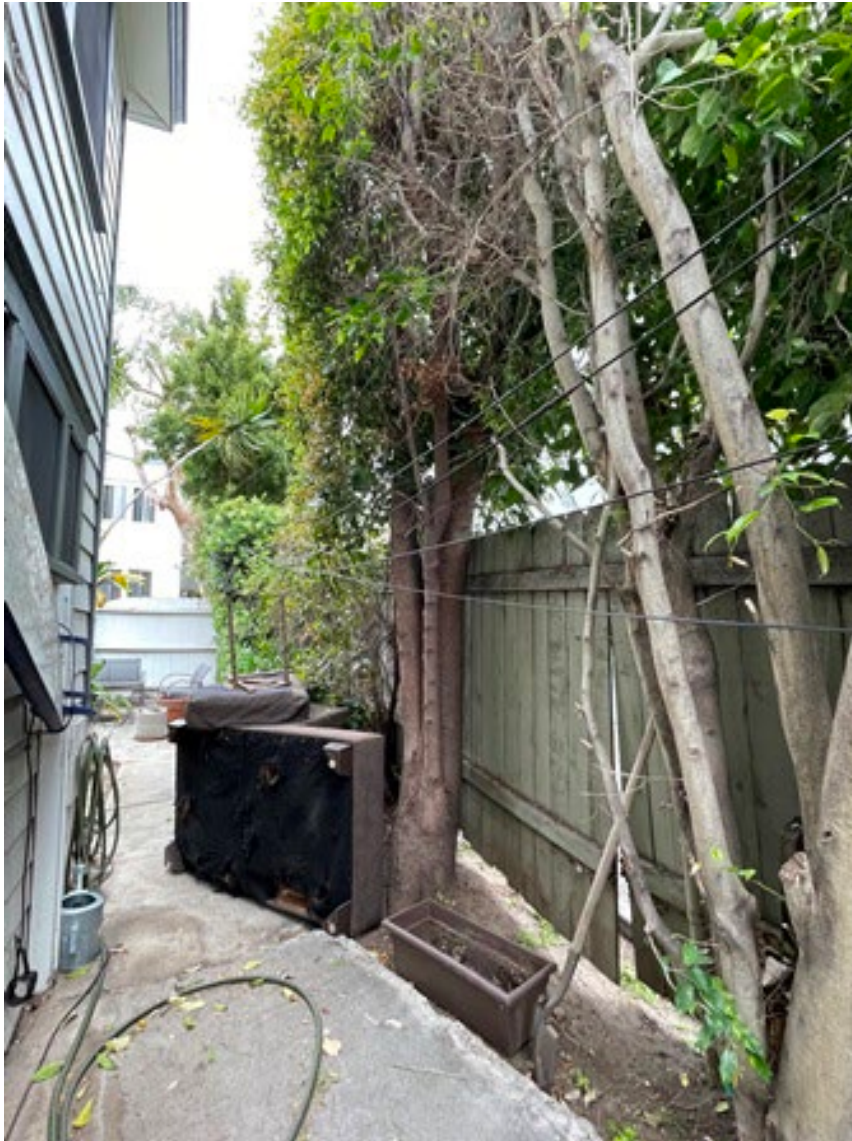
#11 Brush cherry – note narrow planter and lifted paving.

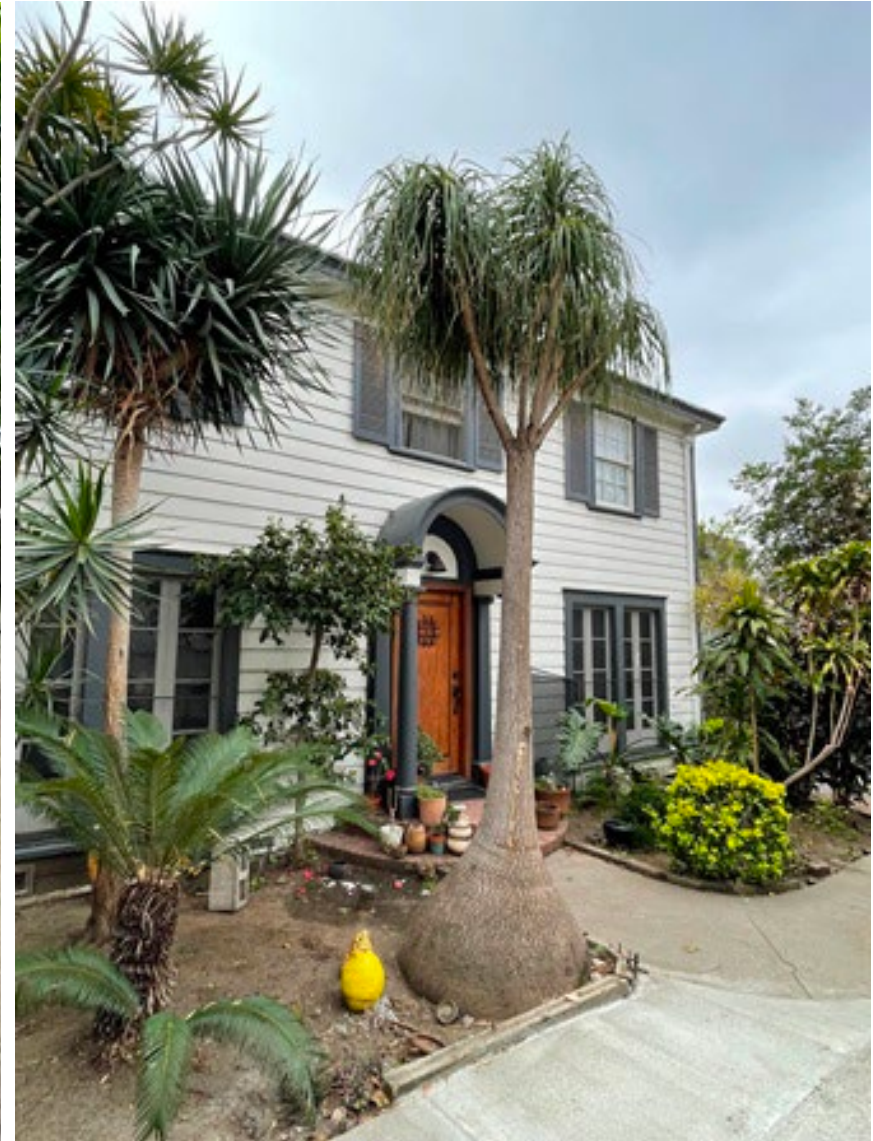
#12 Bottle palm, a somewhat unique form for this species.

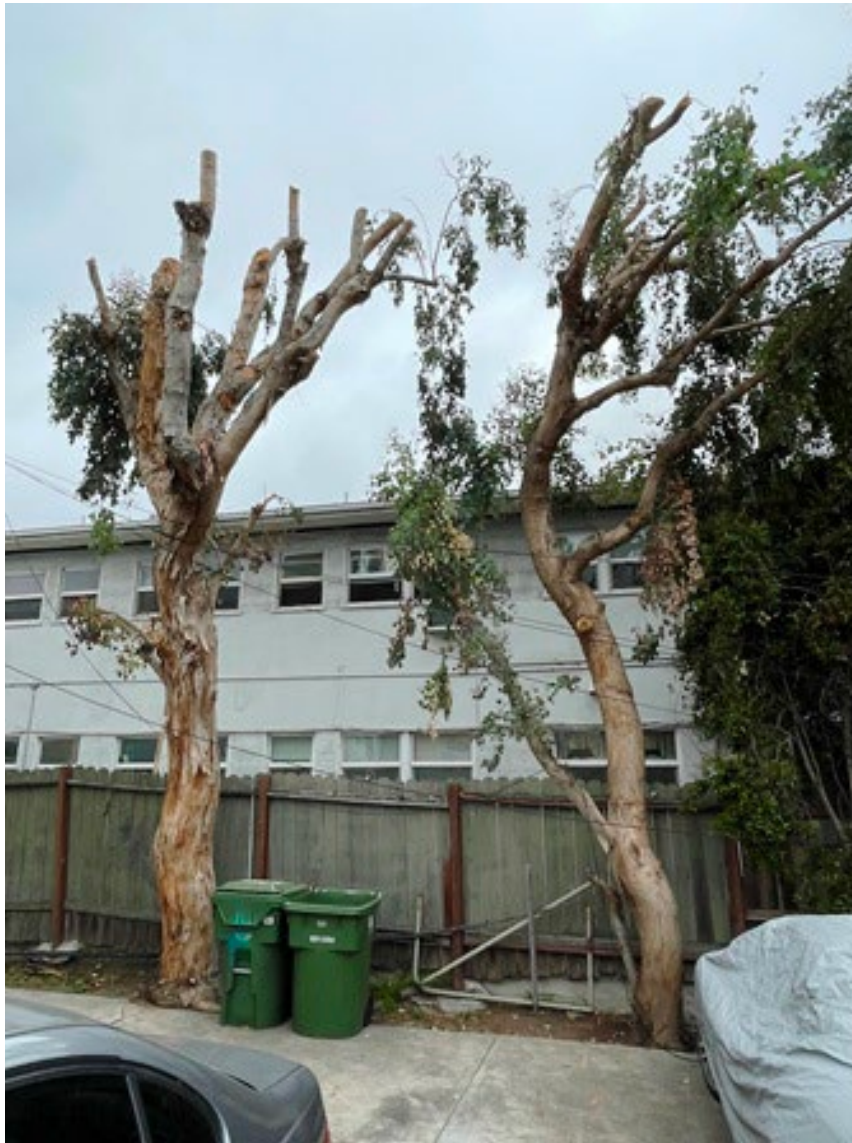
#13 & 14 Silver Mountain gums – note severe topping and heading.

There are two moderate sized Silver Mountain gums in a narrow planter next to the central parking area. Both have been severely topped and headed.

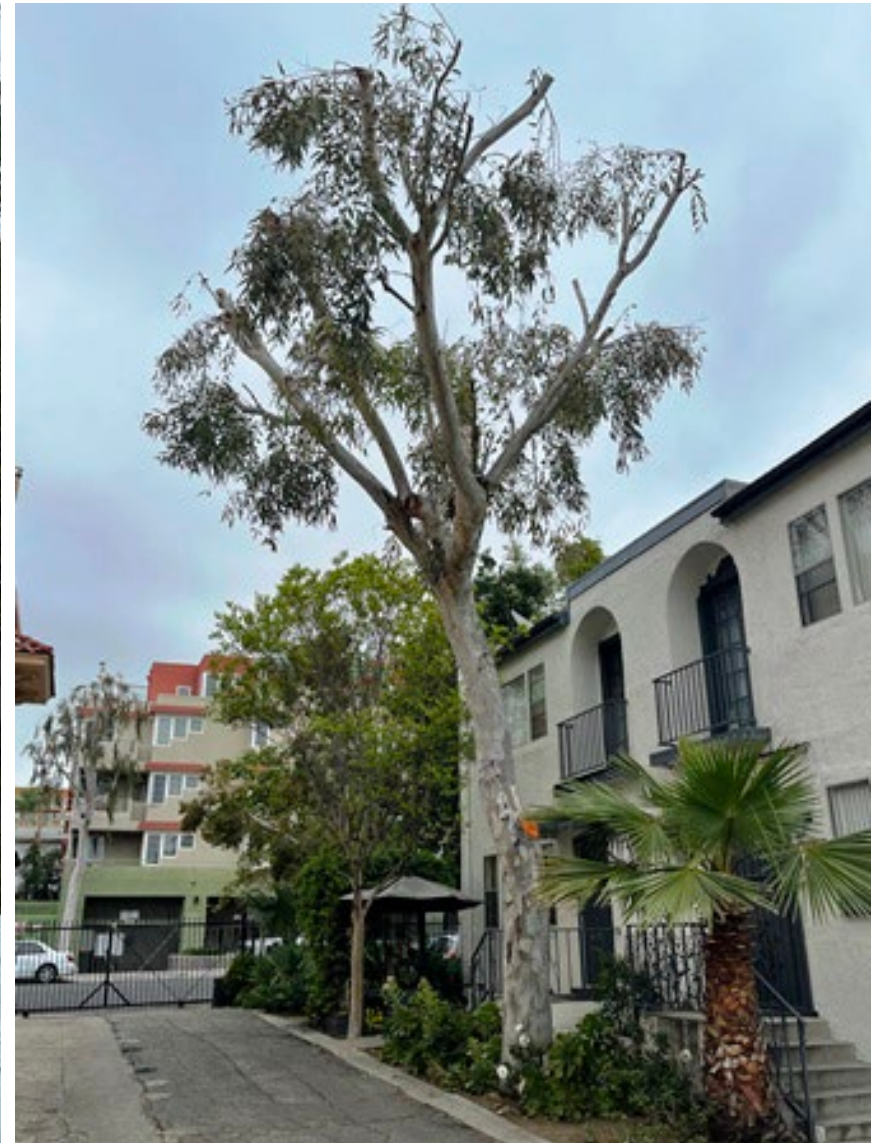
#15 Red gum – note severe topping and heading

A medium size red gum is in front of the 5420 building. It has also been topped and headed severely.

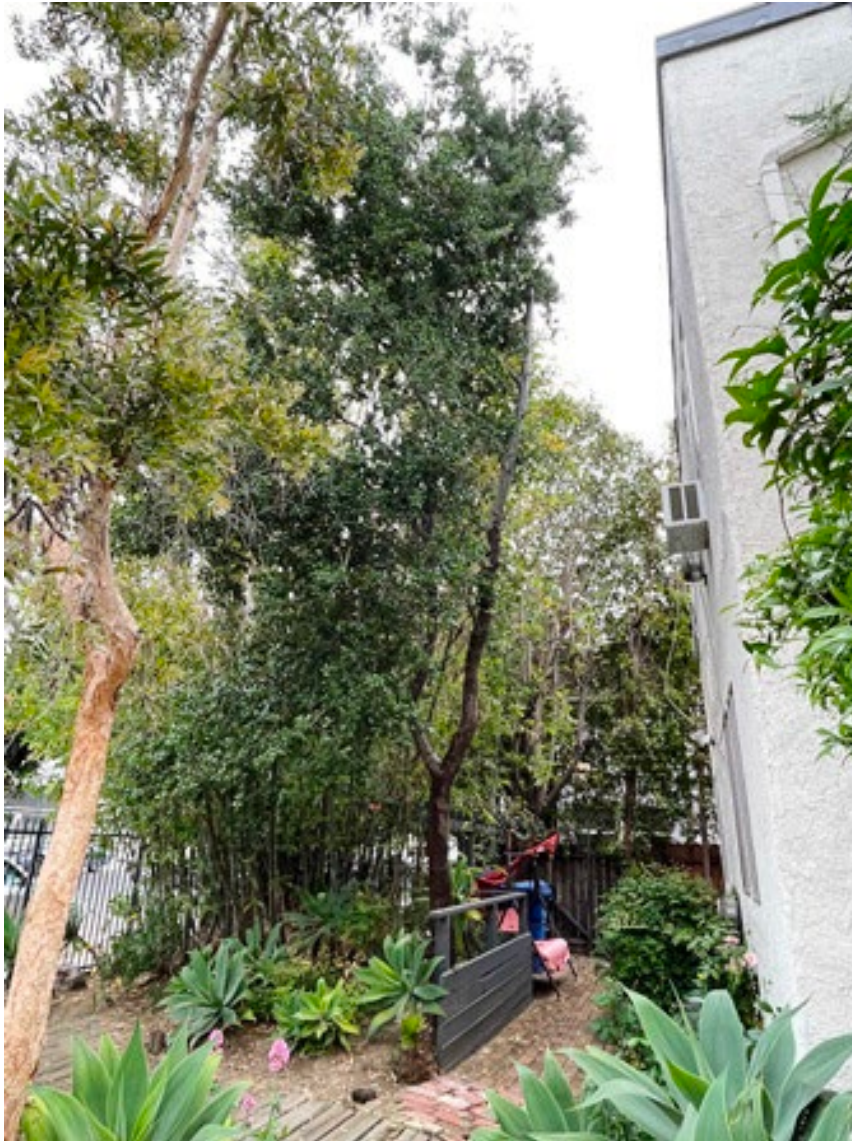
#16 Coast live oak

The one protected coast live oak (#16) is in front, near the building. It is tall, but skinny. The protected sycamore (#17) is small, and out near the sidewalk. The trunk is codominant. The canopy sparse and there is a small amount of anthracnose.

Obtain removal permits for removal of protected trees, coast live oak #16 and California sycamore #17

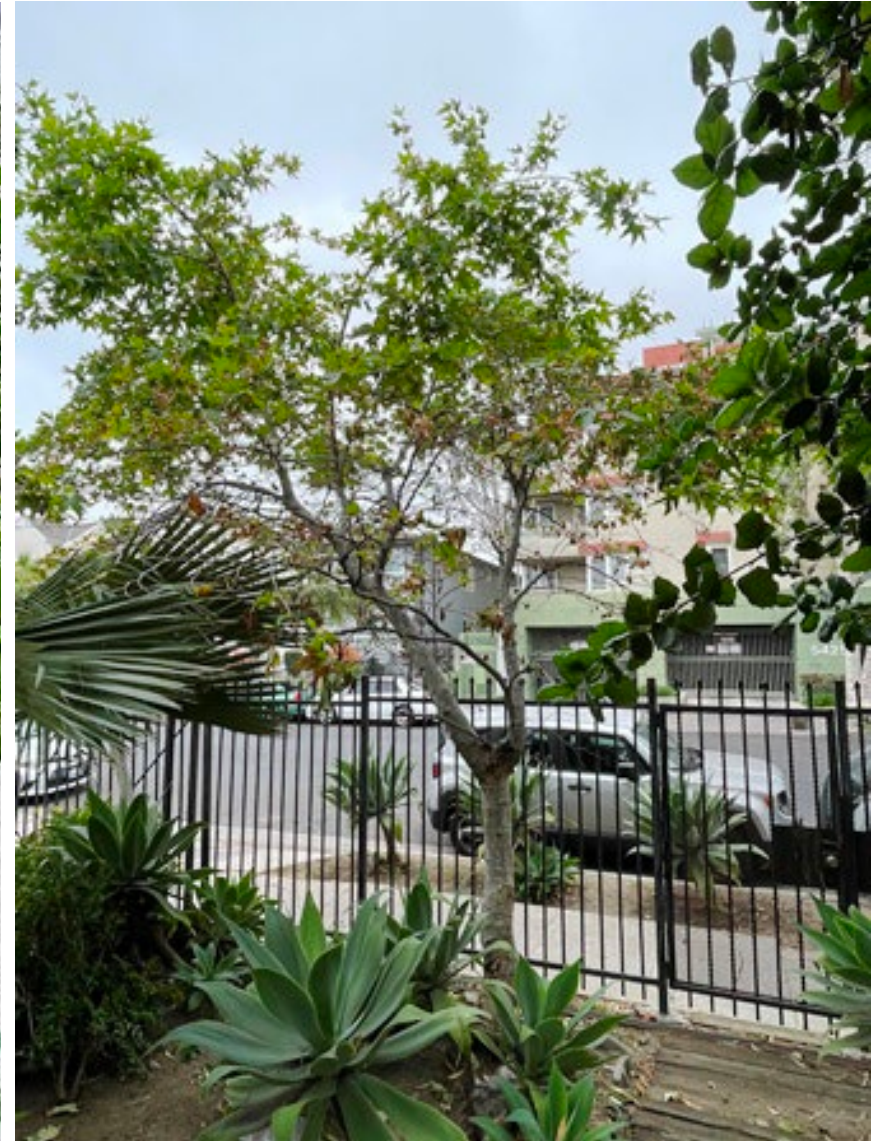
#17 California sycamore

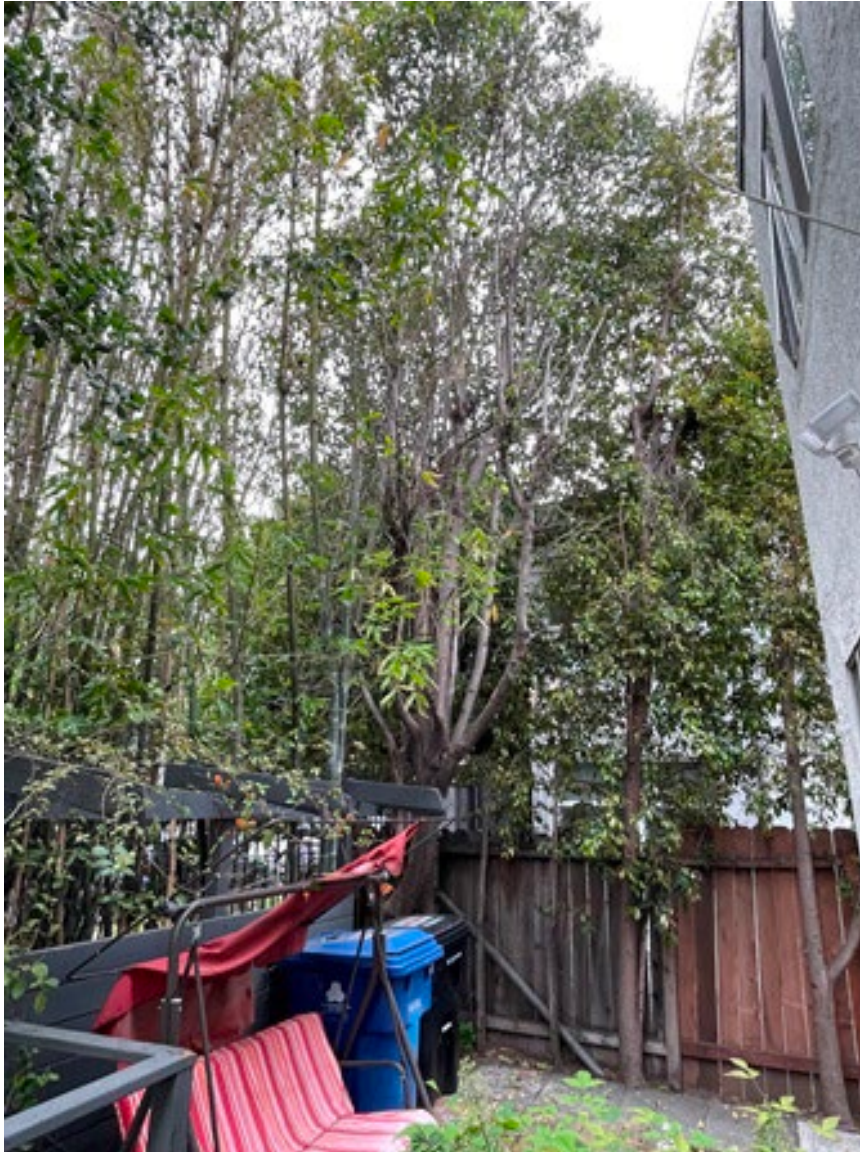
#19 Japanese privet, the top half is dead. Note bamboo crowding it.

The front garden area is disorganized and crowded, but it contains the two protected trees and a large, but dying, Japanese privet, #18, shown at left.

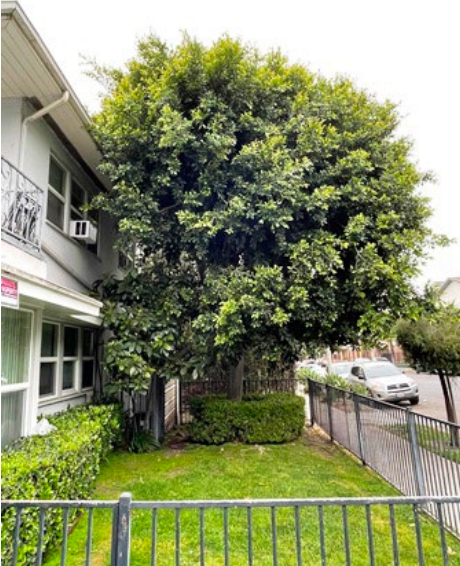
⬅ #23 Indian laurel – note proximity to the building

The Indian laurel tree in front is also not a suitable tree to be so close to the structure. It should be removed. The project landscape architects will recommend better tree or trees for this location.
