Tree Evaluation Report

ARBORIST REPORT

Morningside Project

August 26, 2024

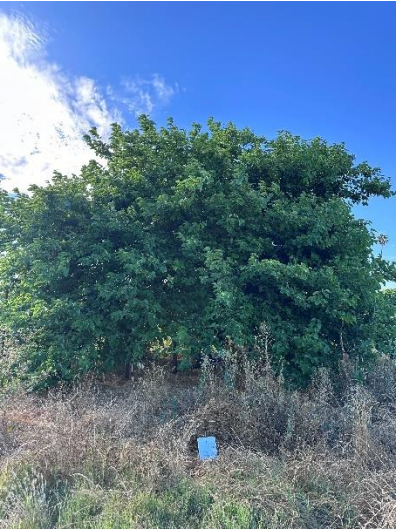
Tree #1

Tree ID	Botanical Name	Common Name	Height (Ft)	Canopy Spread (Ft)	DBH (Inches)	Health	Protected Status	Suitability	Current Proposed Disposition	Notes	
1	<i>Morus alba</i>	White Mulberry	18	30	12 & 12-24	3	Yes	Moderate	Remove	Codominant stems	
2	<i>Washingtonia robusta</i>	Mexican Fan Palm	40	12		18	3	Yes	Moderate	Remove	Against fence line
3	<i>Pinus halepensis</i>	Aleppo Pine	35	20		18	1	Yes	Low	Remove	Failed tree; laying horizontal on ground.
4	<i>Washingtonia robusta</i>	Mexican Fan Palm	6	10		14	3	Yes	Moderate	Remove	Seedling
5	<i>Washingtonia robusta</i>	Mexican Fan Palm	6	10		14	3	Yes	Moderate	Remove	Seedling
6	<i>Juniperus chinensis 'Torulosa'</i>	Hollywood Juniper	12	8		6	2	No	Low	Remove	Nursery stakes present
7	<i>Juniperus chinensis 'Torulosa'</i>	Hollywood Juniper	12	8		6	2	No	Low	Remove	Lean
8	<i>Juniperus chinensis 'Torulosa'</i>	Hollywood Juniper	8	4		6	1	No	Low	Remove	Trunk damage
9	<i>Juniperus chinensis 'Torulosa'</i>	Hollywood Juniper	16	6		6	2	No	Low	Remove	Lean

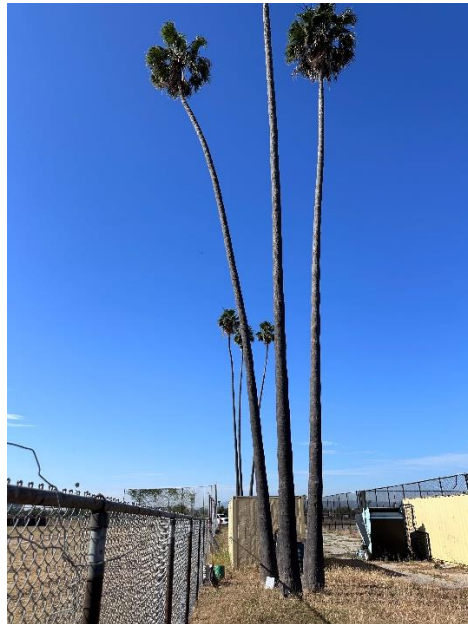
Tree #23

22	<i>Washingtonia robusta</i>	Mexican Fan Palm	1	3		2	2	No	Low	Remove	Seedling
23	<i>Washingtonia robusta</i>	Mexican Fan Palm	85	12		14	3	Yes	Moderate	Remove	
24	<i>Washingtonia robusta</i>	Mexican Fan Palm	85	12		14	3	Yes	Moderate	Remove	
25	<i>Washingtonia robusta</i>	Mexican Fan Palm	85	12		14	3	Yes	Moderate	Remove	
26	<i>Washingtonia robusta</i>	Mexican Fan Palm	85	12		14	2	Yes	Low	Remove	Trunk damage
27	<i>Washingtonia robusta</i>	Mexican Fan Palm	85	12		14	2	Yes	Low	Remove	Trunk damage
28	<i>Washingtonia robusta</i>	Mexican Fan Palm	85	12		14	2	Yes	Low	Remove	Trunk damage
29	<i>Washingtonia robusta</i>	Mexican Fan Palm	50	12		14	3	Yes	Moderate	Remove	Unskinned
30	NUMBER NOT UTILIZED										
31	NUMBER NOT UTILIZED										
32	NUMBER NOT UTILIZED										
33	NUMBER NOT UTILIZED										
34	NUMBER NOT UTILIZED										
35	NUMBER NOT UTILIZED										
36	NUMBER NOT UTILIZED										
37	NUMBER NOT UTILIZED

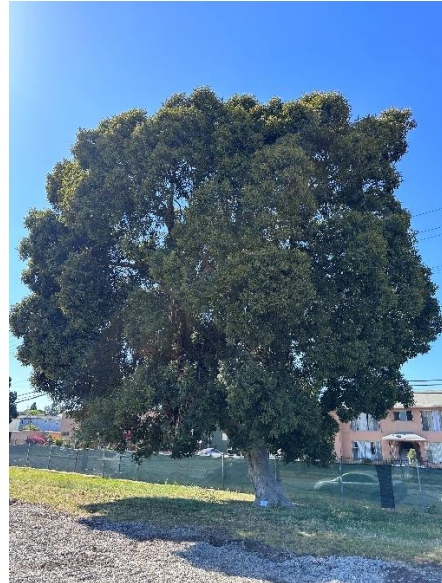
Tree #45

38	NUMBER NOT UTILIZED										
39	NUMBER NOT UTILIZED										
40	NUMBER NOT UTILIZED										
41	NUMBER NOT UTILIZED										
42	NUMBER NOT UTILIZED										
43	NUMBER NOT UTILIZED										
44	NUMBER NOT UTILIZED										
45	<i>Ficus rubiginosa</i>	Rusty Fig	45	45		38	3	Yes	Moderate	Remove	Original lean and imbalanced canopy due to overhead lines
46	<i>Washingtonia robusta</i>	Mexican Fan Palm	30	12		20	3	Yes	Moderate	Remove	Fire scorch
47	<i>Washingtonia robusta</i>	Mexican Fan Palm	18	12		18	3	Yes	Moderate	Remove	Fire scorch
48	<i>Washingtonia robusta</i>	Mexican Fan Palm	6	10		16	3	Yes	Moderate	Remove	Seedling
49	<i>Washingtonia robusta</i>	Mexican Fan Palm	65	18	18 & 18 & 18- 54		1	Yes	Low	Remove	Fire scorch
50	<i>Washingtonia robusta</i>	Mexican Fan Palm	10	12		20	3	Yes	Moderate	Remove	Hybrid
51	<i>Cupaniopsis anacardioides</i>	Carrotwood Tree	16	4		3	2	No	Low	Remove	Basal damage, Seedling

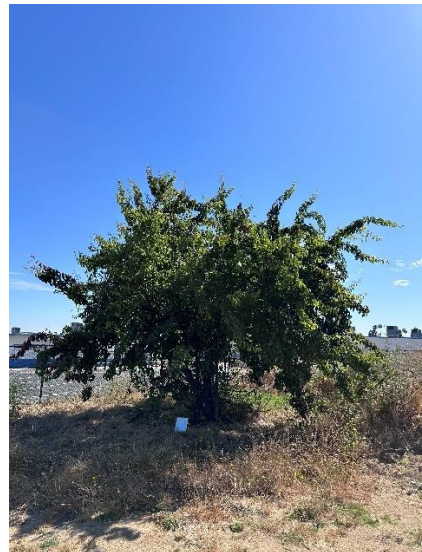
Tree #52

52	<i>Prunus calleryana</i>	Bradford Pear	18	20		7 & 6=13	2	Yes	Low	Remove	Original stakes, low branch structure, poor structure
53	<i>Washingtonia robusta</i>	Mexican Fan Palm	1	3		5	2	No	Low	Remove	Seedling
54	<i>Washingtonia robusta</i>	Mexican Fan Palm	1	3		5	2	No	Low	Remove	Seedling
55	<i>Washingtonia robusta</i>	Mexican Fan Palm	1	3		5	2	No	Low	Remove	Seedling
56	<i>Washingtonia robusta</i>	Mexican Fan Palm	1	3		5	2	No	Low	Remove	Seedling
57	<i>Washingtonia robusta</i>	Mexican Fan Palm	1	3		5	2	No	Low	Remove	Seedling
58	<i>Washingtonia robusta</i>	Mexican Fan Palm	1	3		5	2	No	Low	Remove	Seedling
59	<i>Washingtonia robusta</i>	Mexican Fan Palm	1	3		5	2	No	Low	Remove	Seedling
60	<i>Washingtonia robusta</i>	Mexican Fan Palm	1	3		5	2	No	Low	Remove	Seedling
61	<i>Washingtonia robusta</i>	Mexican Fan Palm	1	3		5	2	No	Low	Remove	Seedling
62	<i>Washingtonia robusta</i>	Mexican Fan Palm	1	3		5	2	No	Low	Remove	Seedling

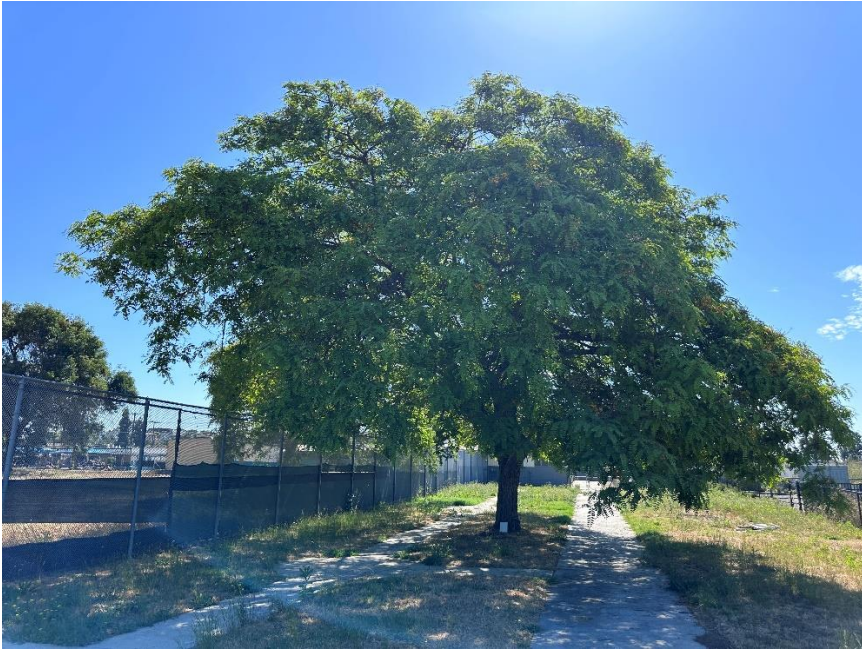
Tree #74

63	<i>Washingtonia robusta</i>	Mexican Fan Palm	1	3		5	2	No	Low	Remove	Seedling
64	<i>Washingtonia robusta</i>	Mexican Fan Palm	1	3		5	2	No	Low	Remove	Seedling
65	<i>Washingtonia robusta</i>	Mexican Fan Palm	1	3		5	2	No	Low	Remove	Seedling
66	<i>Washingtonia robusta</i>	Mexican Fan Palm	1	3		5	2	No	Low	Remove	Seedling
67	<i>Washingtonia robusta</i>	Mexican Fan Palm	1	3		5	2	No	Low	Remove	Seedling
68	<i>Washingtonia robusta</i>	Mexican Fan Palm	1	3		5	2	No	Low	Remove	Seedling
69	<i>Washingtonia robusta</i>	Mexican Fan Palm	1	3		5	2	No	Low	Remove	Seedling
70	<i>Washingtonia robusta</i>	Mexican Fan Palm	1	3		5	2	No	Low	Remove	Seedling
71	<i>Washingtonia robusta</i>	Mexican Fan Palm	1	3		5	2	No	Low	Remove	Seedling
72	<i>Washingtonia robusta</i>	Mexican Fan Palm	1	3		5	2	No	Low	Remove	Seedling
73	<i>Washingtonia robusta</i>	Mexican Fan Palm	1	3		5	2	No	Low	Remove	Seedling
74	<i>Tipuana tipu</i>	Tipu Tree	40	40		16	3	Yes	High	Remove

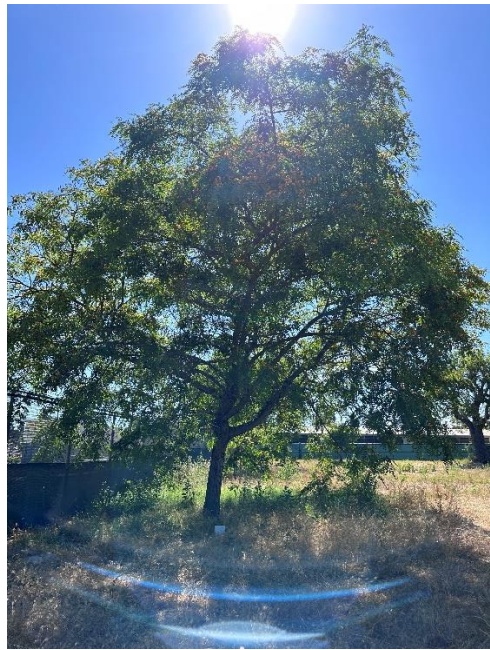
Tree #75

75	<i>Tipuana tipu</i>	Tipu Tree	48	48		15	3	Yes	High	Remove	
76	<i>Tipuana tipu</i>	Tipu Tree	10	8		4	1	No	Low	Remove	Trunk damage
77	<i>Tipuana tipu</i>	Tipu Tree	35	42		17	3	Yes	High	Remove	
78	<i>Koelreuteria bipinnata</i>	Chinese Flame Tree	12	10		11	2	Yes	Low	Remove	Poor structure
79	<i>Fraxinus oxycarpa 'Raywood'</i>	Claret Ash	48	40		40	1	Yes	Low	Remove	Decay, multiple limb failures.
80	<i>Koelreuteria bipinnata</i>	Chinese Flame Tree	28	25		14	2	Yes	Moderate	Remove	Trunk bleeding
81	NUMBER NOT UTILIZED										
82	<i>Fraxinus oxycarpa 'Raywood'</i>	Claret Ash	50	46		32	2	Yes	Low	Remove	Multiple limb failures.
83	<i>Fraxinus oxycarpa 'Raywood'</i>	Claret Ash	35	18		22	1	Yes	Low	Remove	
84	<i>Fraxinus oxycarpa 'Raywood'</i>	Claret Ash	46	32		25	2	Yes	Low	Remove	
85	<i>Fraxinus oxycarpa 'Raywood'</i>	Claret Ash	37	40		32	2	Yes	Low	Remove	
86	<i>Fraxinus oxycarpa 'Raywood'</i>	Claret Ash	35	30		32	1	Yes	Low	Remove	Excessive dieback.
