State of California – Natural Resources Agency
DEPARTMENT OF FISH AND WILDLIFE
Northern Region
601 Locust Street
Redding, CA 96001
wildlife.ca.gov

March 27, 2026

SUBJECT: FOSTER CAMPUS CONNECTIVITY PROJECT (SCH# [2025080375](#))

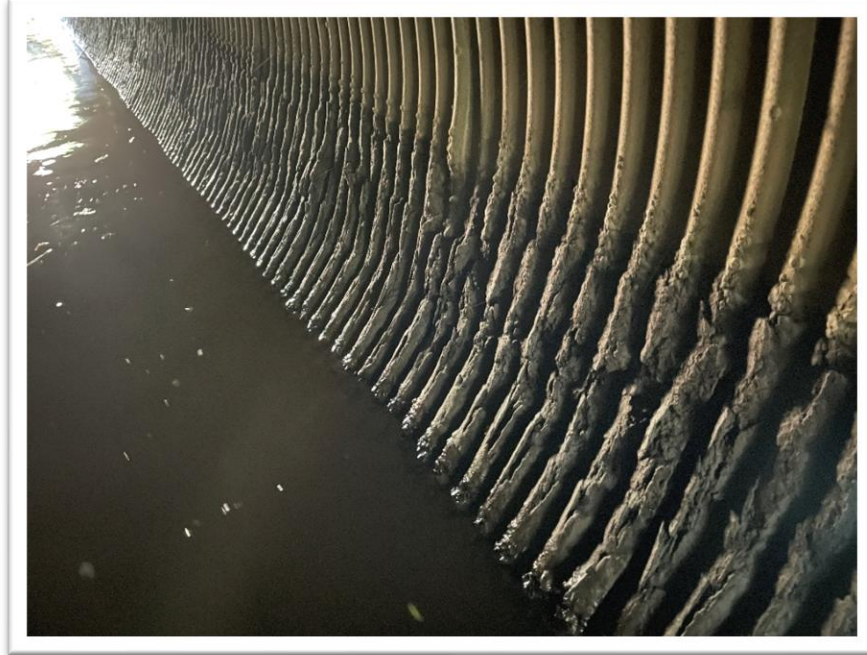
The IS/MND was recently recirculated due to the addition of a shared pedestrian and bike path over McDaniel Slough. The alignment would follow an existing footpath along the railroad prism, which crosses McDaniel Slough via a culvert through an earthen embankment. No additional details were provided about the size or condition of the stream crossing. However, the Passage Assessment Database (PAD) describes the culvert as an “*extremely undersized circular, SSP (6.5' dia [sic] x 57.1' L) in poor condition*” and categorizes it as a partial barrier for resident trout and all age classes of juvenile salmonids (CDFW 2025). Although the culvert appears to provide areas of adequate water depth and low velocity under some flow conditions, it constricts the stream channel and may impede the passage of juvenile salmonids at higher flows. Its condition has further deteriorated since the original assessment in 2010, with severe and widespread rust (Figure 1), including several holes in the culvert walls that allow flows to interact with earthen fill materials (Figure 2). The culvert is also undersized and therefore at risk of plugging due to debris transport and accumulation, as evidenced by the branches partially obstructing the inlet (Figure 3). A utility pipe running perpendicular to the culvert further constricts debris passage during storm flows (Figure 4).

The compromised structure is at the end of its service life and is unlikely to support long-term use of the proposed pedestrian and bike path. Repairing or maintaining the existing culvert would be a violation Fish and Game Code section 5901, which makes it unlawful to construct or maintain any device that prevents, impedes, or tends to prevent or impede the passage of fish up- or downstream. To remediate fish passage and restore stream channel morphology, CDFW recommends removing the culvert and replacing it with a full-span footbridge (**Recommendation 1**). The crossing should be designed by an engineer to accommodate 100-year flow and associated debris and sediment while maintaining the native stream substrate (**Recommendation 2**). Upgrading the crossing would require authorization from CDFW pursuant to Fish and Game Code section 1602 et seq. and the California Endangered Species Act (CESA) (Fish & G. Code § 2050 et seq.; see Cal. Code Regs., tit. 14, § 783 et seq.). Please contact CDFW to discuss the Project and explore permitting pathways (**Recommendation 3**).

Figure 1. Well-developed rust line along the interior culvert wall, showing extensive corrosion. Taken facing upstream, March 18, 2026.

- 1) To remediate fish passage and restore stream channel morphology, remove the culvert and replace it with a full-span footbridge.
- 2) The crossing should be designed by an engineer to accommodate 100-year flow and associated debris and sediment while maintaining the native stream substrate.
- 3) Contact CDFW to discuss the Project and explore permitting pathways.

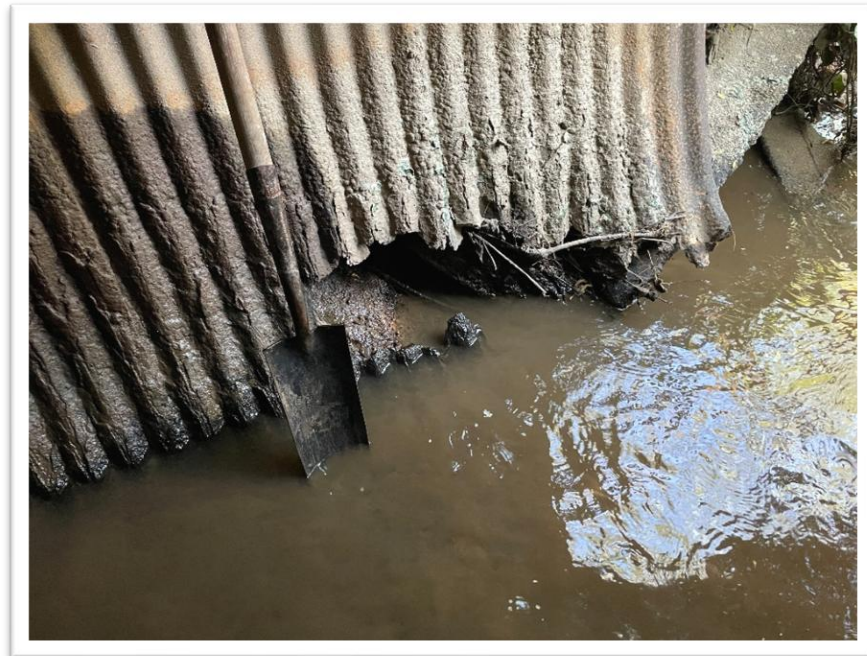
Figure 2. Section of rusted out culvert wall where flows have begun to erode earthen fill materials. Taken at the outlet (shovel included for scale), March 18, 2026.

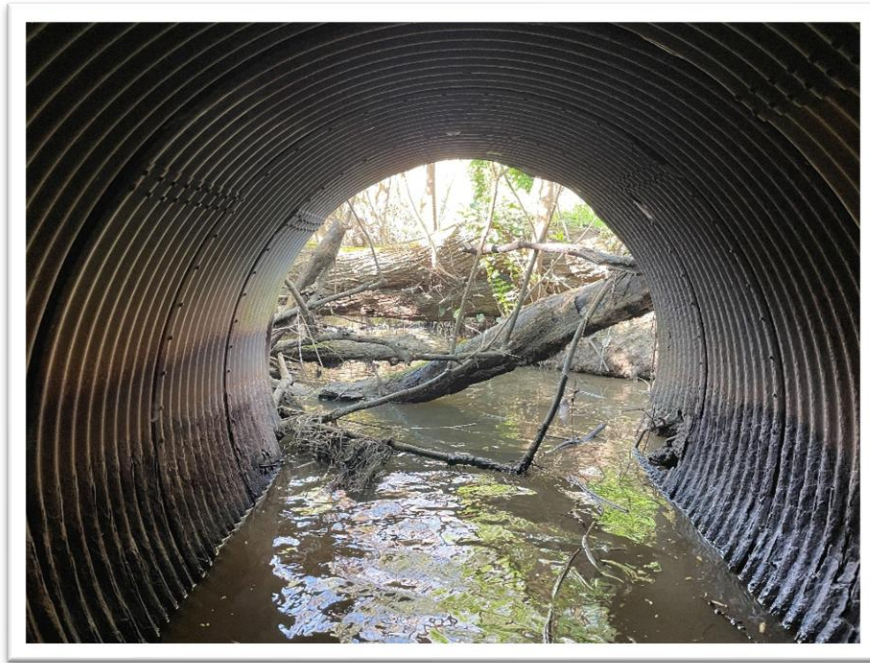
Figure 3. Culvert inlet is partially obstructed by large branches. Note rust line located mid-wall and rusted out areas at water level. Taken facing upstream toward the inlet, March 18, 2026.

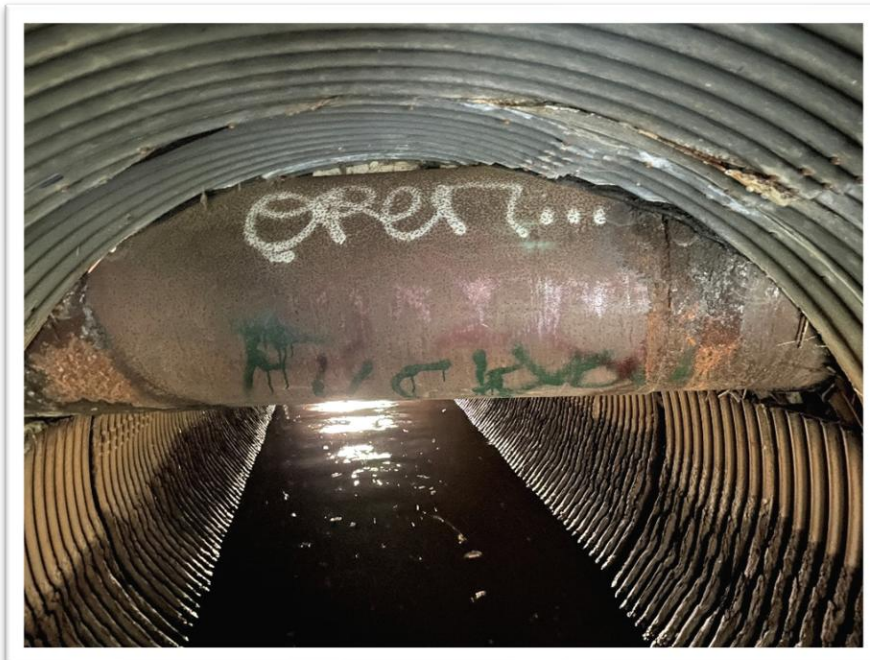
Figure 4. A utility pipe running perpendicular through the culvert has the potential to catch storm debris. Taken near the outlet, facing upstream, March 18, 2026.
