# Exhibit C-1

December 29, 2022

Geologic Study  
Meka Vineyard Landslide Study  
4473 Atlas Peak Road  
Napa, California

Project Number: 7615.01.09.2

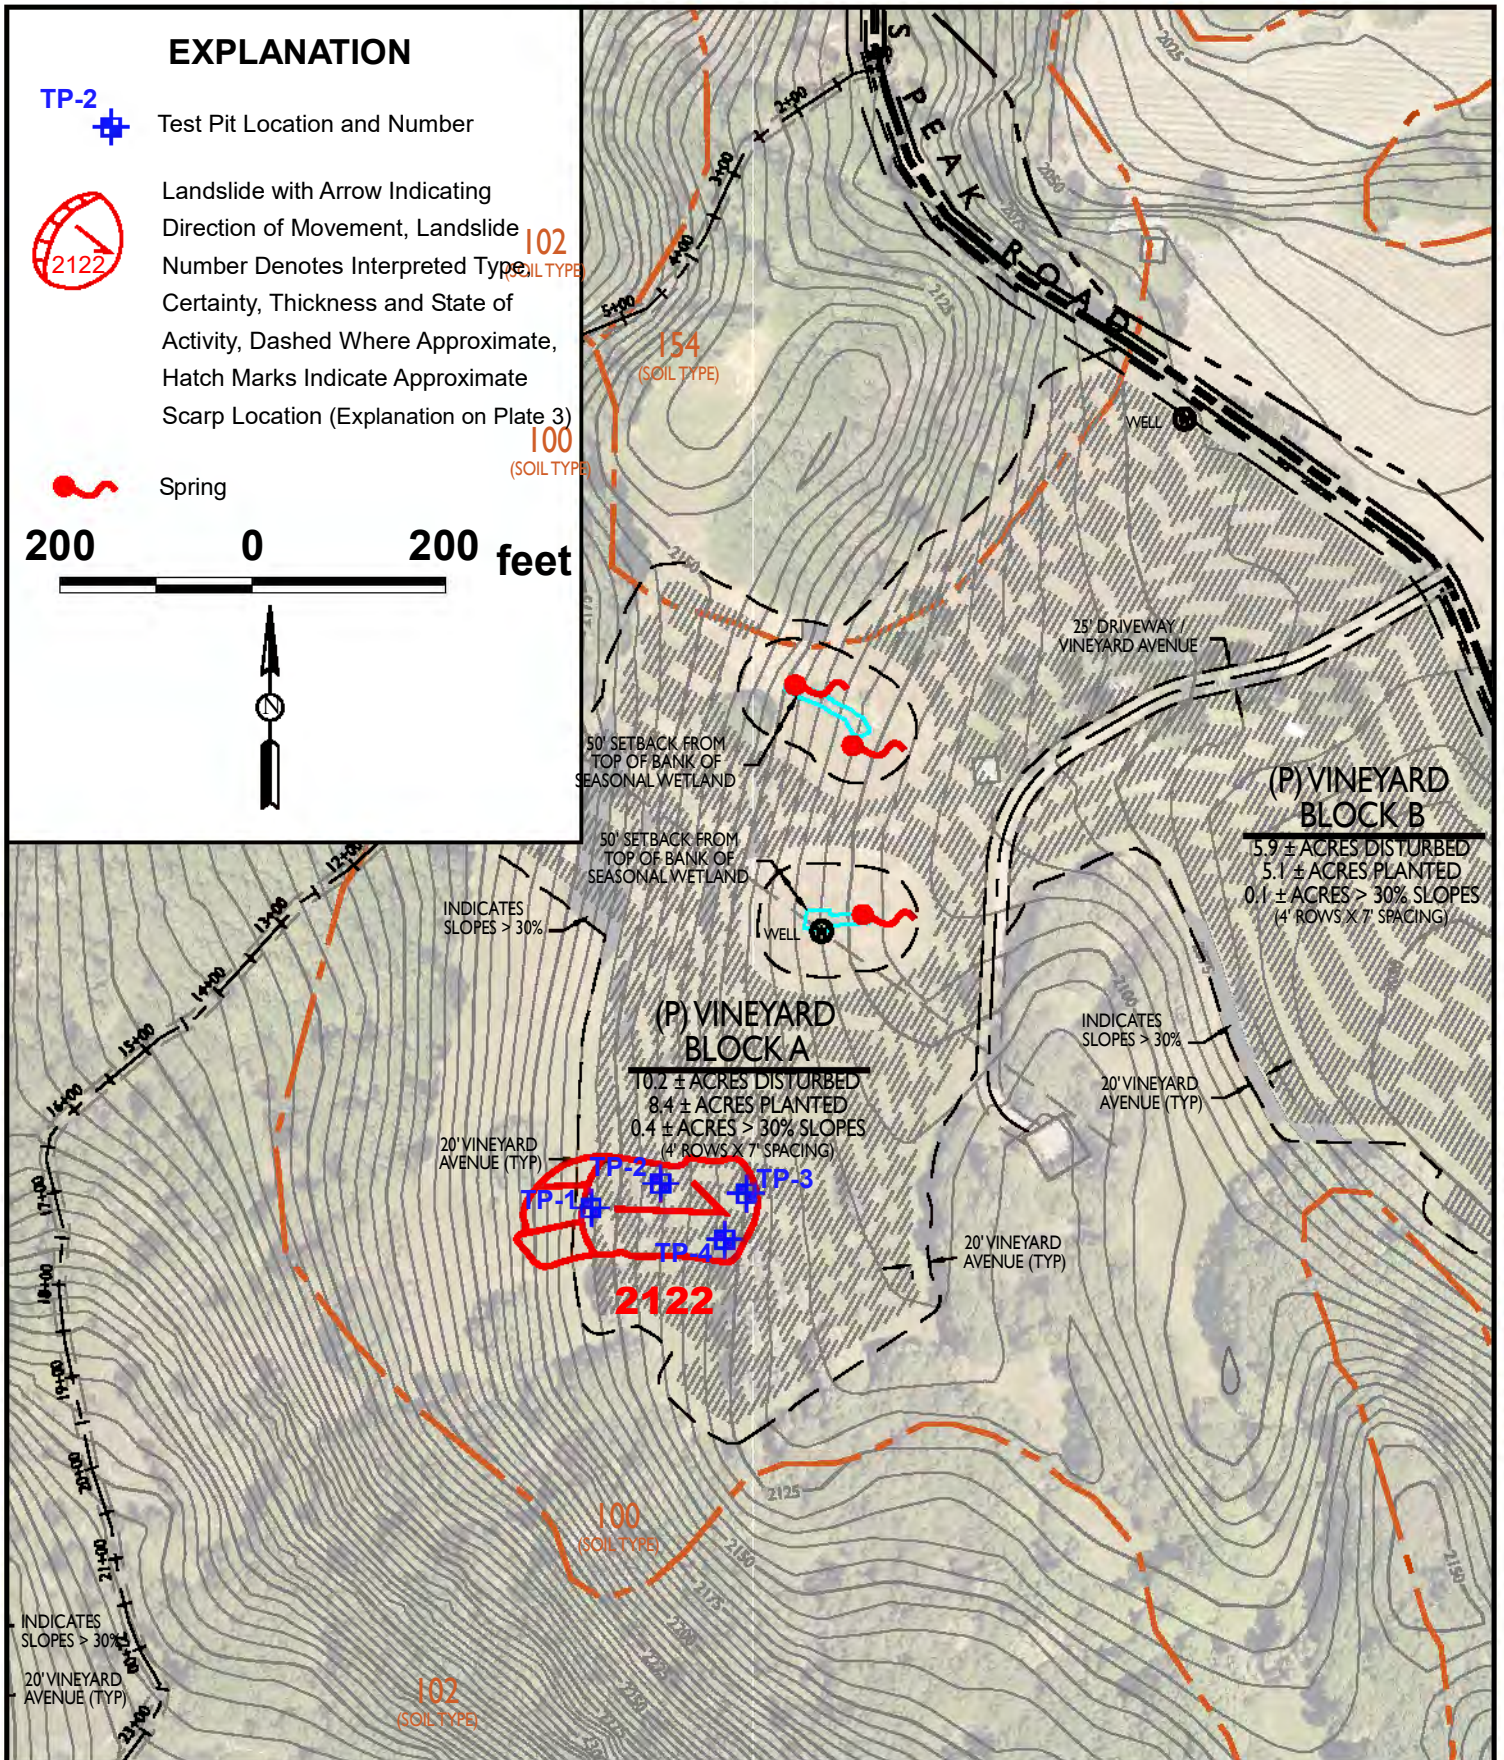
## EXPLORATION PLAN

We mapped the surface expression of the landslide and natural springs within Vineyard Block A, as shown on Plate 2. The landslide was identified using landslide identification nomenclature presented on Plate 3. The landslide in Vineyard Block A was designated as a translational slide with definite certainty, a thickness between 5 and 20 feet deep and dormant state of activity.

Our test pits and laboratory tests indicate that the landslide deposits in the southern portion of Vineyard Block A range in thickness from about 5 to greater than 12 feet. In test pit TP-2 we were unable to reach the bottom of the landslide deposits due to the capabilities of the exploration equipment. We judge that slide plane should be within a few feet of the depth of our exploration based on the depth of the slide plane encountered in test pits TP-1 and TP-4 located immediately upslope and downslope respectively of test pit TP-2. The landslide deposits are generally comprised of a heterogeneous mixture of sandy silt with cobbles and boulders. These deposits exhibit low plasticity (LL=39.8 and PI=11.5) and very low expansion potential (EI=11). A detailed description of the subsurface conditions found in our test pits is given on Plates 4 and 5. Free groundwater was not encountered in our test pits at the time of excavation.

Provided mitigation of the landslide is not performed, setbacks for vineyard plantings and avenues should be maintained at 30 feet or greater from the mapped perimeter of the landslide shown on Plate 2.

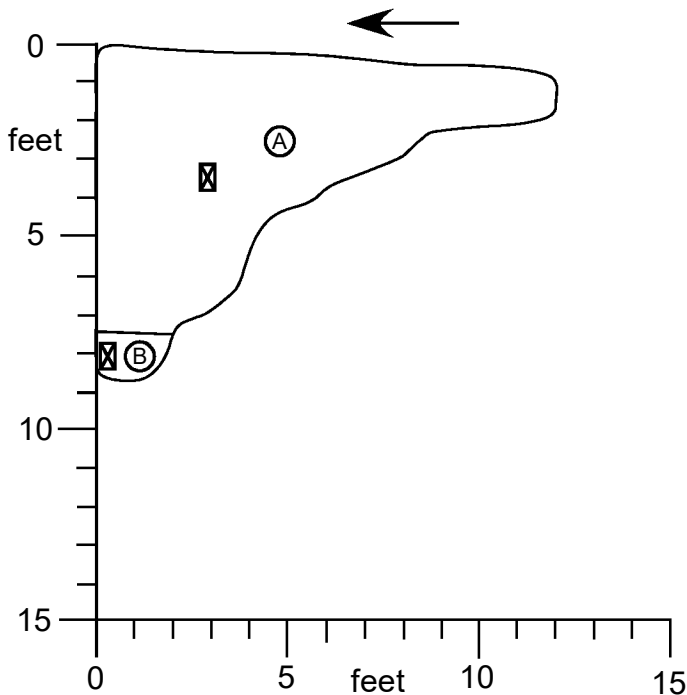
**TP-1**  
W 255°

- (A) REDDISH BROWN SANDY SILT WITH COBBLES AND BOULDERS (ML), stiff, dry, porous in upper 1/2 foot, abundant fine rootlets, tree roots to 7-1/2 feet, matrix supported with cobble sized sunrounded to subangular volcanic clasts scattered, picks up subangular boulders towards bottom (Landslide Deposits)

LL=39.8, PI=11.5, %<#200=54.8, EI=11(very low)

- (B) REDDISH BROWN AGGLOMERATE, massive, firm to moderately hard, moderately strong, moderately to highly weathered, resistant, subrounded volcanic cobbles and boulders within a weathered matrix

Excavator refusal at 8-1/2 feet  
No groundwater encountered

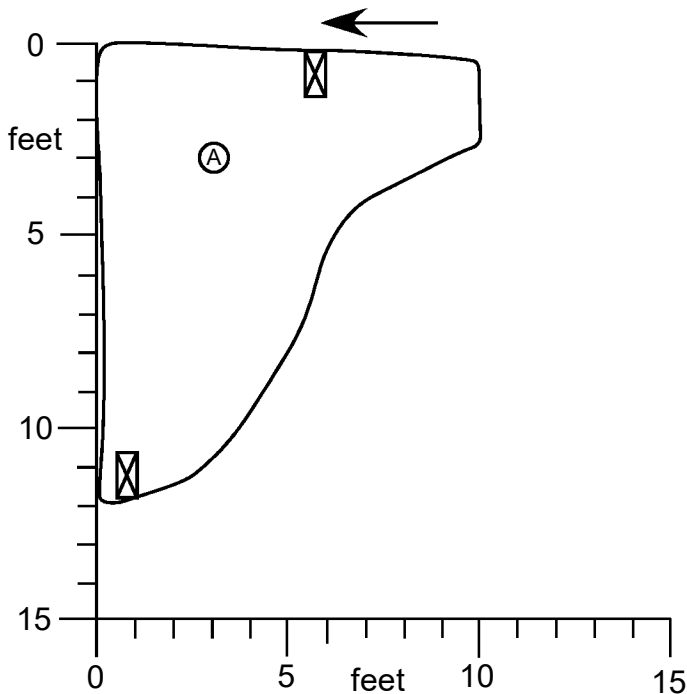
**TP-2**  
W 248°

- (A) REDDISH BROWN SANDY SILT WITH COBBLES AND BOULDERS (ML), stiff, dry, porous in upper 1/2 foot, abundant fine rootlets, tree roots to 7-1/2 feet, matrix supported with minor subrounded cobbles, scattered, subangular boulders towards bottom (Landslide Deposits)

No Groundwater encountered

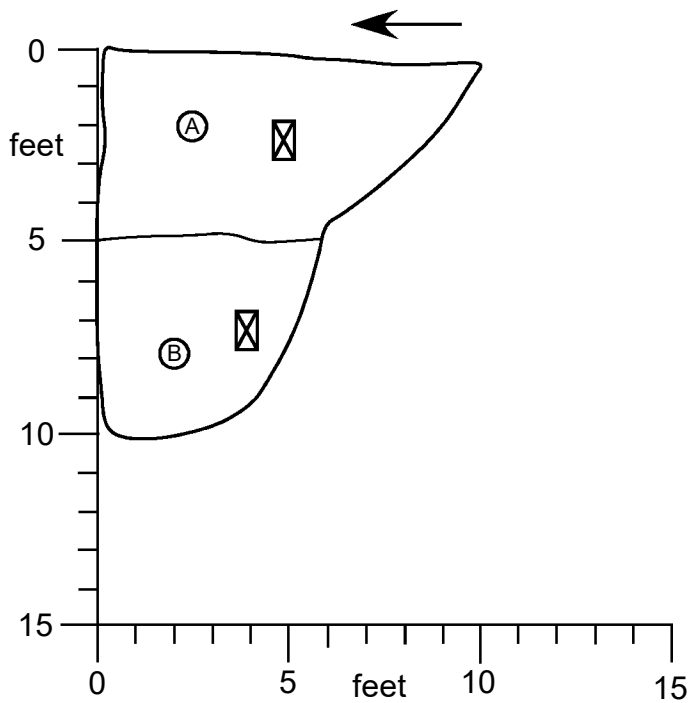
**TP-3**  
SW 245°

- (A) REDDISH BROWN BOULDERS AND COBBLES WITH SILT AND SAND, loose in upper 1 foot, dry, porous in upper 1 foot, rootlets, matrix supported, subangular to subrounded cobbles and boulders, boulders up to 3 feet long and 2 feet wide (Landslide Deposit)
- (B) YELLOW BROWN TUFFACEOUS AGGLOMERATE, massive, firm to moderately hard, moderately strong, moderately to highly weathered, basaltic andesite clasts in SILTY/SAND matrix

No groundwater encountered

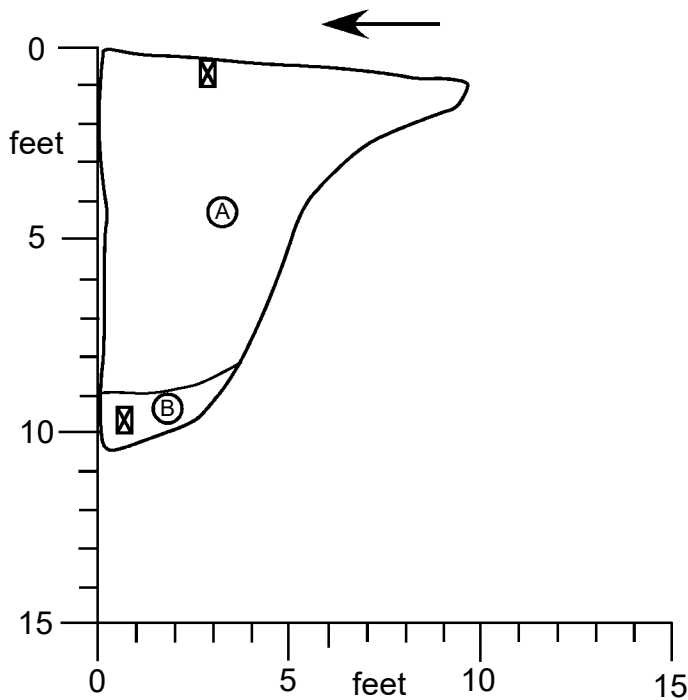
**TP-4**  
SW 242°

- (A) REDDISH BROWN BOULDERS AND COBBLES WITH SILT AND SAND, loose in upper 1 foot, dry and porous in upper 2 feet, rootlets, matrix supported, subangular to subrounded cobbles and boulders, boulders up to 3 feet long and 2 feet wide (Landslide Deposit)
- (B) YELLOW / BROWN LITHIC TUFF, massive, firm to moderately hard, weak to moderately strong, highly weathered

Excavator refusal at 10-1/2 feet  
No groundwater encountered
