### Tree Inventory Report

**CITY OF LOS ANGELES PROTECTED TREE REPORT  
THE STAR  
6061, 6063, 6069 & 6087 W. SUNSET BOULEVARD  
LOS ANGELES, CA 90028**

**APRIL 3, 2025**

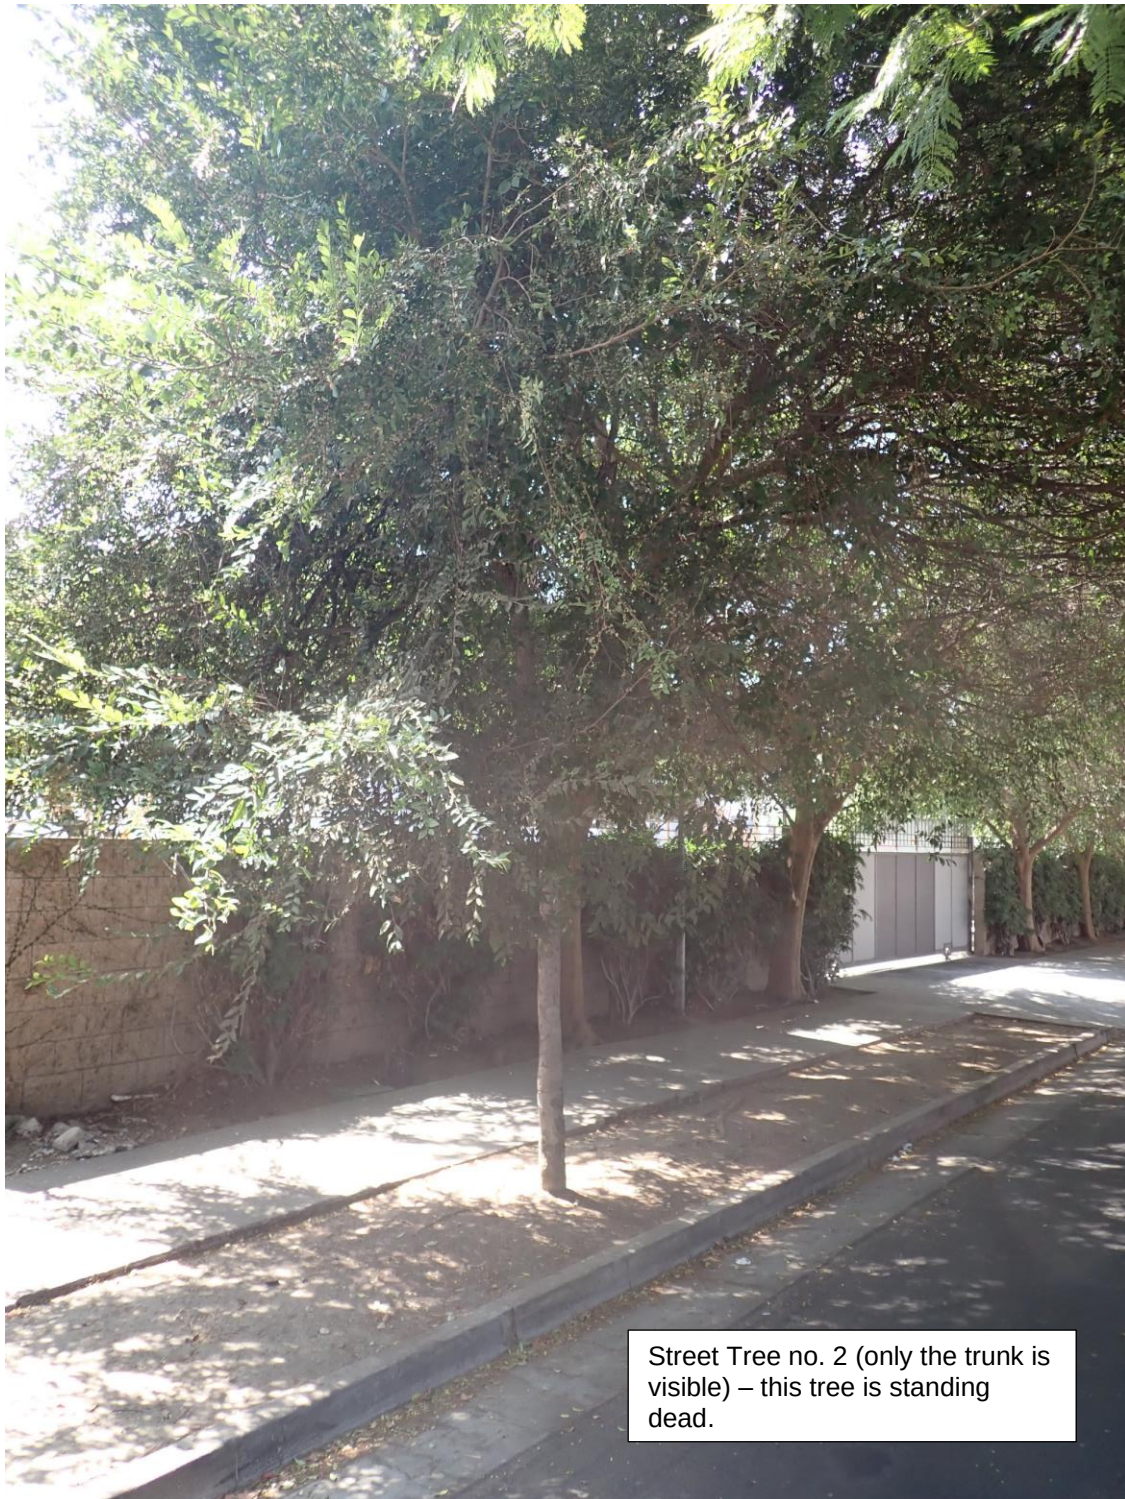
Tree ST2 (Protected) – pink trumpet tree (*Handroanthus impetiginosus*) facing southwest

Street Tree no. 2 (ST2) is recommended for removal because it is standing dead, therefore has hazardous risks.

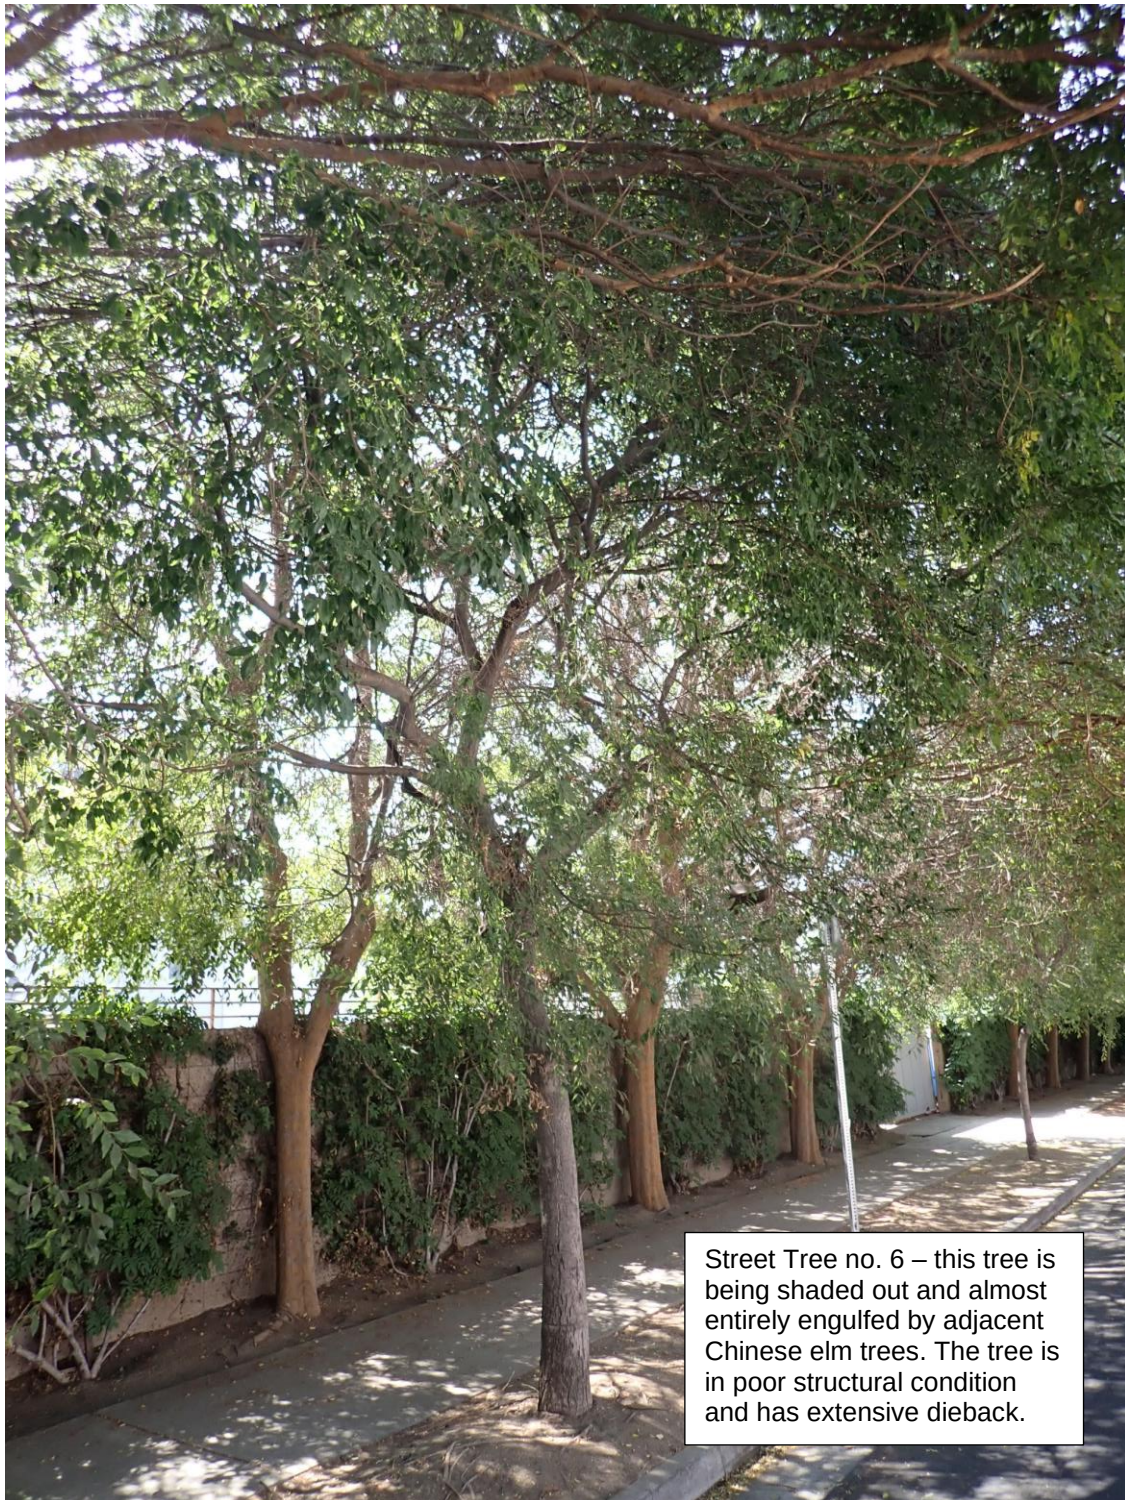
Tree ST6 (Protected) – pink trumpet tree (*Handroanthus impetiginosus*) facing southwest

Street Tree no. 6 (ST6) is recommended for removal due to its poor structural condition. The tree has extensive dieback and has been shaded out over the years by adjacent Chinese elm trees that have almost fully engulfed the canopy.

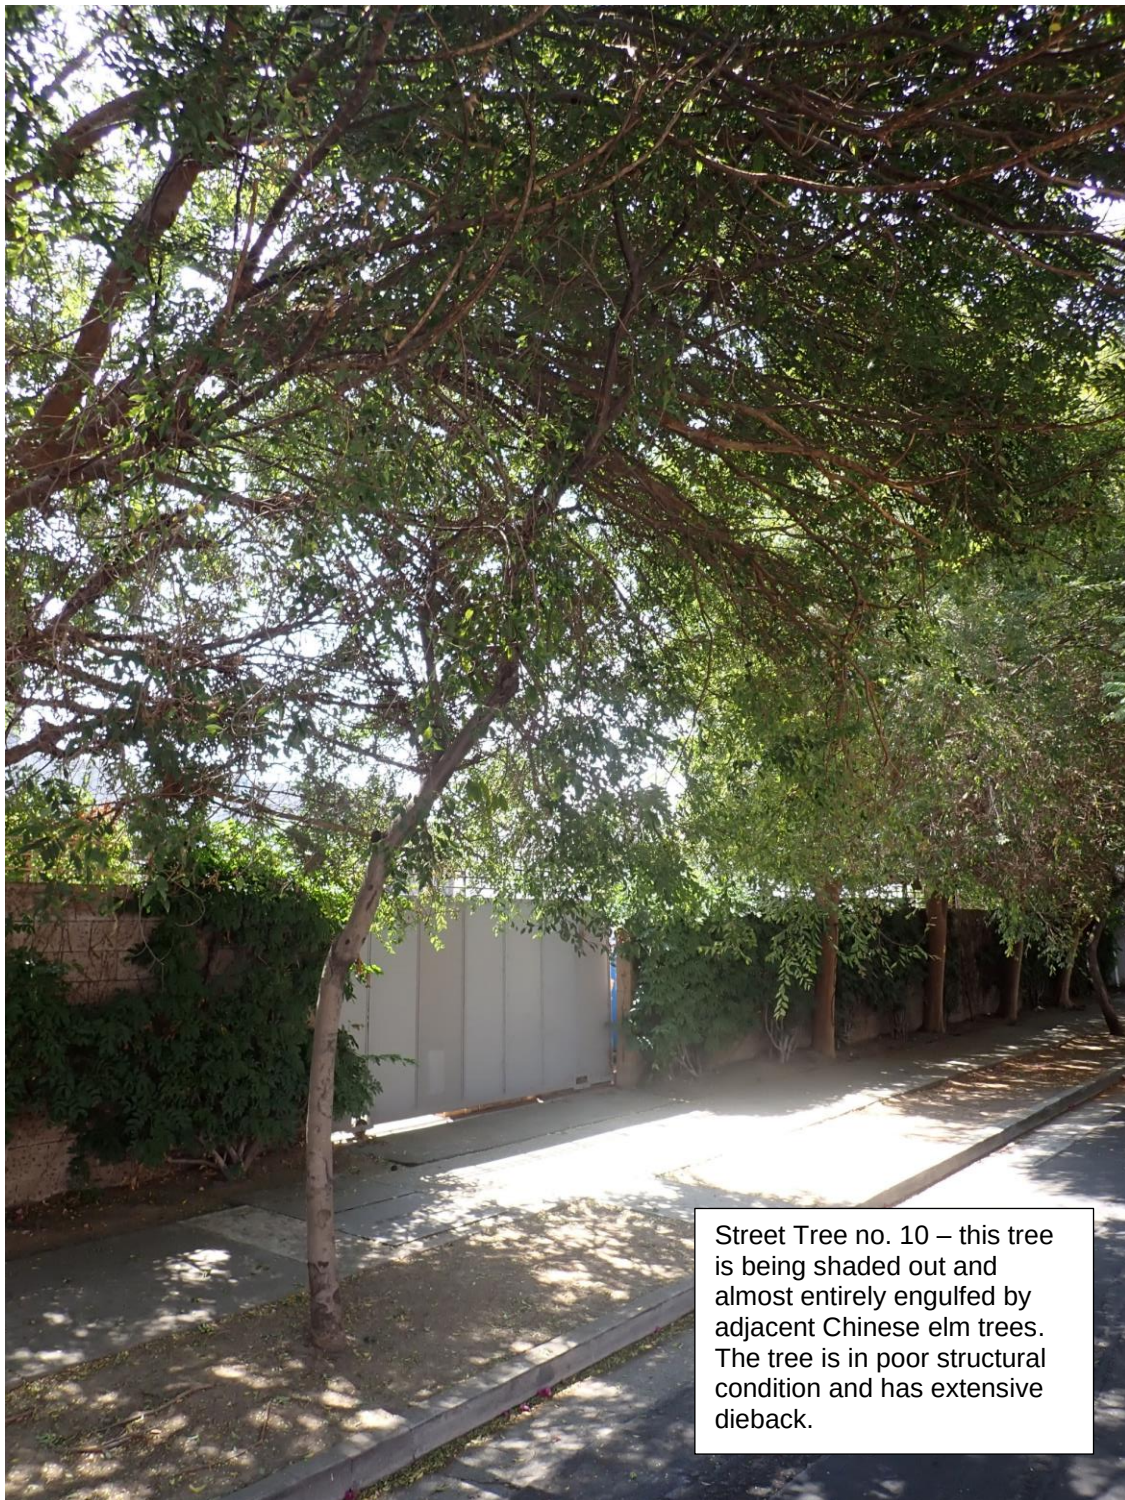
Tree ST10 (Protected) – pink trumpet tree (*Handroanthus impetiginosus*) facing southwest

Street Tree no. 10 (ST10) is recommended for removal due to its poor structural condition. The tree is mostly dead and has been shaded out over the years by adjacent Chinese elm trees that have almost fully engulfed the canopy.

Street Tree no. 10 – this tree is being shaded out and almost entirely engulfed by adjacent Chinese elm trees. The tree is in poor structural condition and has extensive dieback.

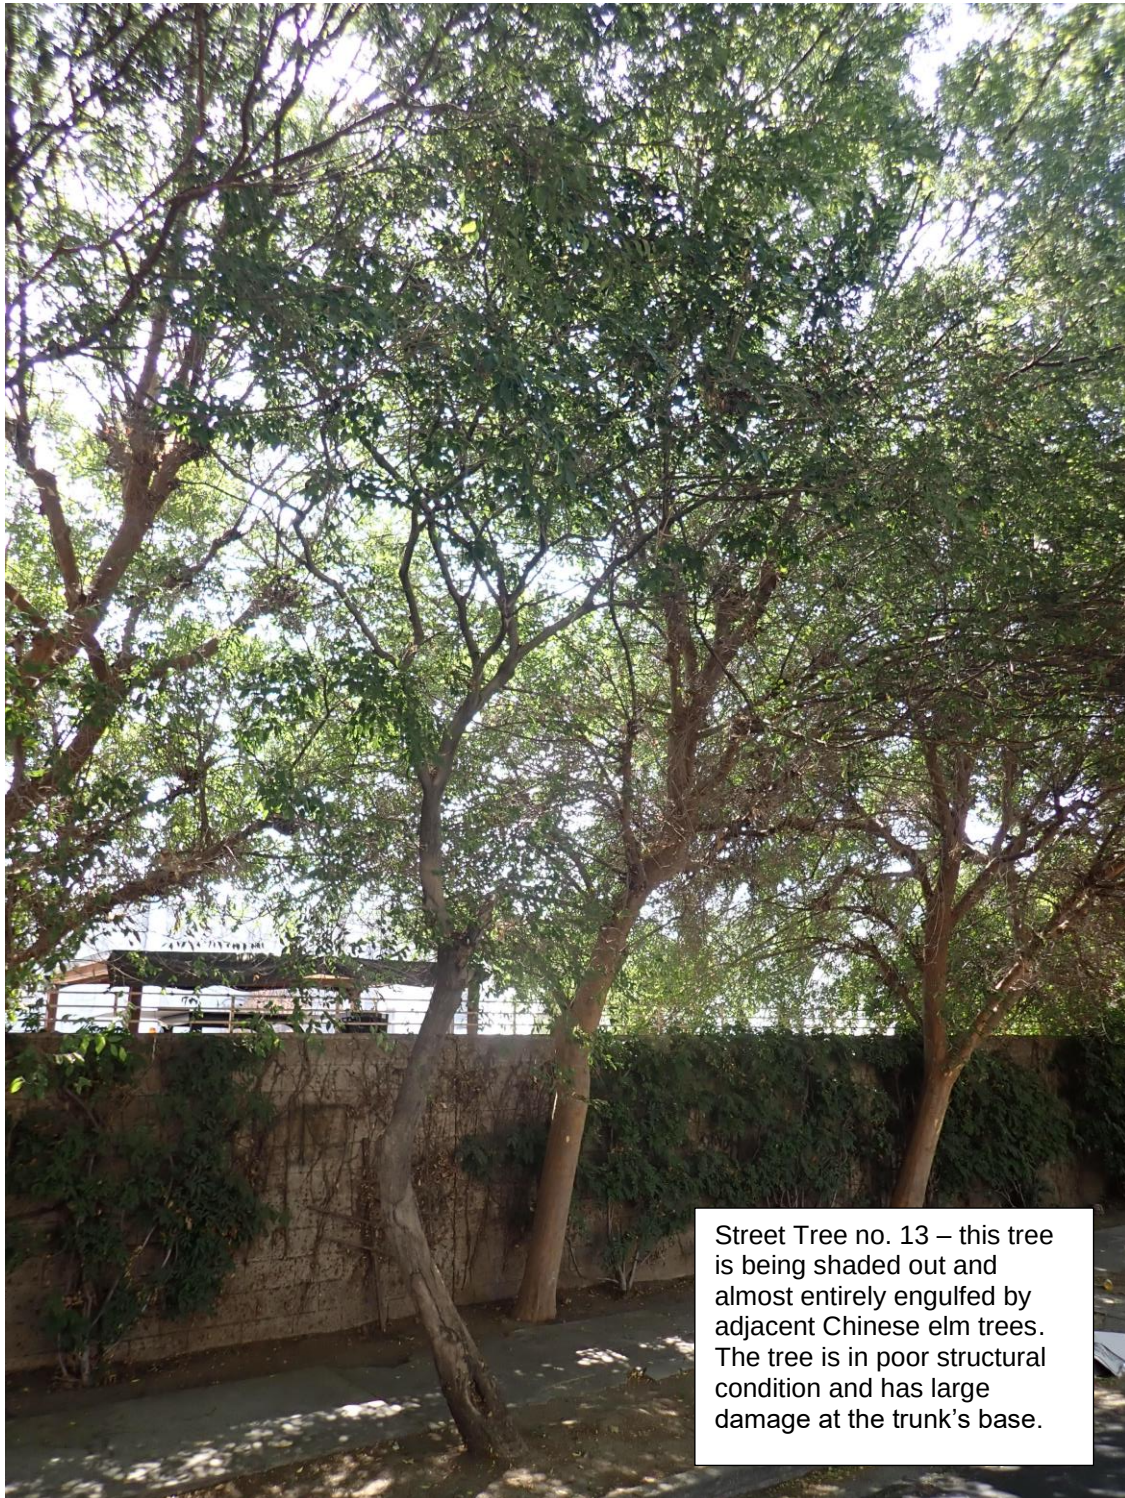
Tree ST13 (Protected) – pink trumpet tree (*Handroanthus impetiginosus*) facing southwest

Street Tree no. 13 (ST13) is recommended for removal due to its poor structural condition. The tree has a large amount of damage at the trunk's base, extensive dieback and has been shaded out over the years by adjacent Chinese elm trees that have almost fully engulfed the canopy.

| Street Tree/<br>Offsite/Private<br>Property (ST,<br>OS, PP) | Tree<br>ID<br>No. | Common Name | Botanical Name | DSH /<br>DBH<br>(in.) | BT Ht.<br>(palms/palm-<br>like) (Ft.) | DSH <<br>4" or<br>Sapling | Height<br>(Ft.) | Canopy<br>N (Ft.) | Canopy<br>E (Ft.) | Canopy<br>S (Ft.) | Canopy<br>W (Ft.) | Health<br>Grade | Structure<br>Grade | Infectious<br>Disease | Suggested<br>Treatments | Naturally<br>Occurring<br>(N) or<br>Planted<br>(P) | Comments | Disposition<br>(Preserve,<br>Remove) | Reason for<br>Removal | Replacement<br>Ratio |
|---|---|---|---|---|---|---|---|---|---|---|---|---|---|---|---|---|---|---|---|---|
| ST | 13 | pink trumpet tree | <i>Handroanthus impetiginosus</i> | 7 | | | 18 | 11 | 12 | 0 | 5 | B- | C | | | P | damage at base,<br>shaded out,<br>moderate dieback,<br>HOB, break on ST<br>side | Remove | Poor<br>structure –<br>see notes on<br>p. 14-15 | 2:1 |

Street Tree no. 13 – this tree is being shaded out and almost entirely engulfed by adjacent Chinese elm trees. The tree is in poor structural condition and has large damage at the trunk's base.

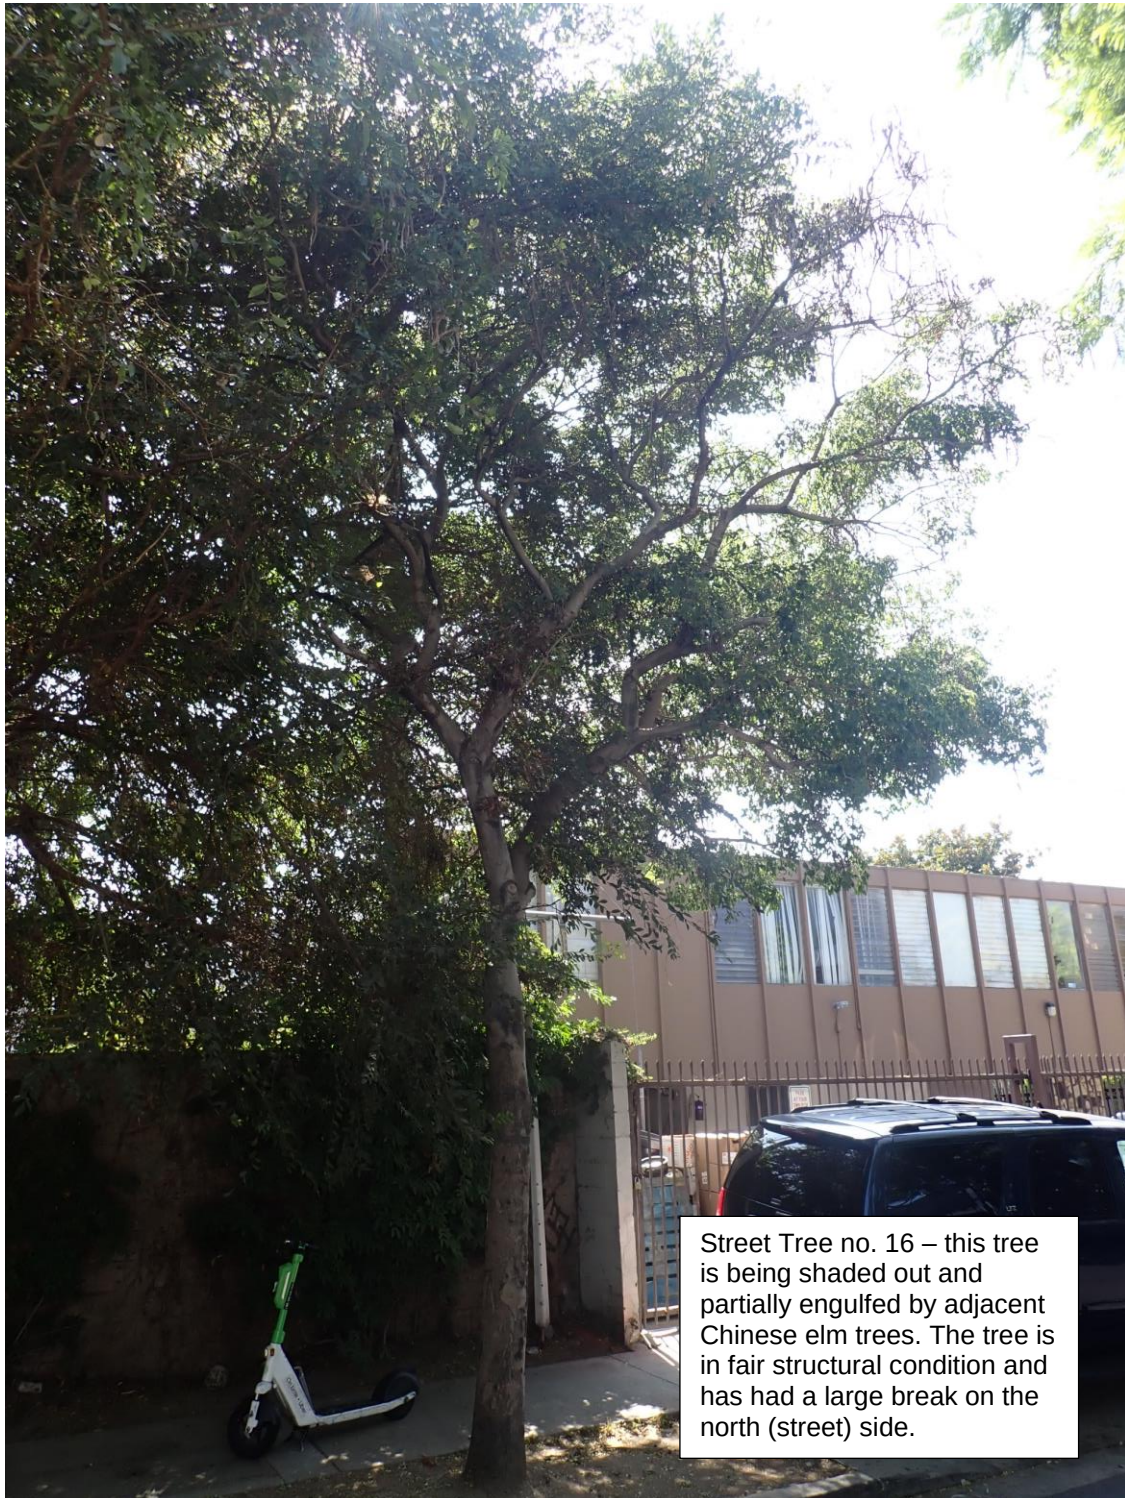
Tree ST16 (Protected) – pink trumpet tree (*Handroanthus impetiginosus*) facing south

Street Tree no. 16 (ST16) is recommended for removal due to being shaded out over the years by adjacent Chinese elm trees that have partially engulfed the canopy. The tree has a large break on the north (street) side.

Street Tree no. 16 – this tree is being shaded out and partially engulfed by adjacent Chinese elm trees. The tree is in fair structural condition and has had a large break on the north (street) side.

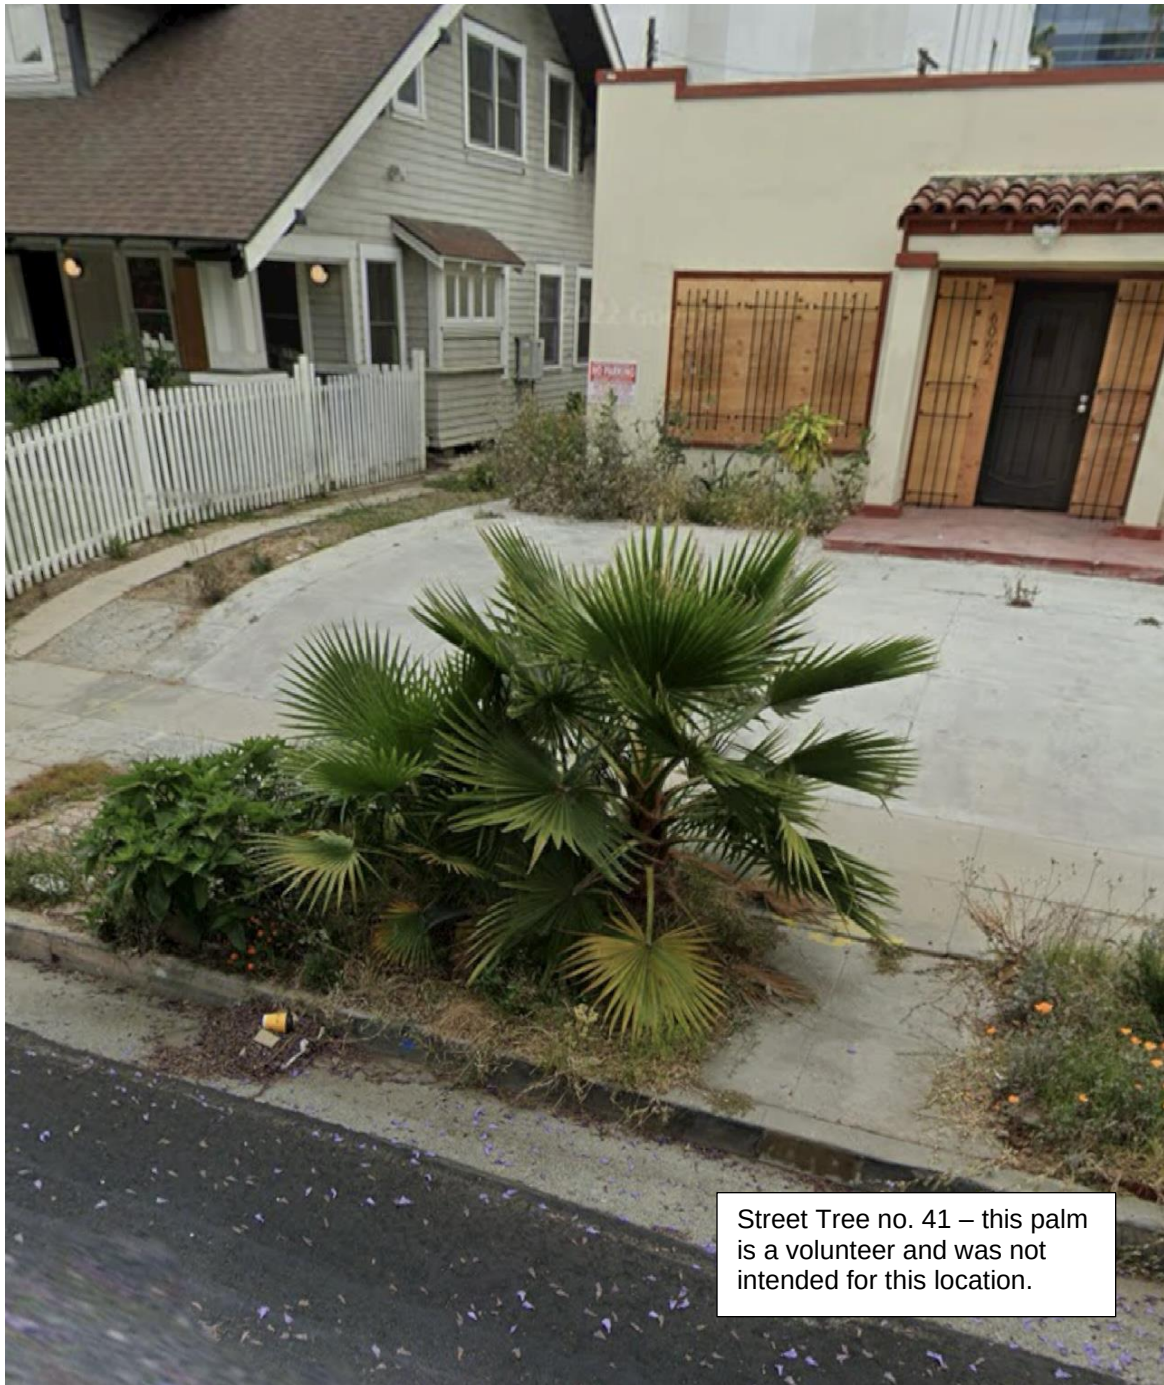
Tree ST41 (Protected) – Mexican fan palm (*Washingtonia robusta*) facing south

Street Tree no. 41 (ST41) is recommended for removal because it is a palm volunteer that was not planted in nor intended for this space. The palm was only between two and three feet in height at the time of our assessment.

| Street Tree/<br>Offsite/Private<br>Property (ST,<br>OS, PP) | Tree<br>ID<br>No. | Common Name | Botanical Name | DSH /<br>DBH<br>(in.) | BT Ht.<br>(palms/palm-<br>like) (Ft.) | DSH <<br>4" or<br>Sapling | Height<br>(Ft.) | Canopy<br>N (Ft.) | Canopy<br>E (Ft.) | Canopy<br>S (Ft.) | Canopy<br>W (Ft.) | Health<br>Grade | Structure<br>Grade | Infectious<br>Disease | Suggested<br>Treatments | Naturally<br>Occurring<br>(N) or<br>Planted<br>(P) | Comments | Disposition<br>(Preserve,<br>Remove) | Reason for<br>Removal | Replacement<br>Ratio |
|---|---|---|---|---|---|---|---|---|---|---|---|---|---|---|---|---|---|---|---|---|
| ST | 41 | Mexican fan palm | <i>Washingtonia robusta</i> | | 1, 2 | | 3 | 3 | 3 | 3 | 3 | A | B | | | P | volunteer | Remove | Volunteer –<br>see notes on<br>p. 14-15 | 2:1 |
