September 26, 2025  
Rincon Project No. 25-17323

**Subject: Jurisdictional Assessment of two Shallow Retention Basins for the Forest Lawn Cathedral City Specific Plan Project in Cathedral City, Riverside County, California**

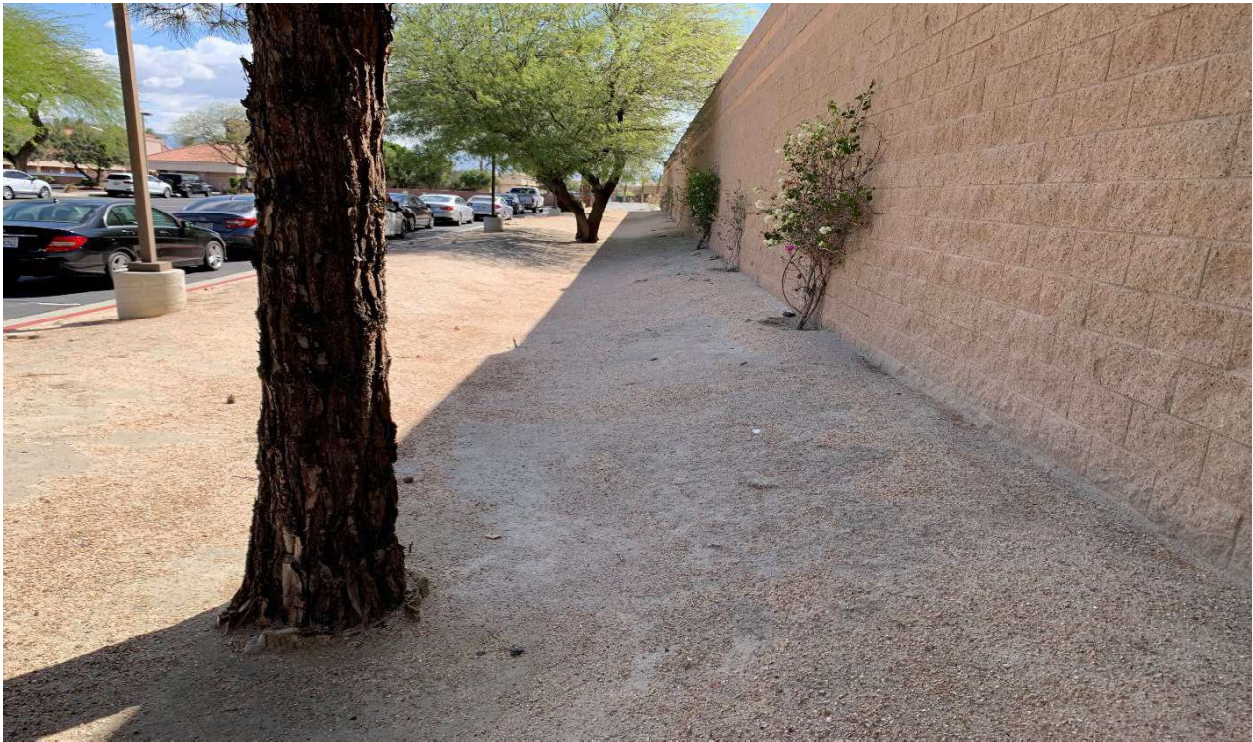
**Photograph 1.** East-facing view of landscaped area south of parking lot where runoff is collected.

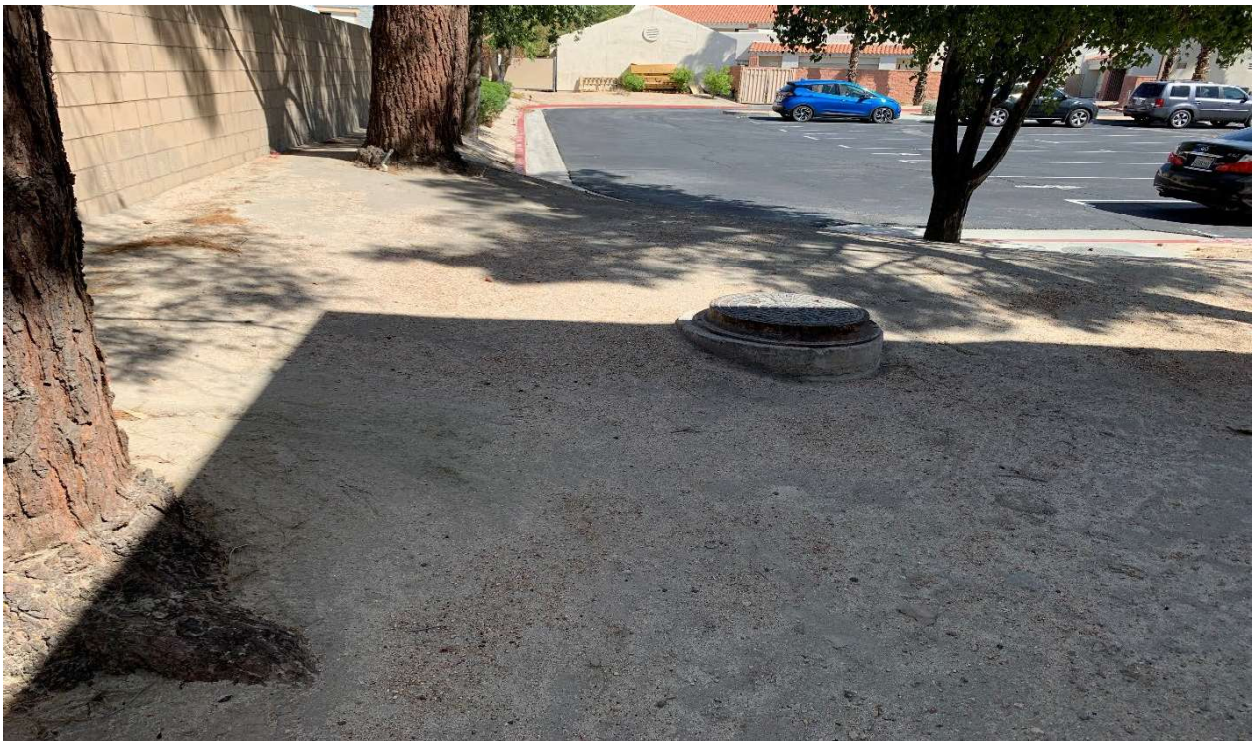
**Photograph 2.** A man-hole is shown in the landscaped area in between the shallow retention basins and the parking lot. No drainage feature or evidence of flows is present.

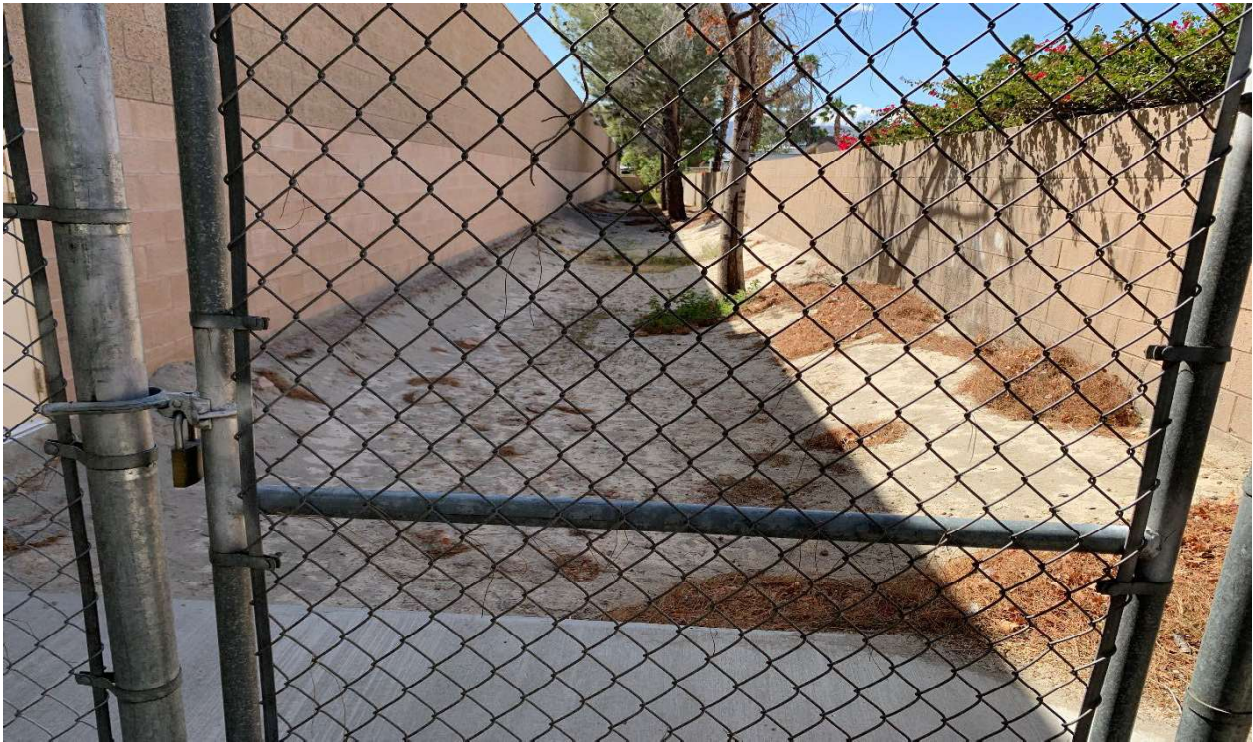
**Photograph 3.** South-facing view of chain-link fence and north end of the retention basin.

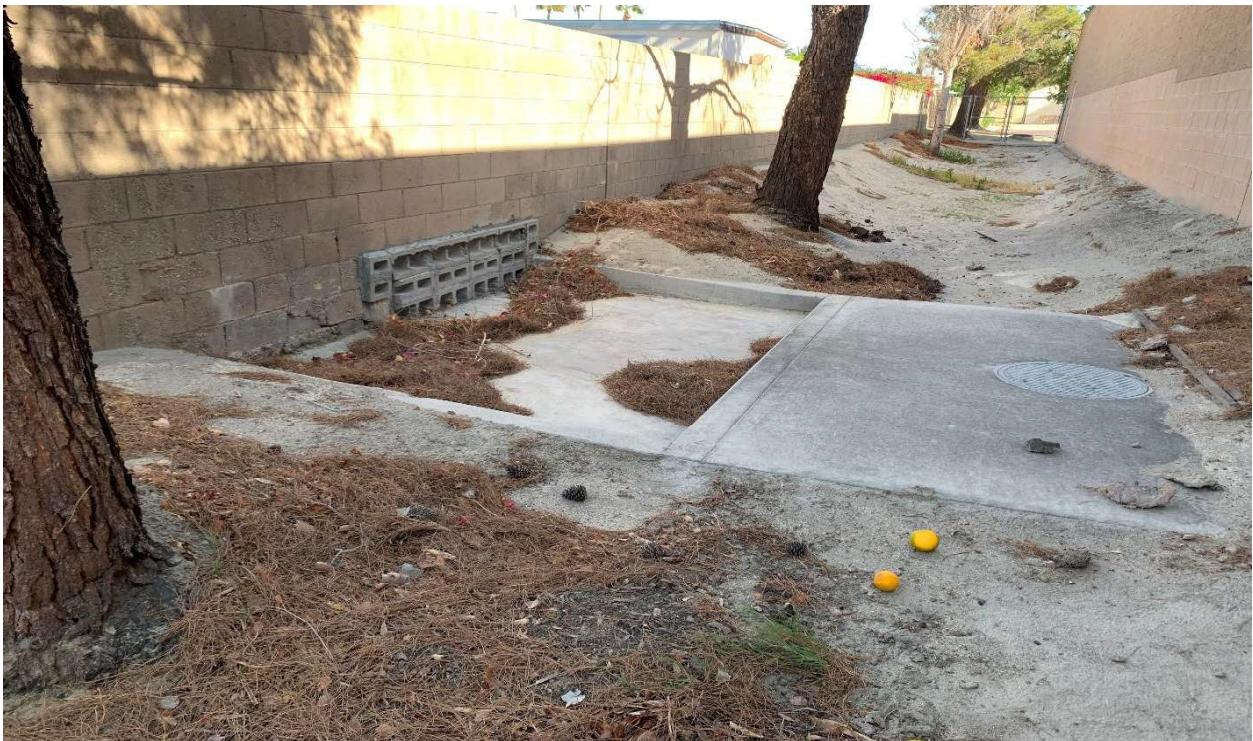
In a small area within the north-south trending portion of the retention basins, a concrete pad and flat, narrow culvert collects road runoff from an offsite concrete channel to the west and conveys this runoff into the underground storm drain system.

**Photograph 4.** View of concrete pad and flat, narrow culvert collecting road runoff from offsite, facing northwest.

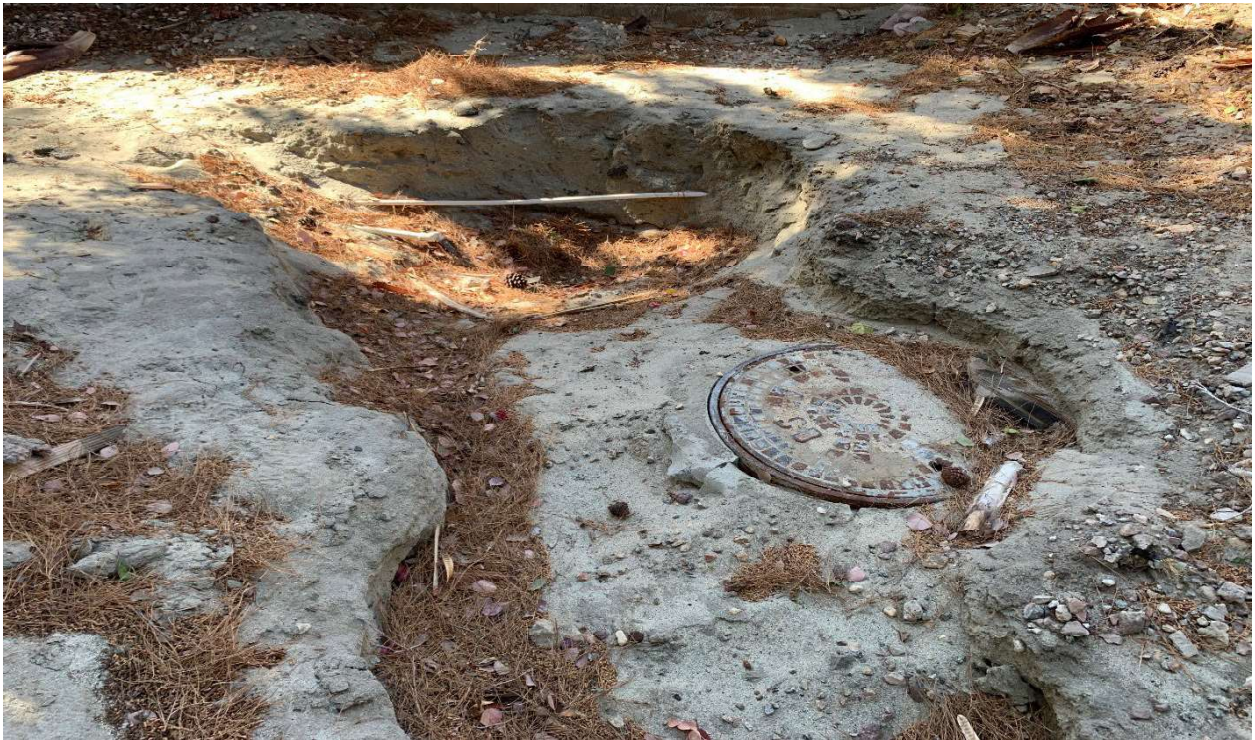
Despite the presence of a slight depression within the shallow retention basins, no evidence of hydrology such as sediment transport or deposits, drift deposits, an OHWM, or bed and banks were observed, with the exception of one small area at the southwest corner of the basins where erosion has exposed a manhole and a PVC pipeline. The sandy substrates that are within the basins were likely placed as backfill on top of the underground storm drain system. The basins potentially collect surface runoff from the parking lot and adjacent areas; however, no drainage features are present within the project site. Water within the basins is primarily conveyed through the underground storm drain system. No wetland or hydrophytic vegetation was observed within the storm drain easement. Additionally, as reviewed on aerial photography and confirmed in the field, there is no upstream or downstream connectivity from the basins to any drainage features. As a result, USACE-jurisdictional waters of the U.S., RWQCB-jurisdictional waters of the State, and CDFW-jurisdictional streambeds are not present within the basins.

**Photograph 5.** Eroded area with man-hole and exposed PVC pipe at southwest corner of retention basin.

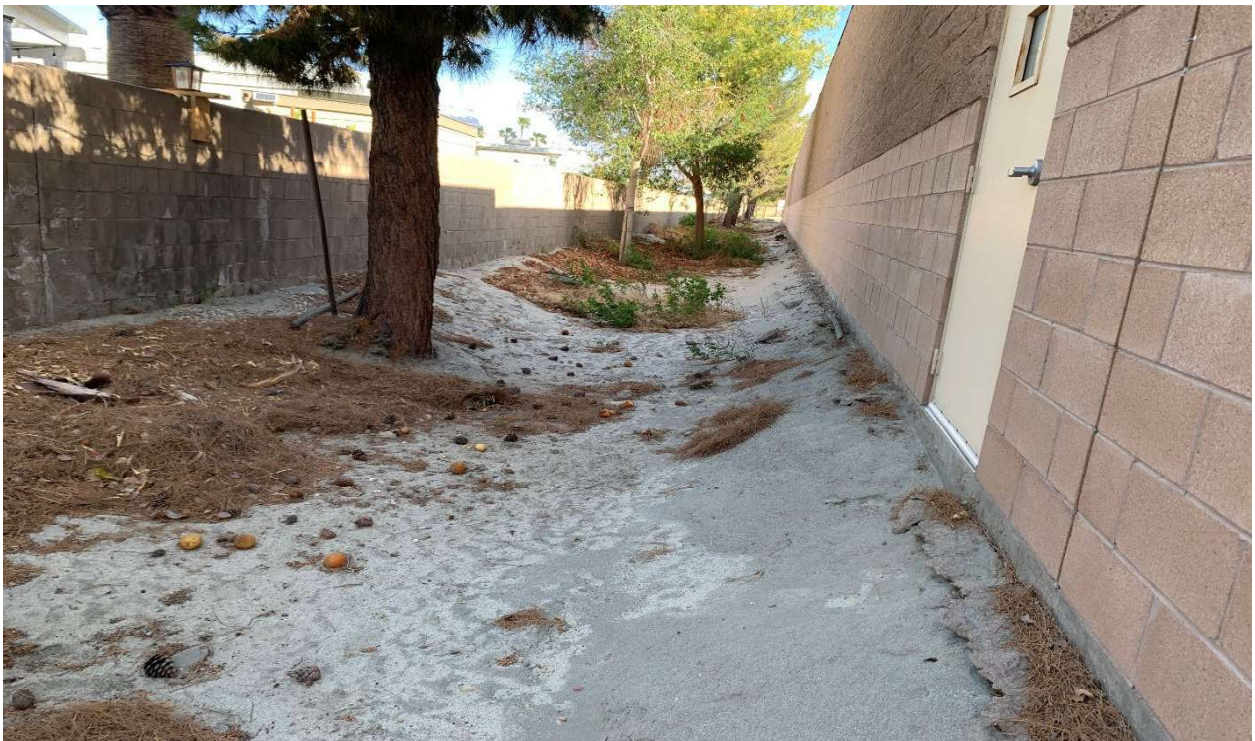
**Photograph 6.** View of ornamental trees in the retention basin, facing north.

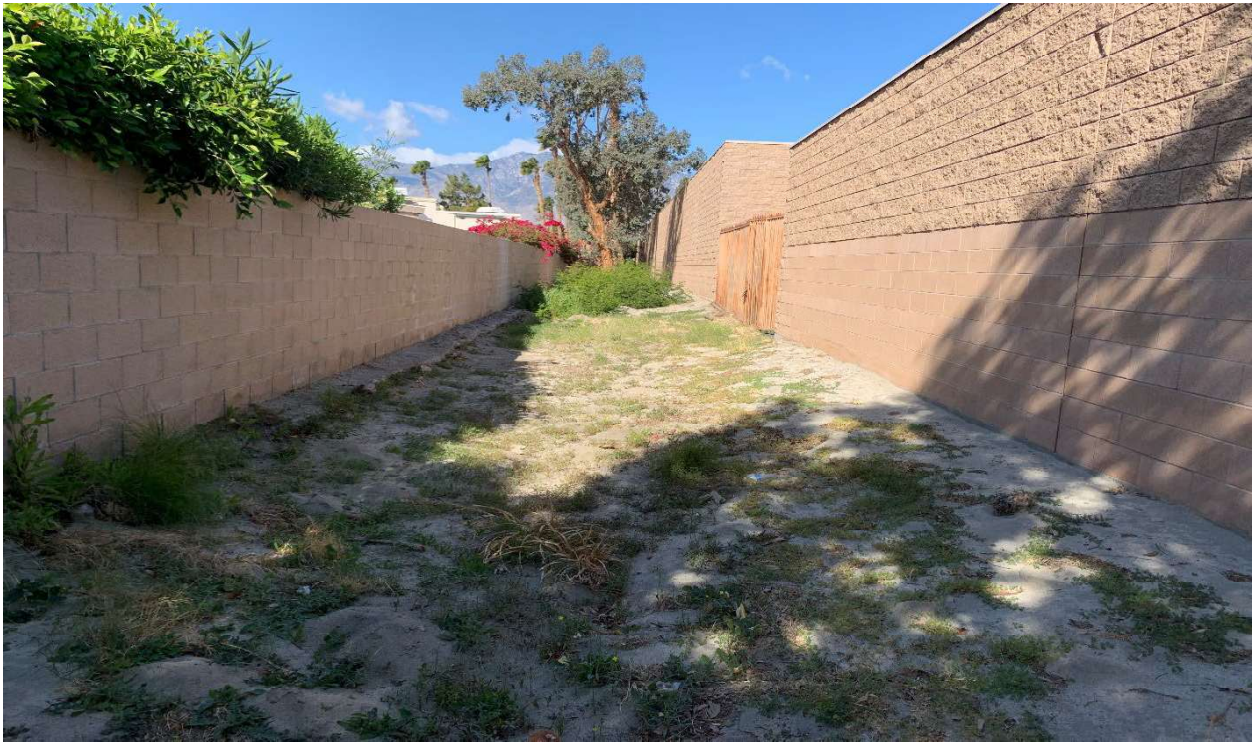
**Photograph 7.** View of Eucalyptus trees and weedy vegetation in retention basin, facing west.

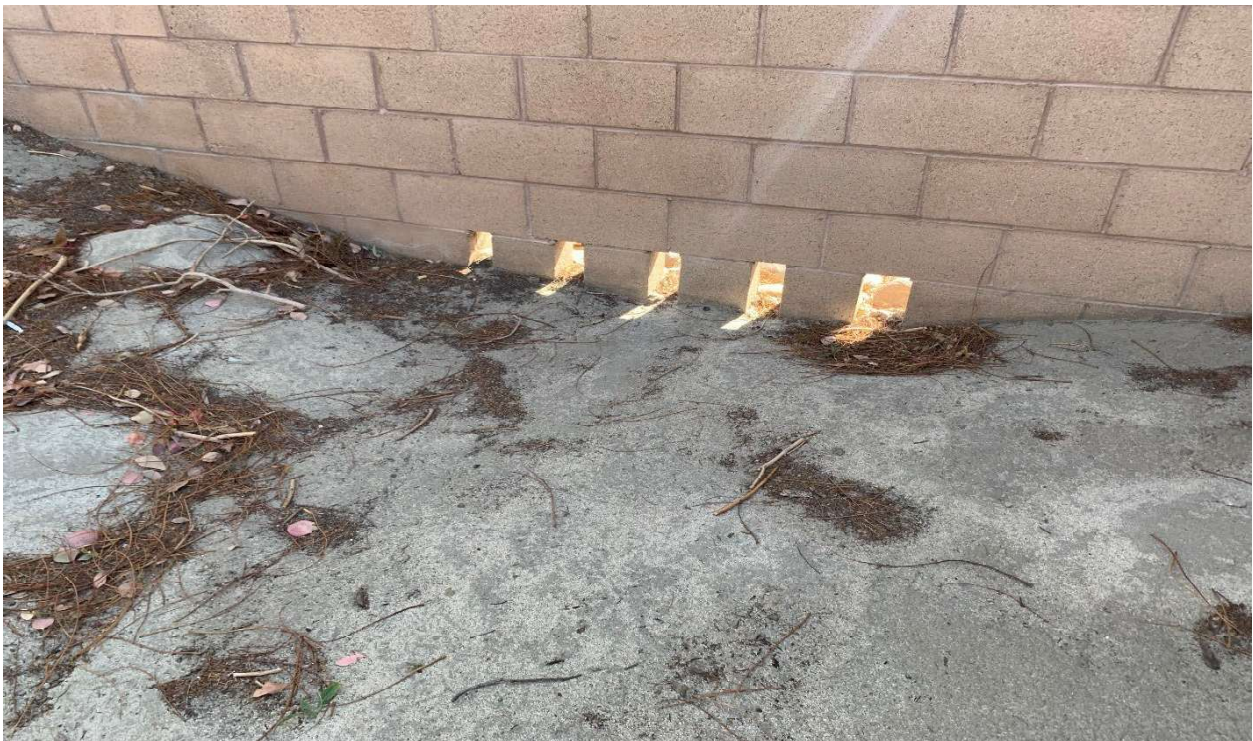
Surface runoff within the retention basins exits at their east-end through five small gaps at the bottom of an existing brick wall. UngROUTED riprap has been placed on the east side of this wall, presumably to control erosion before surface runoff reaches Da Vall Drive. Water within the underground storm drain system is conveyed under Da Vall Drive and exits via a 12-inch pipe onto ungrouted riprap until reaching a concrete channel that conveys flows further away from the project site to the northeast.

**Photograph 8.** View of east end of retention basin, where runoff exits through five gaps at the bottom of the brick wall.

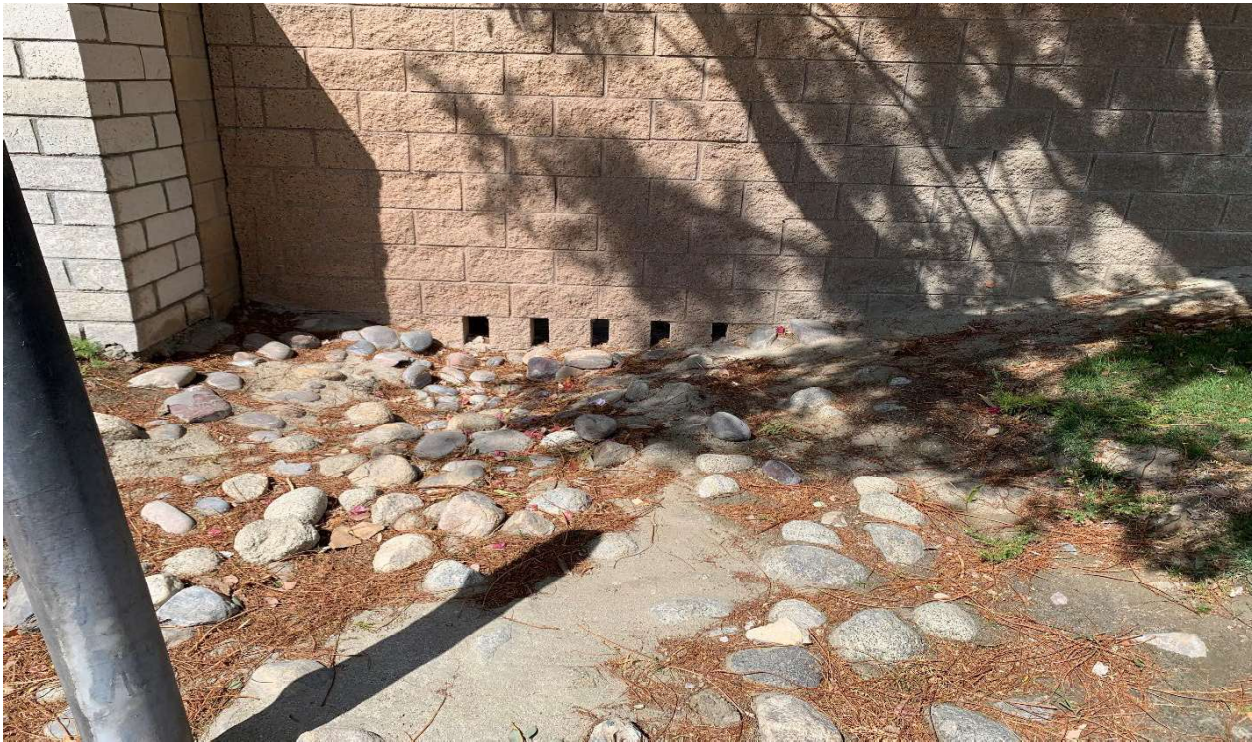
**Photograph 9.** View of ungrouted riprap on east side of brick wall with five gaps in the wall shown.

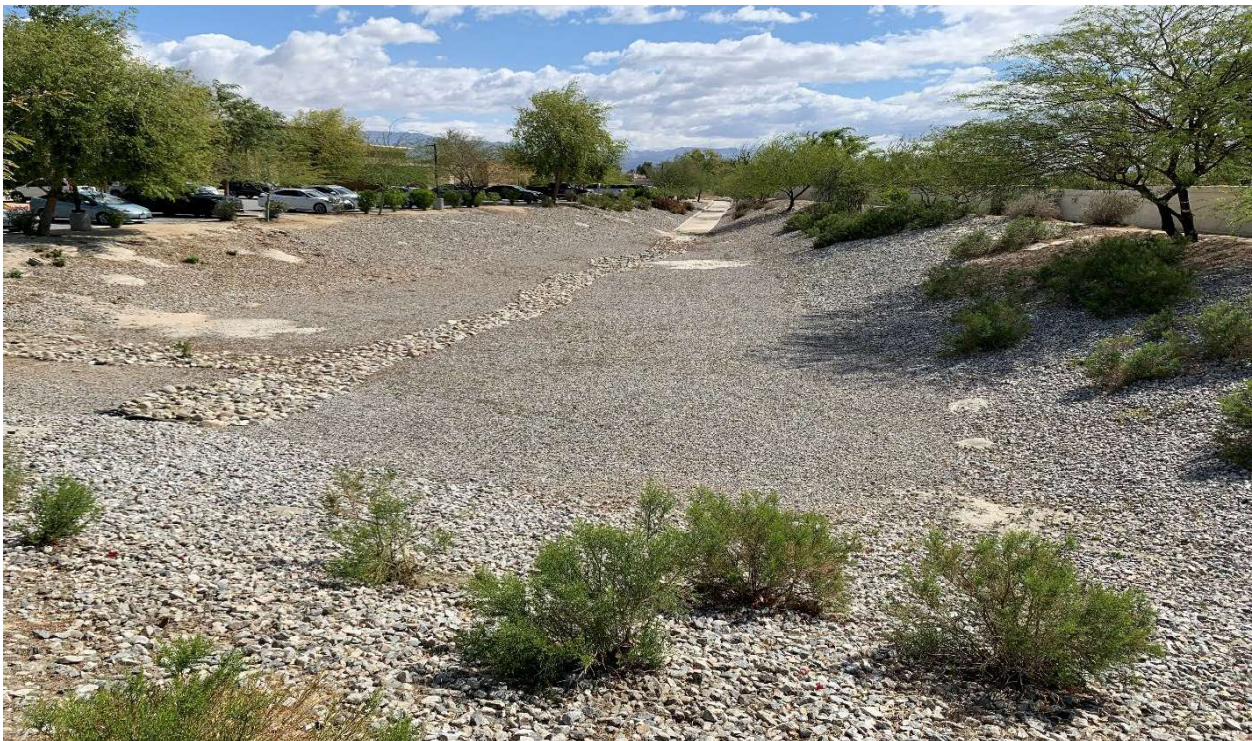
**Photograph 10.** East-facing view of area where flows from the underground storm drain outlet east of Da Vall Drive.
