# **Arborist Survey Report for the Century Palms Project**

**Sacramento County, California**

D. R. Horton CA2, Inc.

**July 2025**

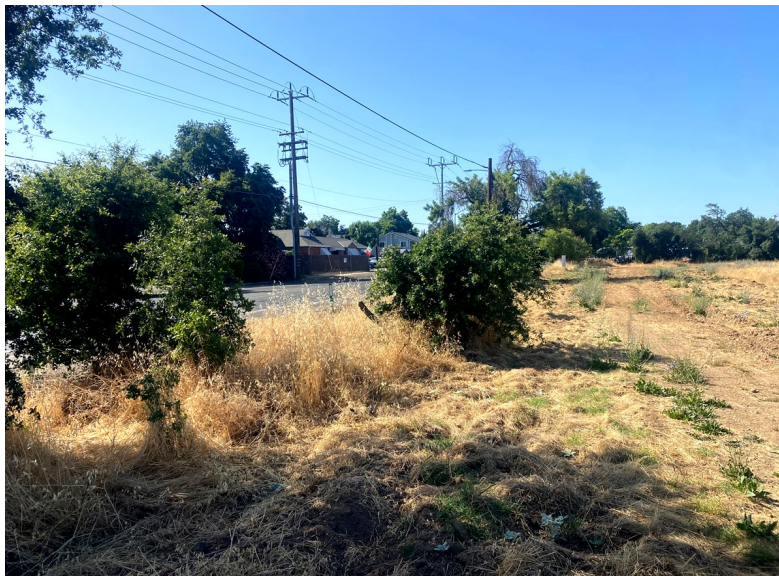
**Photo 1. Representative Photo of the Trees within the Study Area (facing southeast; July 12, 2025).**

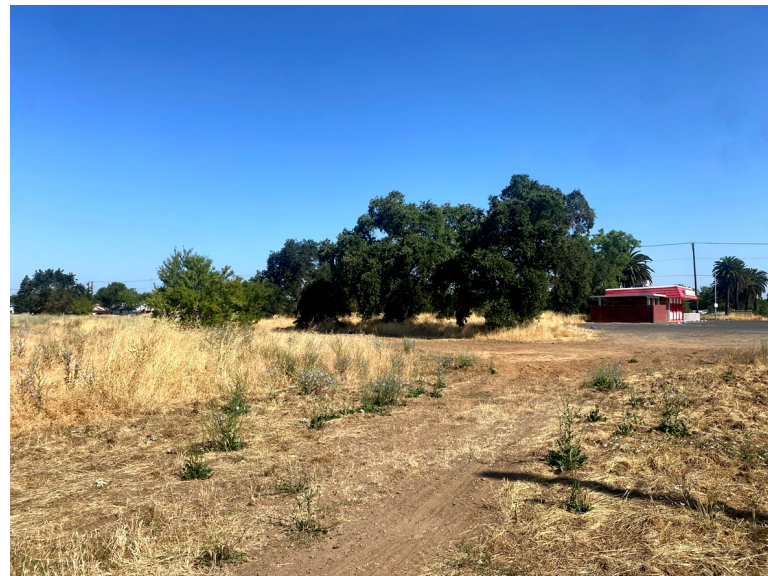
**Photo 2. Representative Photo of the Trees within the Study Area (facing northwest; July 12, 2025).**

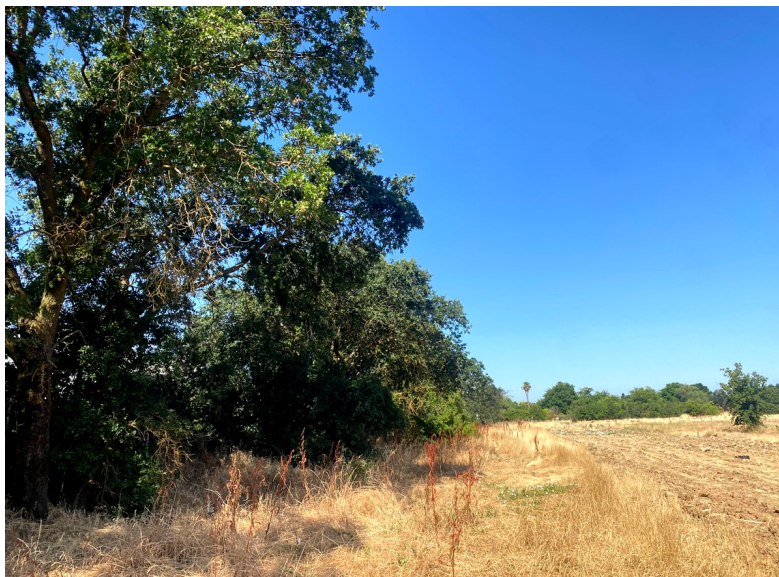
**Photo 3. Representative Photo of the Trees within the Study Area (facing west; July 12, 2025).**

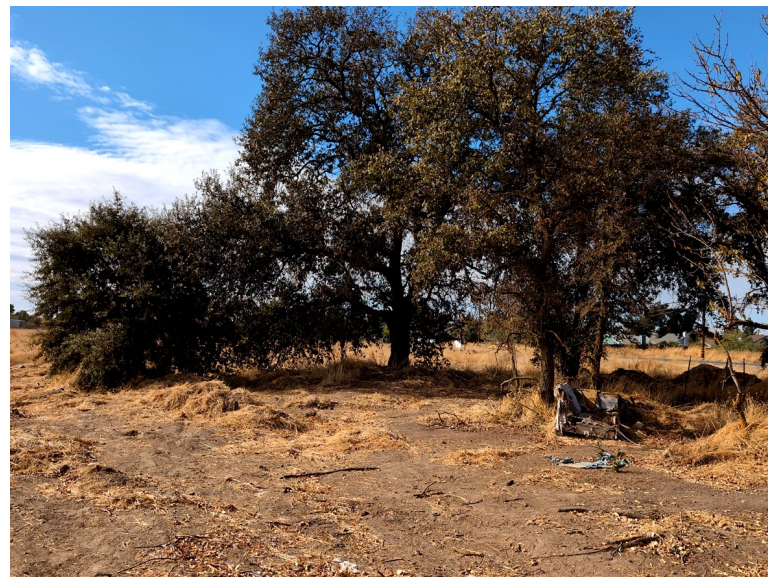
**Photo 4. Representative Photo of the Trees within the Study Area (facing northeast; October 30, 2024).**
