# **Tree Survey and Arborist Report**

*for an approximate 4.1-acre Site*

*Located at 2375 N Tustin St, Orange, California*

*Report Date: June 24, 2025*

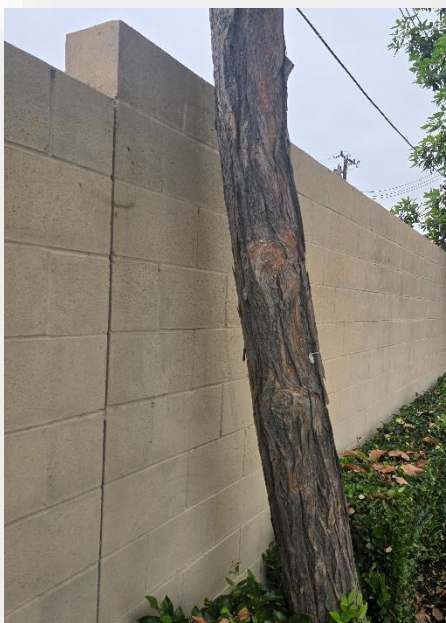
Plate 1. This is a view of a tree planted in close proximity to a block wall (#502).

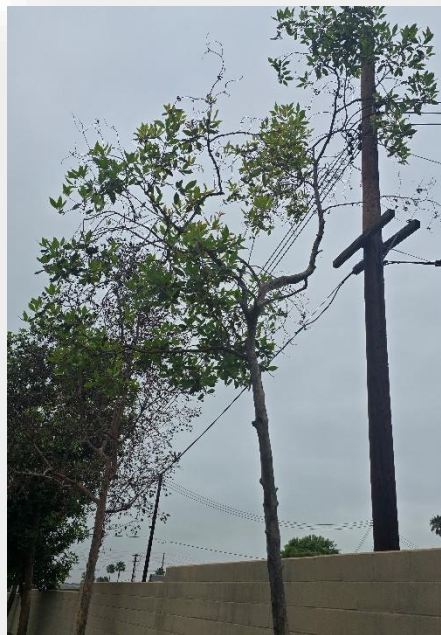
Plate 2. This is a view of a tree canopy with the potential of interfering with nearby electrical lines (#504).

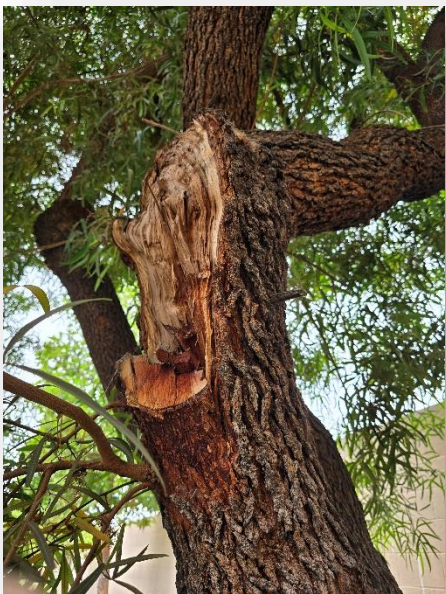
Plate 3. This is a view of a failed branch suggesting a potential of future failure elsewhere in the tree (#511).

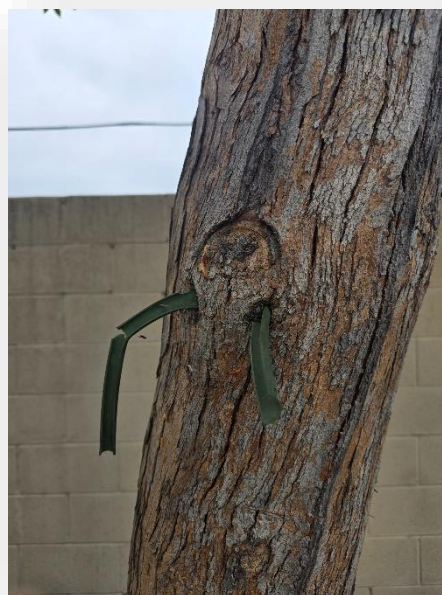
Plate 4. This is a view of an embedded tree tie within the tissue of the tree (#524).

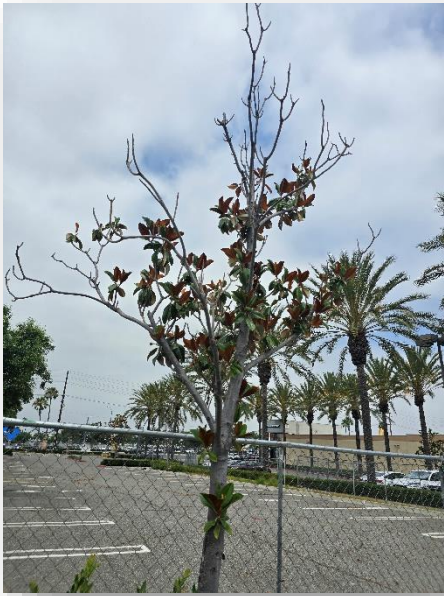
Plate 5. This is a view of upper canopy deadwood or retrenchment (#532).

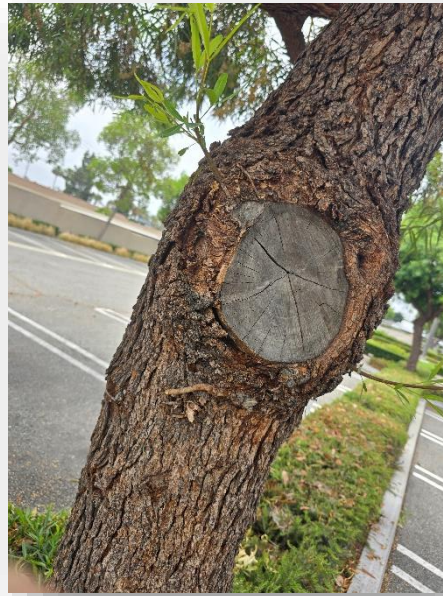
Plate 6. This is a view of the site of a flush cut pruning (#534).

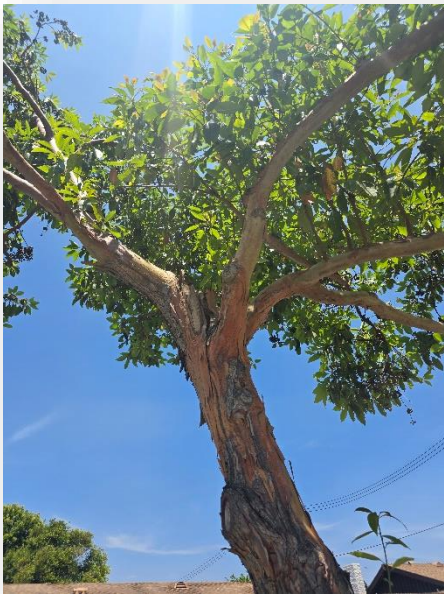
Plate 7. This is a view of a longitudinal stem split that presents an immediate **hazard** of a limb failure (#563).

| 563 | Brisbane Box | 9.5 | | | | | | 9.5 | 26 | 12 | 9 | 338 | 3 | 3 | 4 | Urgent attention needed to mitigate risk of failure | Remove |
| Failed upper limb, increased risk of future failure | | | | | | | | | | 12 | 8.5 | | | | | | |

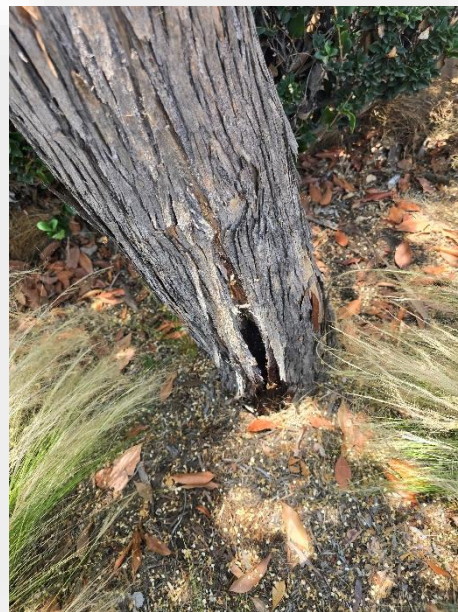
Plate 8. This is a view of exudation or staining within the lower stem of a tree (#565).

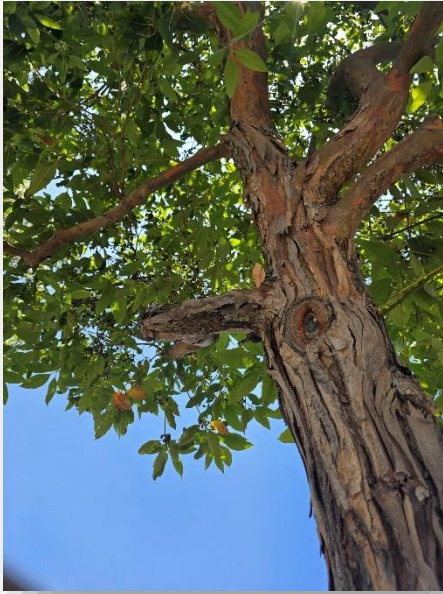
Plate 9. This is a view of tissue decay beneath a branch collar (#566).

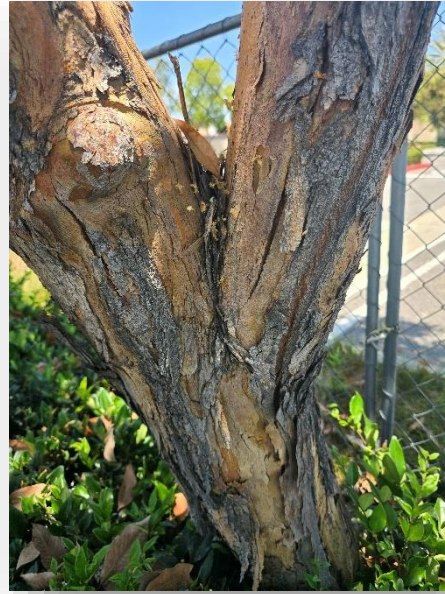
Plate 10. This is a view of included bark at the union of two stems (#727).
