## Preliminary Arborist Report

### Haker Bucknall Multi-Purpose Building San Jose, CA

**PREPARED BY:**  
HortScience | Bartlett Consulting  
2550 Ninth Street, Suite 112  
Berkeley, CA 94710

**January 2025**

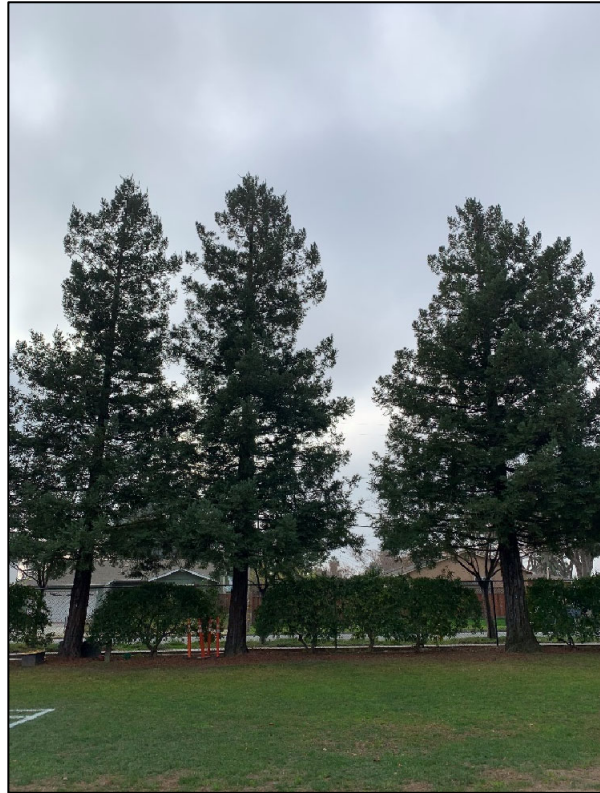
**Photo 1:** Coast redwoods #93 – 95 (left – right) were in good condition.

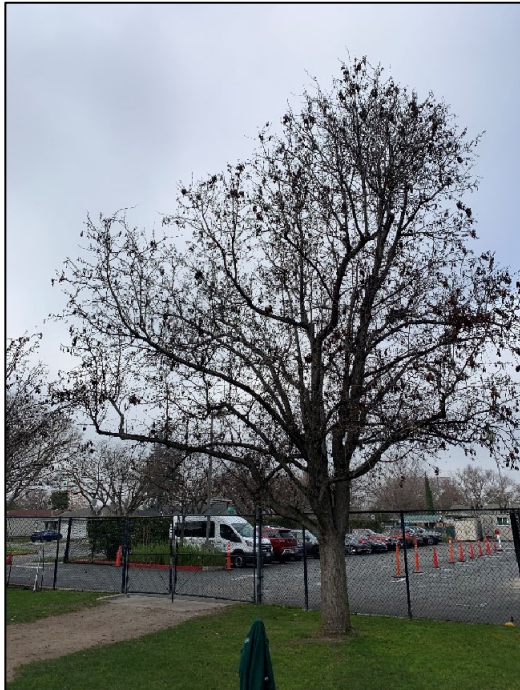
**Photo 2:** Several narrowly attached stems arose from a single point on the trunk of Callery pear #97.

such as moderate fire blight or mistletoe infestation. Pears in poor condition had more serious structural deficiencies like decay in the trunk or a severe lean.

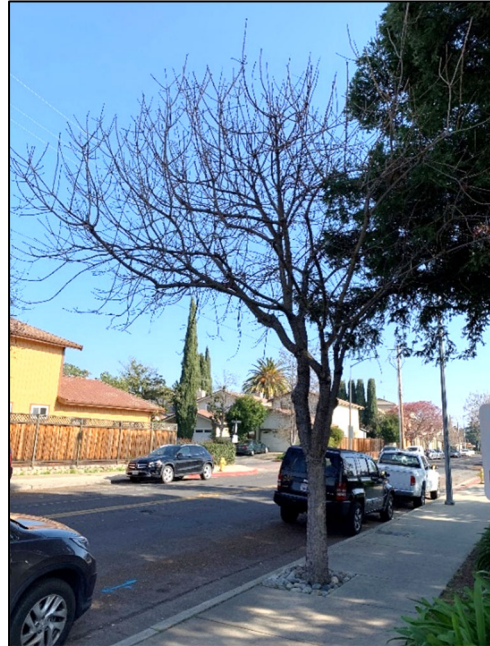
**Photo 3:** Chinese pistache #168 was in fair condition, having developed a one-sided crown due to competition for space with a nearby redwood.

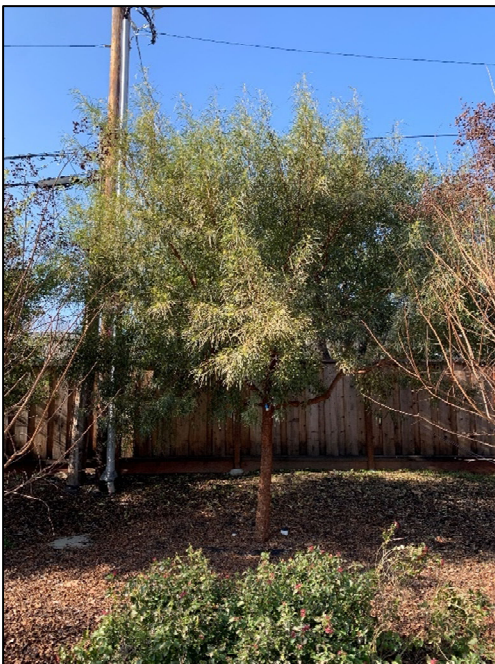
**Photo 4:** African sumac #17 was a good, young tree.

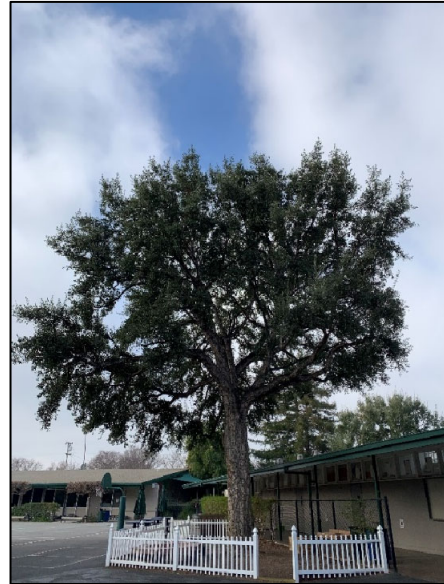
**Photo 5:** Cork oak #109 was in good condition with a well-structured, decurrent growth habit.
