### **ARBORIST REPORT**

# SBCA TREE CONSULTING

Date: September 27, 2024

Project: 43800 Osgood Rd. Tree Inventory

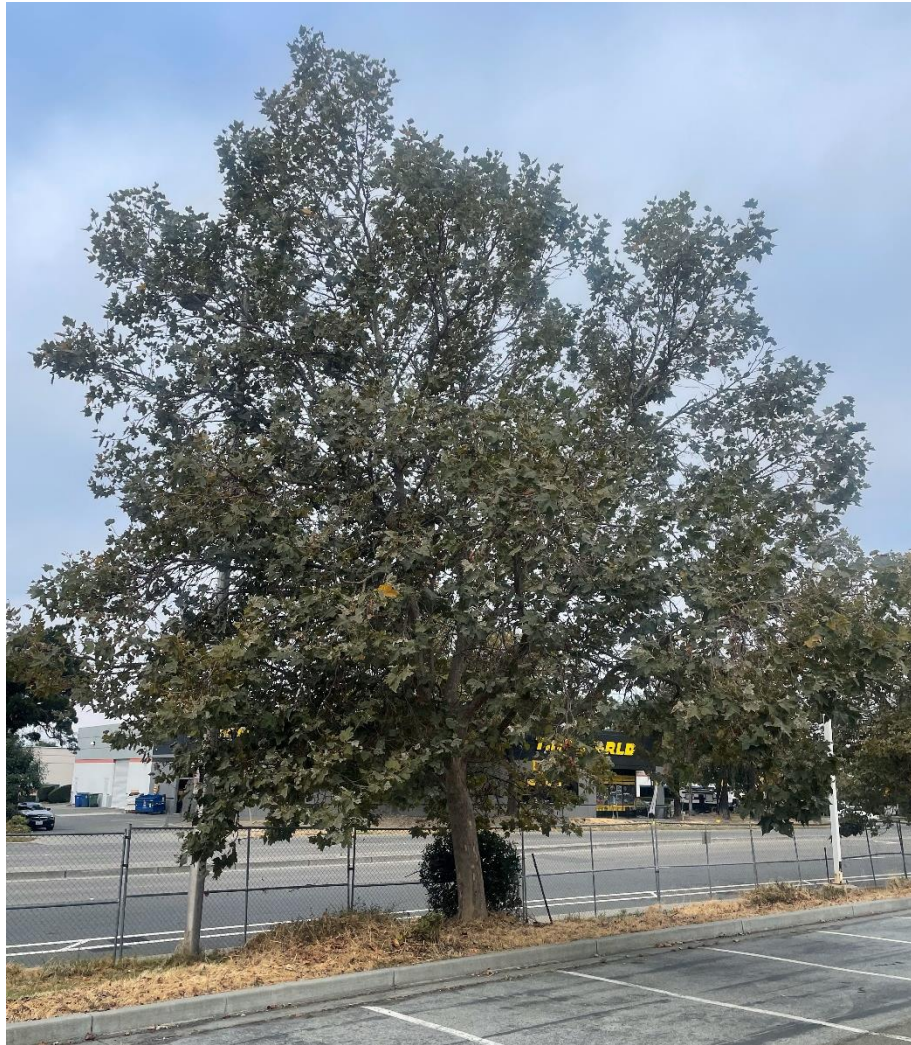
**Photo 1.** Photo shows London Plane tree #12 in good condition, with satisfactory vigor and foliage density. The tree is planted in a larger volume of soil than the parking lot trees, and its larger size reflects the benefits of this.

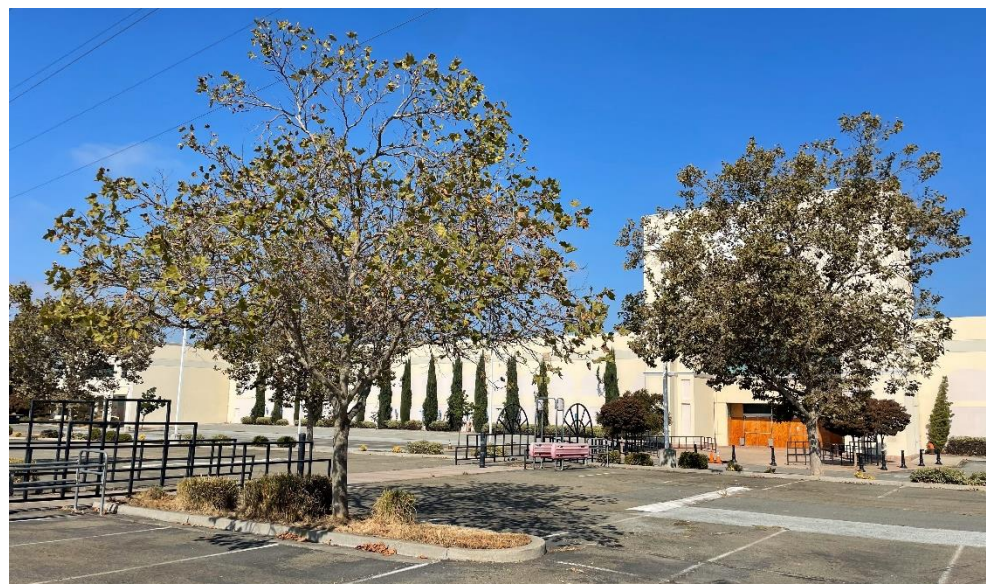
**Soil volume in the parking lot** – Trees located in the parking lot were observed to be in poor health conditions when available soil volume was limited. If the parking lot trees are proposed for retention, expansion of parkways and cut outs and improvement of soil cultural conditions is recommended.

**Photo 2.** Photo below shows London Plane #85 in the foreground and #60 is the background. There is a noticeable difference in health and vigor between the two trees, related to the allotted soil volume provided.

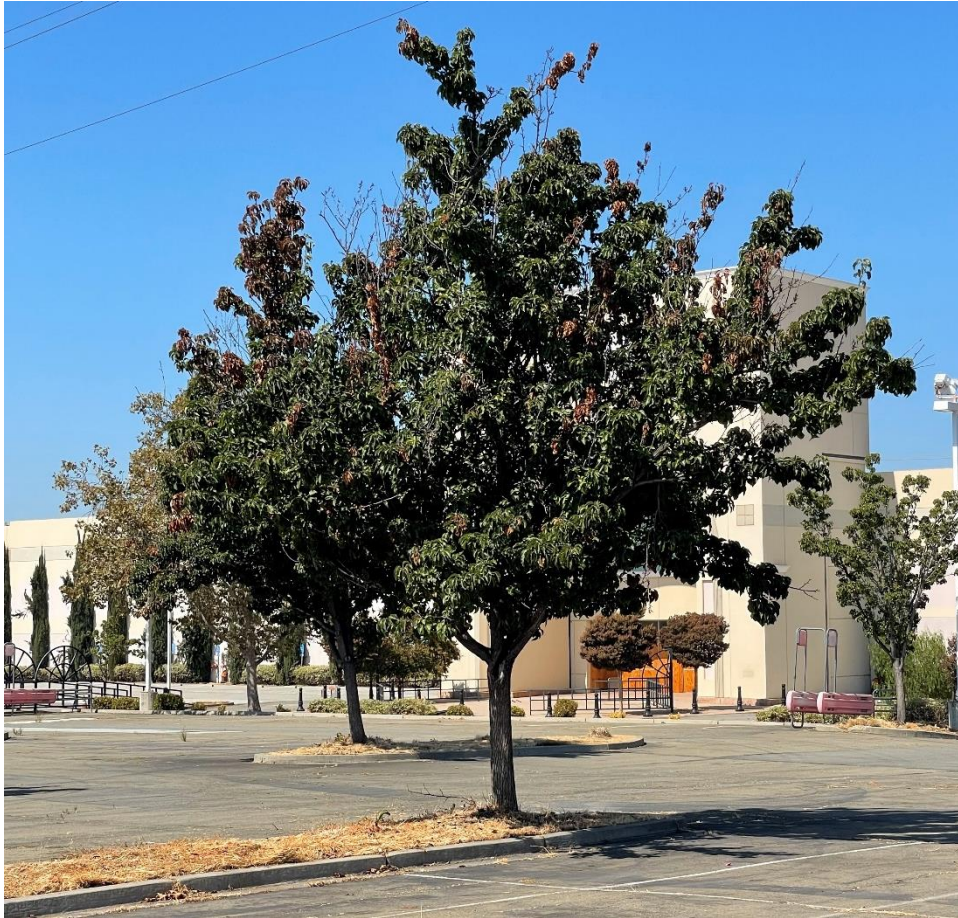
**Photo 3.** Photo left shows Callery Pear #89 that is relatively healthy and was able to grow to a good size, likely due to better nursery stock (less root boundness) and a larger volume of rootable soil.

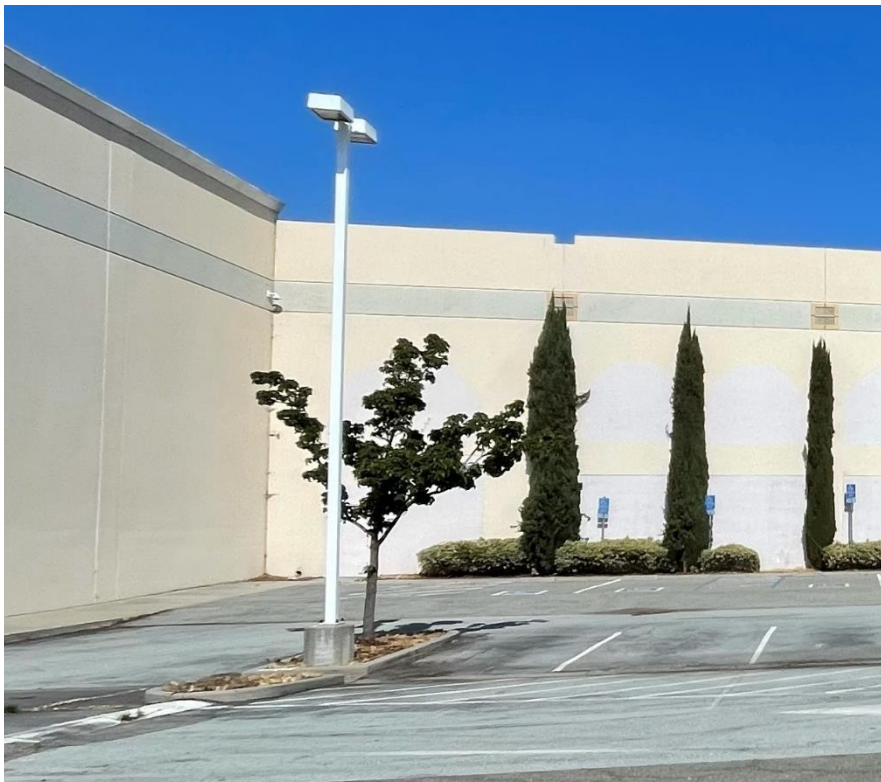
| | Species | Common Name | Total Amount | Protected Tree Amount | Overall Retention Suitability | Comments |
|---|---|---|---|---|---|---|
| 13 | <i>Pyrus calleryana</i> | Callery pear | 29 | 12 | Fair-Poor | Trees are in the parking lot. A few are large and healthy, but most are not thriving, possibly due to poor planting stock or inadequate soil volume. Fire blight disease and poor structures are common with this tree. |

**Photo 4.** Photo left shows Callery Pear #18, which has performed poorly with stunted growth. Most of the pears in the parking area were found to be in a similar condition to #18, rather than to #89 (above).

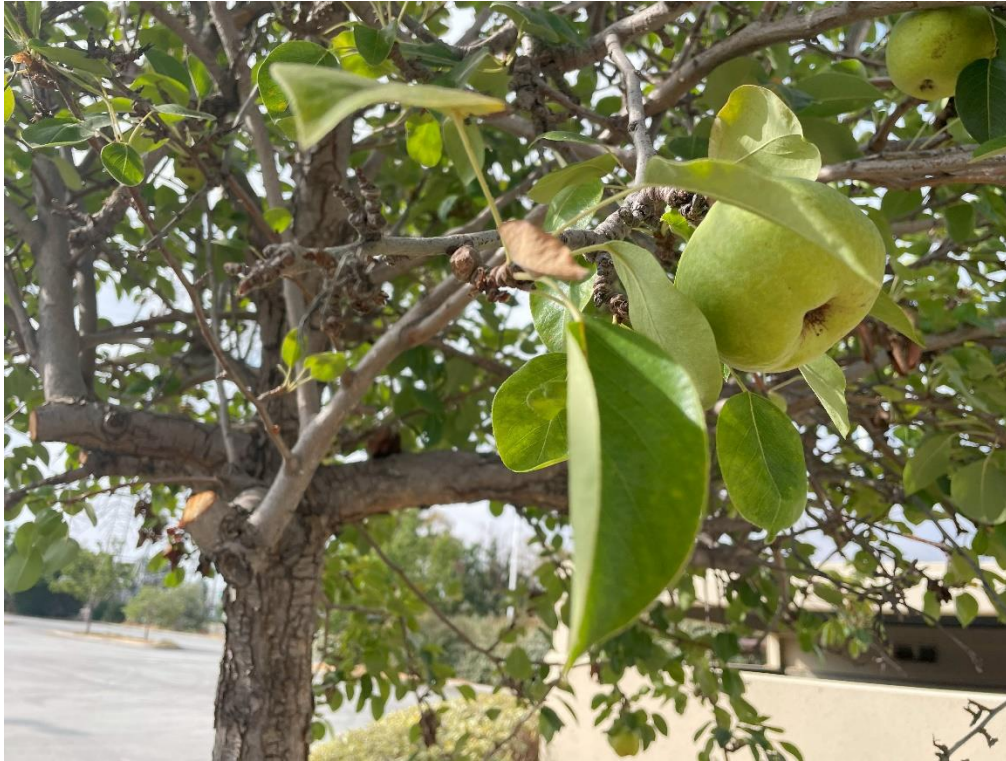
| | Species | Common Name | Total Amount | Protected Tree Amount | Overall Retention Suitability | Comments |
|---|---|---|---|---|---|---|
| 14 | <i>Pyrus communis</i> | Fruiting pear tree | 1 | | Poor | This fruiting pear is likely a mistake from the nursery. A few more undersized fruiting pears were noted in the parking lot. |

**Photo 5.** Photo left shows one of the fruiting pears that was noted in the parking lot. These were likely a mistake from the nursery and not a desirable tree for the location.

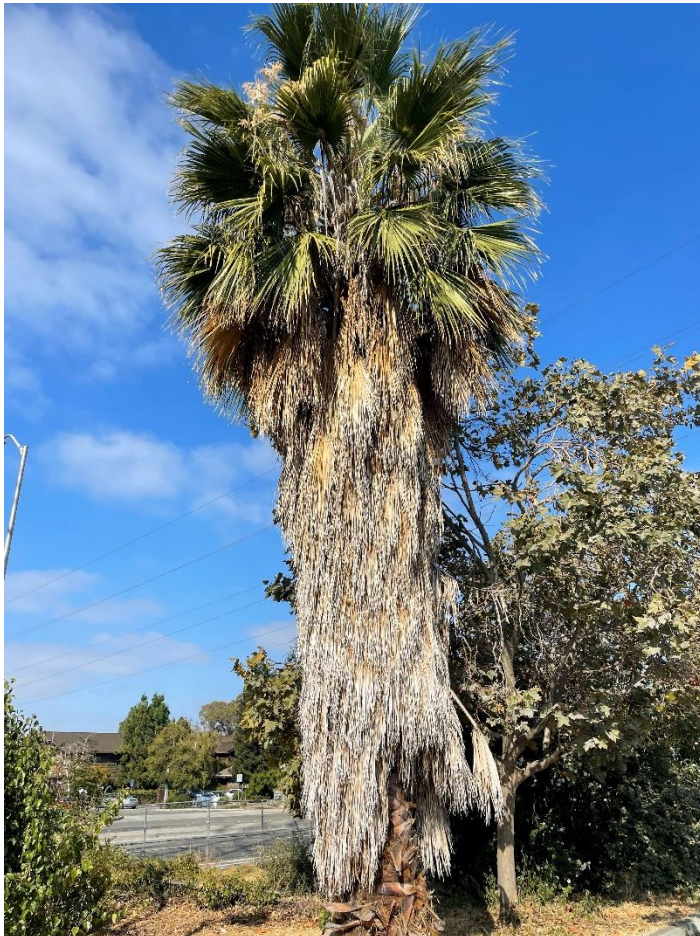
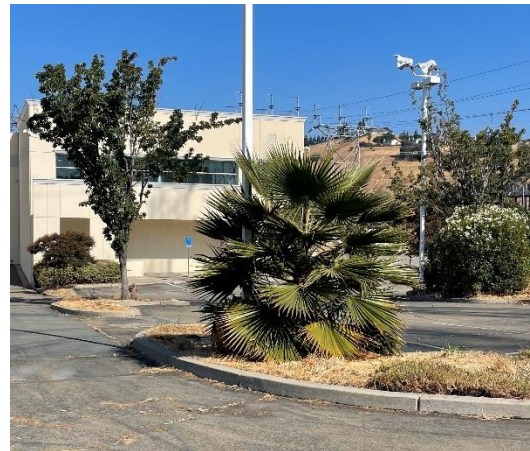
**Photos 6 and 7.** Photos left shows Palm #76. Estimated feet of Clear Trunk is 20'. The above photo shows a palm that was not included in the inventory due to small size.

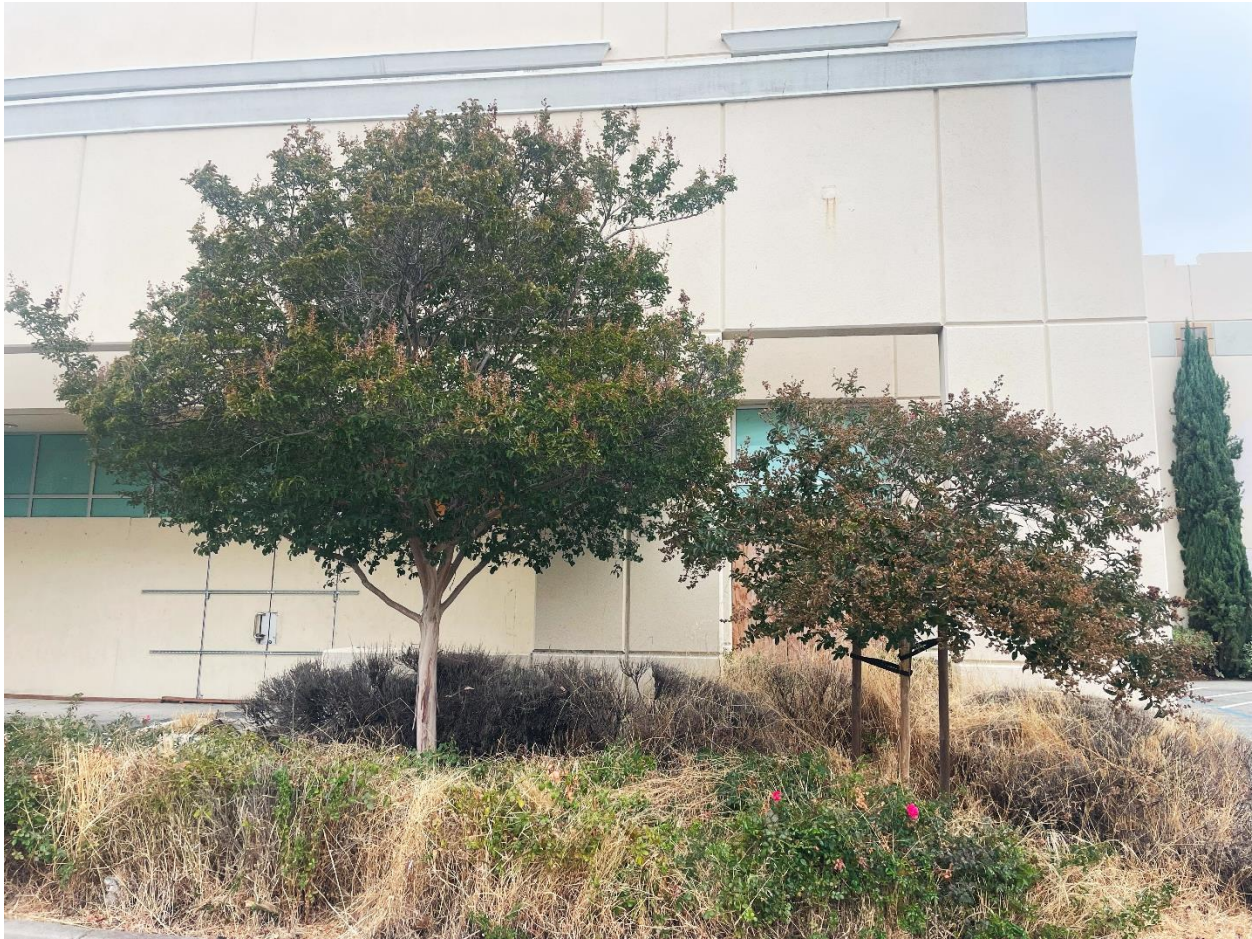
**Photo 8.** Photo above shows Tuscarora Crape Myrtle #17 to the left and an undersized Crape Myrtle to the right that was not surveyed

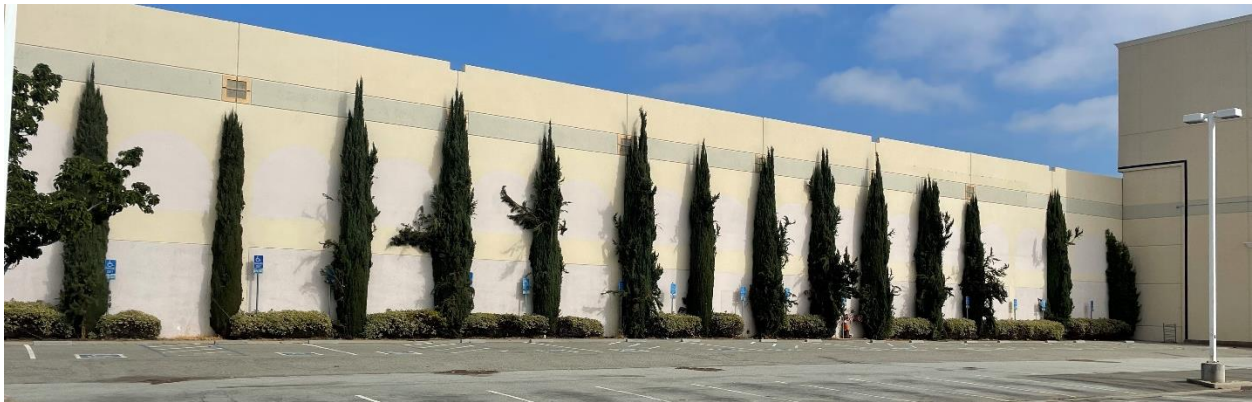
| | Species | Common Name | Total Amount | Protected Tree Amount | Overall Retention Suitability | Comments |
|---|---|---|---|---|---|---|
| 3 | <i>Cupressus sempervirens</i> | Italian Cypress | 19 | 19 | Good | All are located adjacent to and in contact with the building; Most require pruning/sheering to control branches falling away from canopy. DBH measurements were not possible, all tree diameters were taken at the base, all trees are considered protected unless City determines otherwise. |

**Photo 9.** Photo above shows one line of Italian Cypress along the building. Most of the trees have stems that are falling away from the canopies and, if retained, require pruning/shearing work. All trees are considered Protected. However, measurements were not possible at 4.5'.

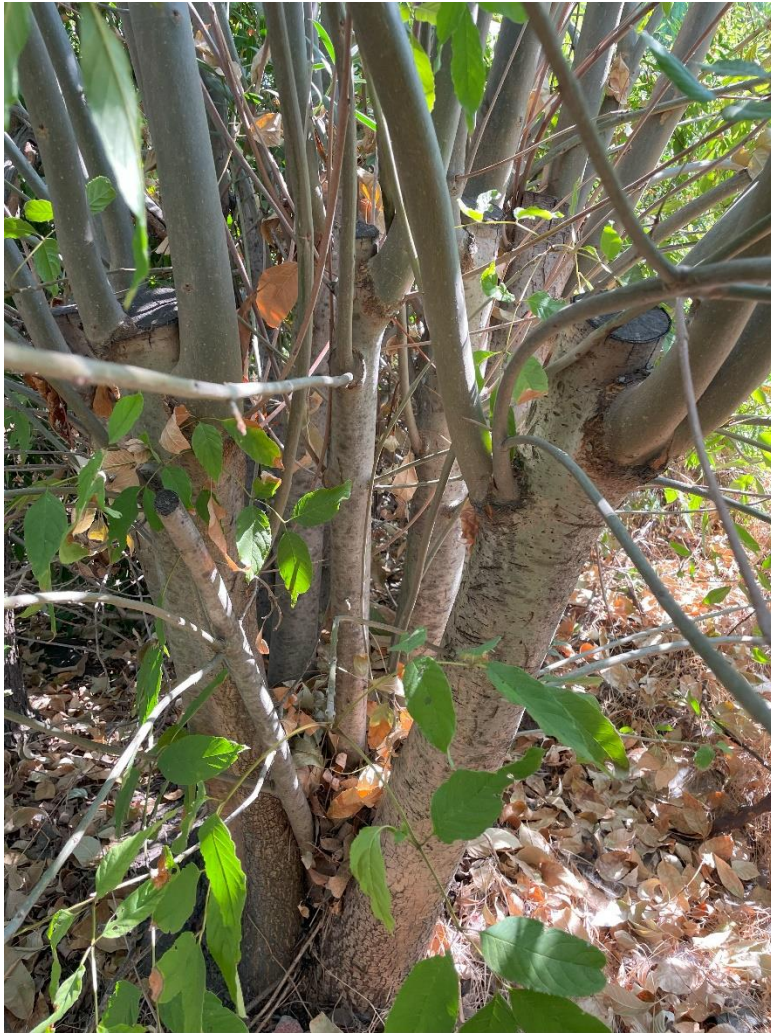
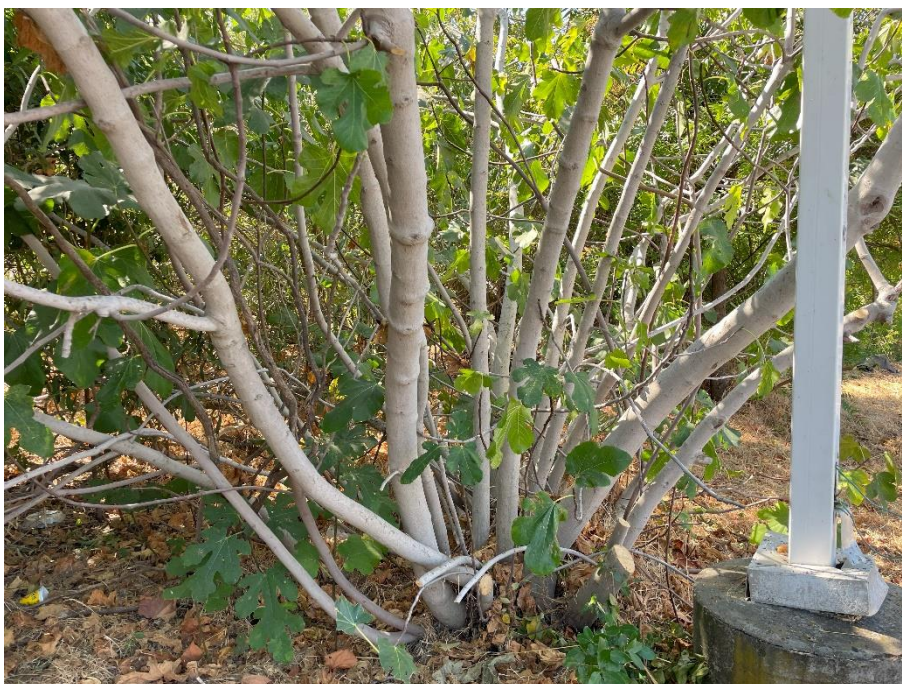
| | Species | Common Name | Total Amount | Protected Tree Amount | Overall Retention Suitability | Comments |
|---|---|---|---|---|---|---|
| 4 | <i>Ficus carica</i> | Fruiting Fig | 1 | 1 | Poor | Likely volunteer that came up from a seed; The tree has an excess of 20 stems. |
| 5 | <i>Fraxinus sp.</i> | Ash species | 2 | 2 | Poor | Both ash were headed at 3' and 4' for high voltage line clearance. Significant response growth suckering. It is the arborist's opinion that these should not qualify as protected due to the heading cuts and suckering. |

**Photos 10 and 11.** Photos this page show ash #121 (left) and fig #122 (below). Adding the cross-sectional areas of all the suckers qualify these trees as protected. However, it is our professional opinion that they should not be distinguished as protected to their very poor structures.

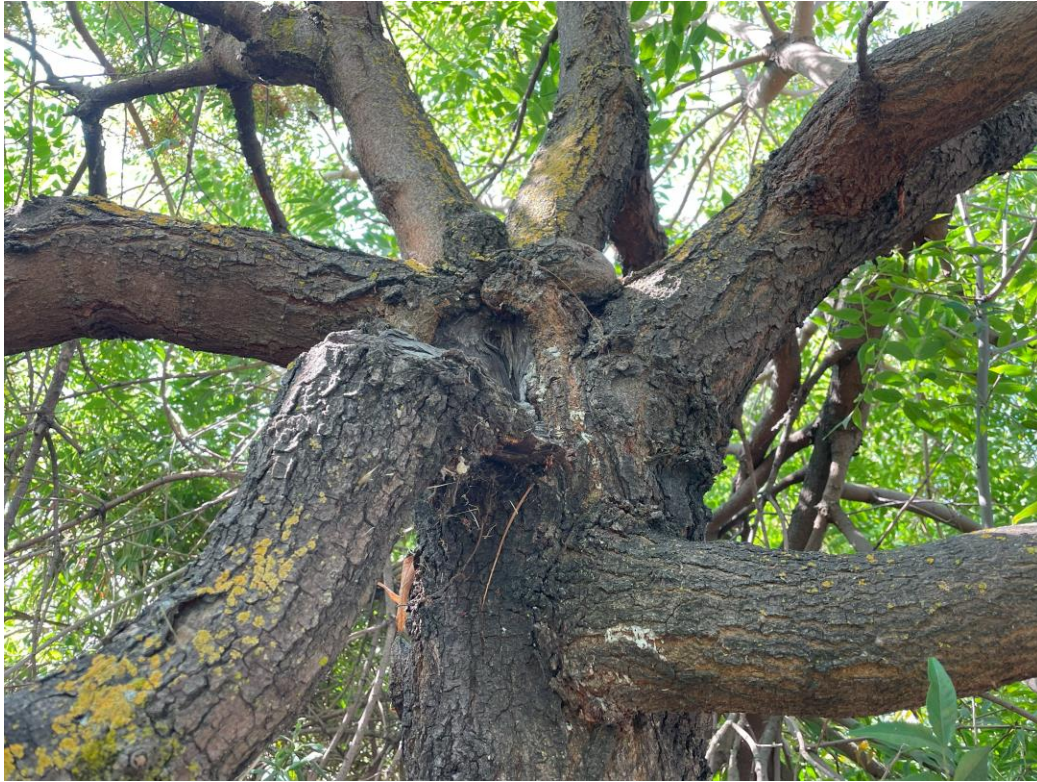
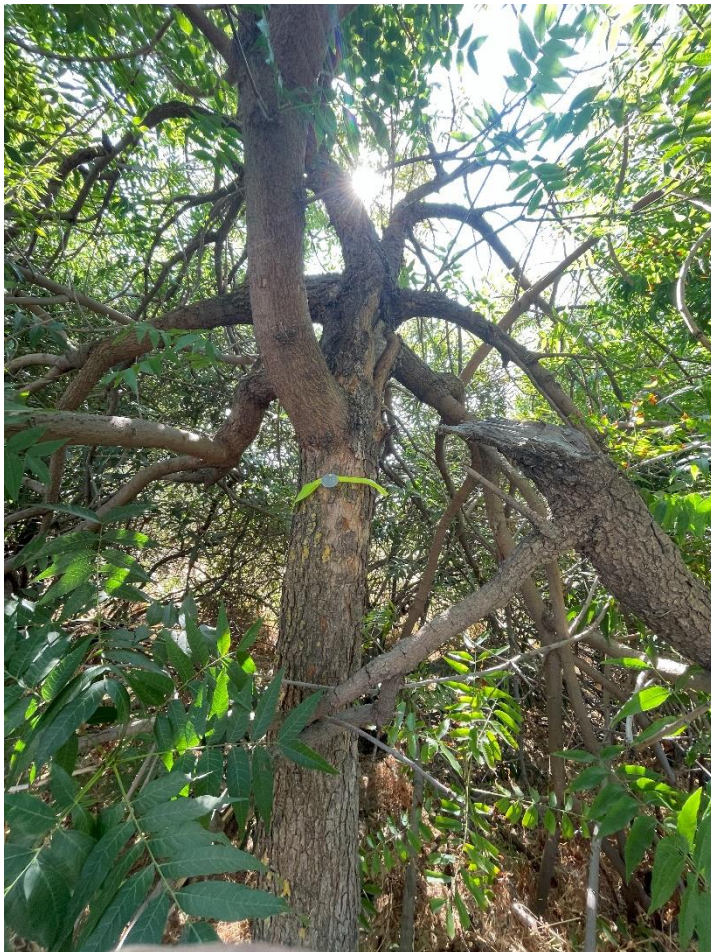
| | Species | Common Name | Total Amount | Protected Tree Amount | Overall Retention Suitability | Comments |
|---|---|---|---|---|---|---|
| 10 | <i>Pistacia chinensis</i> | Chinese Pistache | 29 | 24 | Good-Poor | Drought tolerant species; Clearance pruning is required for many; Many trees along southern property line suffered catastrophic main stem failures from lack of pruning care. |

**Photos 12 and 13.** *Photos this page show two Chinese Pistache along the southern property line that have suffered catastrophic stem failures due to problematic included bark stem attachments and lack of structural pruning care. Ten Chinese Pistache in this area were noted with such failures.*

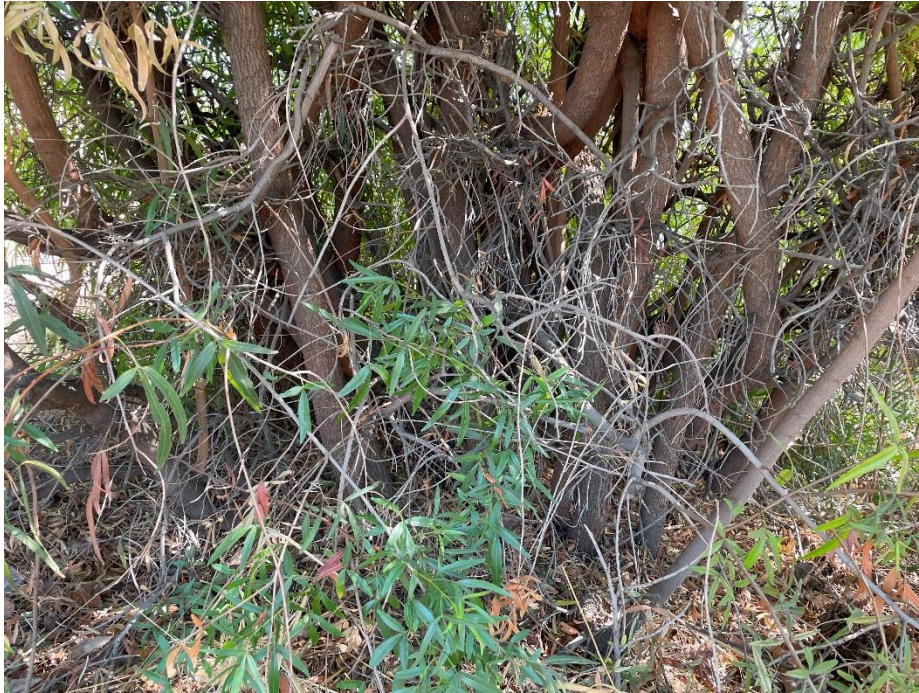
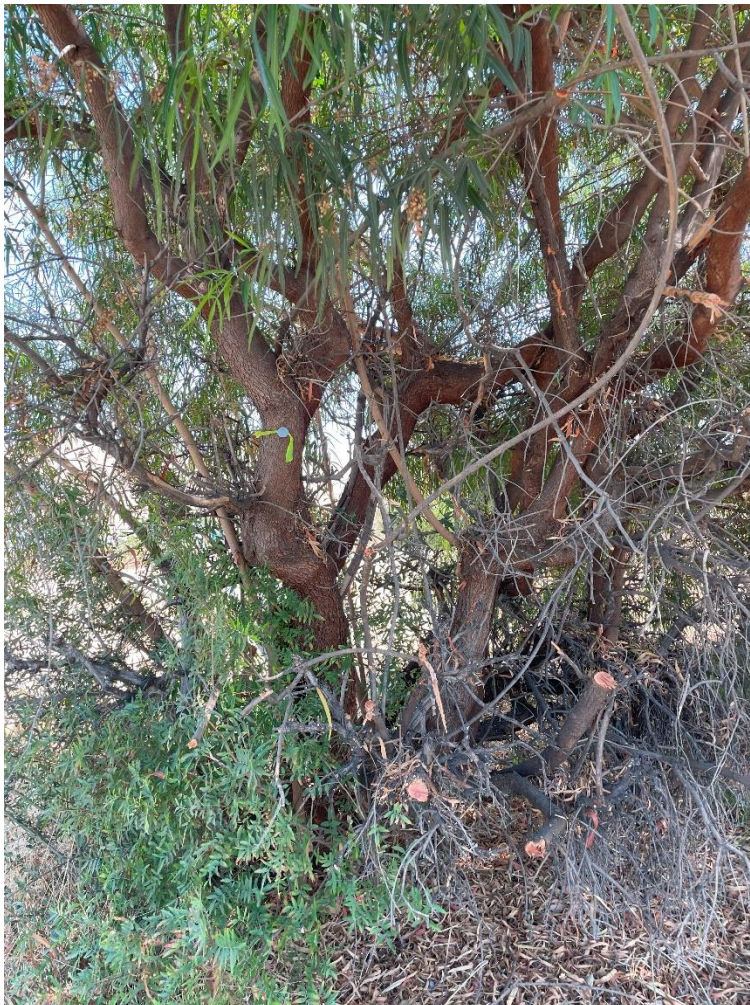
| | Species | Common Name | Total Amount | Protected Tree Amount | Overall Retention Suitability | Comments |
|---|---|---|---|---|---|---|
| 16 | <i>Searsia lancea</i> | African Sumac | 3 | 3 | Poor | Extremely problematic structures made up of multiple suckers. Recent heading cuts were observed, likely for clearance. |

**Photos 14 and 15 –** *Photos this page show two of the three African Sumac and problematic structures. They were given a poor suitability for retention rating due to expected future maintenance requirements.*
