# Tree Survey and Arborist Report

*For an Approximate 13.8-acre Site*

*Located at the NE C/O Hughes Way and Via Oro Ave. in Long Beach, CA*

Report Date: October 9, 2024 (Revised March 6, 2026)

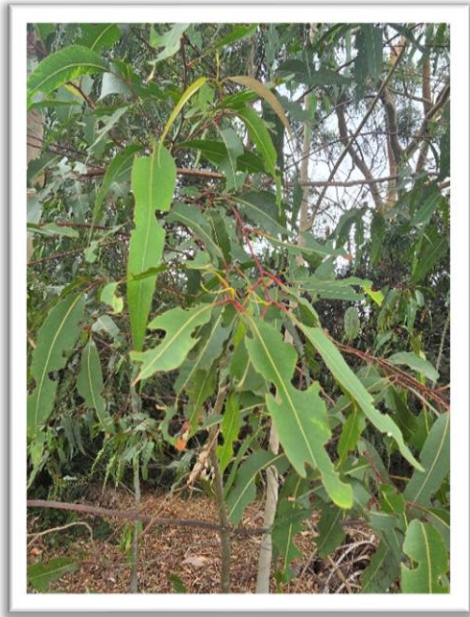
Plate 1. This is a view of significant foliage herbivory (#773).

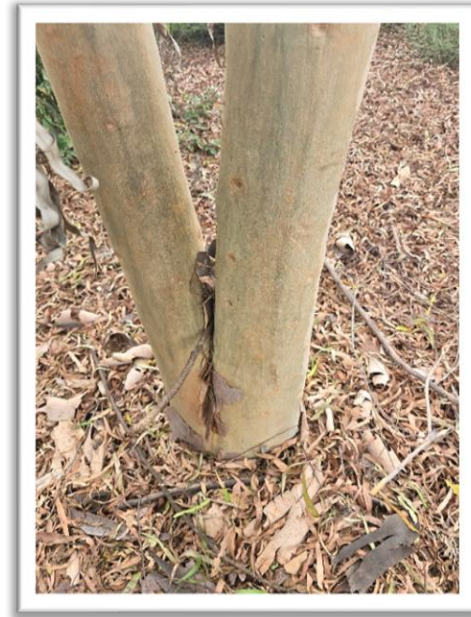
Plate 2. This is a view of a codominant stem system with included bark (#774).

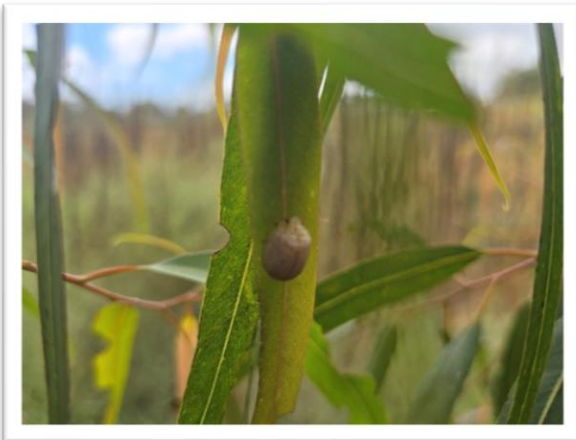
Plate 3. This is a view of a dotted paropsine leaf beetle (*Paropsis atomaria*) on the leaf of a subject tree (#774).

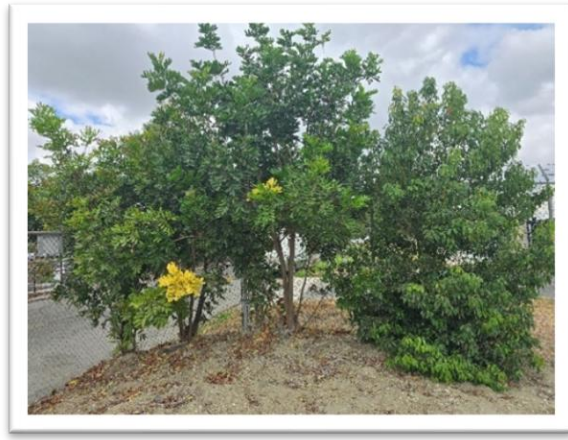
Plate 4. This is a view of several small trees grown along the fence line that have embedded fence in their tissue (#778-779).

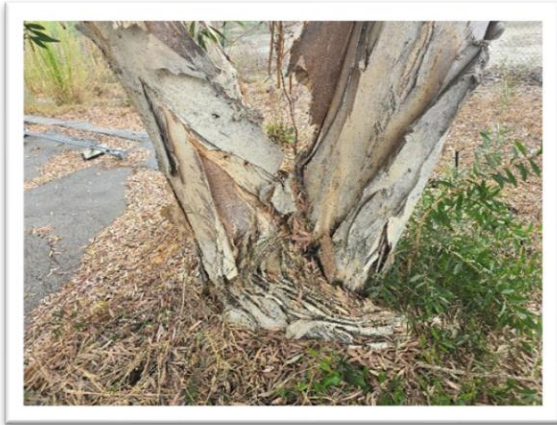
Plate 5. This is a view of large codominant stems with included bark (#780).

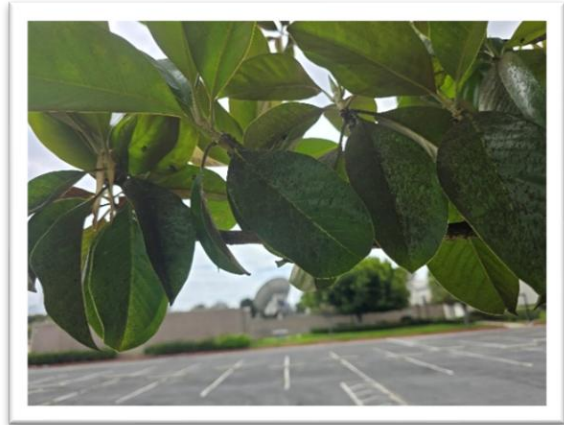
Plate 6. This is a view of sooty mold on the foliage of a tree (#798).

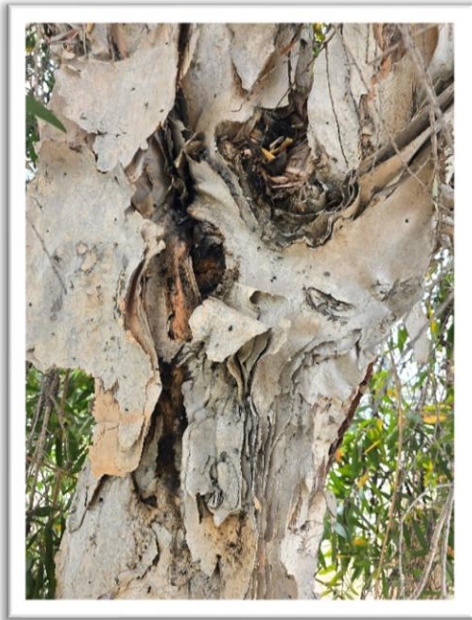
Plate 7. This is a view of two cankers with decayed tissue (#780).

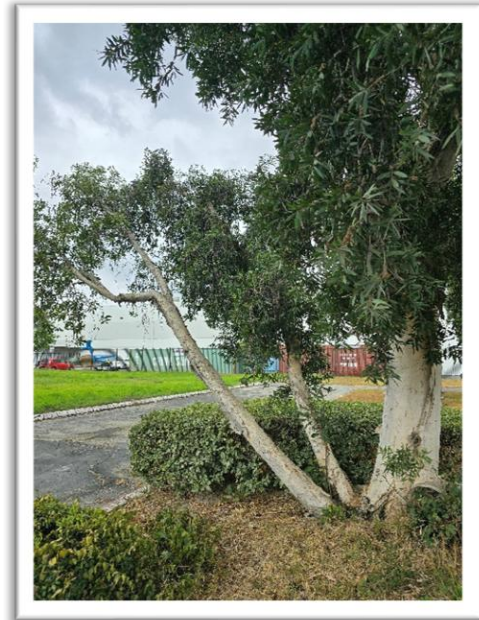
Plate 8. This is a view of large epicormic basal sprouters (#788).

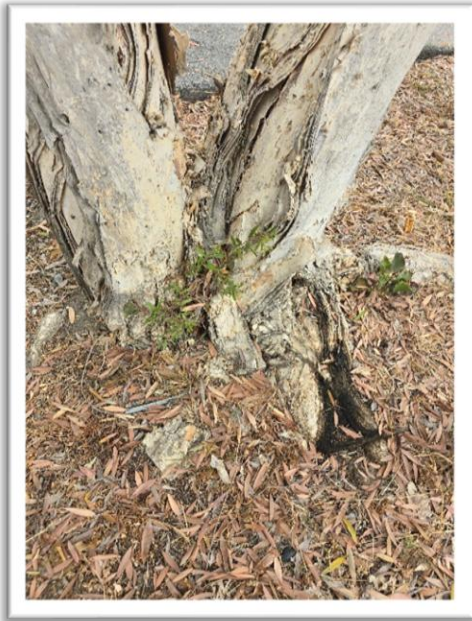
Plate 9. This is a view of decay on a structural root (#792).

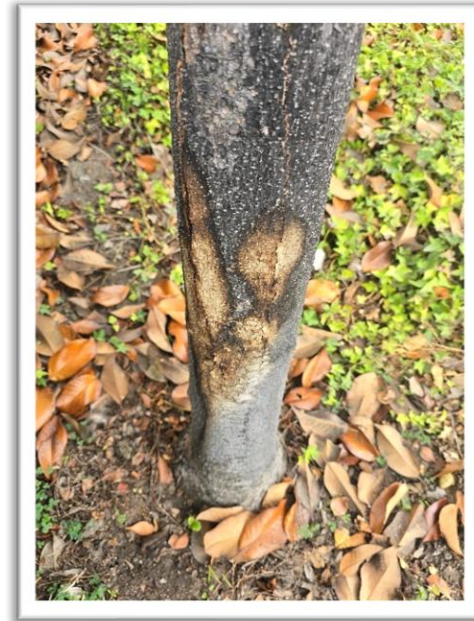
Plate 10. This is a view of stained bark with cankers (#794).

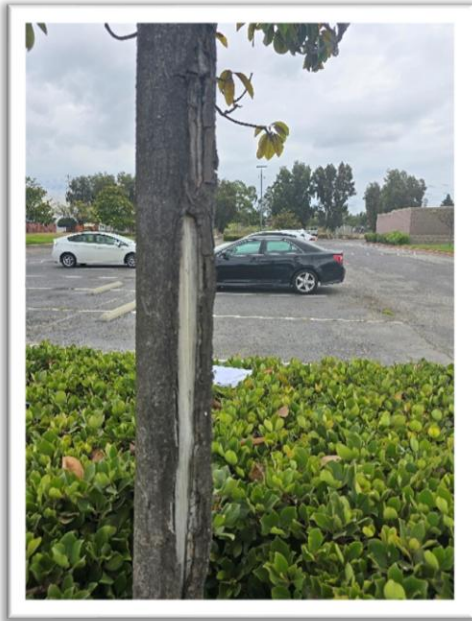
Plate 11. This is a view of a large longitudinal stem canker (#809).

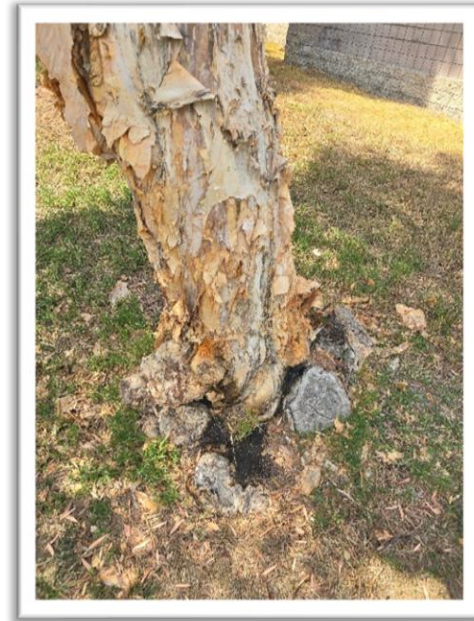
Plate 12. This is a view of decay at the flare of a tree (#822).

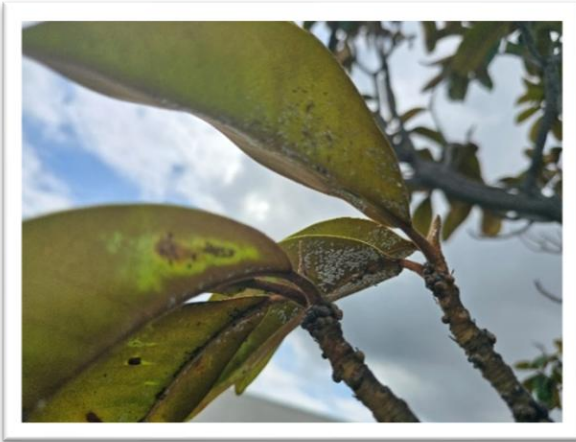
Plate 13. This is a view of magnolia scale, (*Neolecanium cornuparvum*) on twigs and leaves (#809).

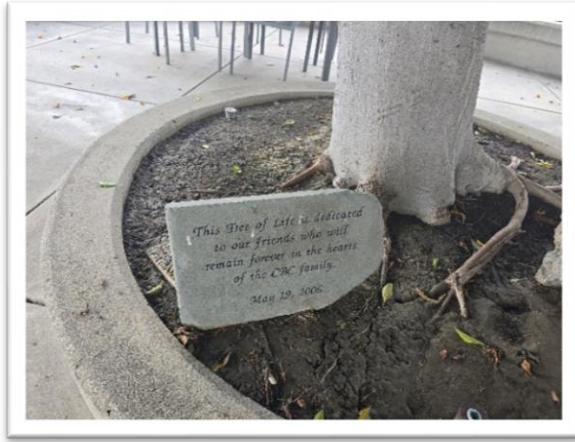
Plate 14. This is a view of a tree planted as a memorial to past staff members of the facility (#812).

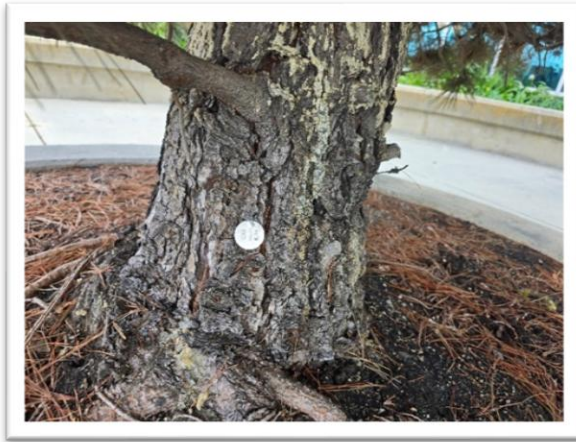
Plate 15. This is a view of severe gummosis on the stem of a tree (#815).

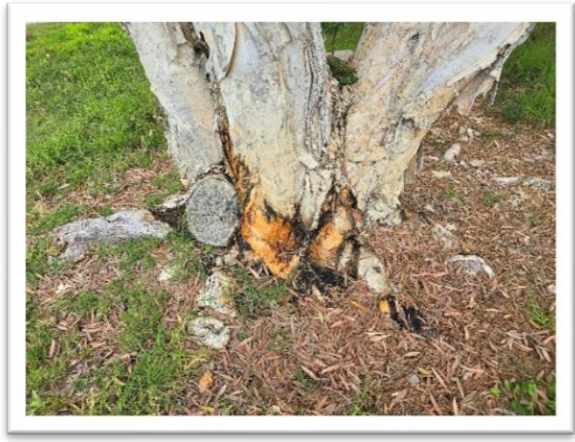
Plate 16. This is a view of codominant stems with included and decayed tissue (#832).

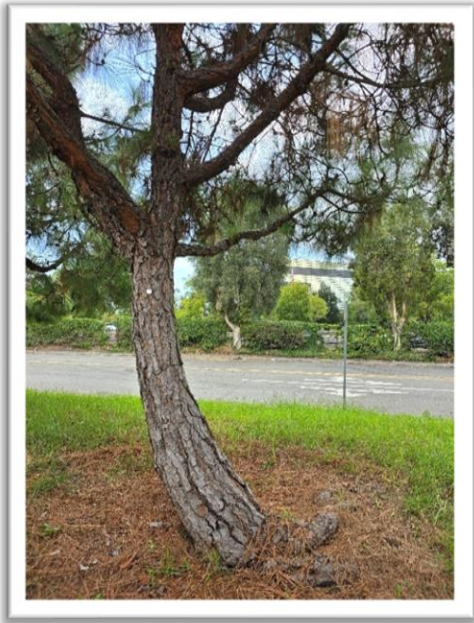
Plate 17. This is a view of a stem with significant sweep lean (#827).

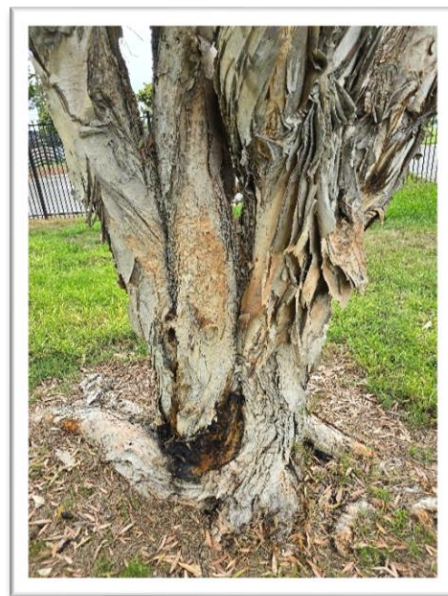
Plate 18. This is a view of included bark and decayed tissue at the flare of a tree (#851).

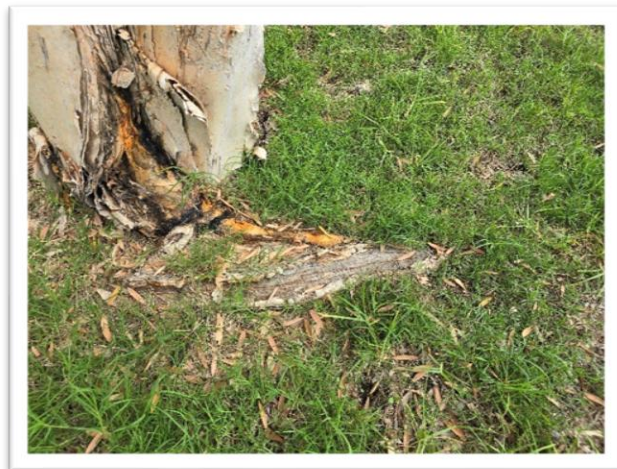
Plate 19. This is a view of a structural root with a canker (#849).
