# ARBORIST REPORT AND TREE PROTECTION PLAN

CA-7286  
5017 Terrace Ave.  
Lakeport, CA

December 2023

Arborist Report & Tree Protection Plan for  
5017 Terrace Ave. (CA-7286)  
Lakeport, CA

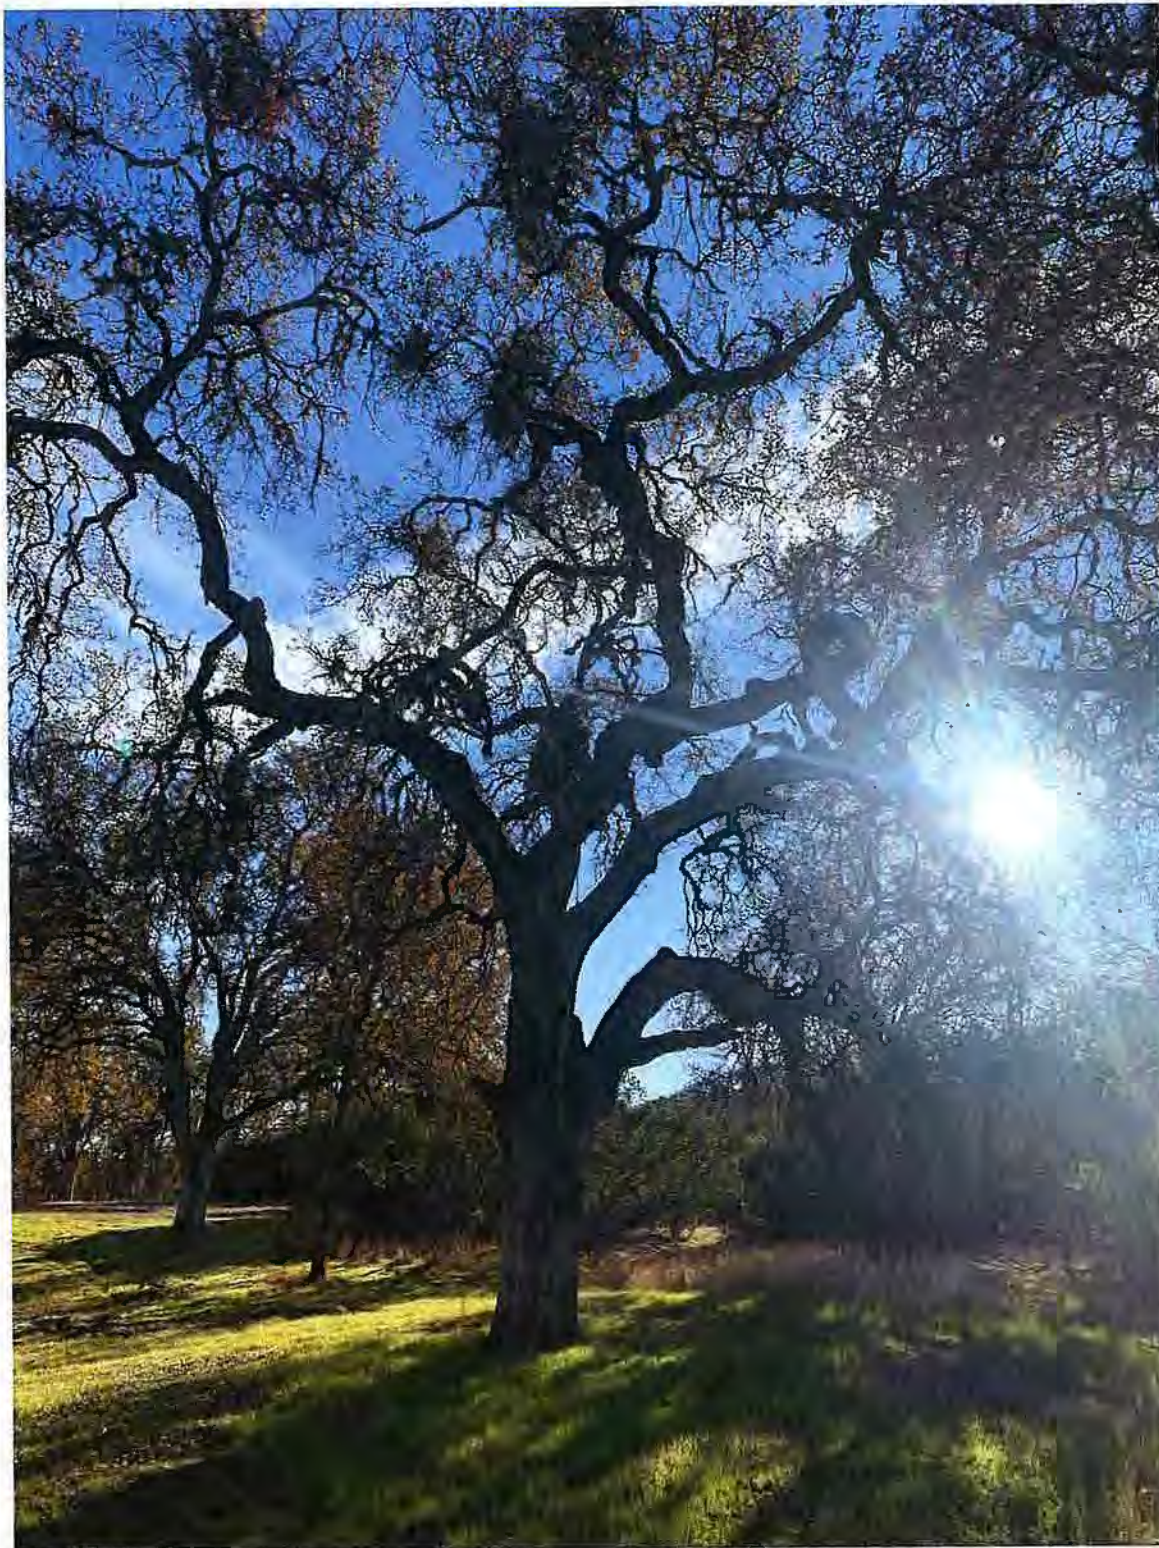
**Photo 6. Another angle of tree #24. Deadwood over 2" diameter should be trimmed and removed.**

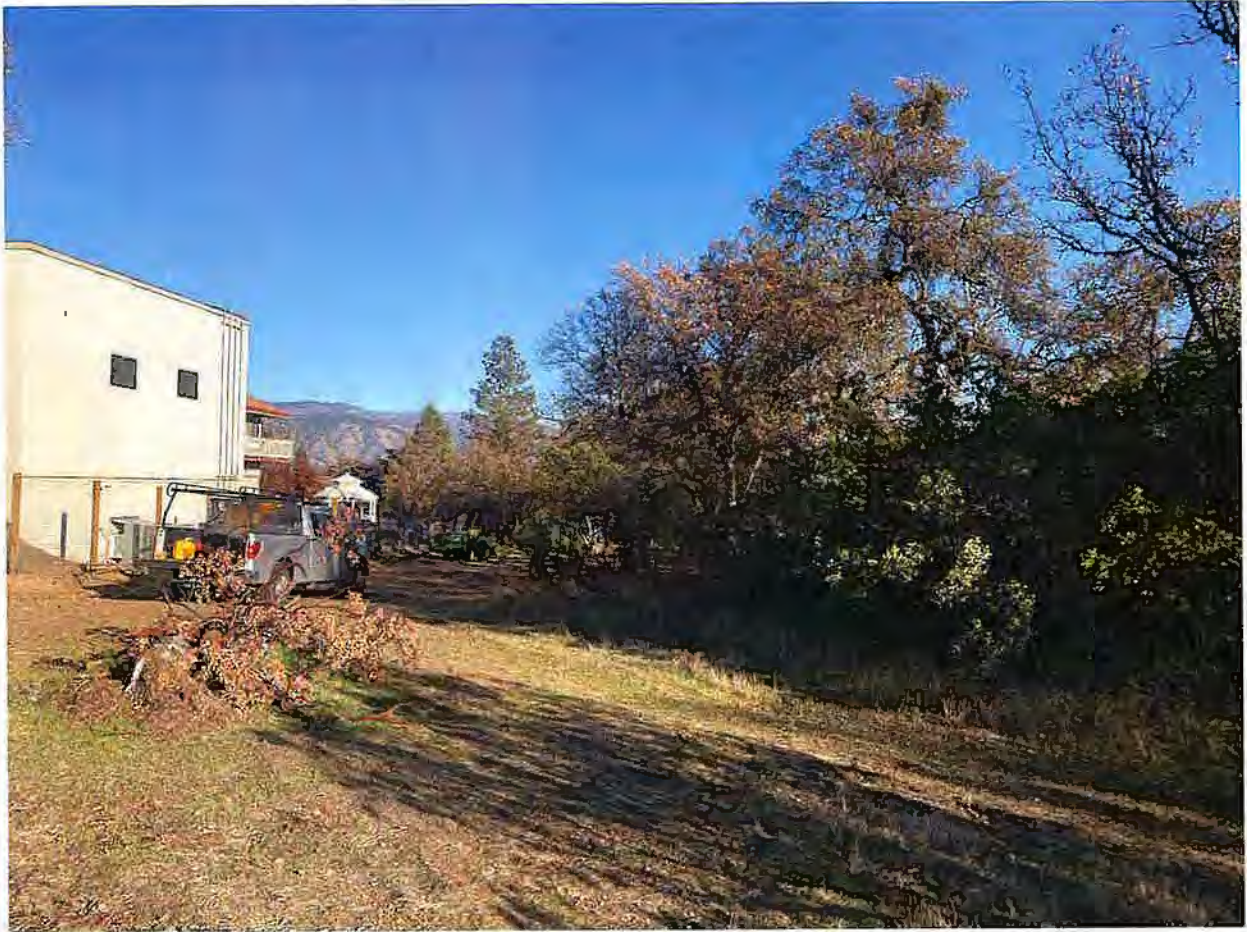
**Photo 7. Area of proposed fenced compound lease area adjacent to trees #26-#28. Any construction within the TPZ of these trees must follow tree protection measures.**

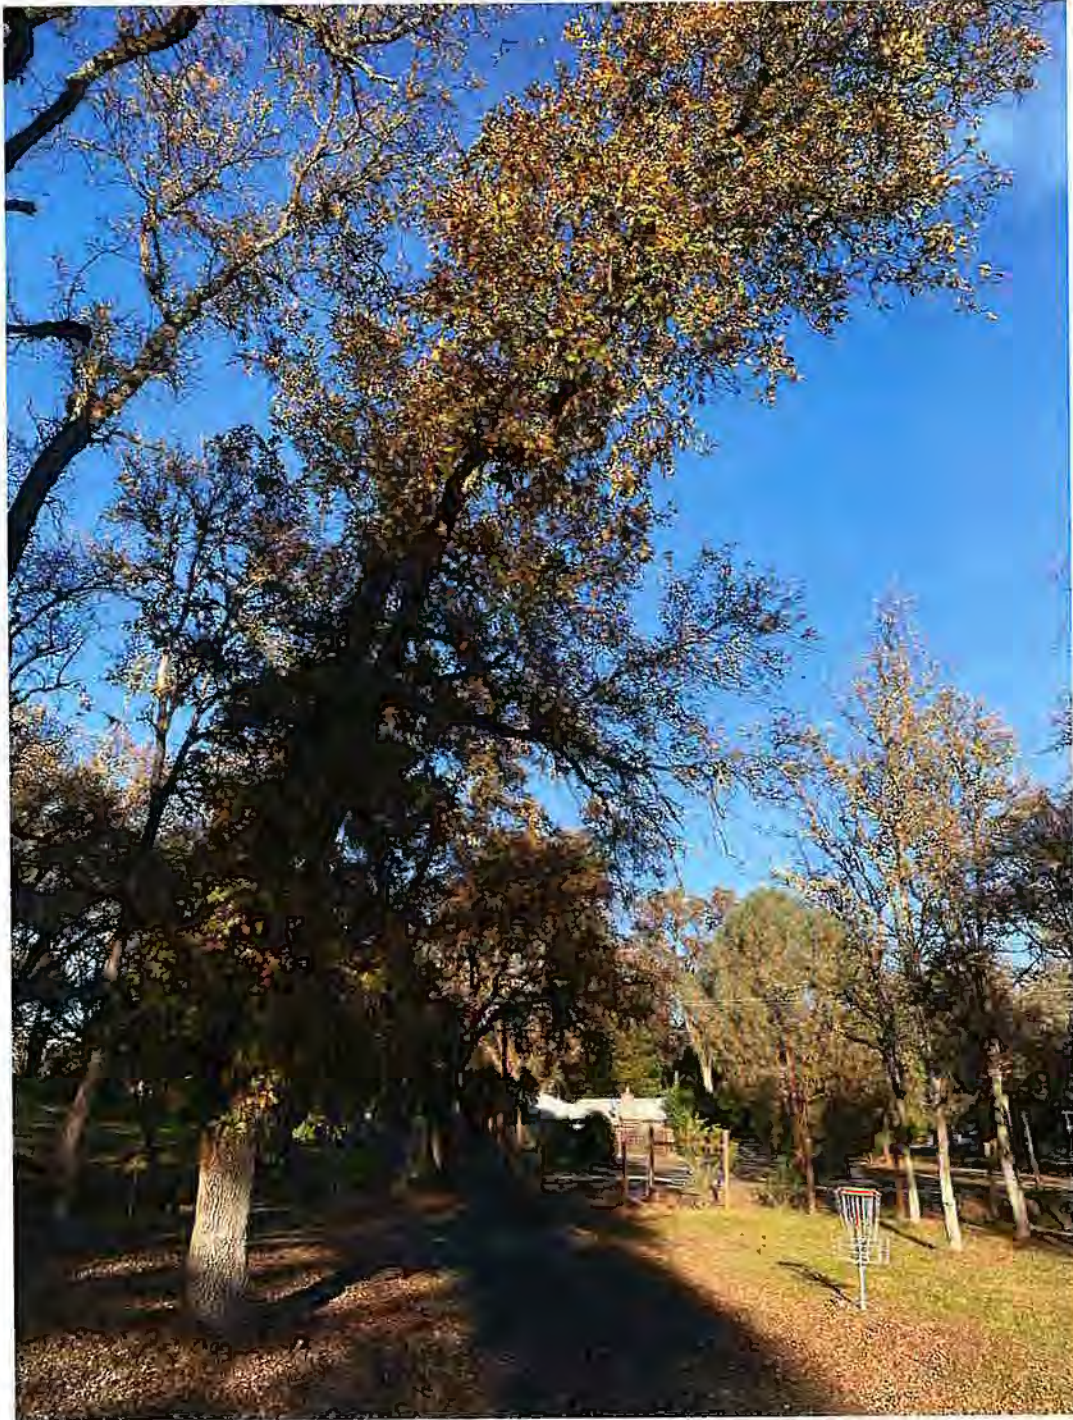
**Photo 8. Tree #50 is leaning over the road near the entrance to the property. Impacts within the TPZ and SRZ from road construction are expected.**
